AIRCRAFT ACCIDENT REPORT AND EXECUTIVE SUMMARY

Reference:	CA18/2/3/9780	
Aircraft Registration	ZS-ICB	Date of Accident	29 March 2019		Time of Accident	1430Z	
Type of Aircraft	Piper PA 30		Type of Operation		Training (Part 141)		
Pilot-in-command Licence Type	Airline Transport Pilot Licence		Age	30	Licence Valid	Yes	
Pilot-in-command Flying Experience	Total Flying Hours		3846.3		Hours on Type	148.4	
Last Point of Departure		Rand Aerodrome (FAGM), Gauteng					
Next Point of Intended Landing		Syferfontein Aerodrome (FASY), Gauteng					
Location of the accident site with reference to easily defined geographical points (GPS readings if possible)							
Westonaria 16nm south-west of Johannesburg CBD at the following GPS co-ordinates: S20° 11' 54" E027° 46' 43.5" with an elevation of 5393ft							
Meteorological Information		Wind: 170° at 06 kts, Visibility: CAVOK, Temperature: 28°C, Dew point: 07°C, Query Nautical height (QNH): 1022hpa					
Number of People On-board	2+0	No. of People Injured	2	No. of People Killed	0

Reference Number : CA18/2/3/9780
Name of Owner : Panayiotou C
Name of Operator : Johannesburg School of Flying
Manufacturer : Piper Aircraft Corporation
Model : PA-30
Natio

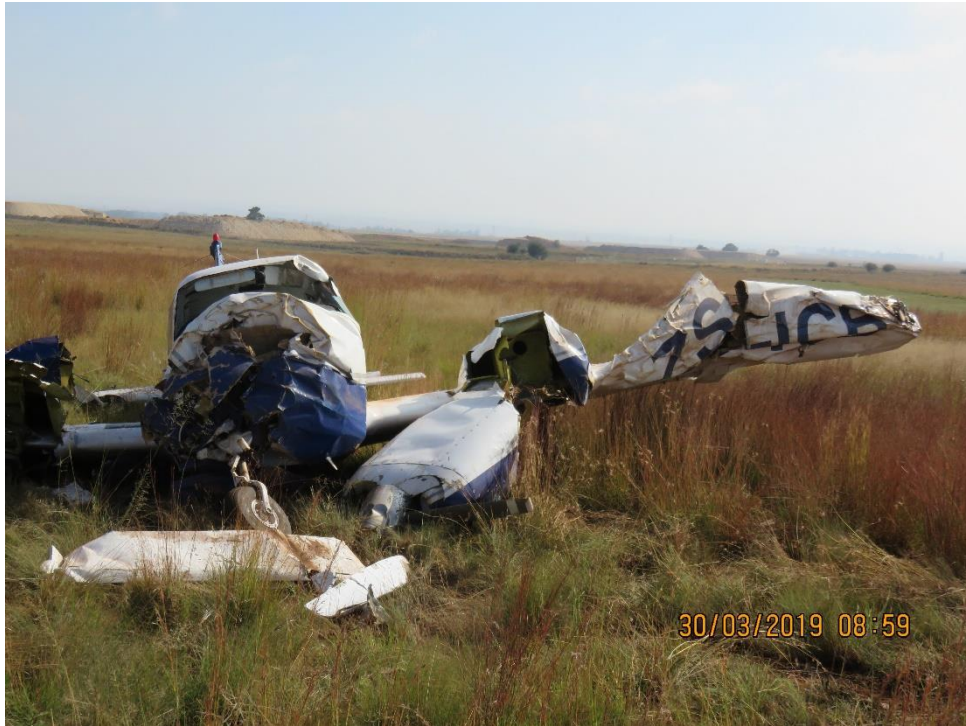
1.3.1 The aircraft was destroyed during the accident.

Figure 2: The aircraft's wreckage at the accident site.

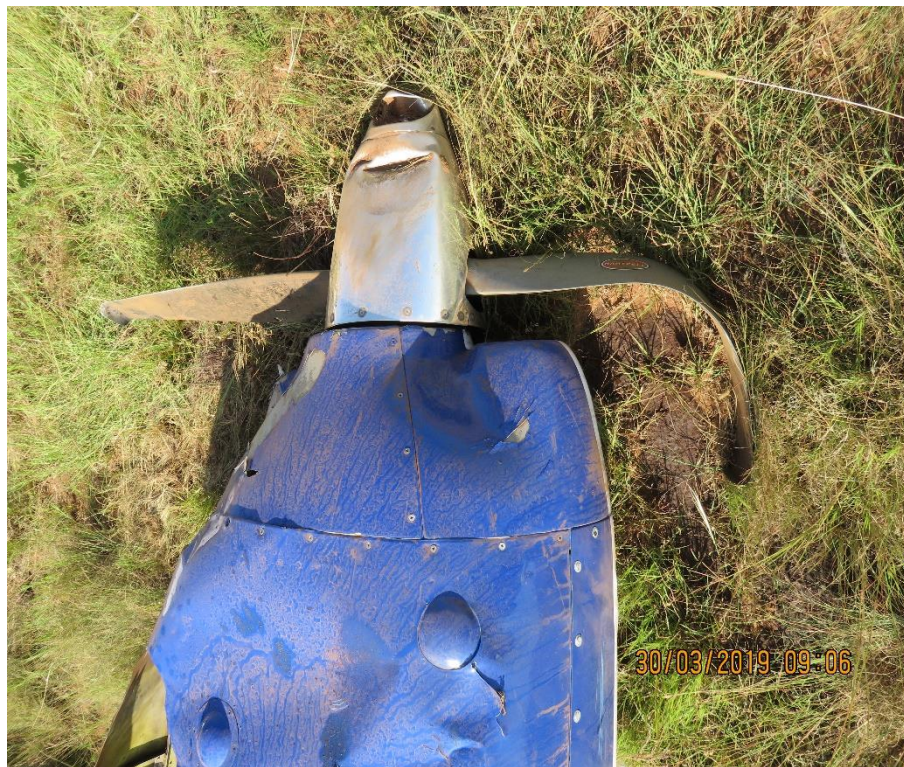
1.12.1 During the second asymmetric circuit exercise, the student pilot applied power to increase speed and, when the aircraft reached 80kts, the student pilot rotated the aircraft. At this time, the instructor felt a sharp pull to the right. The instructor noticed that the right-side engine RPM on the instrument panel were fluctuating. He then took control of the aircraft and tried to continue with the flight by pulling back the right-side throttle and feathering the engine. The aircraft yawed to the right and the right-side wing dropped and impacted the ground.

Figure 3: The damaged right-side engine propeller.

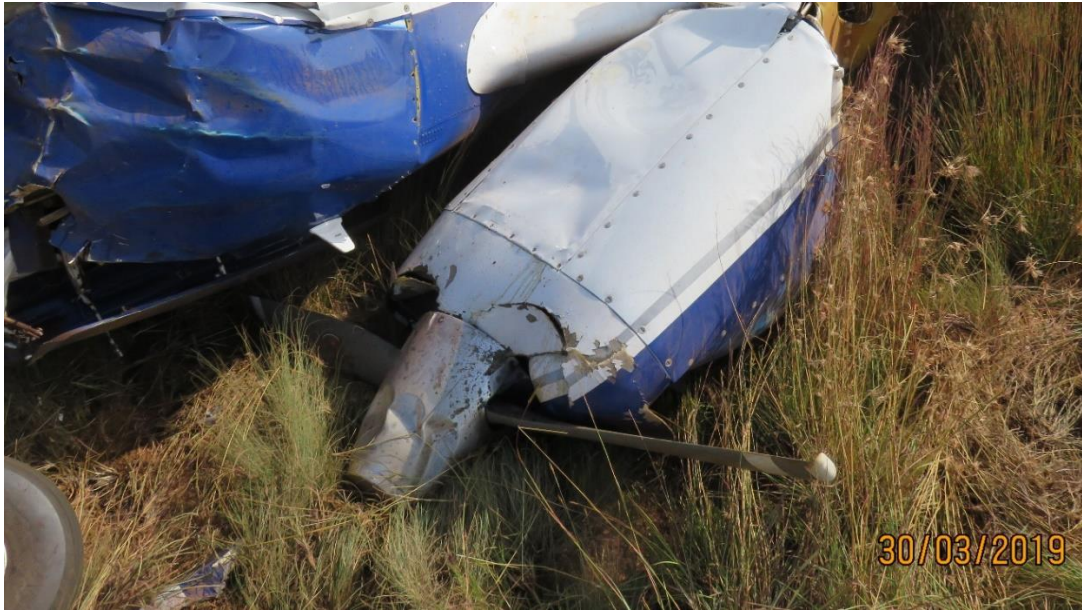
Figure 4: The left-side engine propeller with tips bending backwards. Both propellers were rotating at different revolutions per minute (RPM).

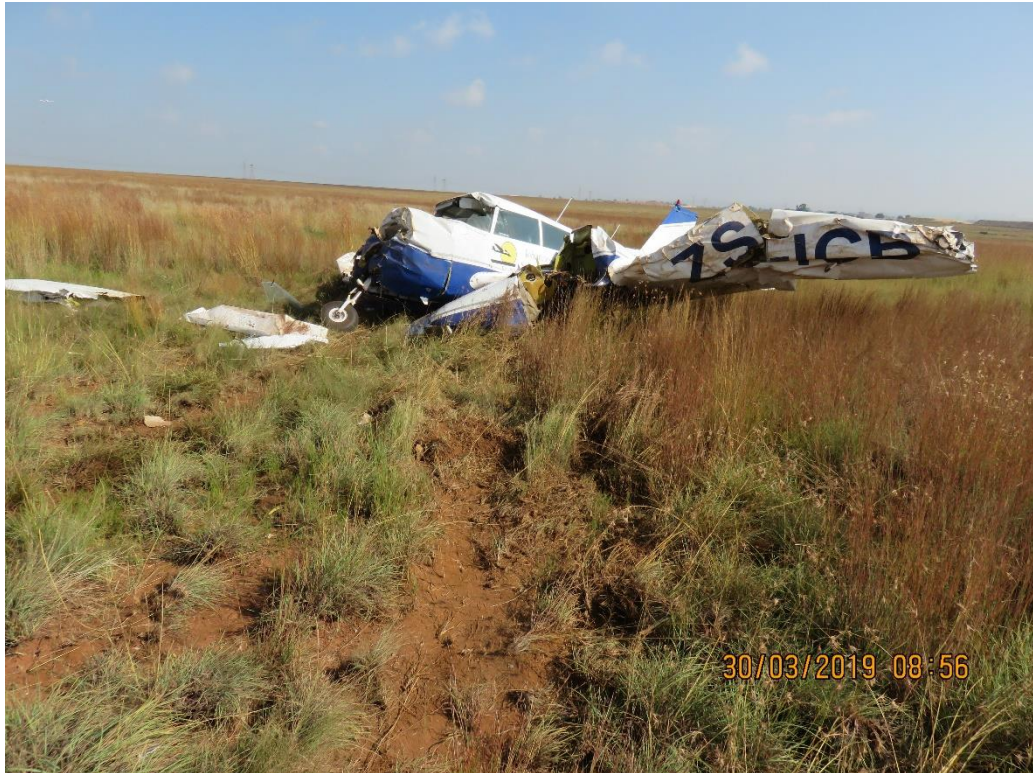
1.12.2 After impacting the ground, the aircraft ground-looped and skidded backwards. The aircraft came to a stop 120 metres (m) beyond the threshold of RWY 14. A 2m outboard wing tip of the right wing and its aileron broke off from the wing spar and the two engines separated from the airframe. The two main landing gears were damaged in the accident sequence. The right-side propeller (Figure 3) showed signs of low speed rotation, indicated by the bent propeller facing backwards. The left-side propeller (Figure 4) showed signs of having had power when making contact with the ground (prop strike resemblance).

Figure 5: The skid marks on the ground and the broken off right-side outboard wing.

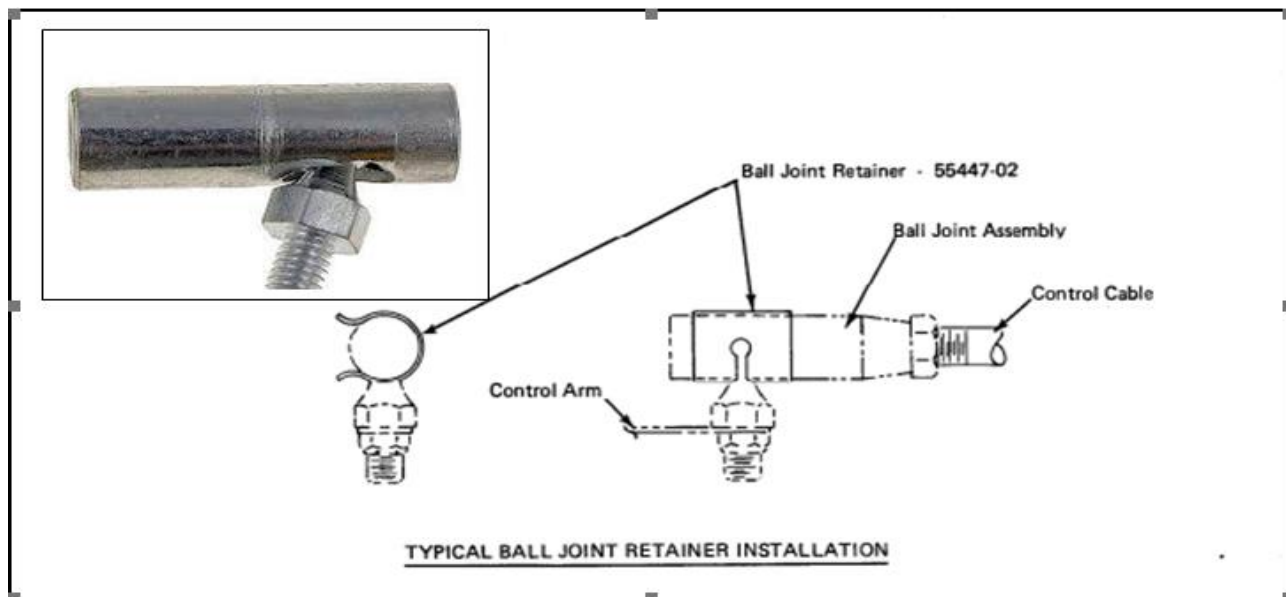
Figure 6: The inset shows a missing retainer which the Service Bulletin is mandating to be installed where a ball joint is located.

1.16.3 Piper issued a Service Bulletin (SB) 515 which relates to the mandatory installation of the ball joint retainer. All the affected aircraft, including ZS-ICB, serial numbers are listed on the SB (see Appendix B).

- 3.2.9 The AMO did not follow the manufacturer's SB 515 issued on 17 January 1977 which states that all Piper PA30 twin Commanche with serial numbers 30 - 1 to 30 - 2000 must be installed with a control cable ball joint retainer. The ZS-ICB serial number is 30 - 1977 and was not fitted with the ball joint retainer. The installation of the unapproved part was in contravention of the manufacturer's SB 515 and Civil Aviation Regulation Part 43.02.22

4.2.2 It is recommended that the Director of Civil Aviation mandate SB 515 an issue Airworthiness Directive (AD).

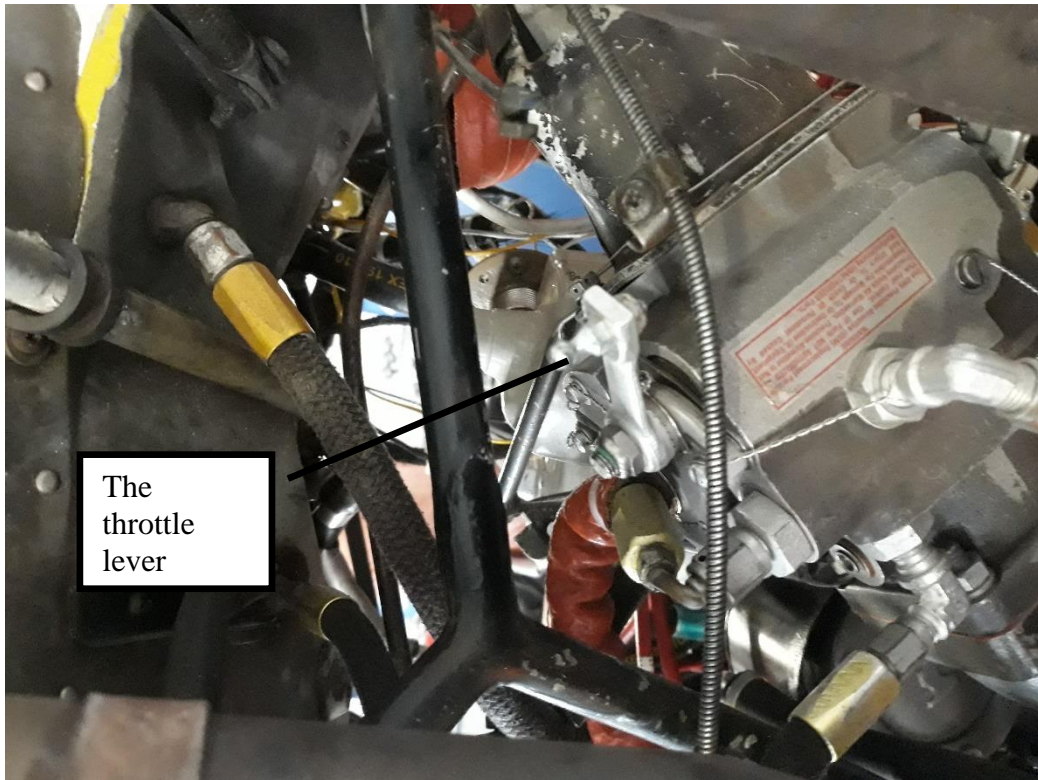
1.16.2 Further inspection on the number 2 engine revealed that the throttle control cable end fitting was missing. The teardown inspection was stopped soon after it was discovered that a throttle control cable end fitting (Figure 7) was missing. It was later found in the wreckage and it was not the original equipment fitted by the manufacturer. On inspection of the logbooks, it was discovered that the throttle control cable end fitting was fitted on 24 July 2018.

Figure 7: The number 2 engine throttle lever which is missing a throttle control cable end fitting.

3.3.1 The right-side engine did not develop power due to separation of an incorrect throttle control cable end fitting when the student pilot applied full power to initiate climb after touch-and-go during asymmetric circuits.

inspected within a reasonable timeframe to ascertain if the approved throttle control cable end fittings were fitted to the engines.

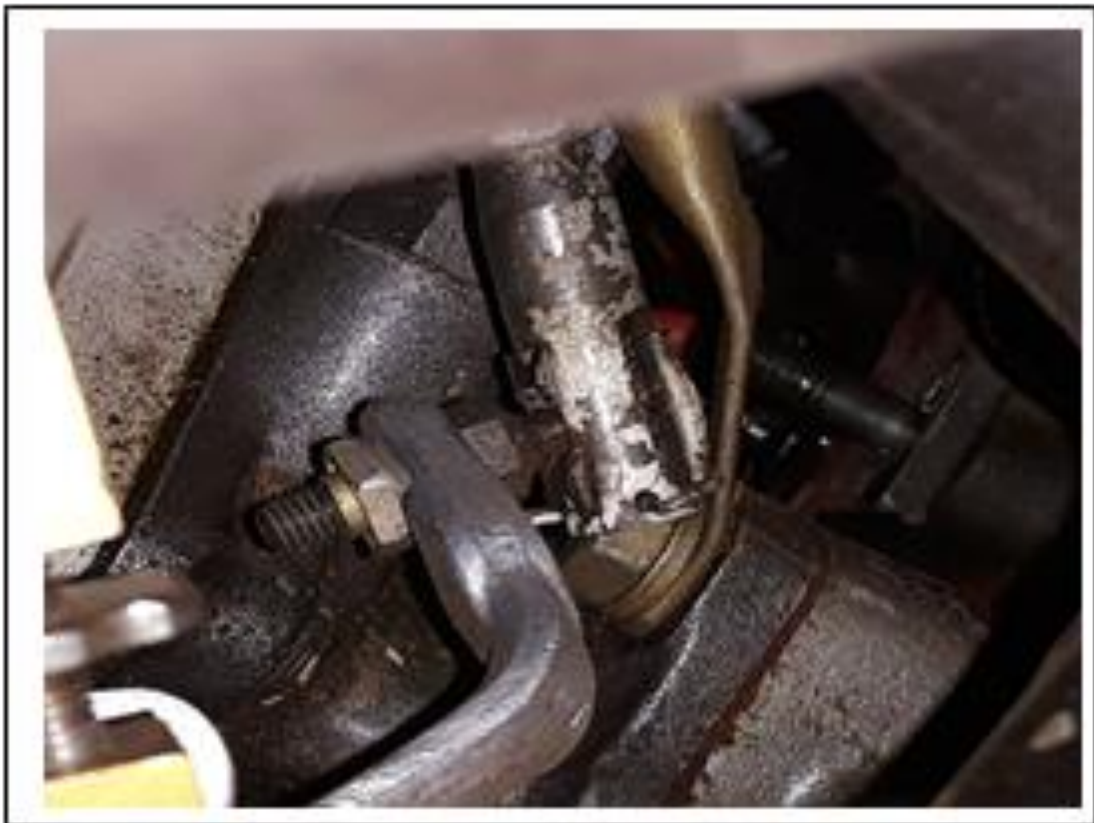
Figure 8: The ball joint retainer that was removed by the investigating team.

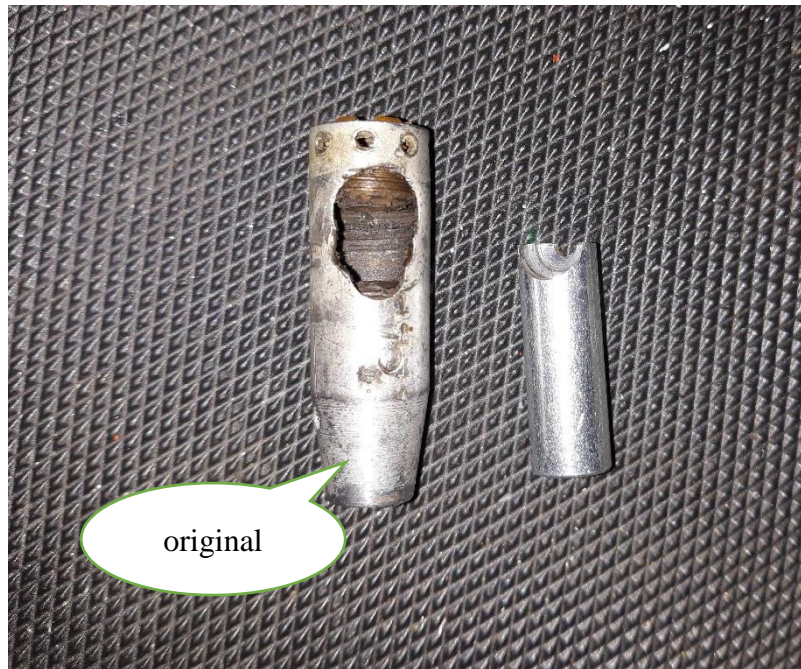
Figure 9: The difference between the manufacturer-approved cable end fitting (original) and the unapproved cable end fitting that had failed.

- 2.3.3 The investigation revealed that an incorrect throttle control cable end fitting was fitted to the aircraft's right-side engine which separated on the third circuit as the student pilot applied full power. This resulted in the aircraft, while flying very low, to pull sharply to the right and to roll in the same direction before impacting the ground with the right wing.

3.4.1 Fitment of an unapproved throttle control rod.

4.2.1 It is recommended that the Director of Civil Aviation mandate that all aircraft maintained by the AMO that were fitted with unapproved parts during engine maintenance be
