Final report RL 2020:04e

Accident at Varberg/Getterön Airport on 5 May 2019 involving the powered sailplane SE-USN of the model SF 25 C, operated by a private individual.

File no. L-53/19

29 April 2020

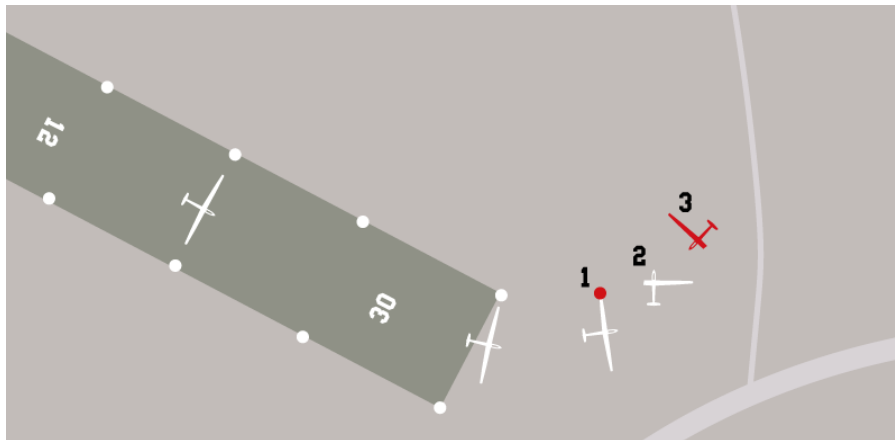
Figure 1. Final stage of the sequence of events. 1: Left wing hits the ground. 2: Front section of the powered sailplane hits the ground. 3: Final position.

The witness who observed the take-off from the flying club's refuelling facility perceived the take-off to be normal up until lift-off, at about one third of the runway and until the aeroplane had reached a height of 20 to 25 metres above the ground. The witness then lost sight of the aeroplane, but suddenly heard the engine stop. He looked up again and saw then that the propeller was rotating slowly. His perception of this was that the pilot was attempting to maintain height and that it looked wobbly. The wind was blowing from the right in the aeroplane's direction of flight and his perception was that the aeroplane turned to the left with the wind and lost height. The left wing hit the ground, slightly before the front section of the fuselage.

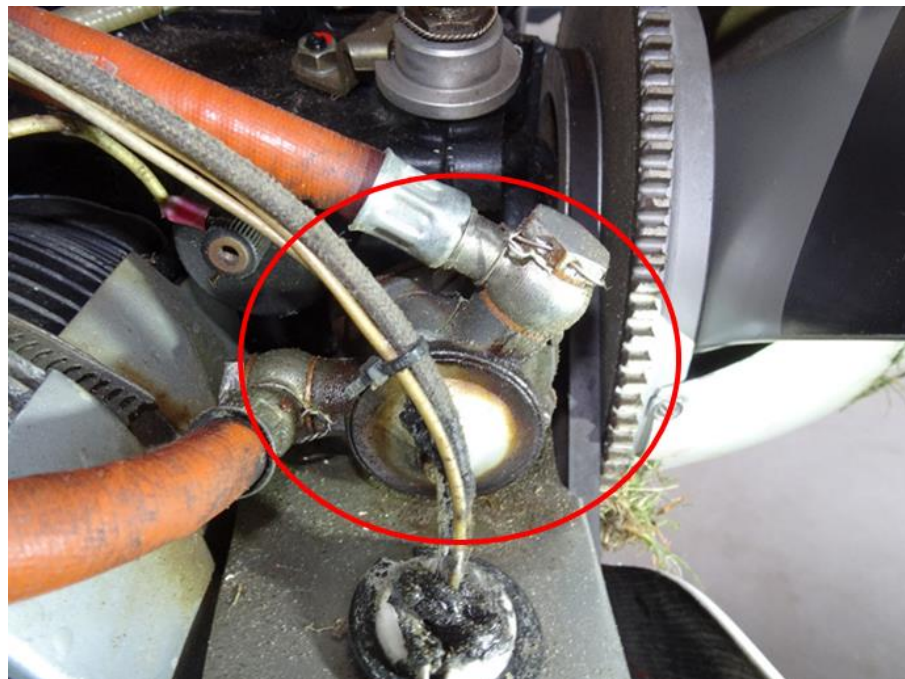
The fuel pump is of the flexible diaphragm type and located at the front on the right side of the engine's crankcase (see Figure 3). A worm gear on the crankshaft drives a gearwheel that moves an eccentric shaft. The eccentric shaft drives a push rod that moves a linkage system that drives the diaphragm.

Figure 3. Mechanical fuel pump mounted on the engine, manufactured by APG.

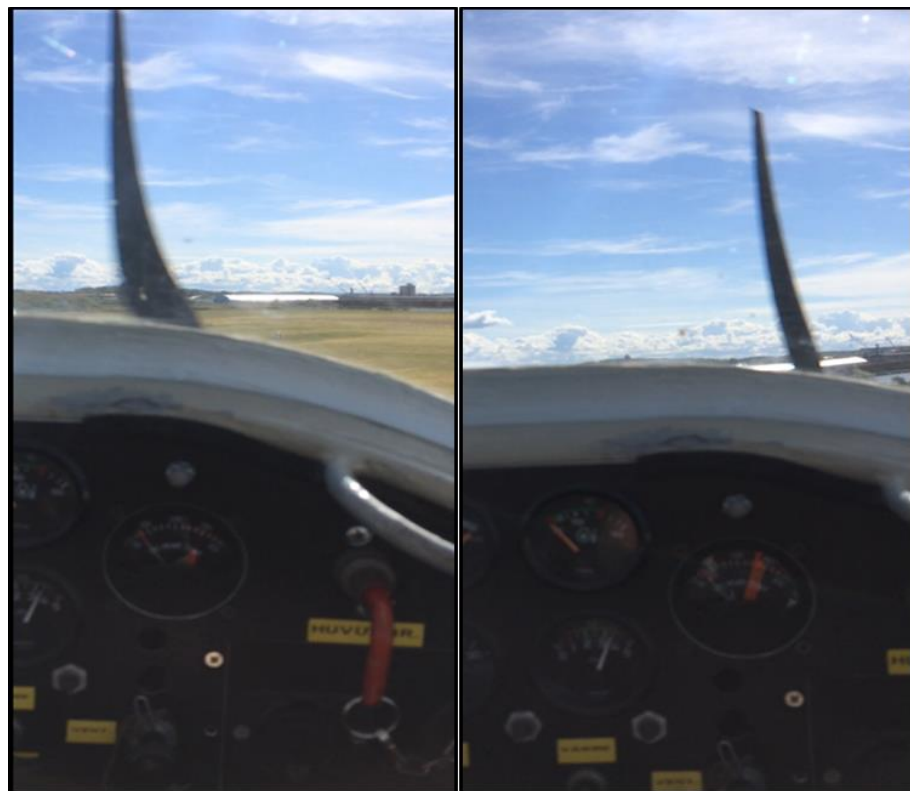
The two images show that the course at the time of the engine failure was the same as at lift-off (cf. with the white roof that is seen in front of the aeroplane) and that the attitude of the nose was normal for the flight phase.

Figure 7. Left image: just after lift-off. Right image: the engine failure.

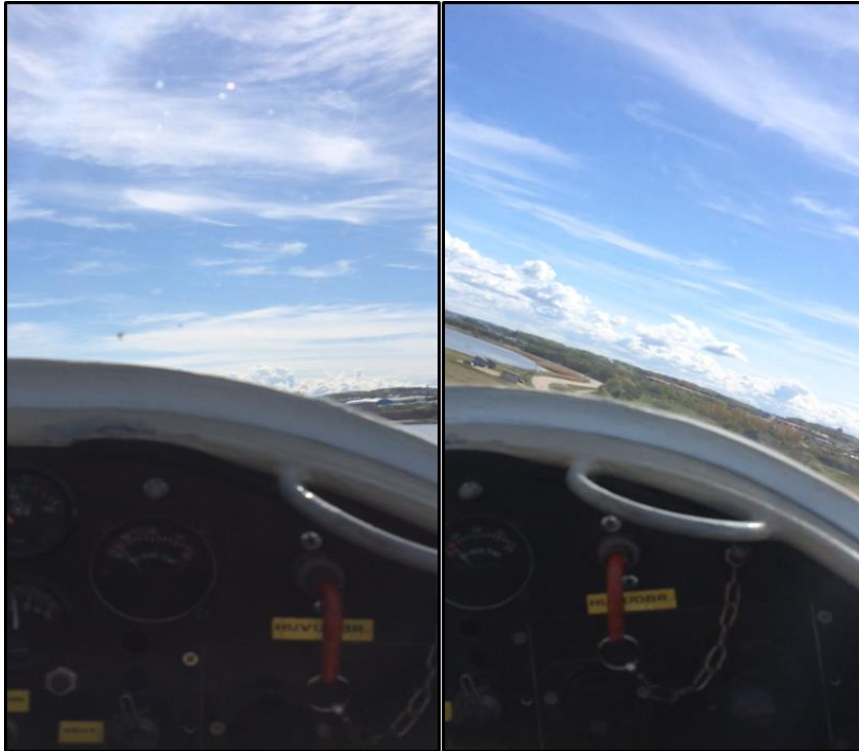
The two images in Figure 8 show that, following the engine failure and in conjunction with the attempt to restart the engine, the aeroplane had a significantly higher nose attitude than at the time of the engine failure. It is evident in the right image that, a few seconds later, the aeroplane enters a slight left turn (20–30 degrees of bank), with a new, somewhat lower nose attitude.

Figure 8. Left image: attempt to restart. Right image: banking and the nose is lowered.

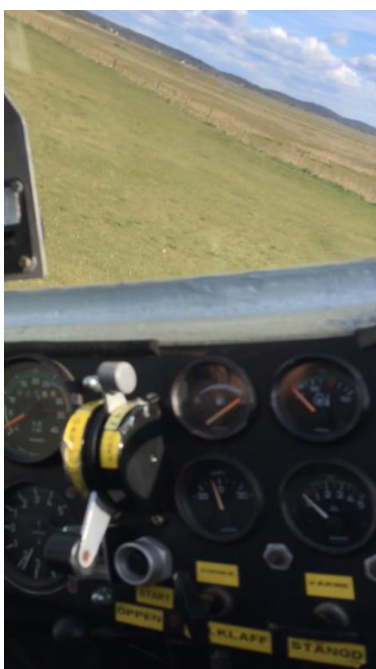
Figure 9 shows the aeroplane's attitude when the left wing makes contact with the ground.

Figure 9. Left wing makes contact with the ground.

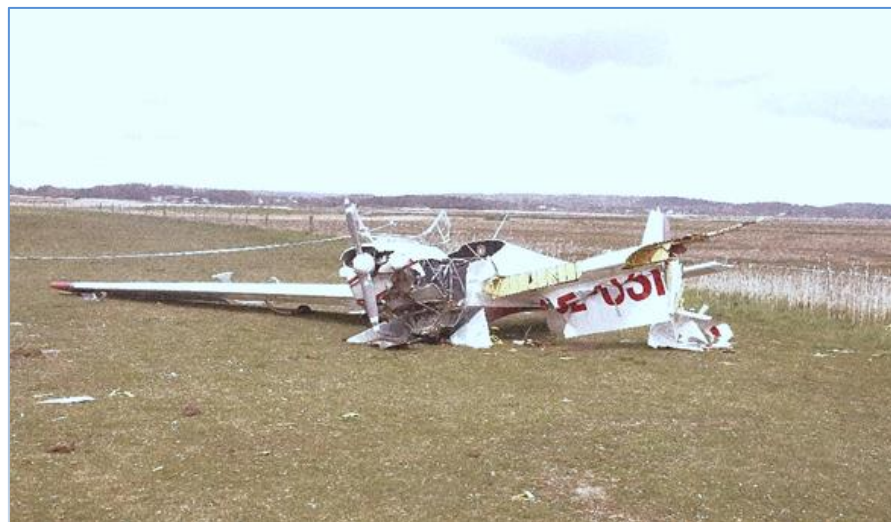
Figure 11. The aircraft's position after the occurrence. Image: Varbergs flygklubb.

The left wing was partly broken off and the broken-off part lay a short distance from the fuselage. The front section of the fuselage suffered major damage on its underside and on its left side forward of the leading edge of the wing. The underside of the rear fuselage also showed signs of damage and the tailwheel was knocked off. One of the propeller's blades was broken a little in from the tip.

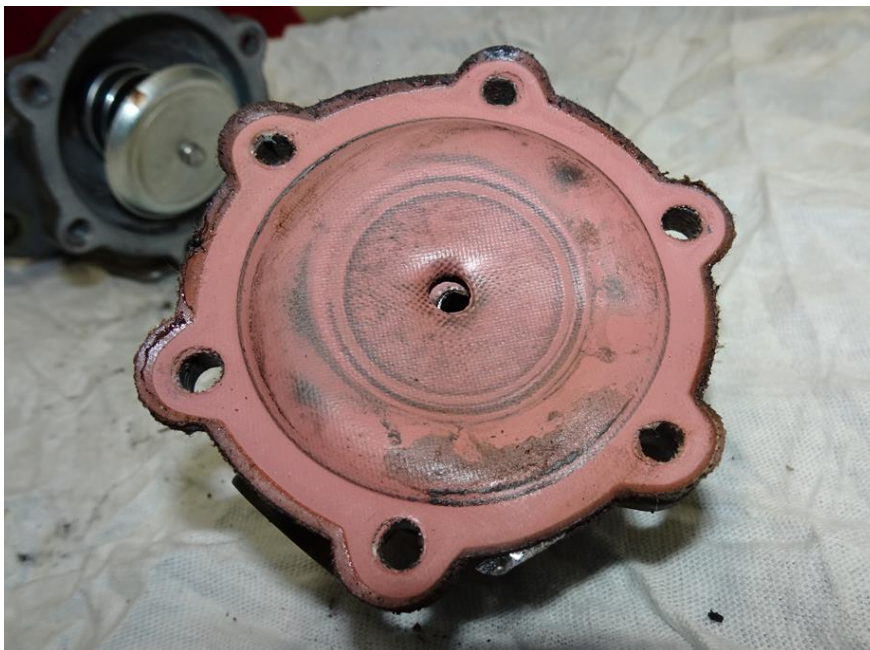
Nevertheless, the aeroplane was then transported to SHK's examination facility for further technical examinations. These examination involved the mechanical fuel pump being disassembled (see Figures 12–14). When the fuel pump was taken apart, it was possible to establish that one of the metal plates that drive the pump diaphragm had come loose.

Figure 12. In the foreground in the image is the diaphragm with the outer half of the fuel pump housing. In the background is the other half of the fuel pump housing with one of the plates that drives the diaphragm.

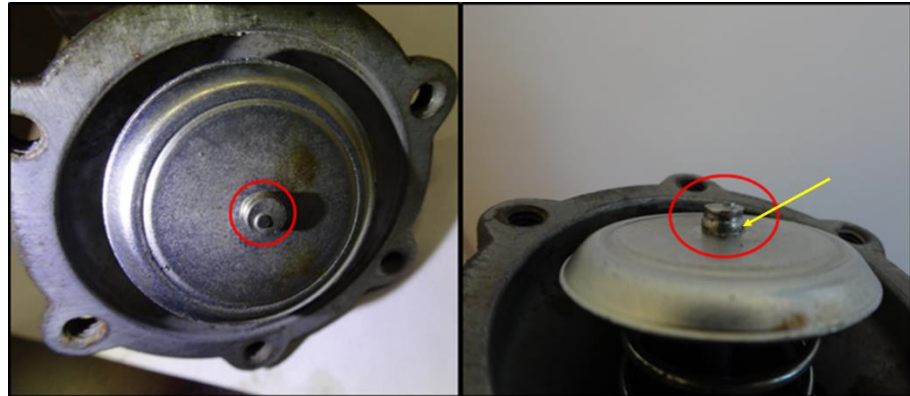
Figure 13. The image shows the interior plate, which is part of how the diaphragm is driven. In the middle of the plate is the part that is supposed to hold the plates and the diaphragm together, the shank and the formed head (the rivet head). The right image shows the swelled shank, marked with a yellow arrow.

The rivet that should hold the drive plate in place had a swelled shank where the diaphragm sat (see Figures 13 and 16). However, the exterior diameter of the formed head was barely noticeably larger than the diameter of the hole in the drive plate. The part of the formed rivet that stuck up over the drive plate was measured as just under 0.4 mm (see Figures 14, 15 and 16).

The pump plates and the pump diaphragm are held together by what is known as riveting. In riveting, it is important that the length of the shaft is correct, as this has to be deformed plastically in order to create a flattened rivet head that expands sufficiently over the hole. The investigation of the riveting of the drive plates and the diaphragm shows that the flattened rivet head has not been sufficiently expanded. The assembly of the diaphragm and drive plates in the fuel pump has therefore been defective.

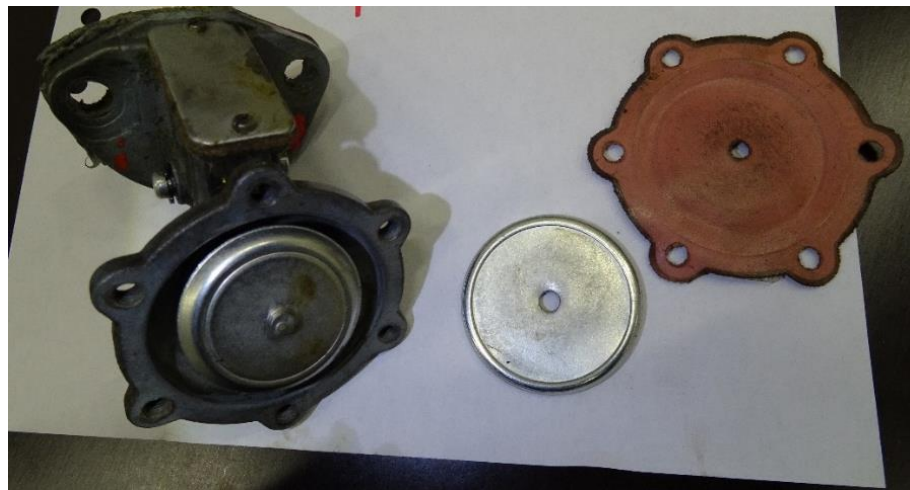
Figure 14. Part of the fuel pump with the loose drive plate and the diaphragm.

During the technical examinations of the fuel pump it was possible to establish that one of the metal plates that drive the pump diaphragm had come loose. The diaphragm stopped being driven when the metal plate came loose. This resulted in the fuel no longer being pumped into the carburettor, which in turn led to the engine shutting down.

The cause of the engine failure was that a drive plate for the pump diaphragm inside the fuel pump came loose as a result of defective assembly.

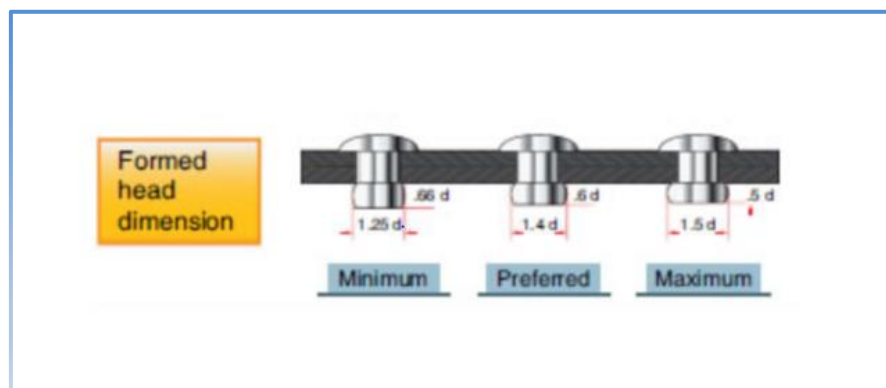
Figure 15. Schematic showing formed rivet heads.

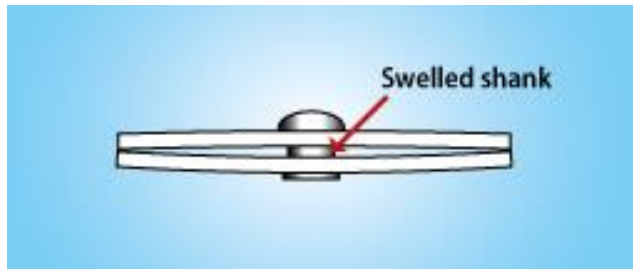
Figure 16. Schematic of riveting where the shank of the rivet has swelled in the middle. See Figure 13, right image, where the shank has swelled.
