Islamic Republic Of Iran
Civil Aviation Organization
Aircraft Accident Investigation Board

Incident Report

Aircraft Model: McDonnell Douglas MD-88

Registration: EP-TBE

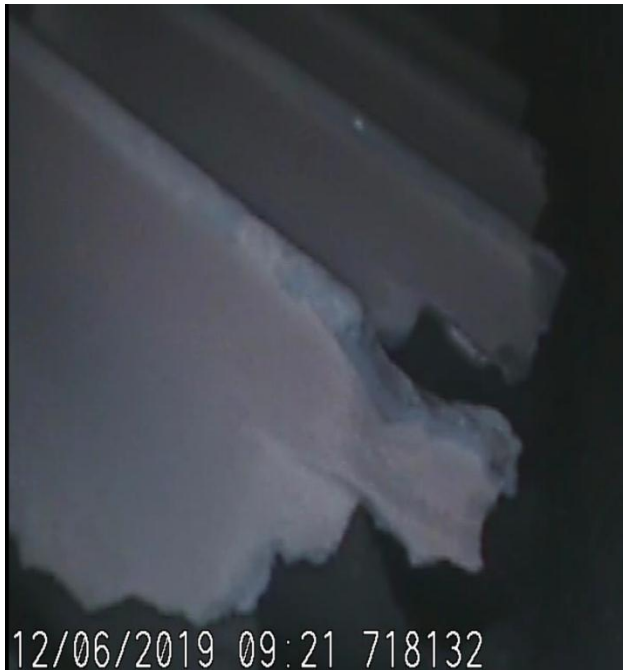
First Stage Turbine Disk (HPT)

Damage observed in the turbine section was consistent with a disruption in airflow from the compressor resulting in increased exhaust temperatures beyond the limits of the turbine components. Due to the mechanical damage to the engine, the origin of the engine failure and an accurate assessment of the engine condition prior to the occurrence could not be established with certainty but probably by considering effects of above factors, engine compressor stall occurred with high EGT and Vibration exponentially until they reach above their allowable limits. Engine hot zone parts was on exposure to high temperature led to fracture of low-pressure turbine 4th stage rotor blades at root which had been creep and elongated before. The number of turbine rotor airfoils that exhibited fatigue is consistent with significant vibratory excitement of turbine stages. Prior to the engine failure, a liberated piece of material, either just preceding or just following from HPT, could travel aft, inducing damage to subsequent turbine stages and resulting in reduced N_1 and the subsequent engine failure.

There was an internal damage in the turbine rotors, as a result of fatigue and possible back pressure resulting from stall and engine "**Surged**". The damage led to subsequent failures of airstream and a general failure of engine failure.

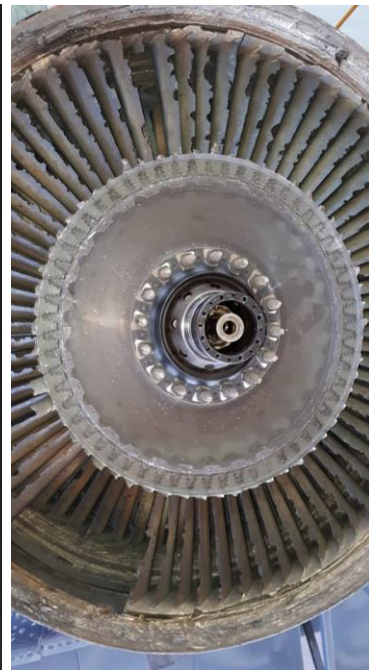
4th Low Pressure Turbine Disk
