## AIRCRAFT ACCIDENT SHORT REPORT

CA18/2/3/9793: A propeller blade separated in-flight, followed by an unsuccessful forced landing on a dirt road.

**Date and time** : 8 June 2019 0946Z  
**Aircraft registration** : ZU-LSA  
**Aircraft manufacturer and model** : Czech Aircraft Works Spol SRO  
**Last point of departure** : Bethlehem (FABM) Aerodrome  
**Next point of intended landing** : Bethlehem (FABM) Aerodrome  
**Location of incident site with reference to easily defined geographical points (GPS readings if possible)** : S27°56'35.74" E28°17'.14.76" at an elevation of 5 561 ft AMSL  
**Meteorological information** : Temperature: 21°C, Visibility: 10km  
**Type of operation** : Part 94  
**Persons on-board** : 1 + 1  
**Injuries** : None  
**Damage to aircraft** : The aircraft was substantially damaged

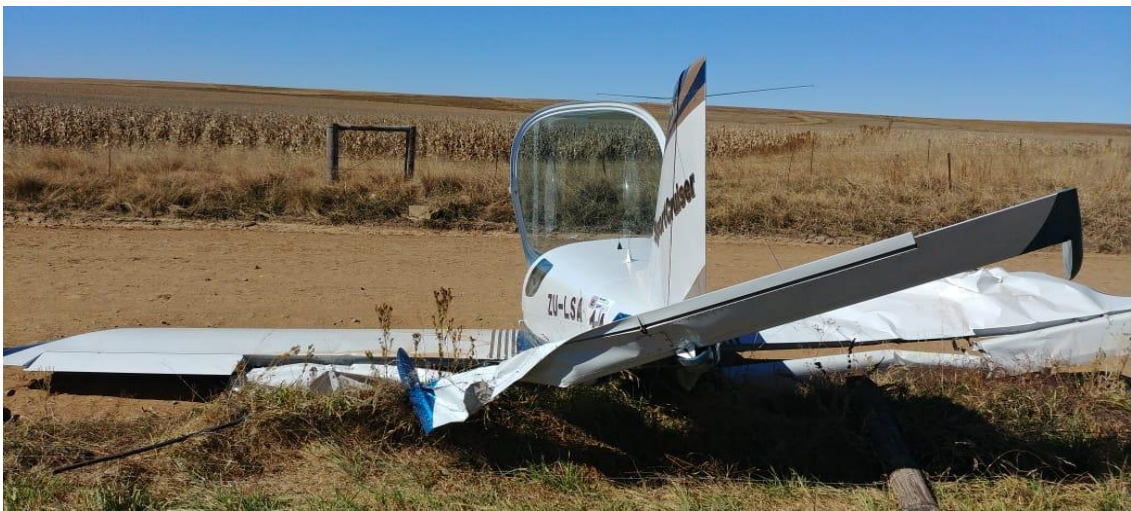
with its right wing and spun around. It eventually came to a stop facing the opposite direction. The landing gear collapsed during the landing roll and the engine carburetors detached from the aircraft. The remaining two blades broke, and the root grip on blade B root failed during the accident sequence. The aircraft sustained substantial damage, however, no person was injured.

**Figure 2:** The SportsCruiser X320 at the accident site. (Picture courtesy of the aircraft owner)

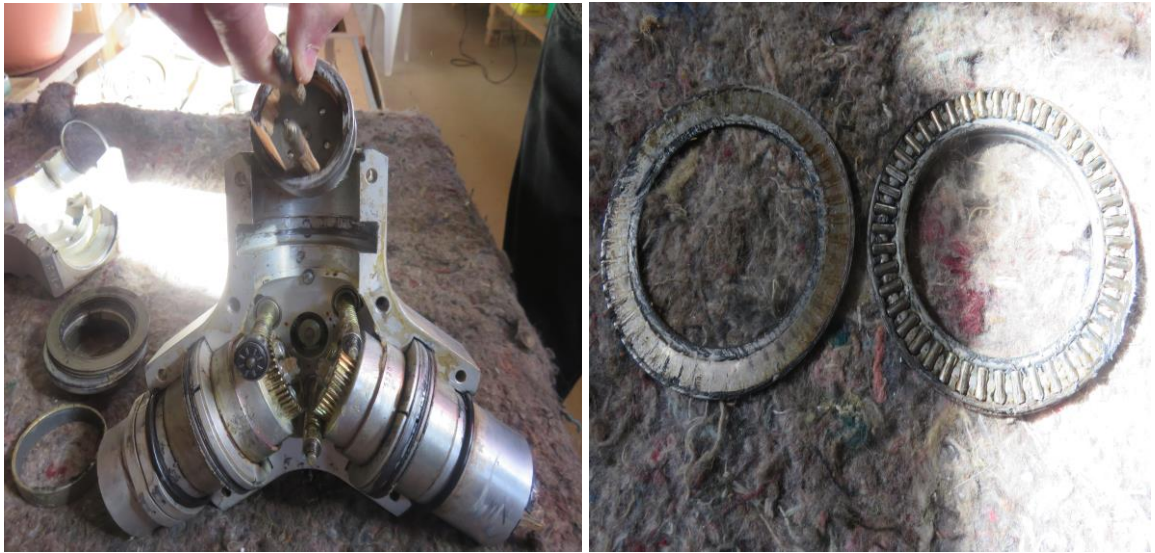
- 3.3 The propeller was removed from the wreckage on 13 June 2019 and transported to Brits (FABS) Airfield for teardown inspection by Woodcomp certified agent, Aircraft Maintenance Organisation (AMO) 969 under the auspices of the investigator-in-charge (IIC). Visual inspection on the hub area indicated nothing abnormal. No evidence of grease leak or any form of damage was observed. The electrical motor for the electrical variable pitch propeller was tested and found to operate in both directions. The propeller hub was dismantled, and all components were examined. Each of the propeller blade and their corresponding aluminium blades sleeves were labelled A, B and C for identification purposes. Visual examination on the hub area also showed that grease had dried out on all components, including the main bearing. However, no signs of internal corrosion, chafing, deterioration and cracks were observed. The mechanical pitch stops were all close to the mechanical fine stop set at 12.5° but not touching.

- 3.4 The adjustment mechanism and all the components were in a relatively good condition. Blade A and B consisted of an entire sleeve and a small amount of fractured wood inside the sleeve, however, the sleeve on blade C had fractured at the position where the blade has a gap where it holds the main bearing. Blade C separated, exposing the special screws and the O-ring shaft seal that prevents the lubricant leak from the main bearings. See Figures 5-8.

**Figures 5 & 6:** On the left is a dismantled propeller hub with some of the bearings visible, and on the right are the main bearings.

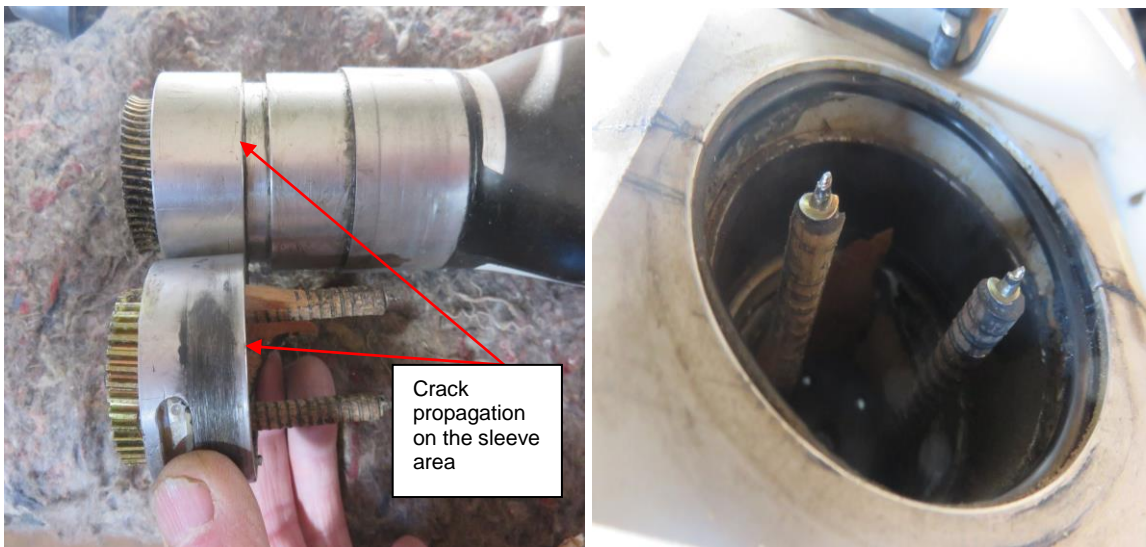
**Figures 7 & 8:** On the left is a picture of blade C showing the aluminium sleeve area where the failure occurred. On the right are special screws and the O-ring shaft seal.

3.8 Post-accident investigation and teardown inspection of the propeller uncovered a failure on blade C aluminium sleeve. What caused this blade to separate was the in-flight propagation of a fatigue crack in the blade sleeve that had been visually covered up by non-compliance to the manufacturer's service instructions. The failure emanated from fatigue caused by vibration stresses.

- 5.1 The failure of blade C aluminium sleeve was due to lack of maintenance which caused all three blades not to operate in a synchronised movement. Due to centrifugal/aerodynamic forces acting on the blades, it (the blades) started to vibrate, causing an initiation of a crack on blade C sleeve which increased overtime, before separating in-flight. The failure resulted in an unsuccessful forced landing.

- 3.5 The Woodcomp Service Bulletin (SB) – No UL02/2012 EN, Rev. C dated 8 November 2012 requires that the propeller overhaul intervals be conducted after 300 operating hours or every five years, whichever occurs first. The reason for this is that the propeller is subjected to centrifugal and aerodynamic forces each time it is operated; it is also subjected to vibration load caused by the propeller’s own vibration and the vibration induced by the engine. The SB stated above was not complied with.
