DUTCH
SAFETY BOARD

Mid-air collision between two Piper Super Cubs near Oudemolen, 21 June 2019

The Hague, October 2021

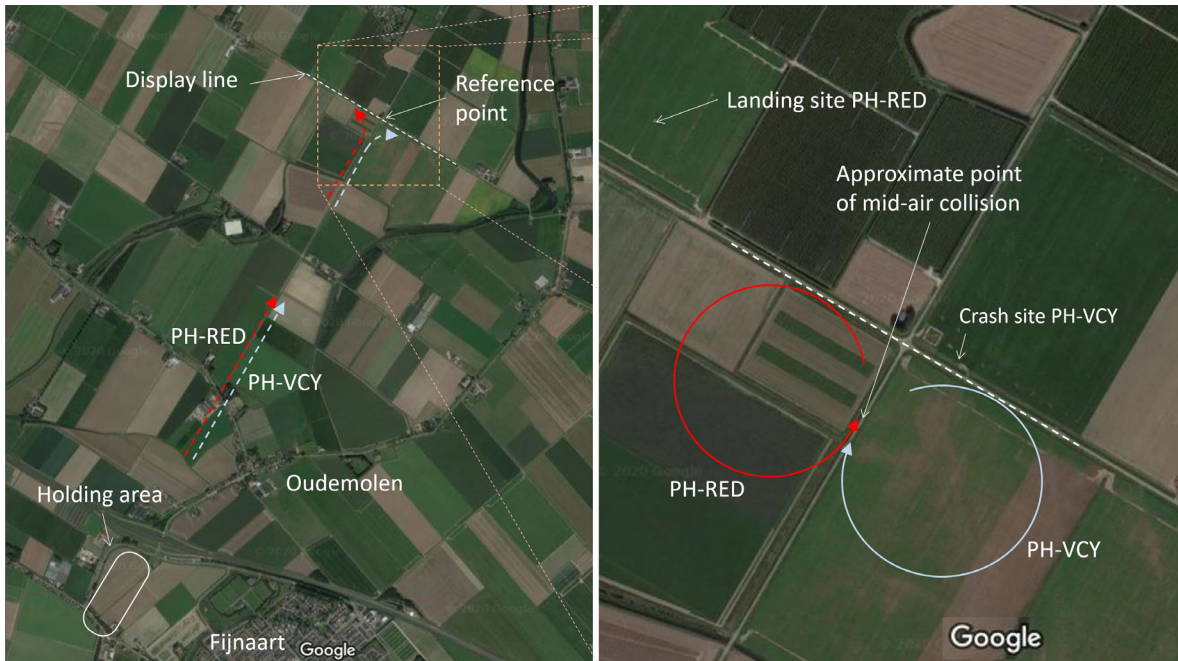
The formation rejoined at the holding area and proceeded inbound towards the reference point to perform the display for a second time. At the reference point, the leader directed the formation to split-up, after which both aircraft started their opposite turns. This time, however, after 360° of level turn, the two aircraft collided (see Figure 1).

Figure 1: Location of the formation exercise and crash location of PH-RED (leader) and PH-VCY (wingman) near the village of Oudemolen. (Source map: Google Maps; modified by Dutch Safety Board)

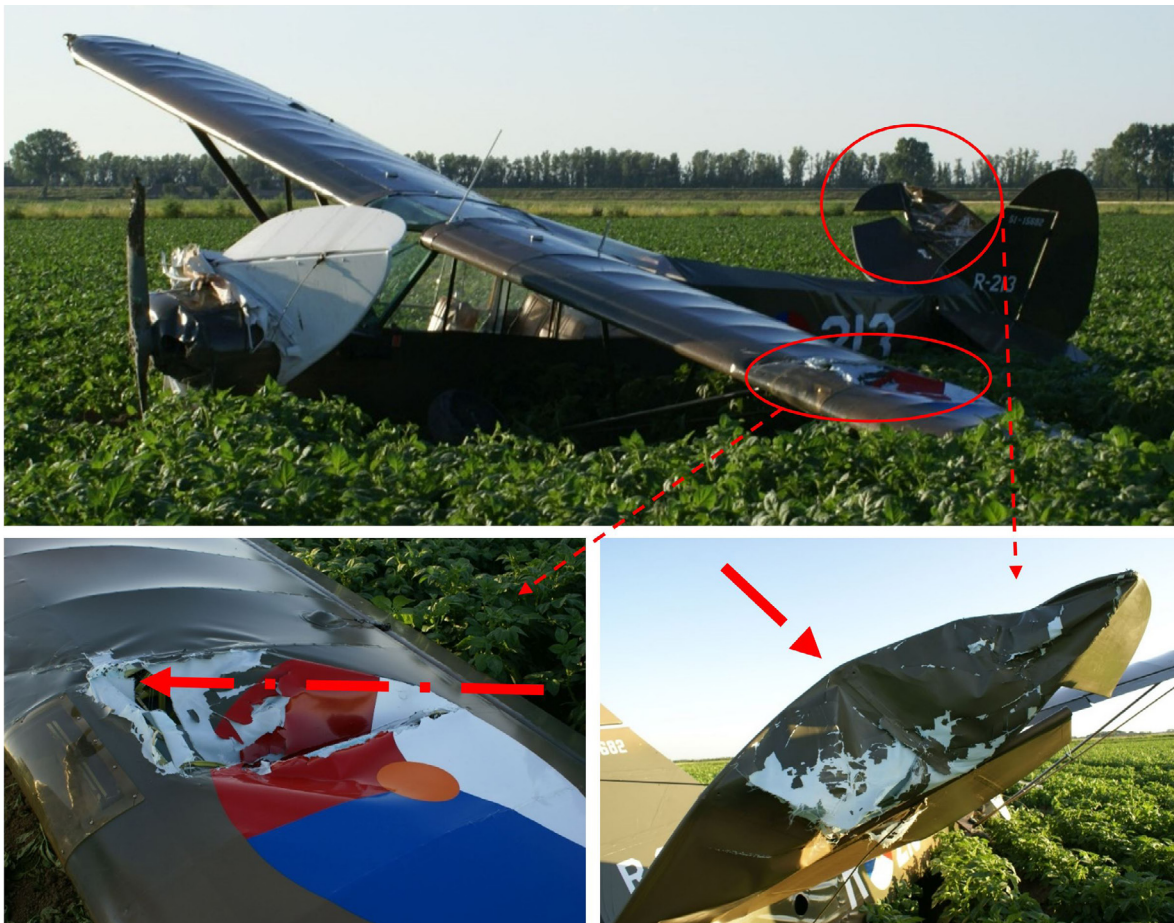
The examination showed that RED's right hand elevator had a distinct dent and was deformed. The horizontal tail section and the aft fuselage were twisted to the left as a result of the collision. Furthermore, RED's left wing tip had a large indent just behind the left wing light. The construction inside of the wing tip was damaged and the wing's bottom skin cover was punctured. RED's left wing tip damage area had scrapes indicating that the movement off collision was from behind, moving forward and to the right (see Figure 2).

Figure 2: PH-RED's damage pattern right elevator and left wing tip. (Source: Dutch Safety Board)

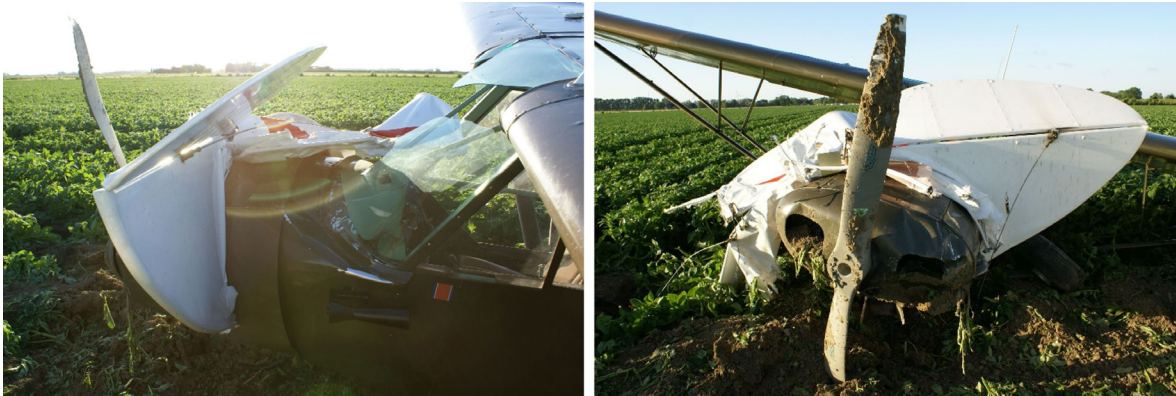
The cockpit windscreen of RED was broken and for the major part missing. The windscreen frame was deformed at the lower left section. RED's propeller showed several indents on the leading edge of the propeller blade (see Figure 3).

Figure 3: PH-RED's damaged windscreen and PH-VCY's horizontal stabiliser blocking PH-RED's windscreen. (Source: Dutch Safety Board)

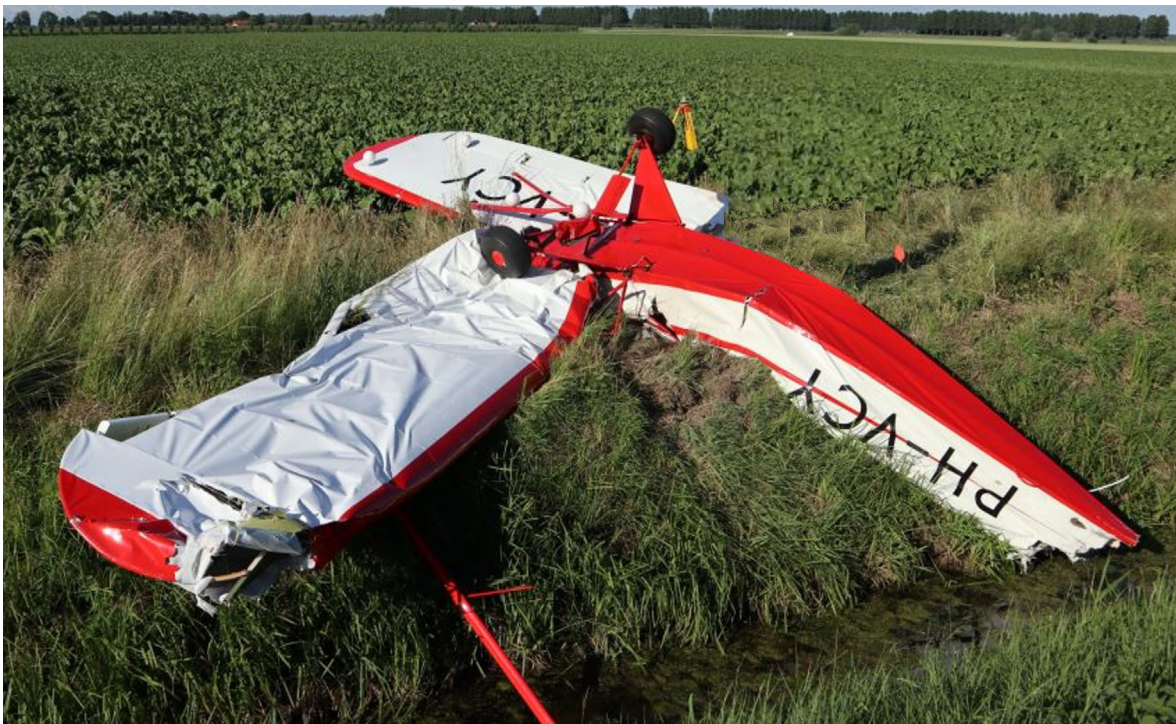
The examination of VCY showed that the right wing was structurally damaged and partly disconnected from the fuselage. The right wing tip was substantially damaged and deformed. Furthermore, the tail section was cut off from the aft fuselage on approximately a 45° angle (see Figure 4). The other damages to VCY were caused by the crash.

Figure 4: Wreckage of PH-VCY, damaged right wing (lower left corner) and the cut-off angle rear fuselage. (Source: Dutch Safety Board)

Furthermore, the assessment of the mid-air collision damage revealed that the propeller of RED had marked indents on the leading edge of the propeller blade. Further, it was found that the steel tubes of VCY's aft fuselage frame showed distinct cut and shear marks. And, that the entire aft tail section of VCY was cut at approximately 45 degree angle (see Figure 5). This implies that VCY had crossed in close proximity in front of RED, whereby the propeller of RED had cut off the aft tail section of VCY.

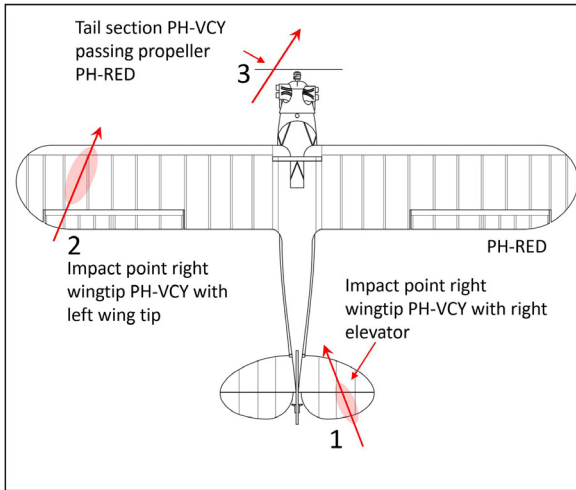
The mid-air collision consisted of three distinct events (Figure 5). The sequence of the parts is based on the statement of the passenger in the leader's aircraft, and the described damage pattern as a result of the mid-air collision.

The first event of the mid-air collision was that the wingman with its right wing tip struck the leader's right side of the horizontal tail first. Then, the wingman moved forward and to the left. The second event was the wingman with its right wing tip striking the leader's upper side of the left wing tip. The third event was the wingman crossing the nose and propeller of the leader within close proximity with a right angle of bank between 90° and 180°. This crossing caused the tail section of wingman's aircraft to be cut off (see Figure 6).

Figure 5: PH-RED's (leader) damage pattern and PH-VCY's (wingman) direction of movement. (Source: Kaboldy, Wikipedia Commons, modified by the Dutch Safety Board)

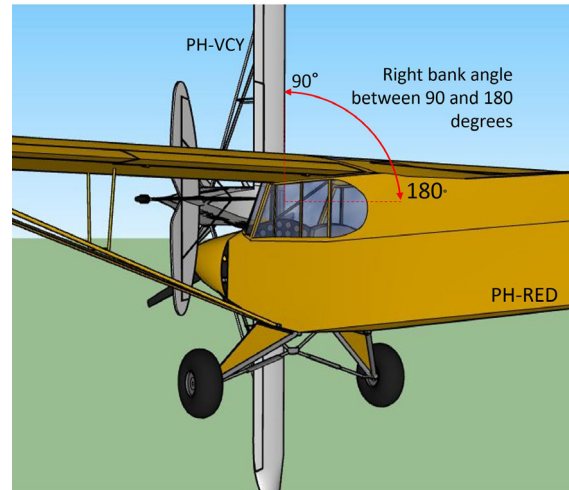
Figure 6: Propeller PH-RED (leader) cuts of tail section of PH-VCY (wingman). (Source: Dutch Safety Board)

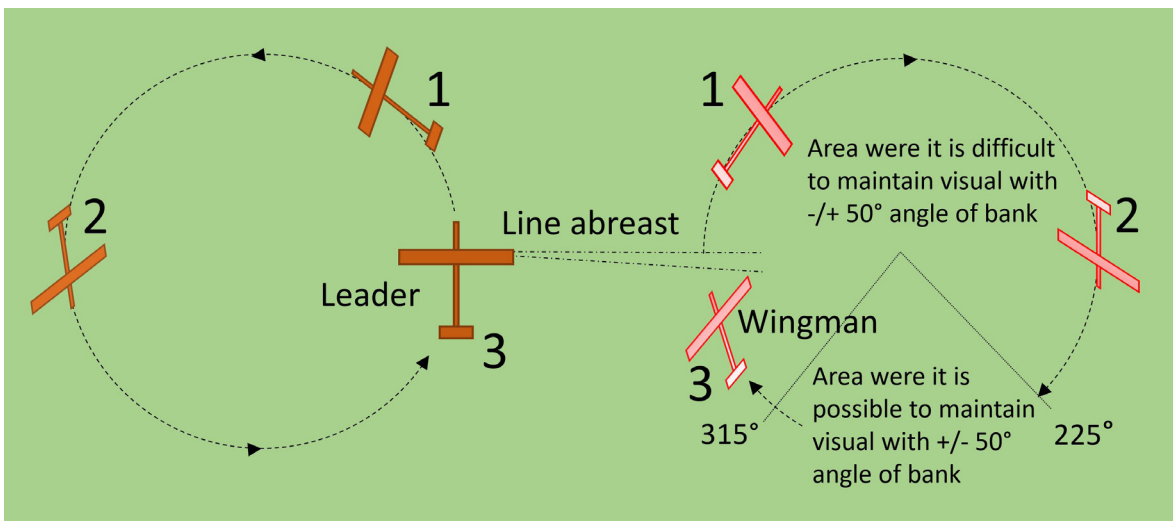
The new manoeuvre starts with a formation split up from a line abreast position, followed by two opposite 360° level turns, finishing with a rejoin in a line abreast formation. The objective of the exercise is to fly the manoeuvre symmetrically. However, during the end phase of the rejoin the wingman is to be slightly aft and closing in from behind in a controlled manner (see Figure 7). The intended separation between the leader and the wingman in the line abreast formation is the width of one wingspan, which is approximately 11 meters. The 360° turn is flown with approximately 50° angle of bank. The manoeuvre progresses fairly quickly: it takes approximately 25 seconds to complete the 360° turn. The fact that both aircraft had different types of engines and thus a different performance, did not hamper the ability of the aircraft to perform the manoeuvres symmetrically.

Figure 7: Geometry of the 360 degree opposite turn and rejoin manoeuvre. (Source: Dutch Safety Board)

Flying the two opposite 360° turns, poses a difficulty for the pilots to keep each other in sight. After the split-up, pilots will quickly lose sight of each other, because they are turning away from each other (see Figure 7). In this stage of the manoeuvre this is not a concern, because the distance between the aircraft is increasing. Further into the turn, the difficulty of maintaining visual is caused by the high wing of the aircraft; blocking the view to the inside of the turn.

It is reasonable to assume from a theoretical standpoint that while continuing the turn, pilots are able to regain visual contact once they have turned approximately 225° and maintain visual contact until approximately 315° into the turn. After this point, which is during the last 45° of the turn, it will become increasingly difficult to keep each other in sight because of the 50° angle of bank. In other words, during the end phase of the manoeuvre, both aircraft were turning with their bellies towards each other, which made it almost impossible for both pilots to keep each other in sight. And, because of the steep bank angle, it was for the wingman increasingly more difficult to judge the closure during the rejoin.
