Final report RL 2020:08e

Accident at Storsandskär, Västerbotten County, on 14 July 2019 involving the aeroplane SE-MES of the model GA8-TC 320, in conjunction with parachuting activities at Umeå Parachute Club.

File no. L-96/19

9 September 2020

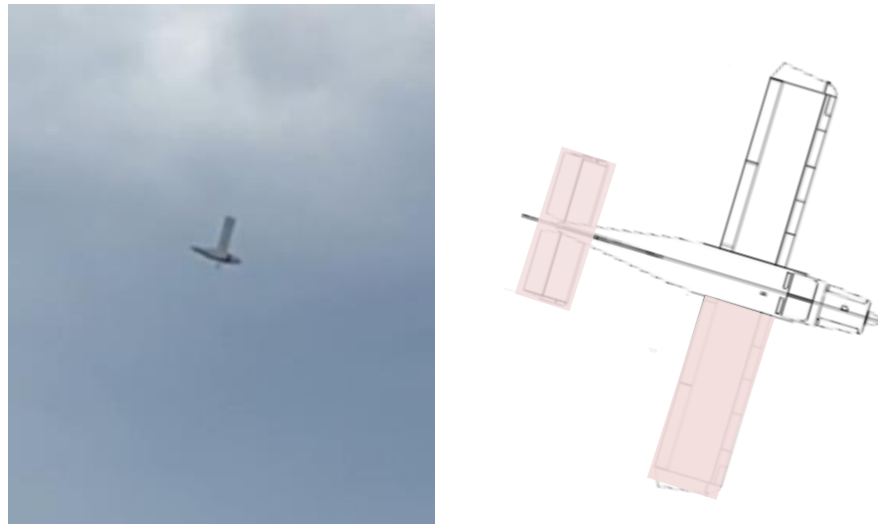
Several films of the final stage of the sequence of events, taken from the ground, show that the aeroplane, without fin and stabiliser, rotated clockwise in the horizontal plane (seen from above), with the left wing pointing upwards, while the right wing was missing (see Figure 3).

Figure 3. Left picture: Aeroplane in the final stage. The right wing, the stabiliser and the fin are missing. Photo: Private. Right picture: Image for clarification purposes that shows the missing parts marked in red. Picture: GippsAero Pty Ltd POH, red markings by SHK.

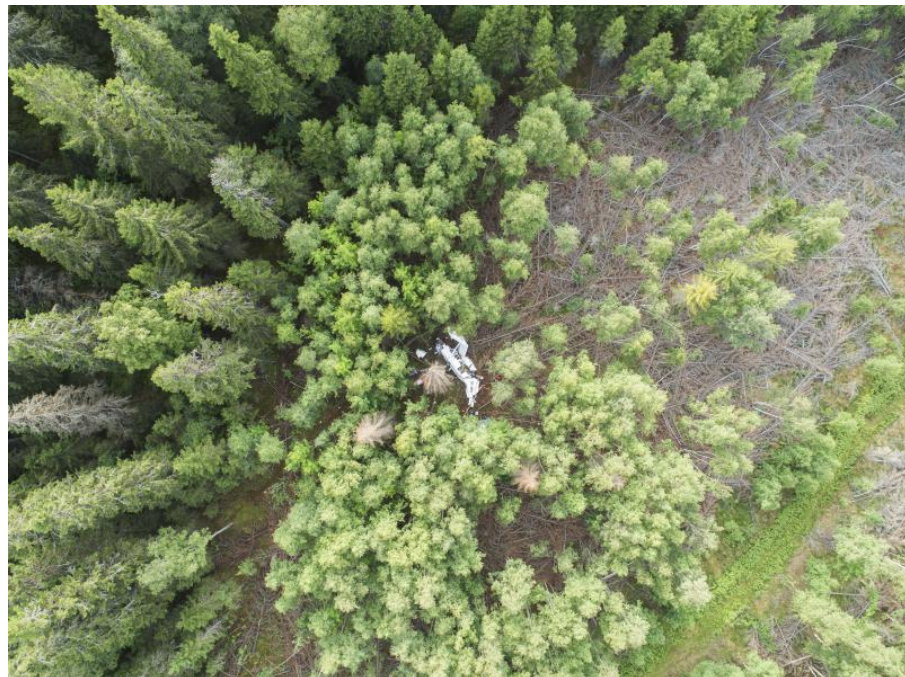
The aeroplane crashed next to a spruce tree. The top and branches of the tree were missing, which indicates that the aeroplane hit the tree during the crash.

Figure 25. Picture taken directly above the crash site. Photo: Drone image from the Police.

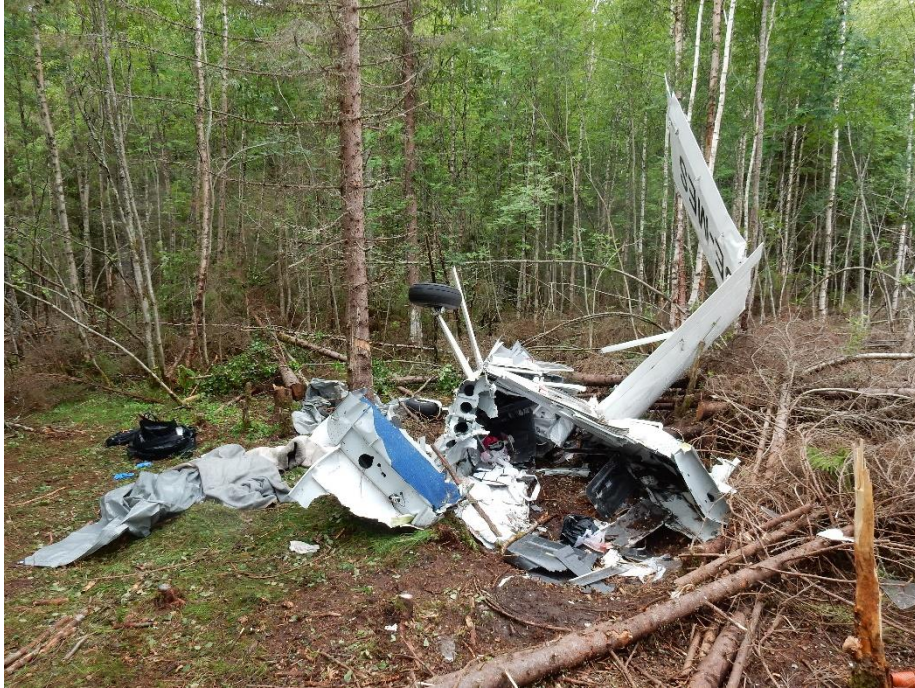
Figure 26. Picture of the wreckage on the day after the accident.

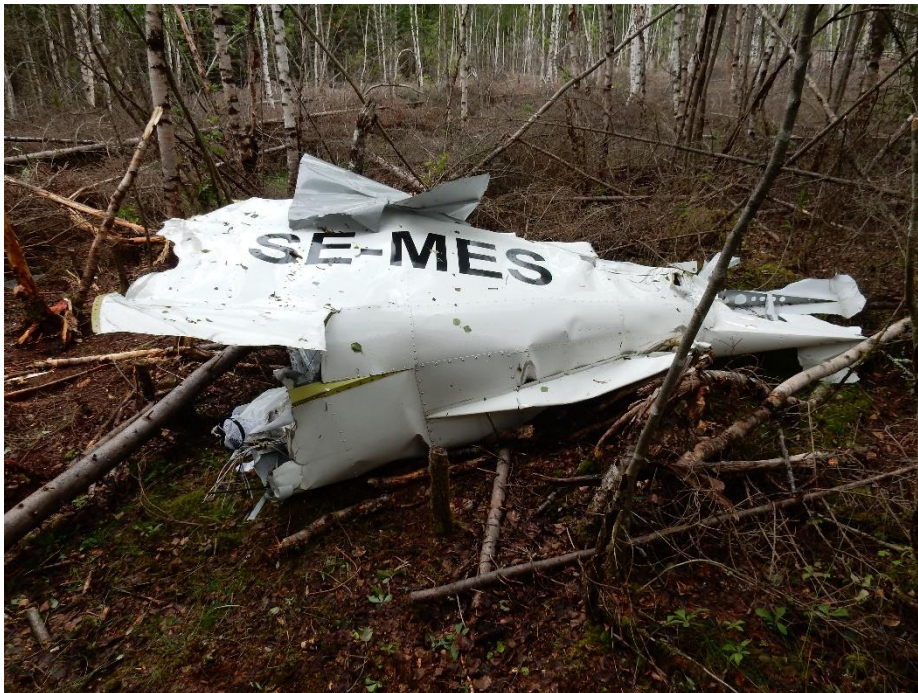
The tail section, which was missing the stabiliser and fin (vertical stabiliser), had been cut off from the fuselage by the fire and rescue service in conjunction with the rescue operation and was lying a few metres away.

Figure 27. The tail section cut off by the fire and rescue service.

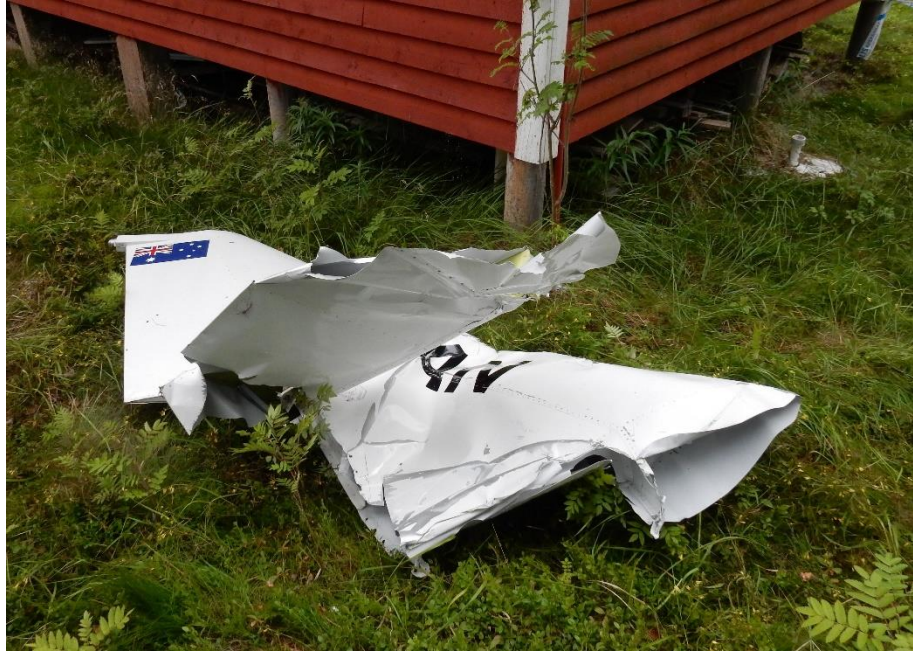
Figure 28. The broken off fin of the aeroplane.

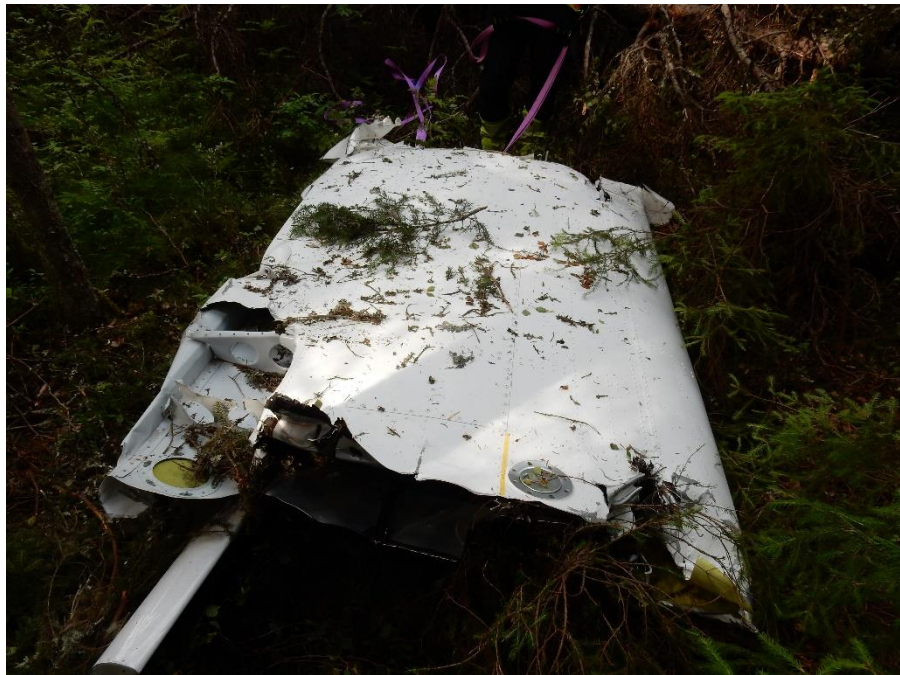
Figure 29. The inner section of the right wing.

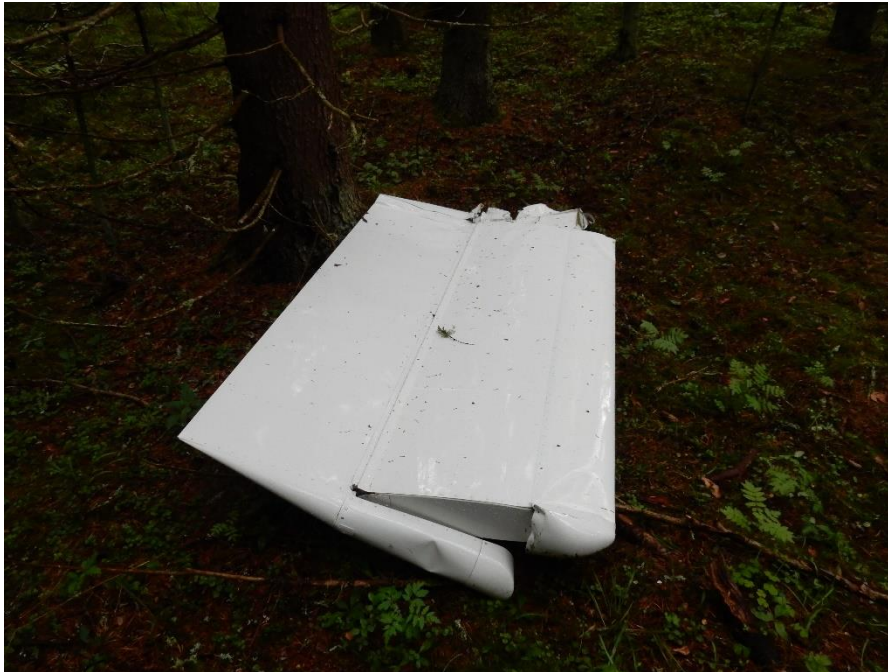
Figure 30. The broken part of the left side of the stabiliser.

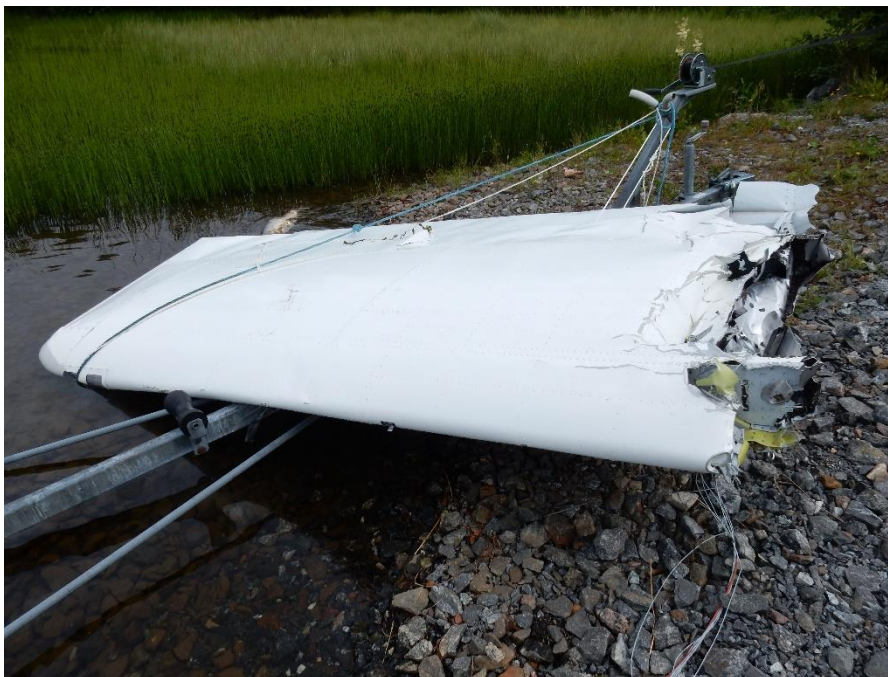
Figure 31. The outer part of the right wing was salvaged from the Ume River.

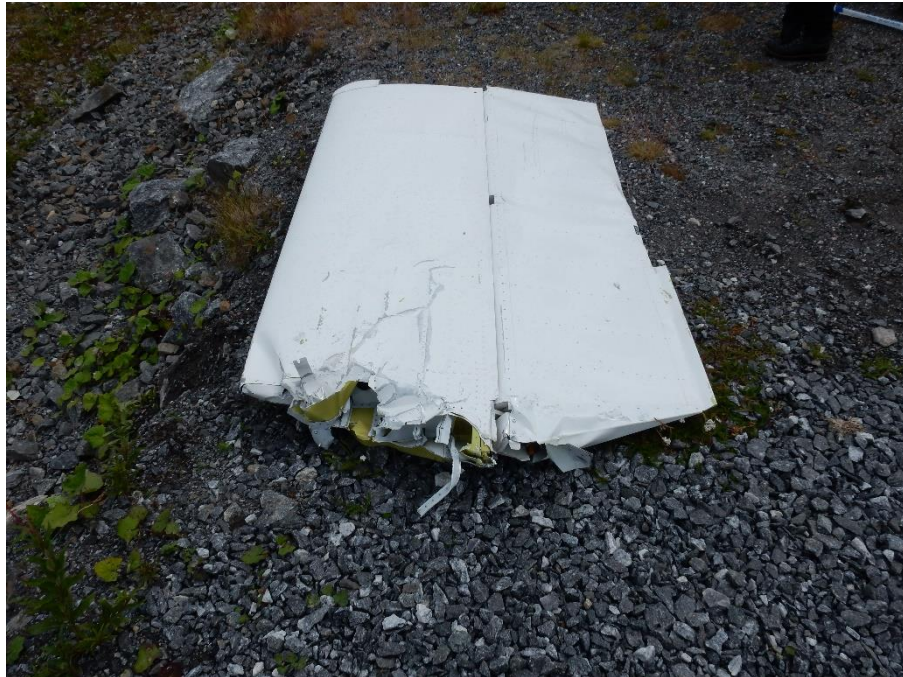
Figure 32. The right section of the stabiliser was salvaged from the Ume River.

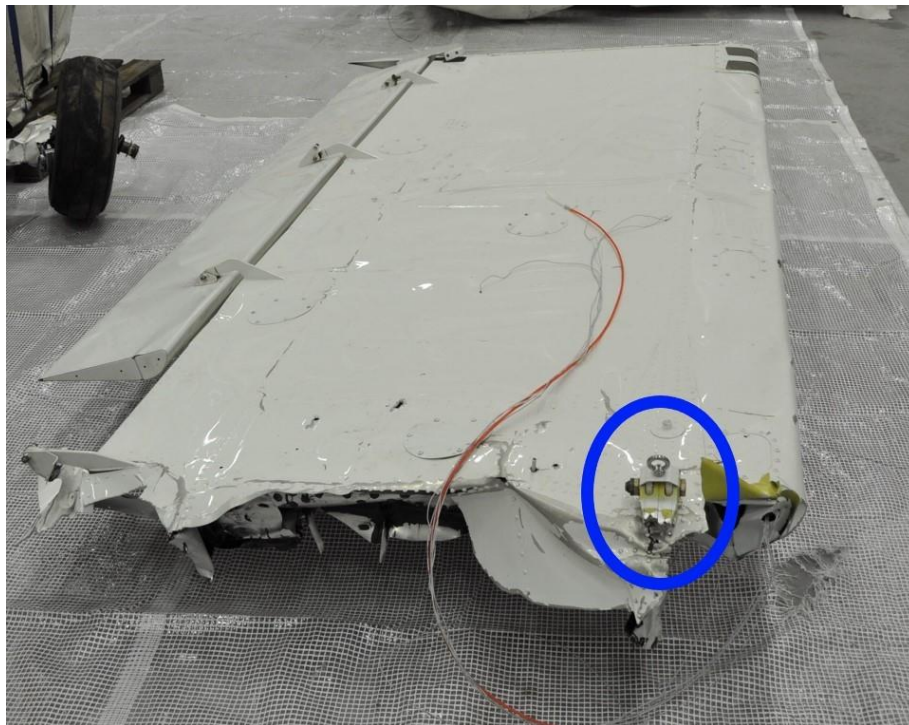
A visual inspection of the broken outer part of the right wing showed remaining deformations on the lower surface of the wing, probably caused by negative g-forces. The right wing strut was broken at its attachment. A detailed examination of the broken surfaces of the wing showed overload fractures. Damage indicates that the right outer wing was broken off upwards by positive g-forces.

Figure 35. Lower surface of the broken outer section of the right wing. The broken attachment to the wing strut is marked.

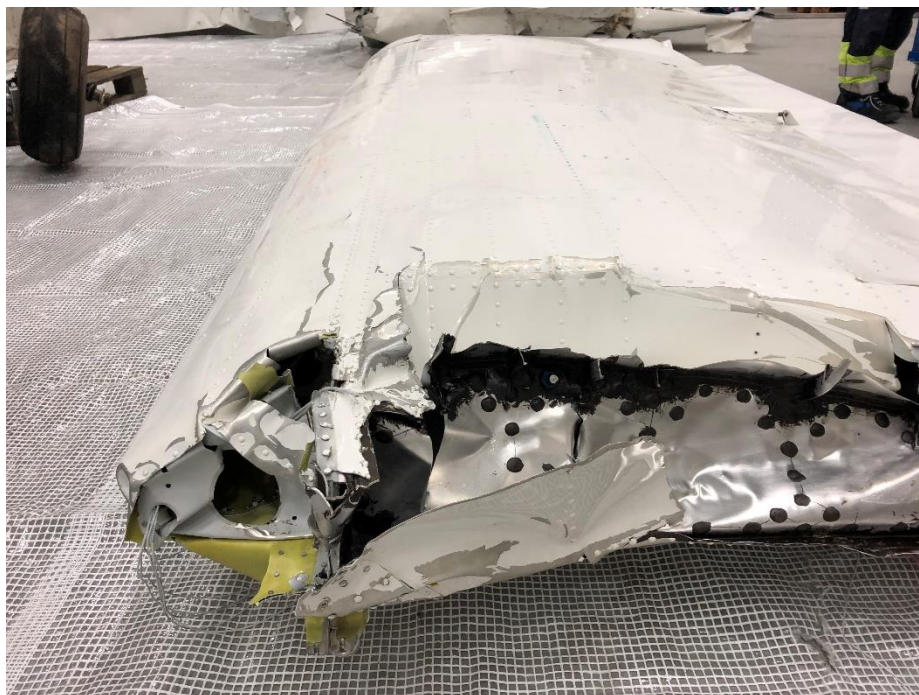
Figure 36. Upper surface of the outer section of the right wing.

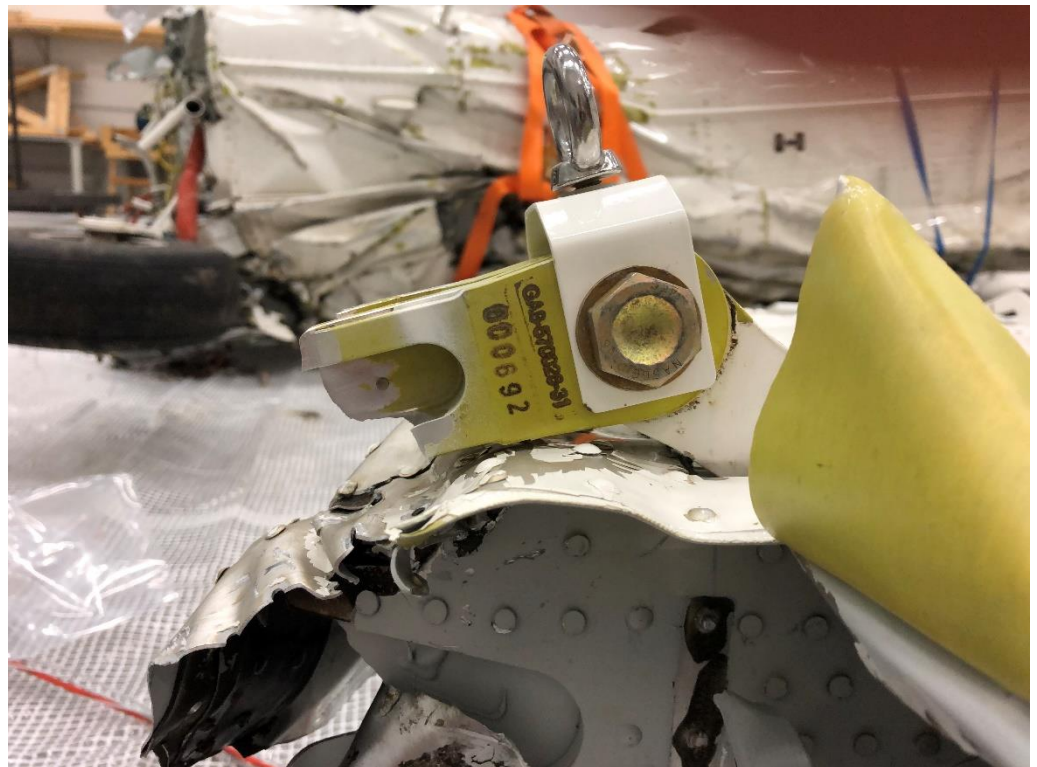
The broken attachment to the right wing strut was pushed into the underside of the wing and was not in its normal position (see Figure 37).

The result of a fractographic examination of the fracture surfaces showed an overload fracture in tension and bending. No signs of corrosion, fatigue cracking or other material defects were found. The examination shows that the fracture of the wing preceded the fracture of the attachment to the wing strut.

Figure 37. The broken attachment to the right wing strut.

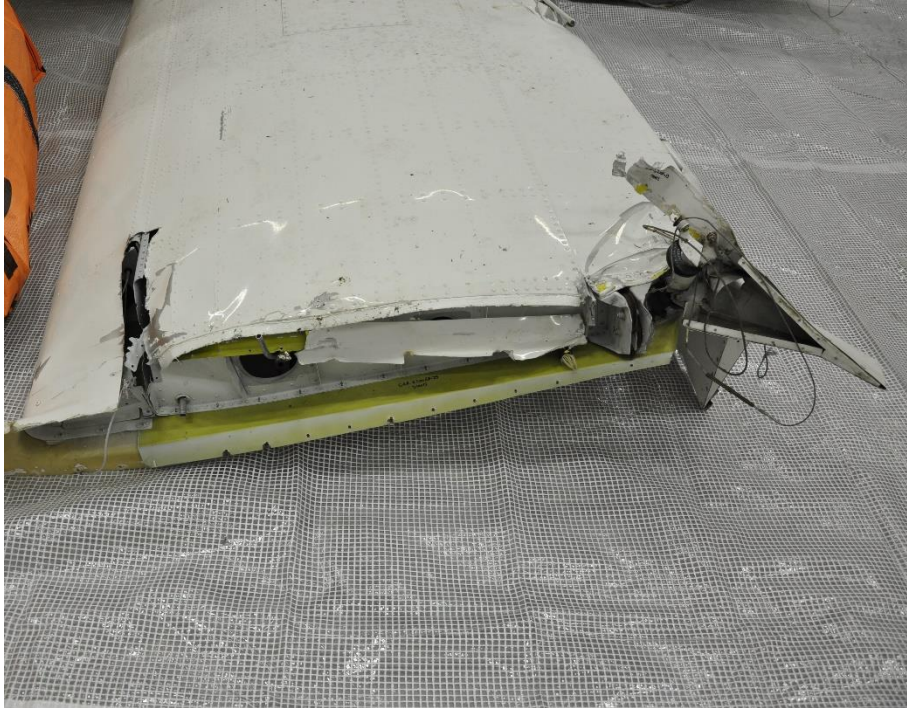
The inner section of the right wing, which was unsupported after the wing strut fractured, had subsequently broken off from the fuselage (see Figure 39).

Figure 39. The inner section of the right wing.

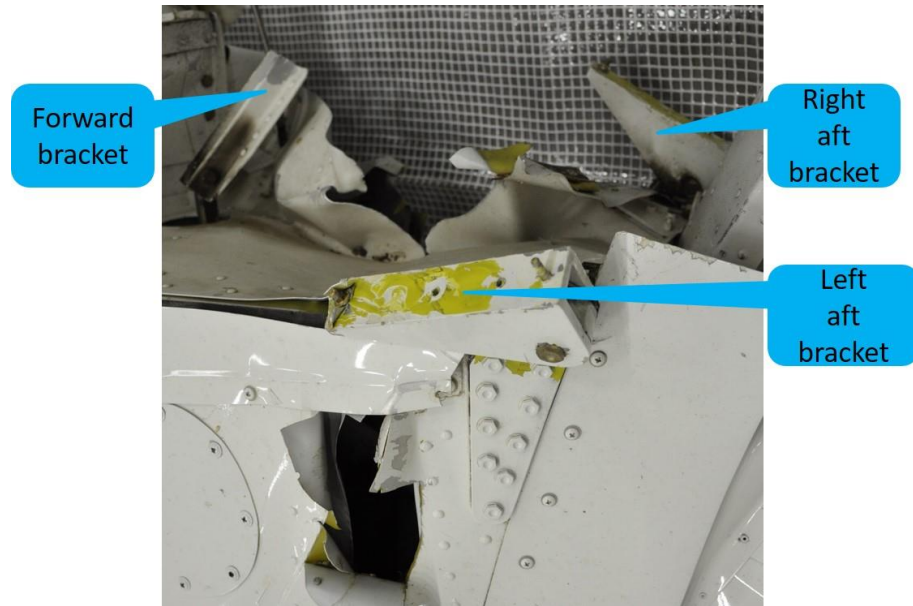
Bolts and nuts to the attachment of the rear brackets were broken under overloading or they were missing as a result of the occurrence.

Figure 40. The stabiliser's attachments.

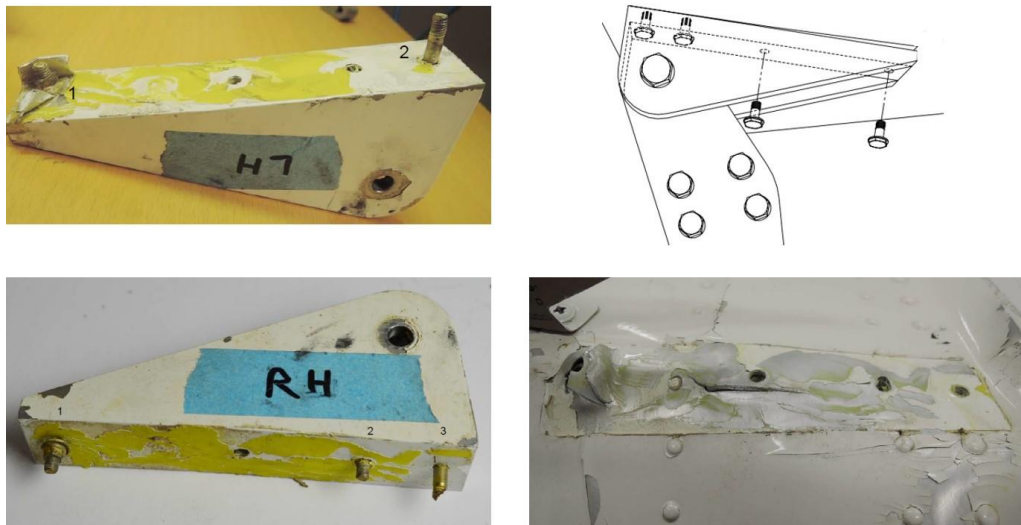
The two rear brackets for attachment of the stabiliser were mounted to the lower surface of the stabiliser using four screws (see Figure 42). The lower right image shows the lower surface of the stabiliser where one of the brackets has been mounted. There was damage to the skin panel and the screw holes in the stabiliser. The other attachment on the stabiliser showed similar damage.

This damage indicates that all the screws were mounted in place at the time of the failure.

Figure 42. The brackets and attachment to the stabiliser. Upper right image: GippsAero Pty Ltd SB-GA8-2002-02 Figure 2.

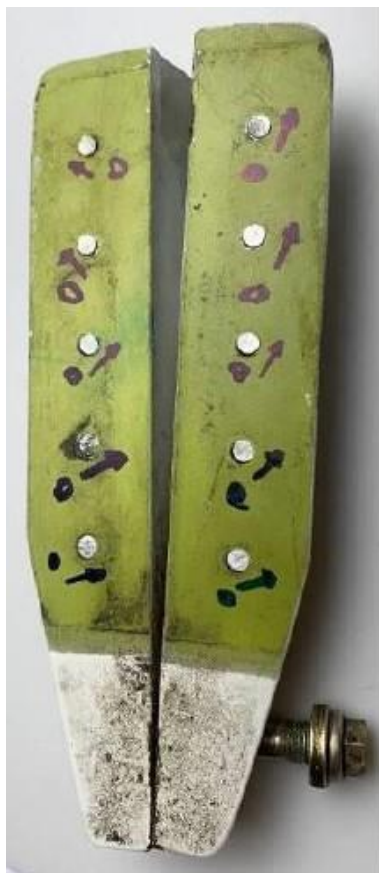
Figure 43. Bracket for front attachment of the stabiliser.

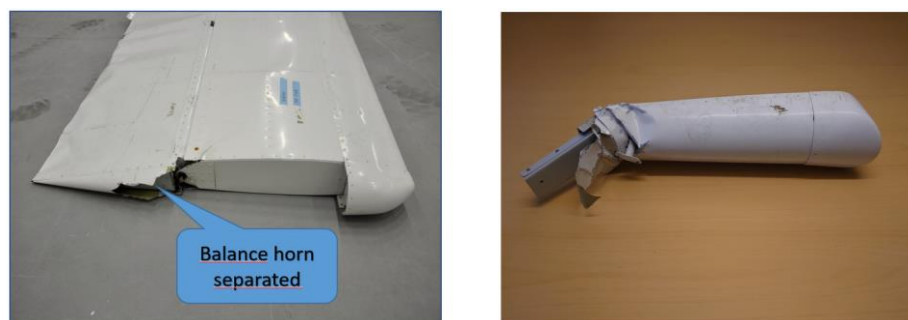
Figure 44. Left picture: Stabiliser and elevator with the balance horn separated. Right picture: The separated balance horn.

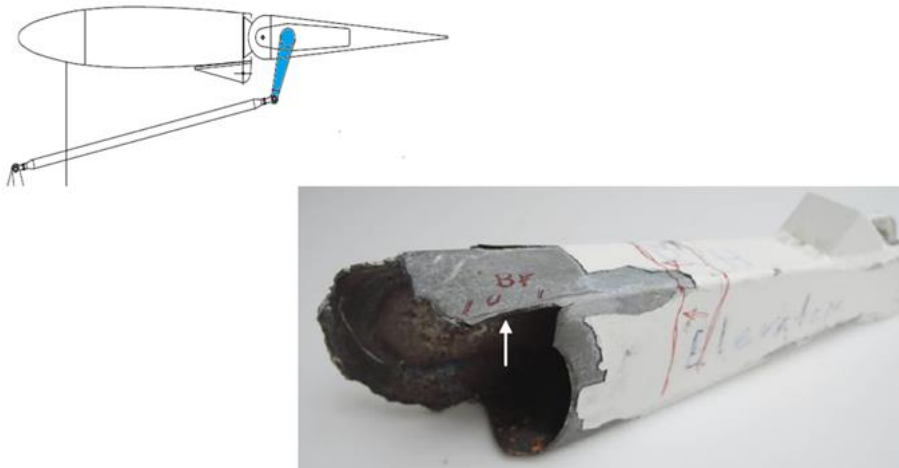
Figure 45. Right control arm to the elevator. Left upper image: GippsAero Pty Ltd GA8-TC 320 Service Manual. Amendment 54. Page 27-15. Figure 27-11, blue marking by SHK.

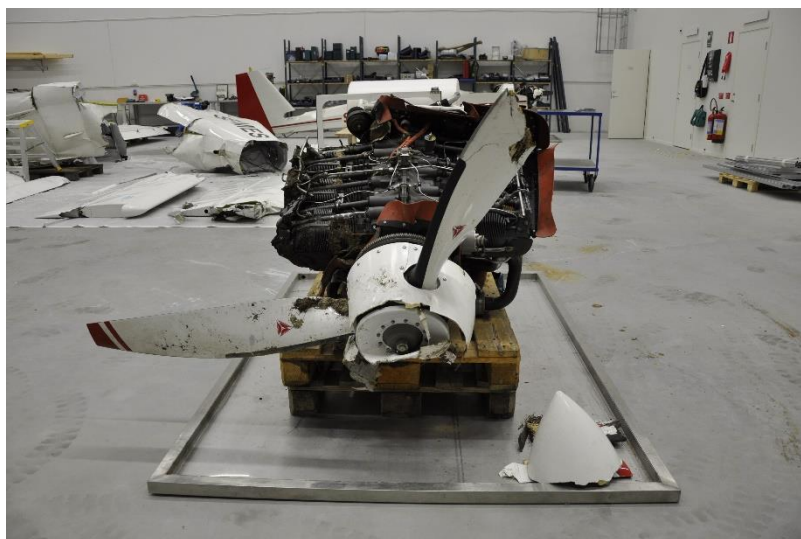
Figure 47. Engine with propeller.

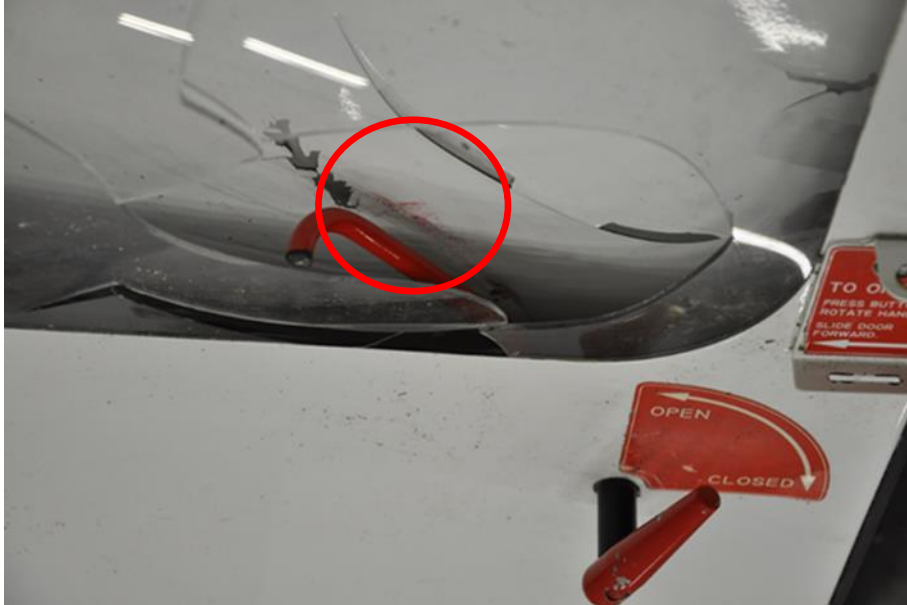
Figure 53. The picture shows an impact mark from the internal door handle on the outside of the fuselage.

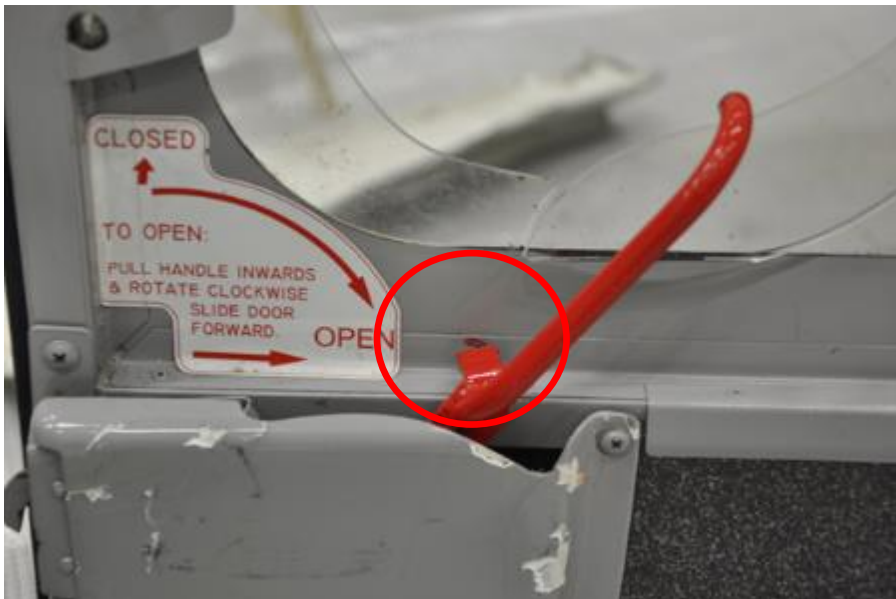
Figure 54. The picture shows a mark from the handle on the inside of the door.

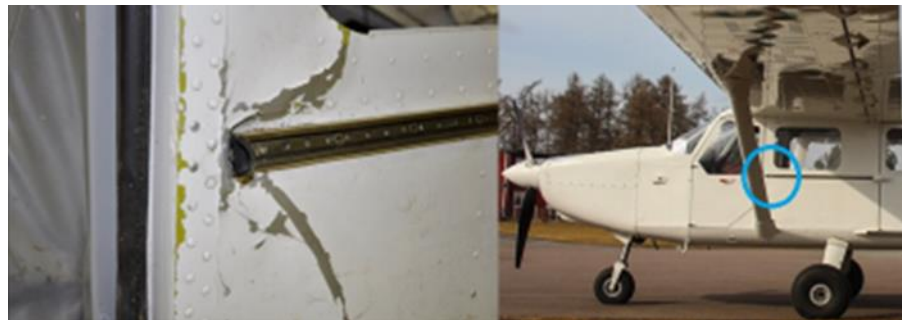
Figure 55. Left picture: Shows damage to the fuselage at the forward position of the door when it is open. Right picture: Marking by SHK that shows the position of the damage on the fuselage. Photo: Krister Karlsmoen.

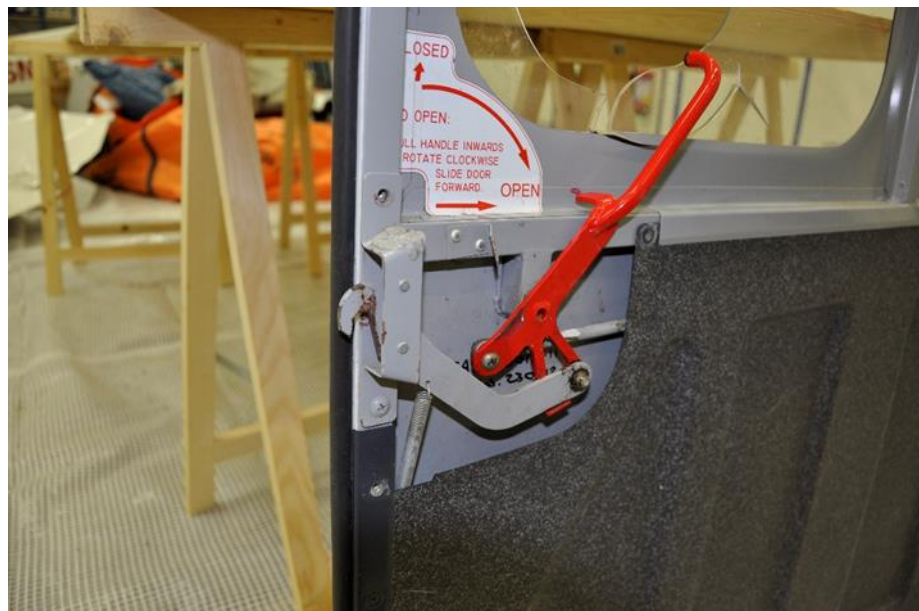
Figure 56. The cabin door's lock hasp.

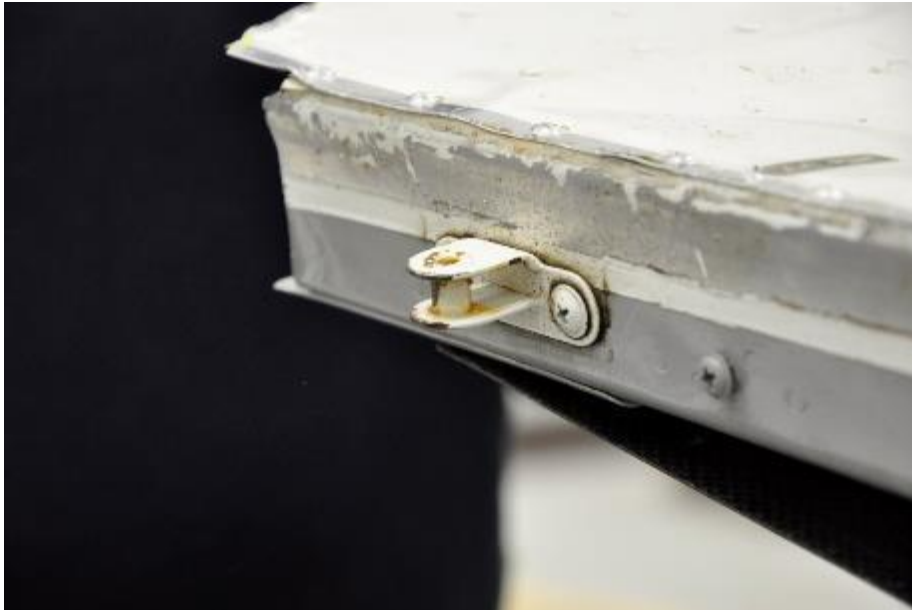
Figure 57. The cabin door's locking pin on the fuselage.

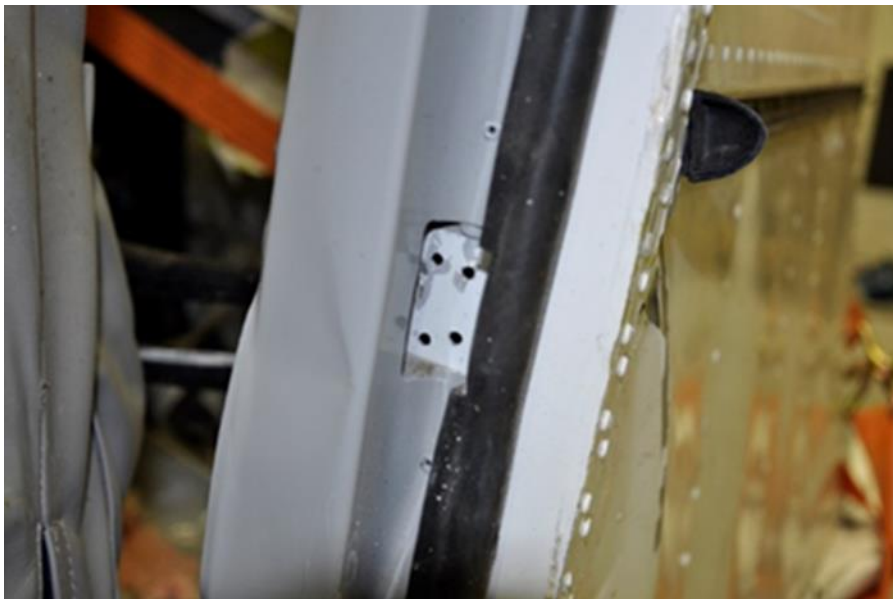
Figure 58. The picture shows that the pilot's door's locking catch was ripped out of its attachment.
