<b>AIRCRAFT ACCIDENT REPORT AND EXECUTIVE SUMMARY</b>
---

Reference:	CA18/2/3/9804	
<b>Aircraft Registration</b>	ZS-HLJ	<b>Date of Accident</b>	23 July 2019		<b>Time of Accident</b>	1106Z
<b>Type of Aircraft</b>	Bell UH-1H		<b>Type of Operation</b>	Fire-fighting (Part 137)		
<b>Pilot-in-command Licence Type</b>	Commercial CPL(H)	<b>Age</b>	53		<b>Licence Valid</b>	Yes
<b>Pilot-in-command Flying Experience</b>	Total Flying Hours	6596.7		Hours on Type	194.9	
<b>Last Point of Departure</b>	Letaba Air Base in Politsi near Tzaneen, Limpopo Province					
<b>Next Point of Intended Landing</b>	Letaba Air Base in Politsi near Tzaneen, Limpopo Province					
<b>Location of the accident site with reference to easily defined geographical points (GPS readings if possible)</b>						
Bosveld Citrus Farm in Politsi at GPS co-ordinates determined to be S23°45'22.71" E030°6'32.97" at 2643ft above mean sea level (AMSL)						
<b>Aircraft Damage</b>	Substantial					
<b>Meteorological Information</b>	Wind: 250°6.5kts; Temperature: 26°C; QNH: 1017hPa, Visibility: CAVOK

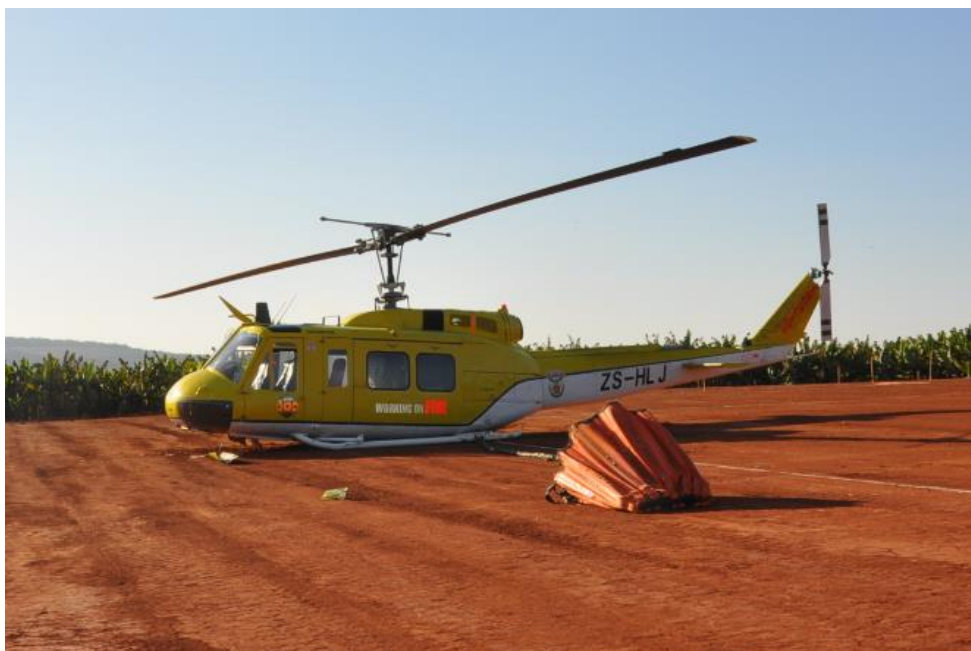
1.3.1 The aircraft was substantially damaged during the accident sequence.

**Figure 2:** The helicopter at the accident site.

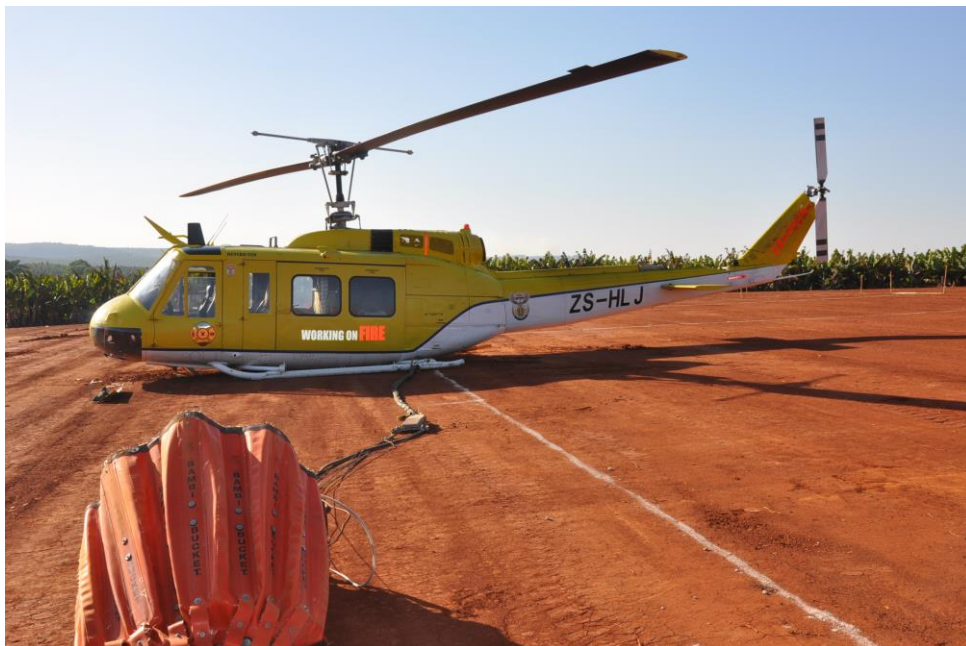
1.12.1 The helicopter crash-landed on an open field in Bosveld Citrus Farm. It impacted the ground hard with both skids. The helicopter sustained substantial damage to the tail boom and transmission mounts. The main wreckage was found at GPS co-ordinates S23°45'22.71" E030°6'32.97. The main rotor drive shaft had remained intact. The number one main rotor blade tip sustained damage but the number two main rotor blade was still intact, as well as all control cables. The skids broke on impact and the underbelly was damaged. The main rotor gear box, tail rotor and tail rotor gear box assembly were not damaged. The cabin area had remained intact.

**Figure 4:** Damage to the skids, tail rotor drive shaft and chin bubble.

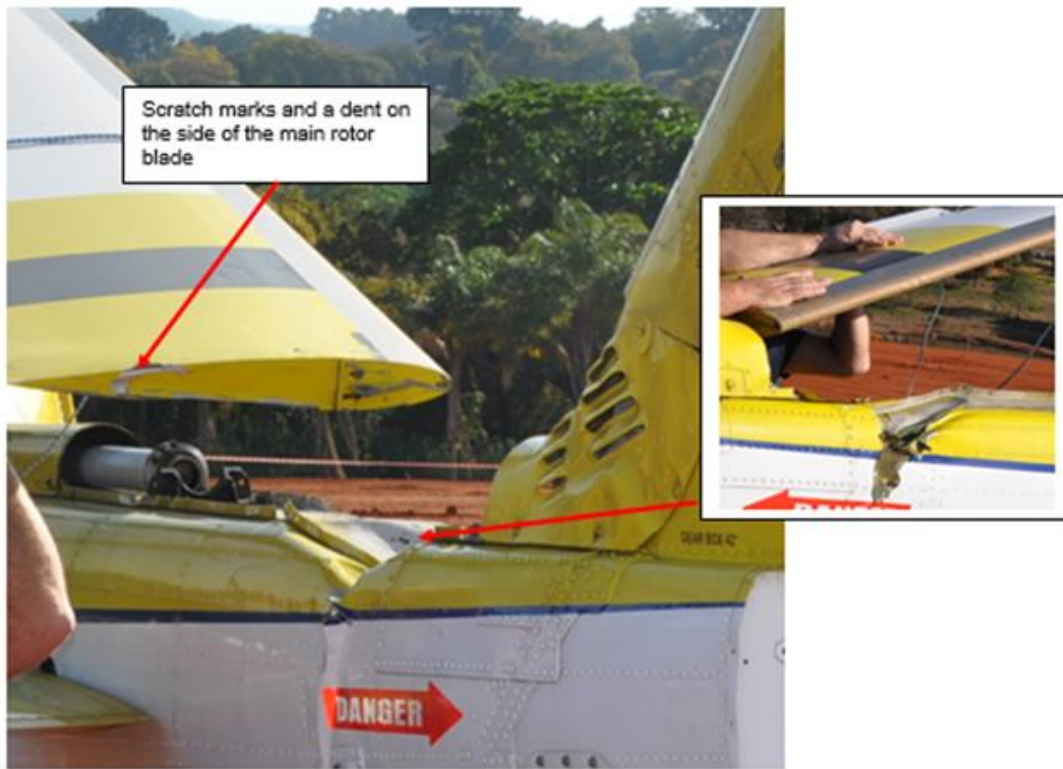
1.12.2 The number one main rotor blade had severed the tail rotor drive shaft during the accident sequence, and the drive shaft was found 30 metres (m) south of the wreckage.

**Figure 5:** The severed tail drive shaft.

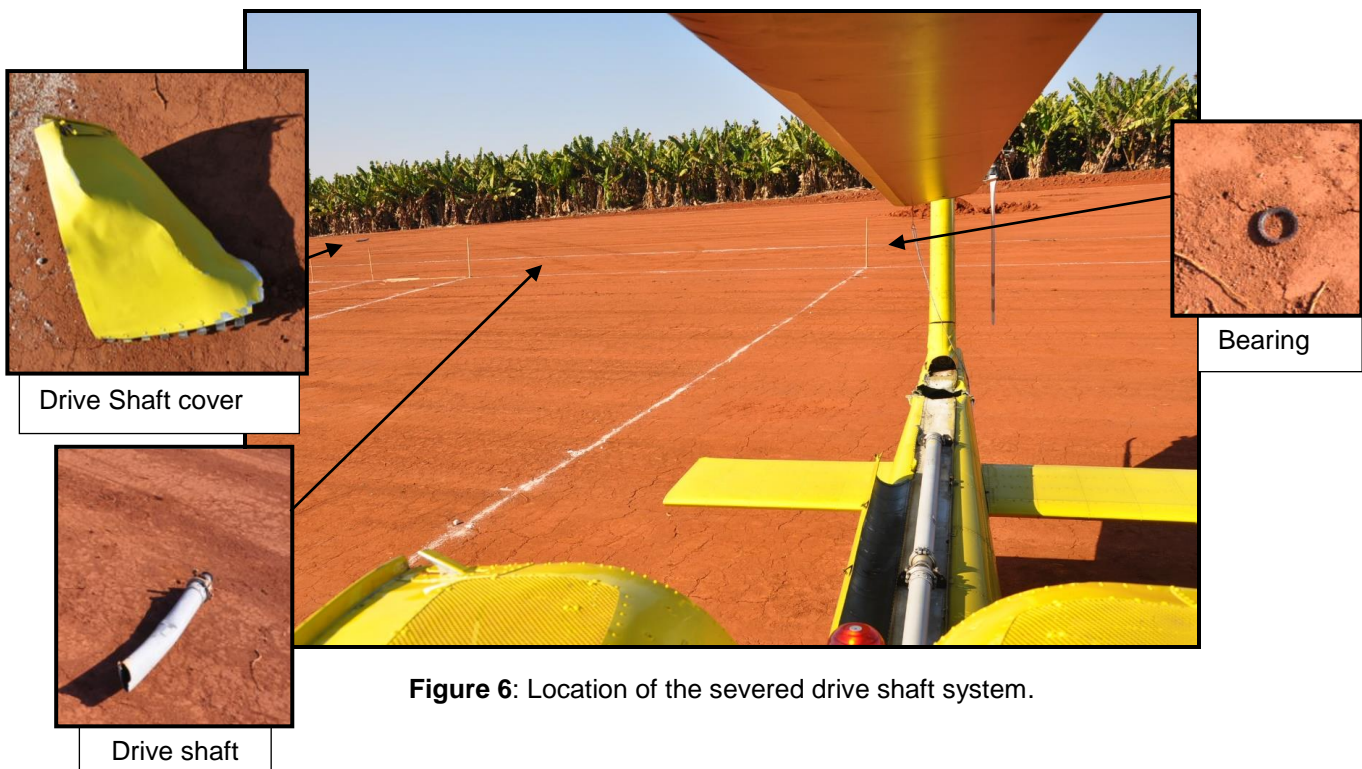
**Figure 6:** Location of the severed drive shaft system.

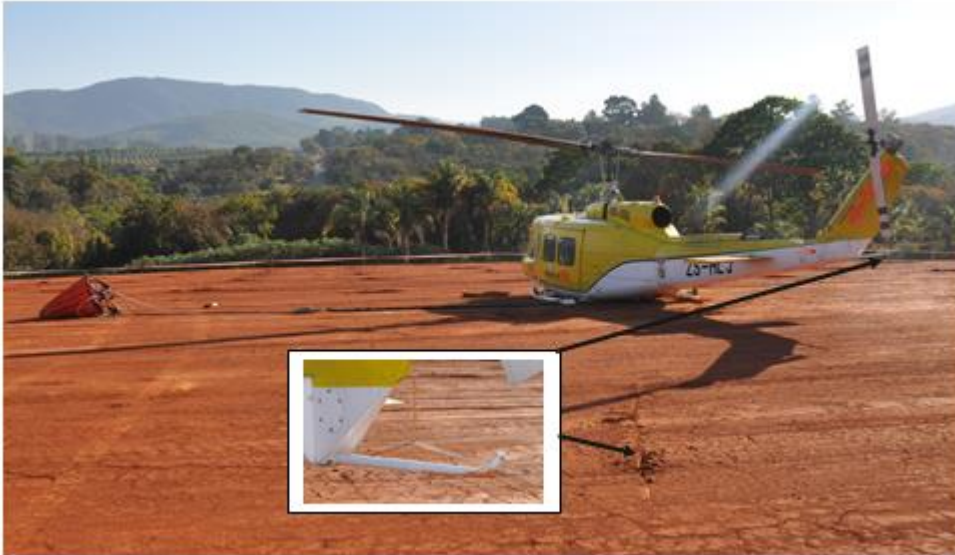
**Figure 7:** The ground scar mark created by the tail rotor guard during the accident sequence.

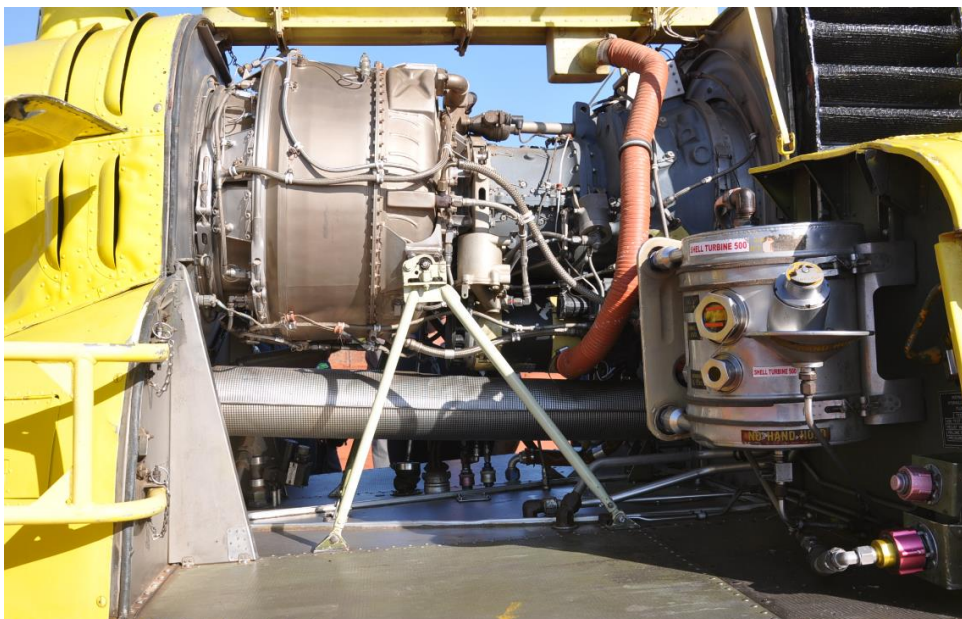
1.12.5 The engine was still intact and attached to the mounting points, and there were no visible signs of oil and hydraulic leaks. The levels were showing  $\frac{3}{4}$  on the sight glass. There were pieces of metal shavings found on the surface of the exhaust shroud of the engine (see Figure 9).

**Figure 8:** The position of the engine post-accident.

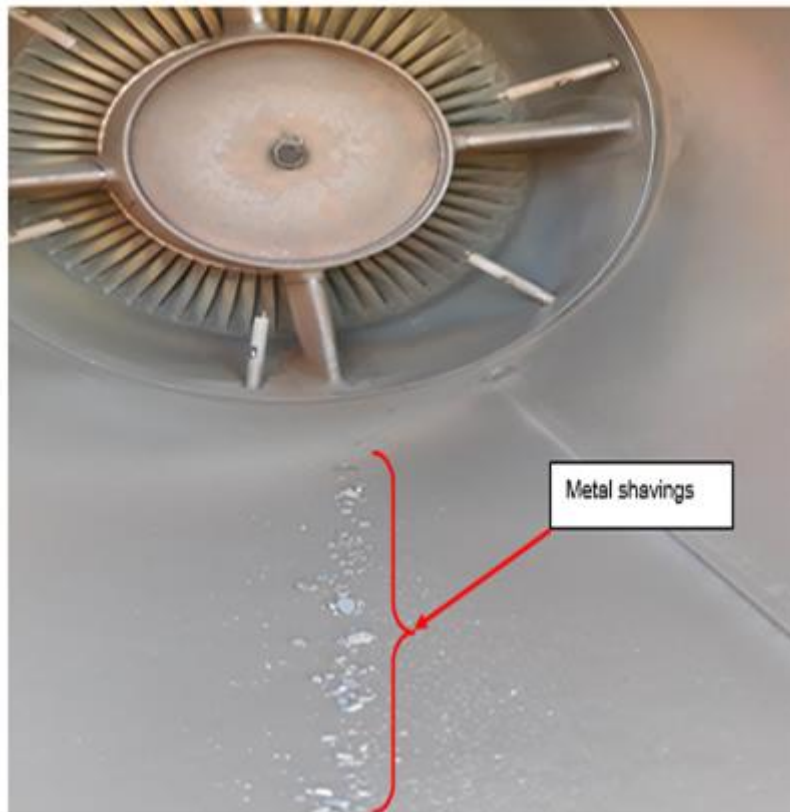
**Figure 9:** Metal debris found in the exhaust area.

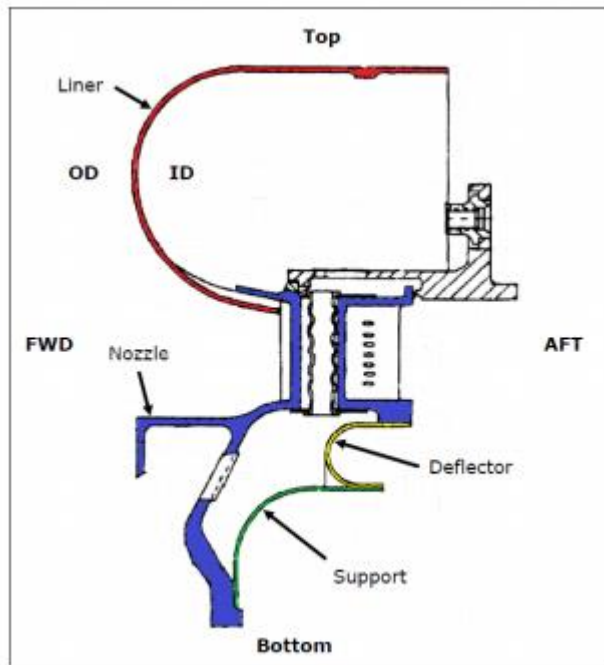
**Figure 14:** The first stage gas producer turbine nozzle assembly.

- Multiple cracks and separations were observed in the first stage turbine nozzle and inner transition liner from the 9 to the 3 o'clock (clockwise) location and near the 6 o'clock location. A melted area of the nozzle was observed near the 6 o'clock location.

- Scanning electron microscope (SEM) evaluation of the first stage turbine nozzle and inner transition liner fracture surfaces revealed evidence of fatigue and reversed bending fatigue emanating from multiple locations; however, the finer fracture features were obscured by oxidation of the fracture surface.

- A representative cross section through the approximate location of an initiation region revealed a trans granular fracture surface indicative of fatigue. The microstructure was indicative of the specified Hastelloy X material. No material anomalies or defects were observed in the cross section.

- The average hardness was measured to be approximately 203 HB (converted from HV500) which was within the drawing specification range of 116-235 HB. A non-uniform wear pattern was observed on the outside surface of the first stage turbine nozzle inner transition liner associated with contact of the combustion chamber inner panel in multiple locations. These wear patterns were associated with contact between the inner panel, inside surface, of the combustion chamber liner with the outside surface of the first stage turbine nozzle inner transition liner.

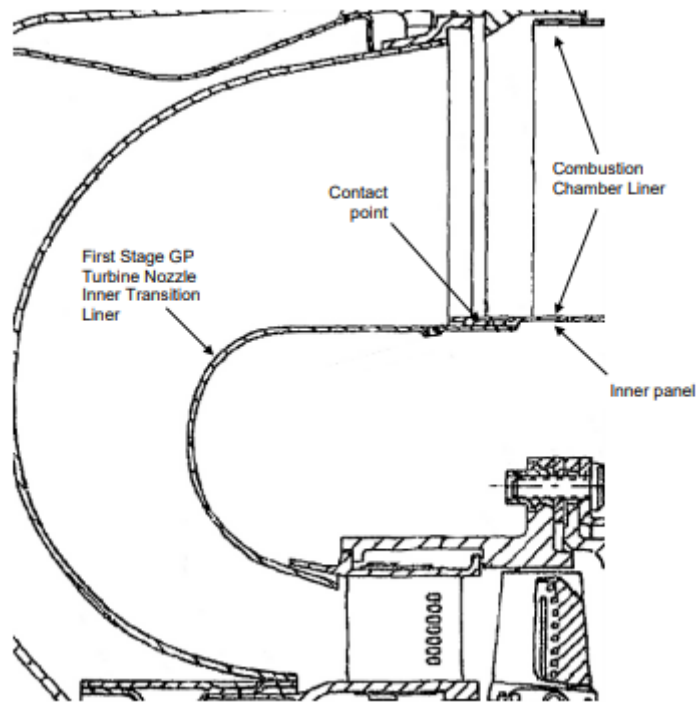
**Figure 15:** The first stage gas producer turbine nozzle to the combustion liner interface.

*The teardown and examination of engine LE-18293B disclosed that the type and degree of damage to the engine was indicative of a vibratory fatigue failure of the first gas producer inner transition liner. The fatigue failure occurred due to a non-uniform interference fit between the first gas producer inner transition liner and the combustion chamber liner. The failure eventually led to an over temperature and damage to the engine to the point that it could no longer provide the power required to sustain flight. The cause for the non-uniform interference fit between the first gas producer inner transition liner and the combustion chamber liner could not be determined.*

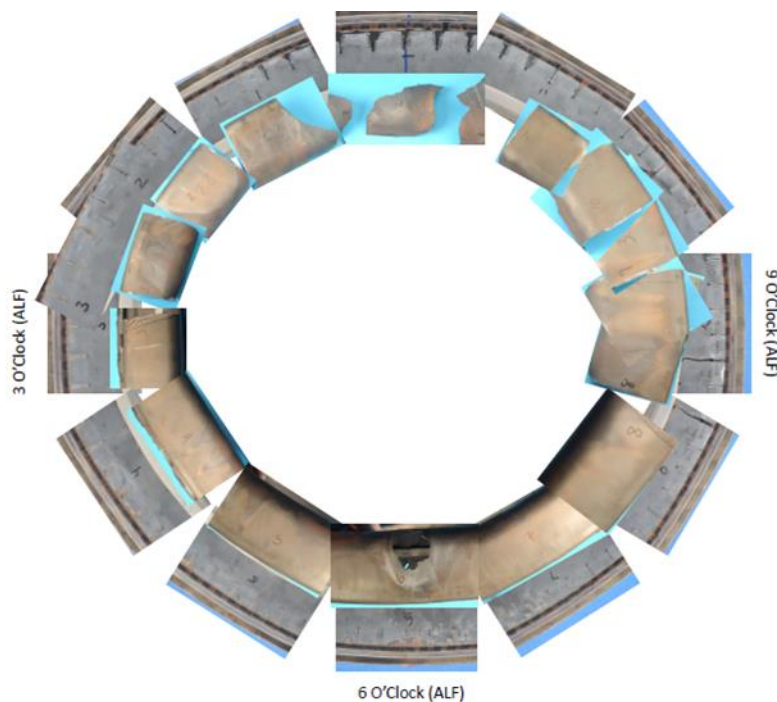
1.16.5 A mosaic of images showing the contact locations between the first stage turbine nozzle inner transition liner and the combustion chamber inner panel. The contact pattern between the two assemblies appeared to be a non-uniform interference fit with almost no contact evident between the 3 to 8 o'clock positions (ALF) and again at the 10 and 11 o'clock positions. This indicates a non-uniform loading of the first stage turbine nozzle inner transition liner to the combustion chamber inner panel leading to crack initiation and propagation due to reverse bending fatigue in a vibratory mode.

**Figure 16:** The mosaic of images showing contact locations between the first stage turbine nozzle inner transition liner and combustion chamber inner panel.

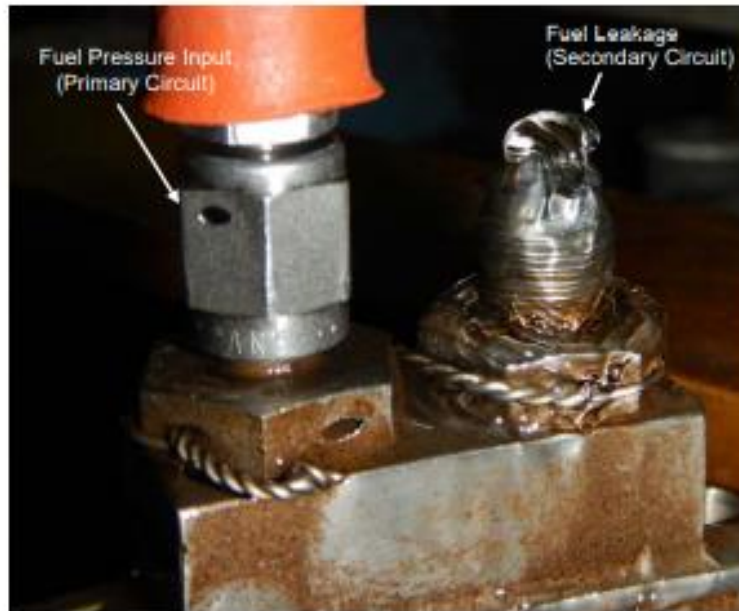
be applied to the primary and secondary fuel circuits independent of one another. Testing showed that when the primary fuel circuit was energized, fuel was observed coming from the secondary fuel circuit. And when the secondary fuel circuit was energized, fuel was observed coming from the primary fuel circuit. This indicated that there was an unintended leak path between the primary and secondary fuel circuits. Image below was taken when the primary fuel circuit was pressurized with the cross flow occurring into the secondary circuit.

**Figure 19:** The cross flow of fuel when one fuel circuit is energised.

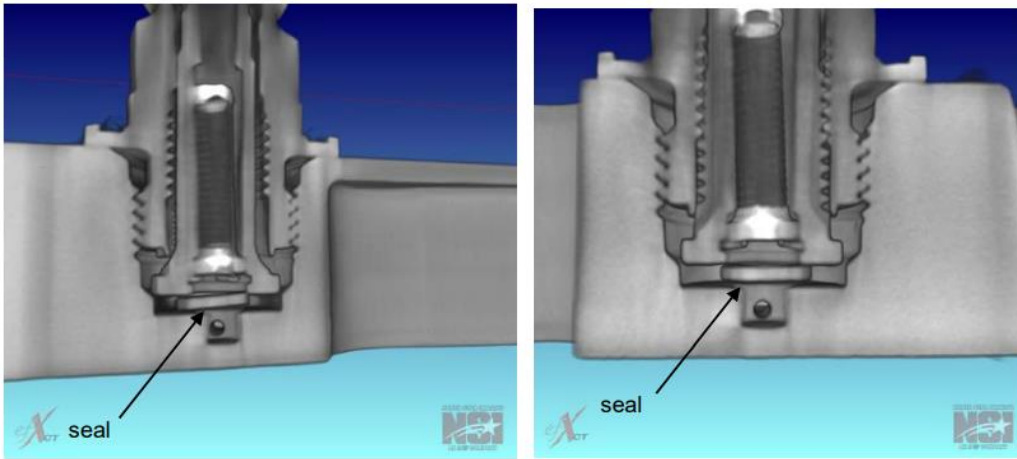
1.16.8 The fuel manifold and fuel nozzle assembly were sent to Honeywell's Computed Tomography (CT) group for scanning and analysis. CT scanning of the manifold showed the two chambers within were still independent of one another with no internal leaks. Further analysis of the CT scans identified several fuel nozzle seals as possibly being out of place or damaged. The following figures show a fuel nozzle seal that appeared to be damaged along with one that did not appear to be damaged. The fuel nozzles were removed from several locations for further investigation where the CT scans showed the seals to be damaged. Examination of the seals showed the fluorosilicone elastomer material was permanently deformed and had areas of separation from the stainless-steel retainer. See the following figures. The seal is constructed of a stainless-steel retainer that is surrounded by a fluorosilicone elastomer, fuel resistant material, which acts as the sealing agent. The CT scan only shows the stainless-steel retainer and not the elastomer material around it because elastomer materials are not viewable when the CT settings are for steel materials.

**Figure 20 and 21:** The CT scan of a damaged seal and the undamaged seal.

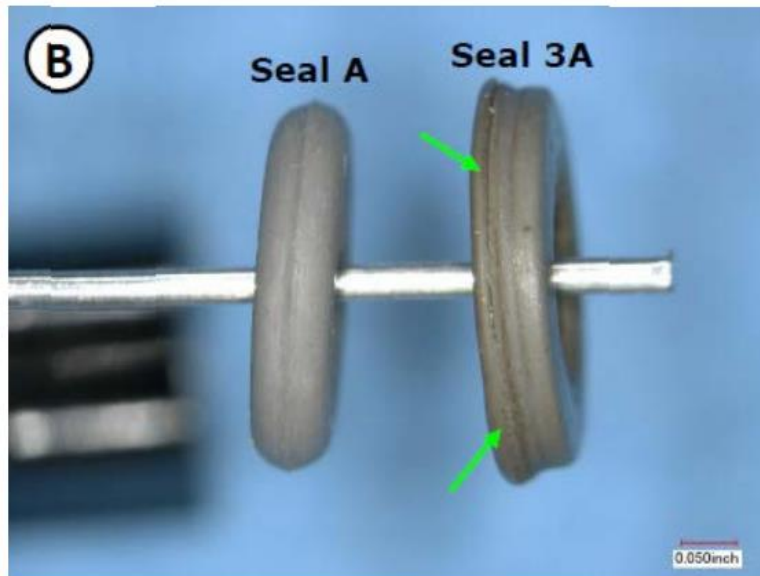
**Figure 22:** The physical differences between a new (Seal A) and the accident engine seal 3A.

1.16.9 Visual observation of the seals suggested they had been exposed to temperatures in excess of their design limits and had “taken a set” as a result of the over temperature condition. The seals were subjected to Differential Scanning Calorimetry (DSC) analysis to determine if the material had been exposed to temperatures beyond its design limits. The DSC testing confirmed the visual observations; the seals had been exposed to temperatures in excess of their design limits. But the testing could not determine if this

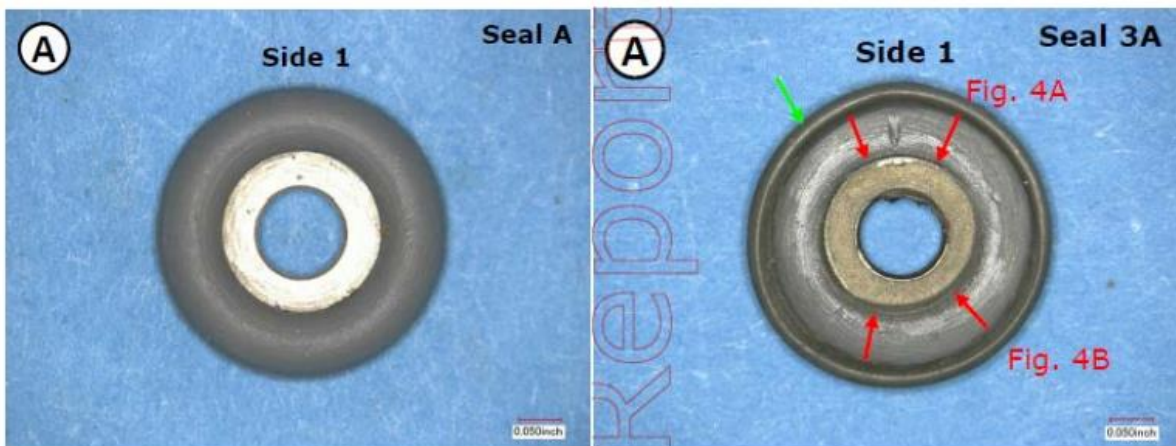
**Figure 23 and 24:** The physical differences between a new (Seal A) and the accident engine seal 3A.
