## *Final report RL 2020:02e*

**Accident at Norrtälje/Mellingeholm airport, Stockholm county, 29 July 2019 involving the aircraft D-EPFH of the model Cirrus SR22, operated by a private person.**

File no. L-101/19

19 February 2020

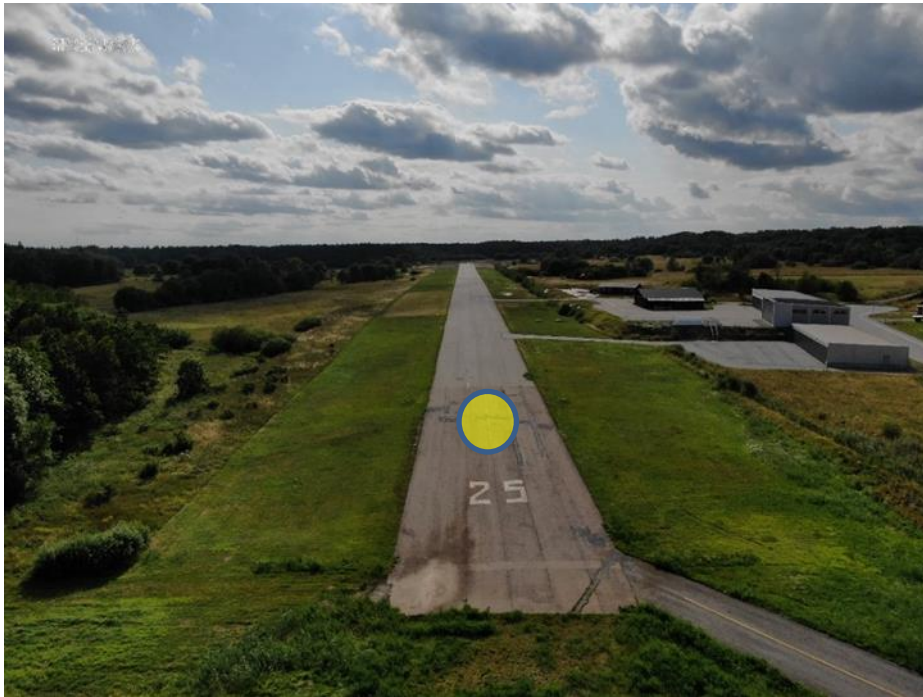
In conjunction with the touchdown, the nosewheel touched down first. There was no flare, which led to a hard landing. This caused the aircraft to bounce, at which point the pilot tried to abort the landing attempt by giving full throttle, which caused the aircraft to yaw to the left. The pilot felt that the aircraft was not climbing, that the speed was too low and that he was at risk of stalling. The aircraft left the runway area and flew into some shrubbery outside the runway strip. It then landed in the terrain, where the aircraft's landing gear and propeller broke off. The aircraft then skidded and veered to the right, and finally came to a stop facing north.

Figure 1. Picture over the final to runway 25 with a yellow marking by SHK at the point of touchdown. Photo: SHK. Published with the consent of The Swedish mapping, cadastral and land registration authority.

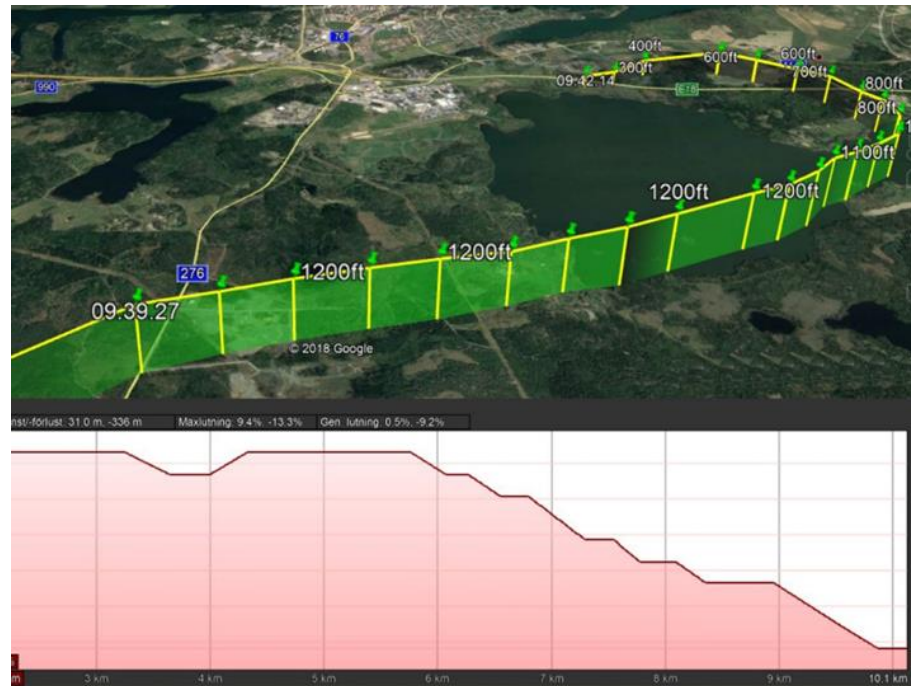
Figure 6. Radar image from LFV with altimeter measurements for the approach. Image: Google Earth.

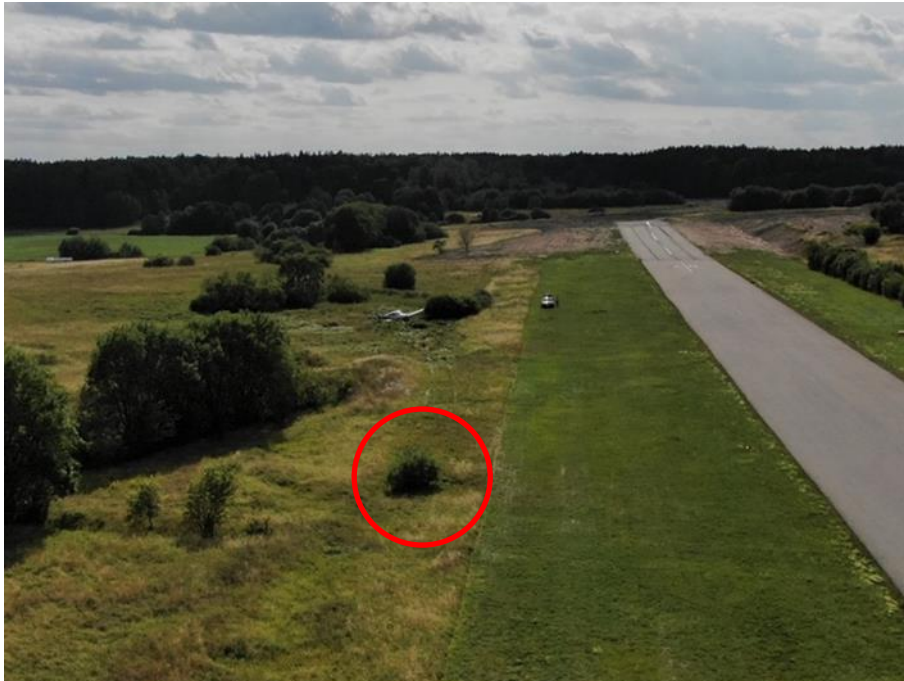
Outside the grass strip and 27 metres to the side of the airstrip, there is some shrubbery that is approximately 3.5 metres wide and 3 metres high. Following the event, there were impact marks around 2 metres up in the vegetation. The aircraft bounced on touchdown and then yawed to the left, exiting the runway, after which it flew around 340 metres before colliding with the shrubbery. After the vegetation, there were tracks on the ground from the landing gear and the aircraft up to the point where the aircraft stopped.

Figure 7. The marked shrubbery had impact marks from the aircraft, marking inserted by SHK, which can be seen in the background. Photo: SHK. Published with the consent of The Swedish mapping, cadastral and land registration authority.

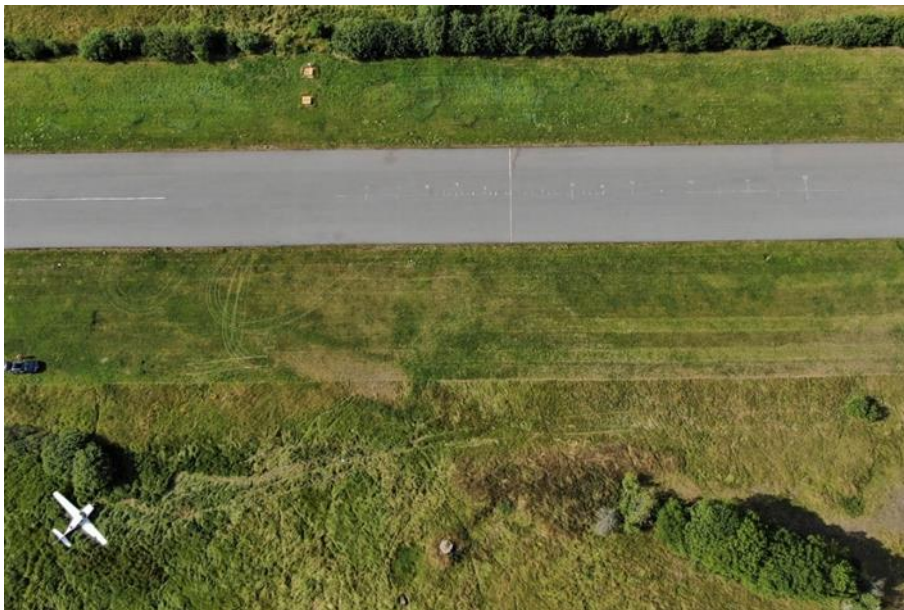
Figure 8. The image shows the aircraft's position in relation to the runway and the tracks. Photo: SHK. Published with the consent of The Swedish mapping, cadastral and land registration authority.

The aircraft ended up approximately 45 metres south of the runway in the high grass.

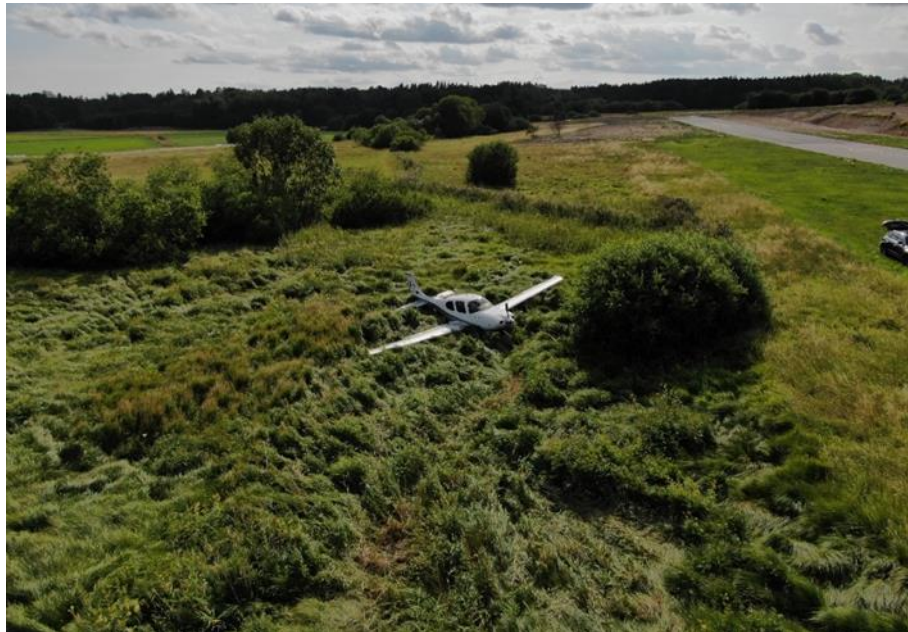
Figure 9. The aircraft at the accident site. Photo: SHK. Published with the consent of The Swedish mapping, cadastral and land registration authority.

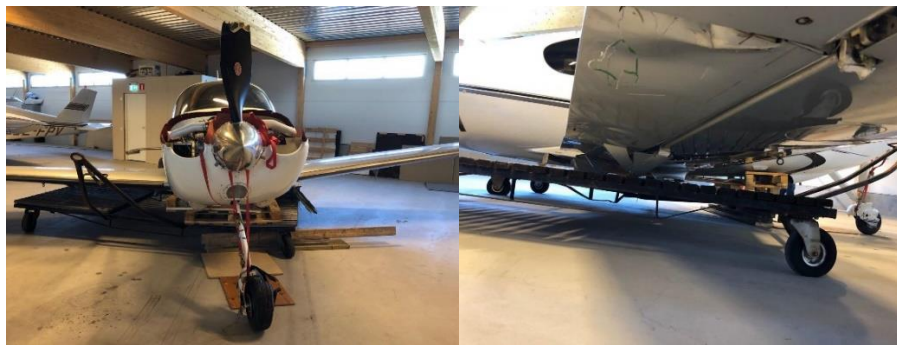
During the event, the aircraft's landing gear and propeller were damaged. Damage also occurred to the fuselage and wings.

Figure 10. Damage to the aircraft.

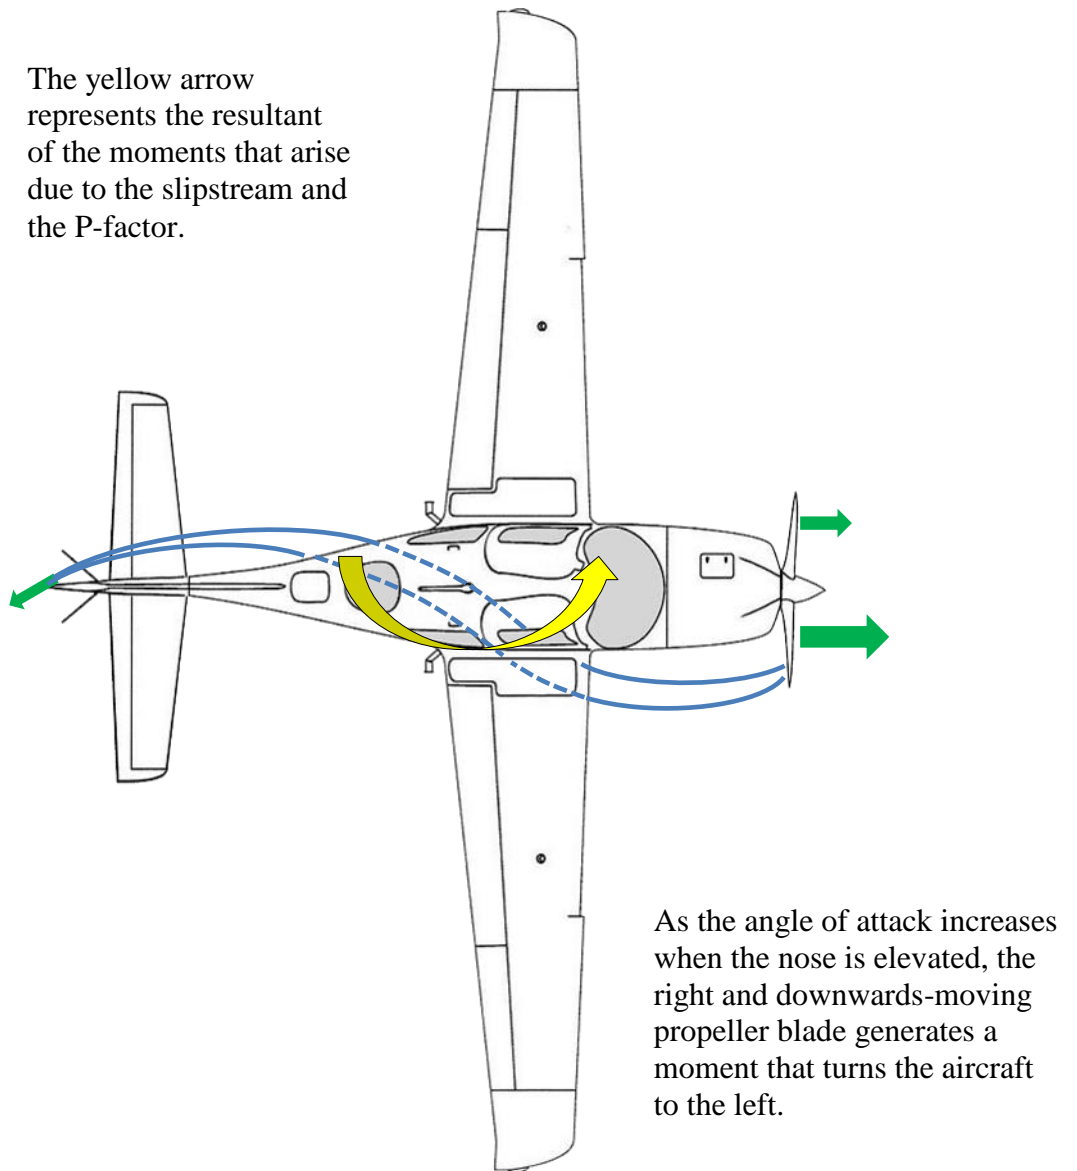
One is the slipstream that occurs as the propeller rotates, creating an airstream around the fuselage that exerts force on the fin. A propeller that rotates to the right, from the pilot's viewpoint, creates an airflow that pushes on the left side of the fin, forcing the aircraft to turn to the left. It is thus necessary to compensate by applying the right rudder.

The other reason is the P-factor. This is an aerodynamic phenomenon that causes an asymmetrical relocation of the propeller's centre of thrust as the aircraft's angle of attack increases. The shift in the centre of thrust prompts the aircraft to yaw slightly to the side. This yawing effect, which can also be expressed as torque, increases along with increasing nose elevation, as the angle of attack increases in relation to the airflow on the side of the propeller where the blades are moving downwards.

In a Cirrus SR22, the engine rotates to the right from the pilot's perspective. This means that the right side of the propeller is moving downwards, resulting in the propeller's centre of thrust shifting to the right. The result is a moment turning the aircraft's nose to the left. The pilot can use a right-side rudder deflection to counteract this phenomenon.

Figure 11. P-factor and slipstream.
