Final report RL 2020:05e

Serious incident at Stockholm/Västerås Airport on 4 September 2019 involving the aeroplane SE-LZF of the type Cessna 172, operated by OSM Aviation Academy, and the aeroplane SE-GVE of the type Piper PA-28, operated by the Voluntary Flying Corps.

File no. L-136/19

15 May 2020

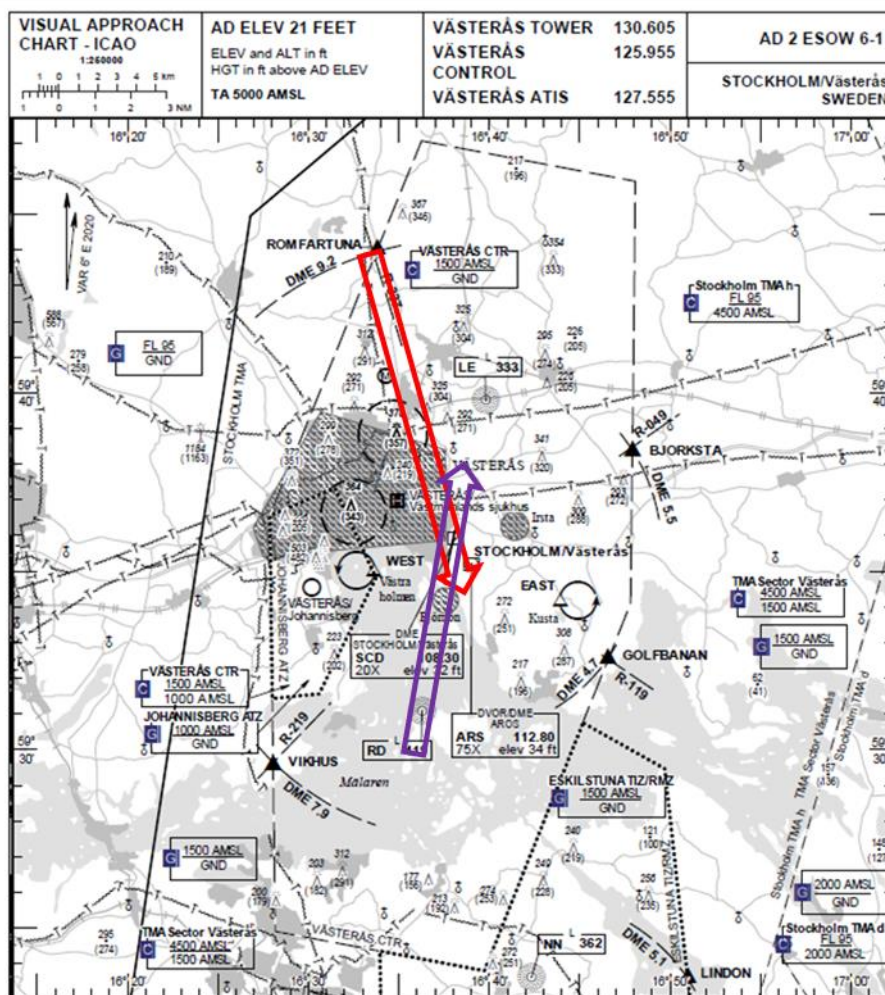
The fact that the aeroplanes were adhering to different AIP procedures for IFR and VFR approaches, respectively, resulted in their flight paths crossing at the same altitude over the runway. Sensor data shows that both aeroplanes passed close to one another at about the same altitude and with a minimum horizontal separation of 150 metres (0.08 Nm). In addition, sensor data show that the Piper PA-28 made a sharp avoidance manoeuvre to the right just before the paths crossed.

Figure 2. Expected flight paths for VFR approach from Romfartuna (red arrow) and go-around from an NDB approach (purple arrow). The arrows have been added by SHK. Source: AIP Sweden.

One and a half minutes later, the PA-28, which was adhering to the procedure for VFR approach to the airport, reported that it was passing the entry point Romfartuna at an altitude of one thousand feet and was proceeding to land. Romfartuna is an entry point that lies to the north-west of the airport (see Figure 2).

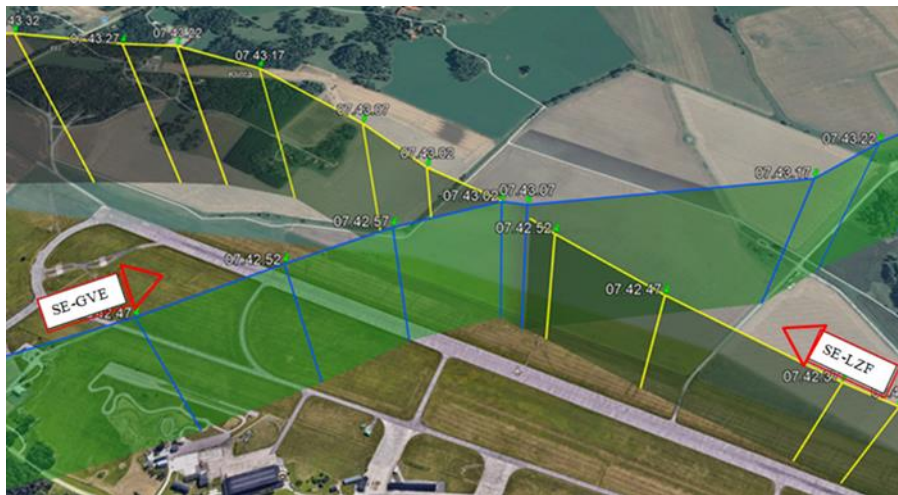
Sensor data show that the aeroplanes passed close to one another at about the same altitude and with a minimum horizontal separation of 150 metres (0.08 Nm). In addition, sensor data show that the PA-28 made a sharp avoidance manoeuvre to the right just before the paths crossed (see Figure 4).

Figure 3. Fused radar track (ARTAS) that shows the Cessna in yellow and the PA-28 in blue. Source: Google, Lantmäteriet registration number Reg. no. R61749_190001.

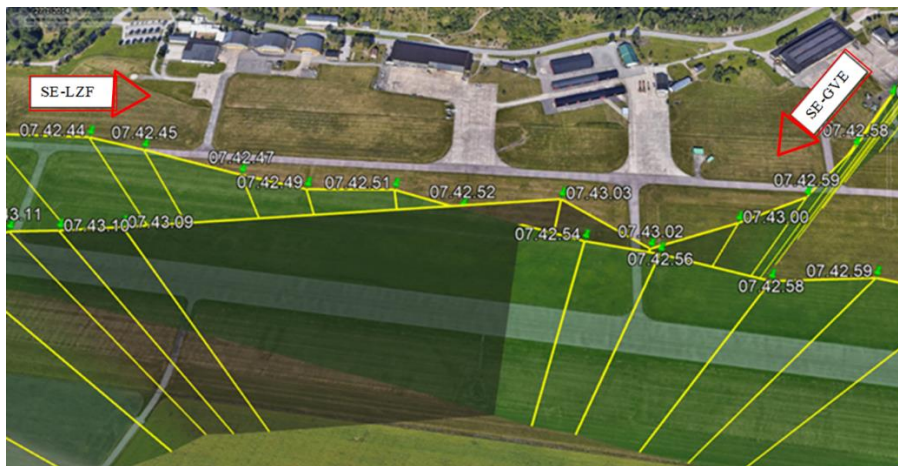
Figure 4. Trajectory based on raw WAM¹¹ radar data shows the PA-28's avoidance manoeuvre with a right turn at 07:42:59. Source: Google, Lantmäteriet registration number Reg. no. R61749_190001.

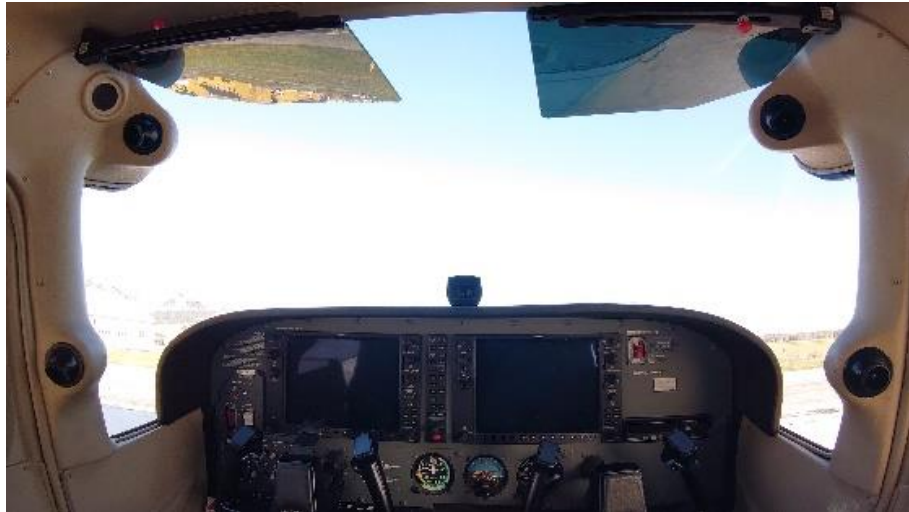
Several factors may have contributed to the incident. The window beam of the Cessna may, to a certain extent, have blocked the Cessna pilot's view and may thereby have contributed to late detection of the approaching PA-28. The Cessna pilot, who was flying in accordance with IFR rules, may be presumed to have been concentrating primarily on the flight and navigation instruments and not sufficiently on outward visual observations. Furthermore, the Cessna was below the horizon from the perspective of the PA-28, which may have made it more difficult for the pilot of the PA-28 to detect the Cessna earlier.

In both the Cessna 172 and the PA-28, the view outward from the pilot’s seat and the front passenger seat allow those sitting there a field of view ahead and to the sides, with the exception of that which is blocked by the window beams that surround the windscreen and side windows (see Figures 7 and 8).

Figure 7. View from the cockpit of a Cessna 172. Photo: OSM Aviation Academy.

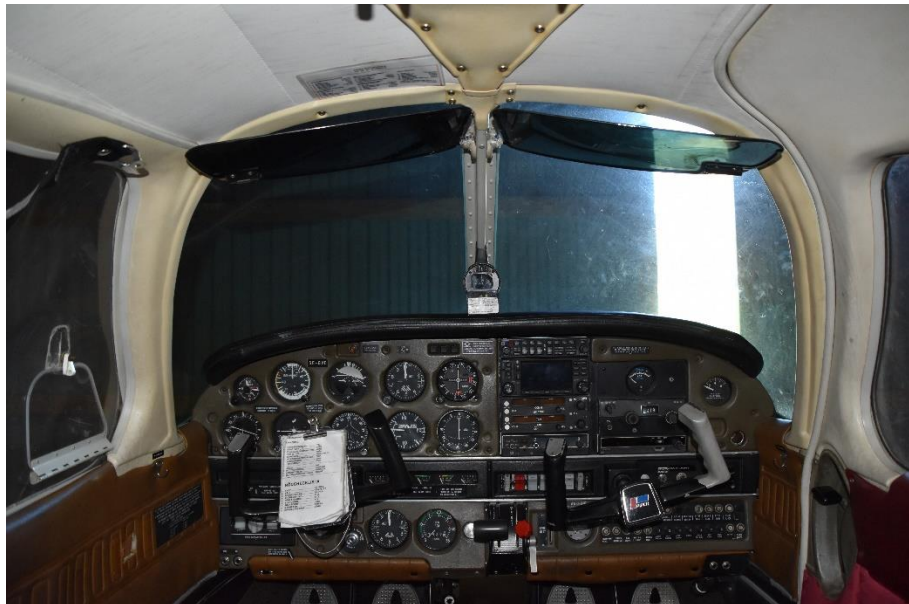
Figure 8. View from the cockpit of a PA-28. Photo: Voluntary Flying Corps.

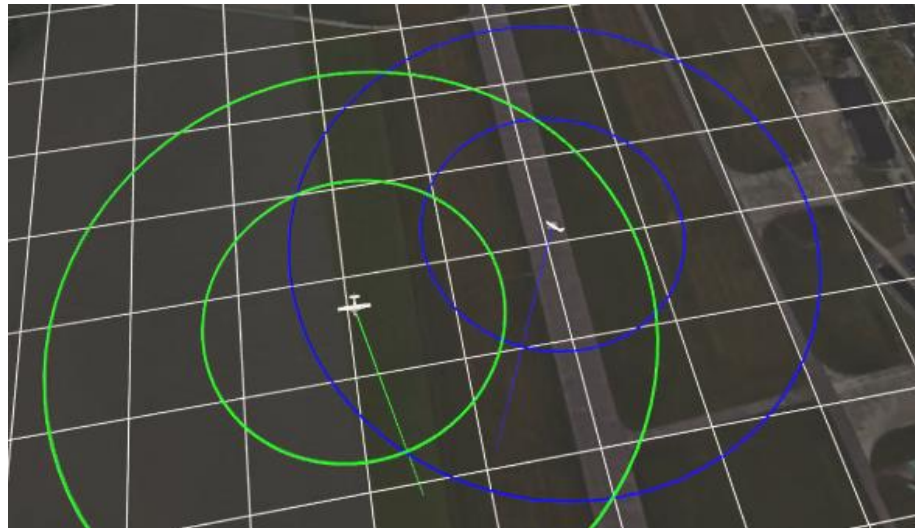
Figure 9. An example of the visualisation of the incident in which distance circles with a radius of 50 and 100 metres indicate the distance between the aeroplanes.

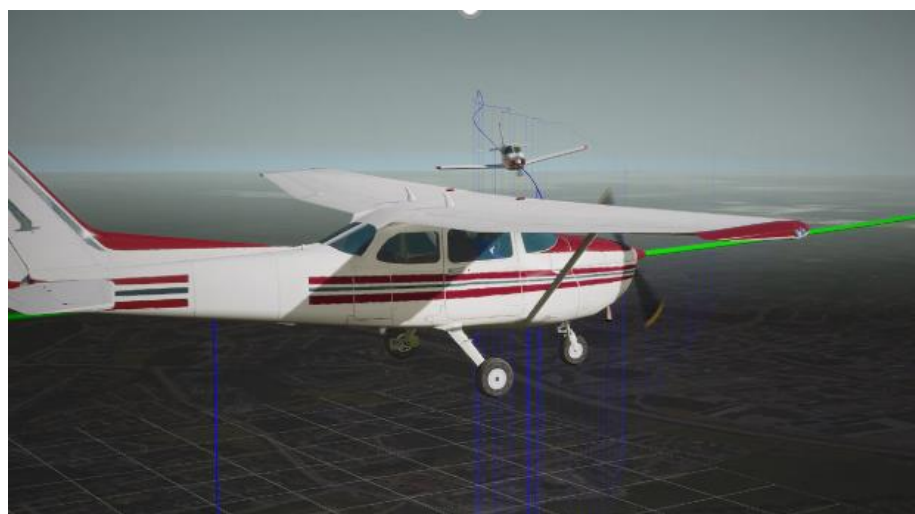
Figure 10. An example of visualisation of the relative position between the aeroplanes just before they passed one another. The models are intentionally enlarged and not to scale.

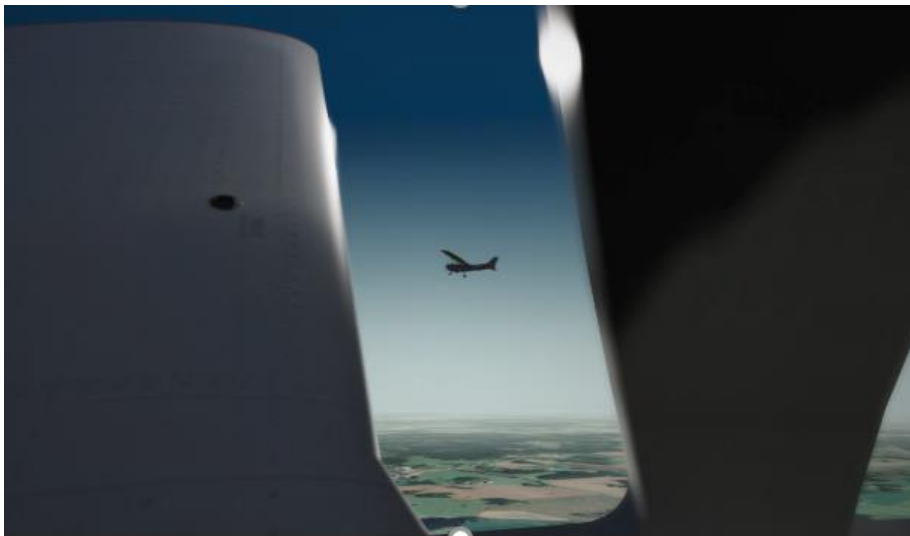
Figure 11. Visualisation of the view to the left from the cockpit of the PA-28 just after passing the other aeroplane.

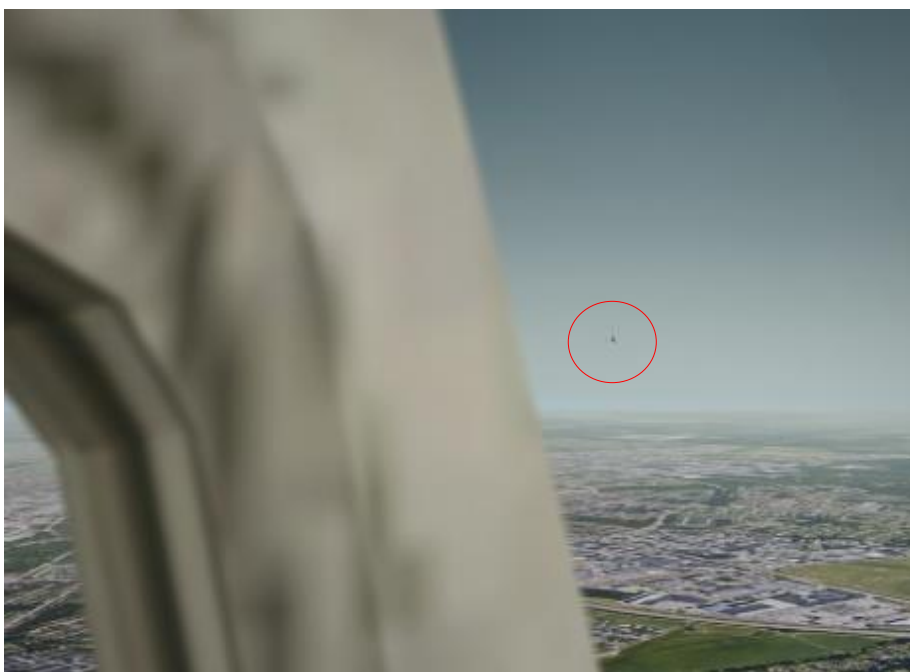
Figure 12. Visualisation of the view from the cockpit of the Cessna just before passing the other aeroplane. The side beam may block the view of oncoming traffic. The silhouette of the PA-28 is seen over the horizon. The red circle marks the PA-28.
