<b>AIRCRAFT ACCIDENT SHORT REPORT</b>
---------------------------------------

**CA18/2/3/9822:** Unstable approach that led to a deep landing and a rotation prior to reaching the take-off speed during a touch-and-go exercise, culminating in a crash.

<b>Date and time</b>	: 22 September 2019; 0455Z
<b>Occurrence type</b>	: Accident
<b>Aircraft registration</b>	: ZU-EHS
<b>Aircraft manufacturer and model</b>	: ICP Italy & Savannah Africa, Oribi
<b>Last point of departure</b>	: Hazyview/Numbi Airfield
<b>Next point of intended landing</b>	: Graskop Airfield
<b>Location of incident site with reference to easily defined geographical points (GPS readings if possible)</b>	: 26°20'54.65" S 027°46'41.62" E, on Runway 16 at Graskop Airfield
<b>Meteorological information</b>	: Wind: 220°/04 kt; Temperature: 22°C; Dew point: 7°C; QNH: 1016 hPa; CAVOK
<b>Type of operation</b>	: Private (Part 94)
<b>Persons on-board</b>	: 1+1
<b>Injuries</b>	: Serious injuries
<b>Damage to aircraft</b>	: Destroyed

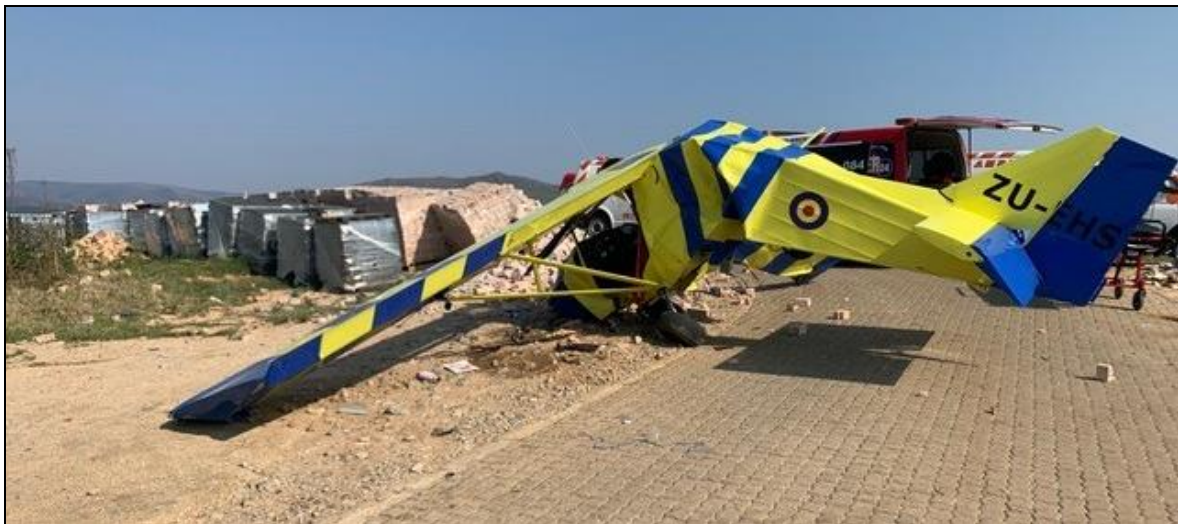
- 2.6. The pilot reported that subsequent to touch down at a speed of 60 miles per hour (mph) and, thereafter, applying full power for take-off, the aircraft became airborne but could not gain height. The aircraft then collided with pallets of bricks that were situated at the end of RWY 16, approximately 100m from the threshold of RWY 34.

**Figure 2:** The aircraft post-accident. (Source: Operator)

- 3.6. The aircraft was structurally intact prior to impact and all damage was consistent with the accident sequence. The aircraft was destroyed during the impact sequence; the pilot and passenger sustained serious injuries.

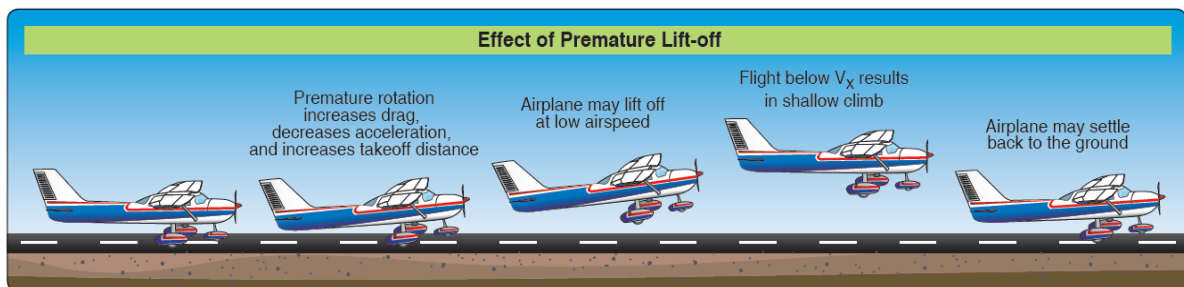
2.14. The Airplane Flying Handbook states that *an attempt to pull the aircraft off the ground prematurely, or to climb too steeply, may cause the aircraft to settle back to the runway or into the obstacles. The Handbook further states that even if the aircraft remains airborne, the initial climb will remain flat and climb performance/obstacle clearance ability seriously degraded until best angle-of-climb airspeed ( $V_X$ ) is achieved.* (See Figure 3)

**Figure 3:** Effect of premature lift-off. Source: Airplane Flying Handbook, Chapter 5
