Final report RL 2020:11e

**Accident at Malmö Airport
17 November 2019 involving the aircraft
SE-LUX of the type Beechcraft 95,
operated by south Sweden Flight Academy
AB.**

File no. L-164/19

17 November 2020

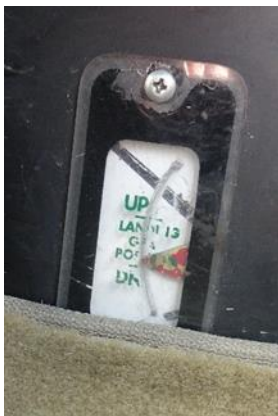
A Mechanical indicator is located at the bottom of the centre console (see Figure 3). This indicator is mechanically linked to the nose wheel actuating mechanism and will show the position of the nose wheel whether electric power is available or not. This indicator does not directly indicate the position of either main landing gear leg, however in the absence of a break in the mechanical linkage between the gearbox and the landing gear legs all three gear-legs must be in the same position.

Figure 3. Mechanical nose wheel position indicator.

With regard to instruction and training for manual landing gear extension, neither the instructor nor the student had performed the procedure, nor did they have knowledge of the mechanical indicator that showed the position of the landing gear. Instead, the mirrors on the cowling were used to try to see if the landing gear was fully extended. The system with mirrors is not useful in darkness and is not something that the type certificate holder recommends. The mechanical indication is included in the documentation for the technical course. According to interviews the mirrors on the engine cowlings were discussed for most as the method for seeing if the landing gear was extended. That is in accordance with what appears from the flight school's risk management log and action program. This may be an explanation for the crew not being aware of or remembering the mechanical indicator.

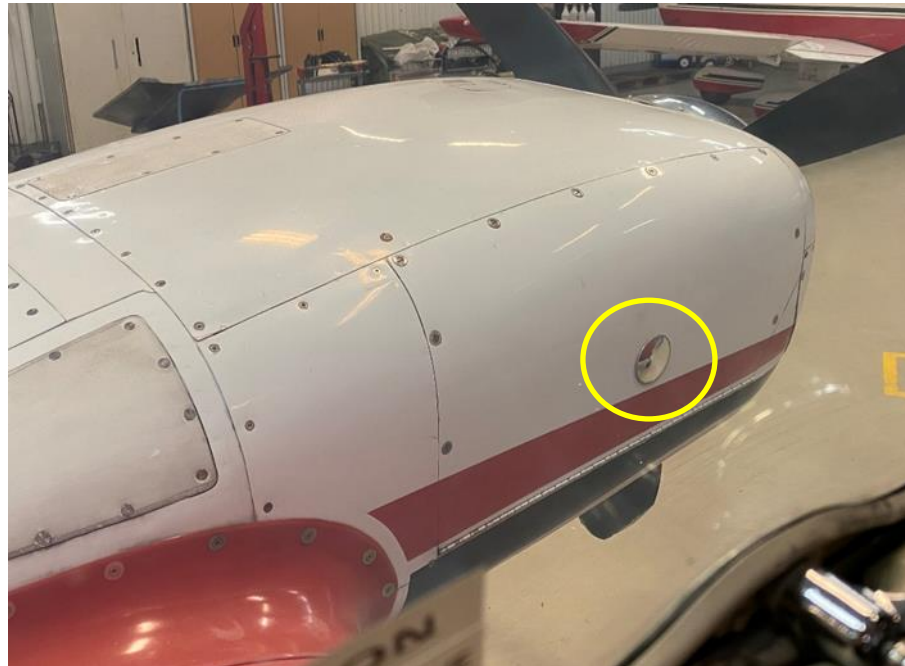
The aircraft had an installed mirror on the left engine gondola that was not described in the aircraft manual or its supplement (see Figure 4). The school also installed a mirror on the right motor gondola so that the instructor visually could check the position of the landing gear. The mirror on the right engine gondola was not present on the aircraft when the SHK investigated the aircraft.

Figure 4. Installed mirror on the left engine cowling to visually verify landing gear position.

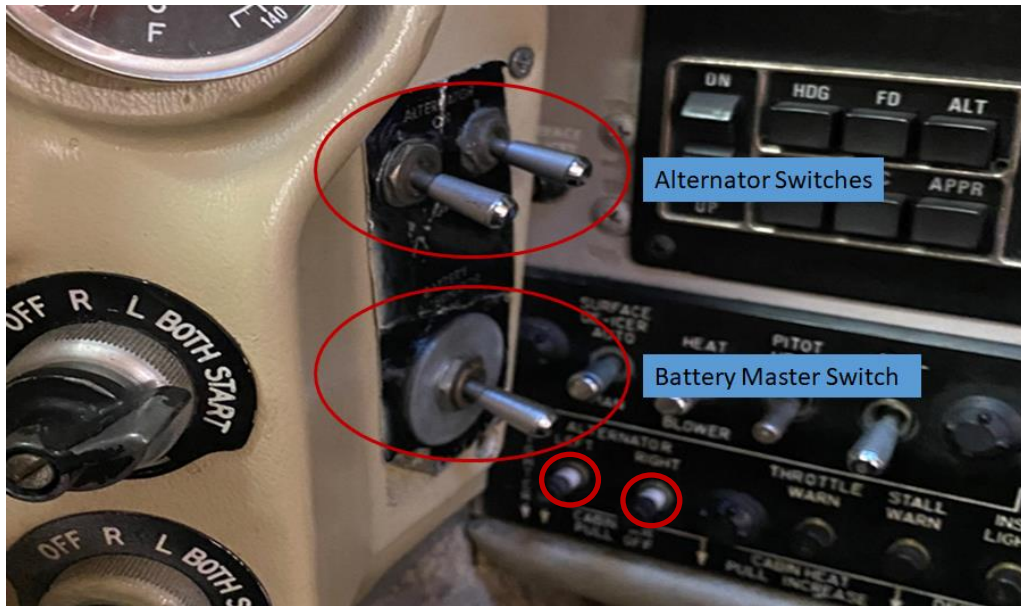
Figure 5. Battery switch, Alternator switches and pulled circuit breakers.

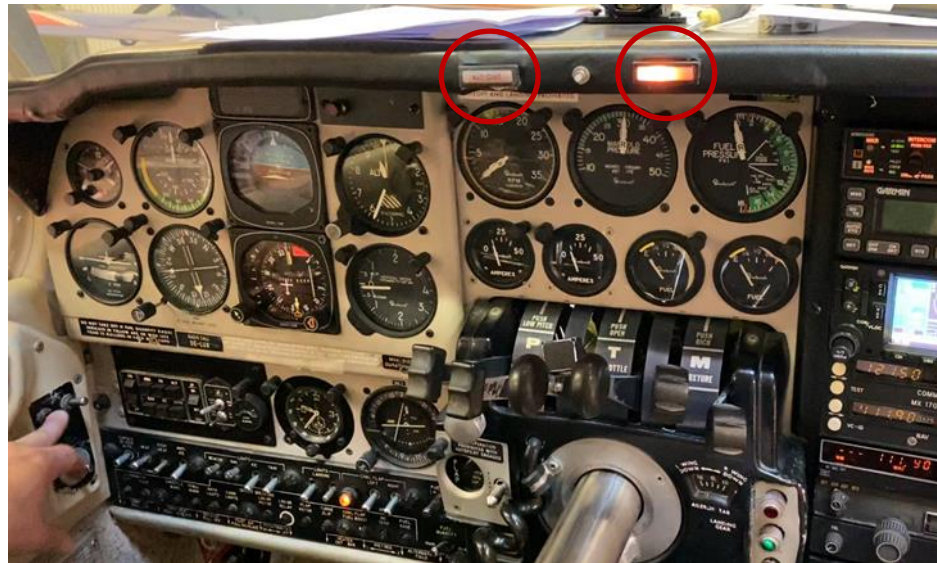
According to POH the “ALT OUT” lights will illuminate when the alternate switch is off. According to SHK:s test of the system the alternator out lights did not illuminate when the alternator switches were in the off position (see Figure 7).

Figure 7. The picture shows left “ALT OUT” light not illuminating when the switch is set to OFF.

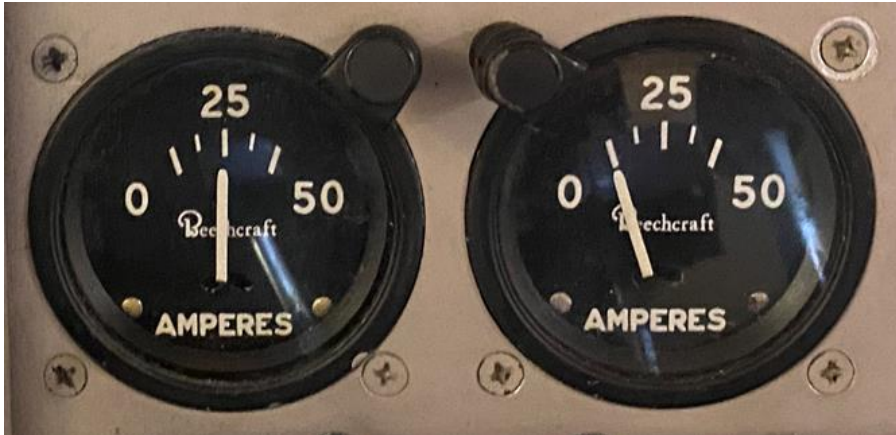
Figure 8. Loadmeters in SE-LUX. The right indicator shows 0 Amperes.

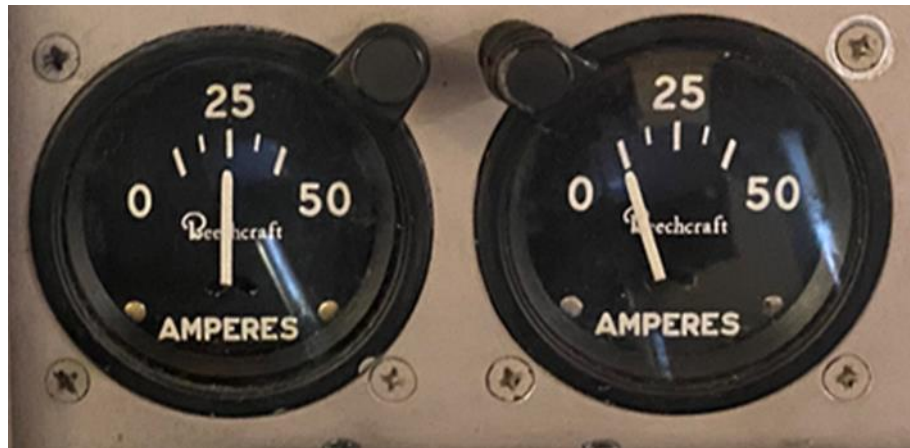
The procedure cannot be checked on the installed load meters with a scale up to 50 amps (see Figure 10).

Figure 10. The loadmeters installed in SE-LUX.

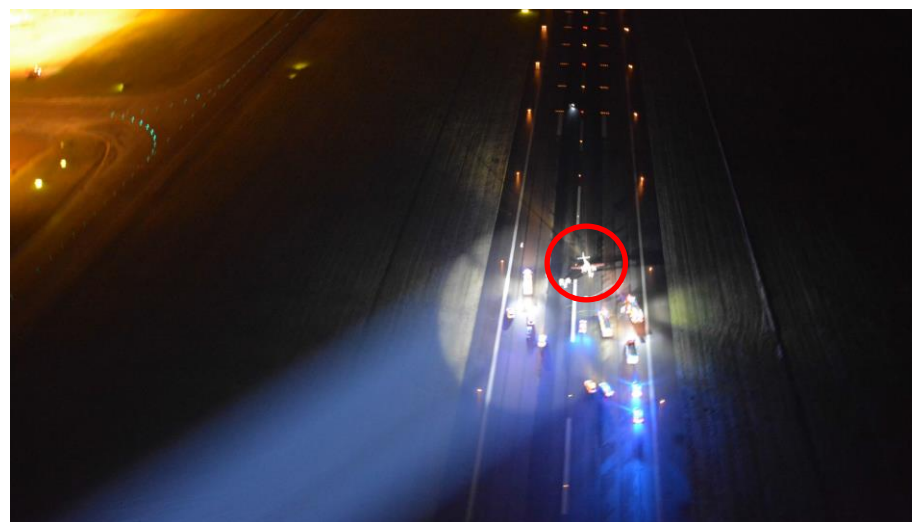
The accident occurred at Malmö Airport on runway 17. After the landing the aircraft stopped on the belly about 1 000 meters (3 280 feet) into the runway.

Figure 14. The aircraft on the runway together with the rescue services of the airport. Circled added by SHK. Picture: Swedish police.

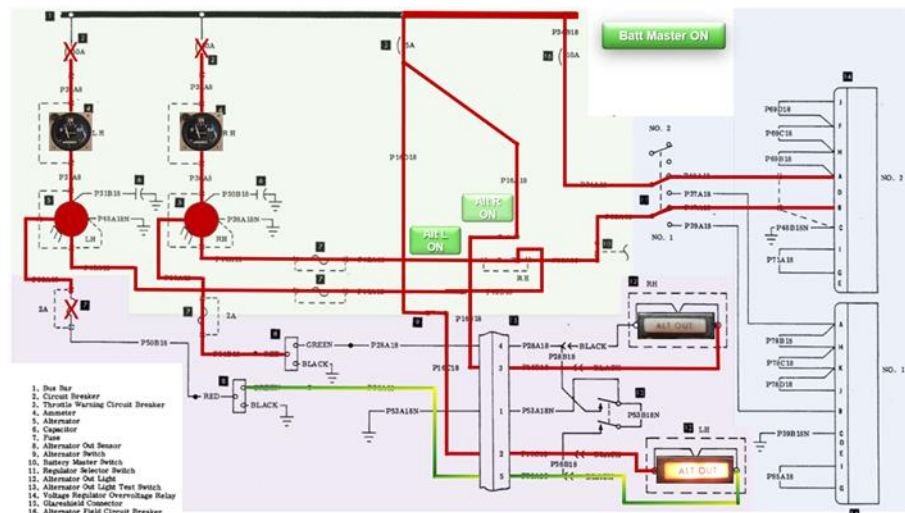
During the initial investigation of the aircraft the following emerged, among other things. The circuit breakers for the left and right alternators were tripped. The switches for both alternators were off. The main battery/alternator switch was off. A fuse between the alternator output “AUX” and the sensor for left fault indication “ALT OUT” had melted, (see Figure 16).

With the main battery/alternator switch and both alternator switches in the “ON” position, both alternator warnings “ALT OUT” were lit. However, one of two light bulbs in the right indicator warning light was broken.

Figure 16. The configuration of the electrical system at the time of SHK:s examination. Red marking illustrates powered wires and components. Yellow-green illustrates wire connecting to ground.

During an investigation of the electrical system, SHK found that a fuse had melted in the system for the alternators’ fault indication “*ALT OUT*”, which would have resulted in the left “*ALT OUT*” warning being lit if the left alternator switch was on (see section 1.12.3).

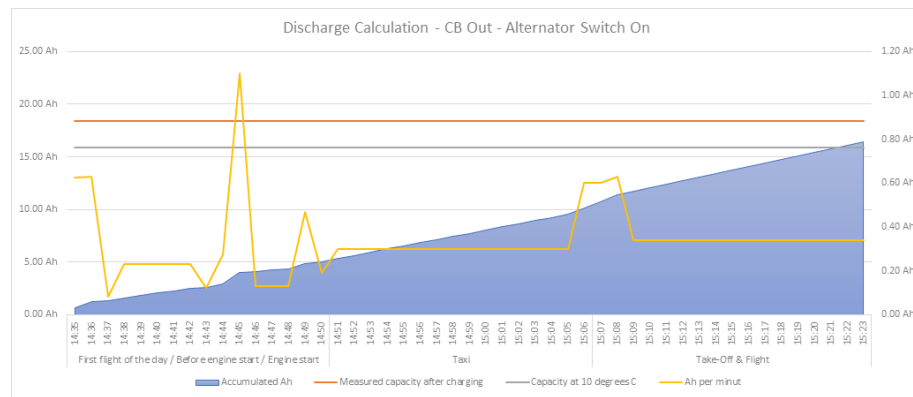
During the technical investigations of the aircraft, the load was measured for different electricity consumers in the aircraft. From these measurements and information from the manual regarding the electricity consumption of components, calculations have been performed to find out the total electricity consumption for the flight in question, if only the battery has supplied the aircraft with voltage. The calculation is reported in the diagram below and is based on interviews, information from ATC communication and radar tracks.

Figure 17. Calculation of discharge for the battery.
