AIRCRAFT ACCIDENT REPORT AND EXECUTIVE SUMMARY

Reference:	CA18/2/3/9844	
Aircraft Registration	ZS-KAJ	Date of Accident	27 December 2019		Time of Accident	1400Z	
Type of Aircraft	Beechcraft Bonanza A36		Type of Operation	Private (Part 91)			
Pilot-in-command Licence Type	Commercial Pilot Licence		Age	47		Licence Valid	Yes
Pilot-in-command Flying Experience	Total Flying Hours		3890.40		Hours on Type	50.60	
Last Point of Departure	Grand Central Aerodrome (FAGC): Gauteng Province						
Next Point of Intended Landing	Louis Trichardt Aerodrome (FALO): Limpopo Province						
Location of the accident site with reference to easily defined geographical points (GPS readings if possible)							
Short of Runway 10 FALO GPS S 23°03'47.17" E 029° 51'21.72" at an elevation of 2989 feet (ft).							
Meteorological Information	Wind direction: 110° wind speed: 10-15kts CAVOK temperature:30°C						
Number of People On-board	1+5	No. of People Injured	0		No. of People Killed	0

Reference Number : CA18/2/3/9844
Name of Owner/Operator : Walter Gilfillen
Manufacturer : Beech Aircraft Corporation
Model : Beechcraft Bonanza A36
Nationality : South African
Registration Marks : ZS-KAJ
Place : Louis Trichardt

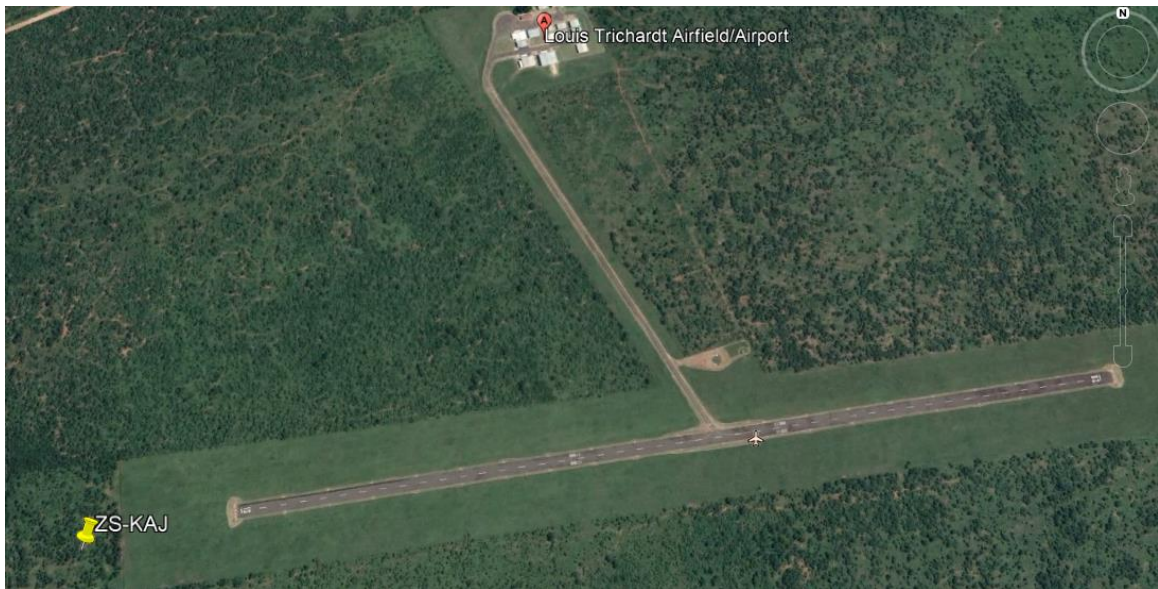
- 1.1.3 The pilot and the passengers did not sustain any injuries during the accident sequence; however, the aircraft was substantially damaged.
- 1.1.4 The accident occurred during daylight on an open field short of Runway 10 at FALO at Geographical Position System (GPS) determined to be S 23°03'47.17" E 029° 51'21.72" at an elevation of 2989 feet (ft).

Figure 1: The accident site in relation to the runway.

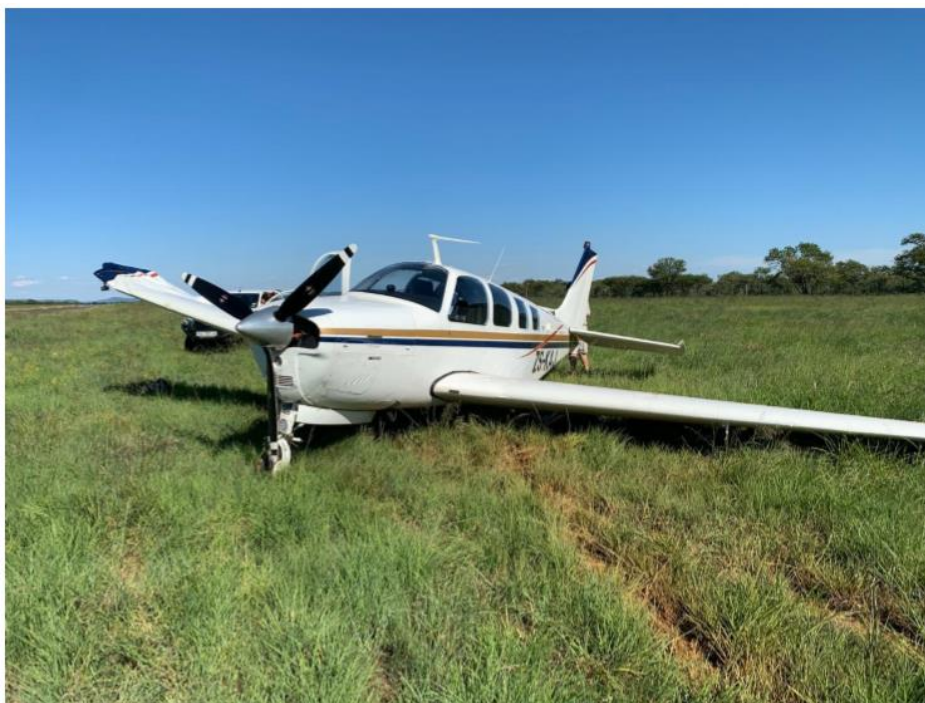
1.12.1 The aircraft took off from FAGC to FALO. During a turn onto final approach, the engine went into idle, glided above trees and landed on a field short of Runway 10. The right wing was damaged due to impact with a tree and the aircraft's main gear collapsed. The aircraft spun around before it finally stopped facing north-west.

Figure 2: The aircraft as it came to rest after the forced landing. (Source: PIC)

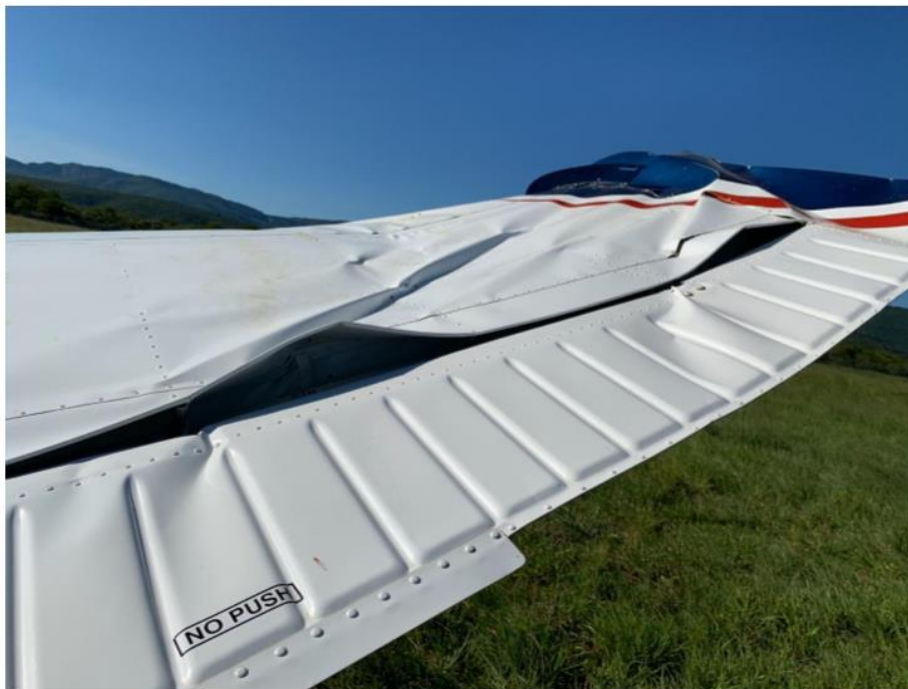
1.3.1 The aircraft sustained damage to the landing gear, as well as the right and the left wing.

Figure 3: Damage sustained to the aircraft's right wing. (Source: PIC)

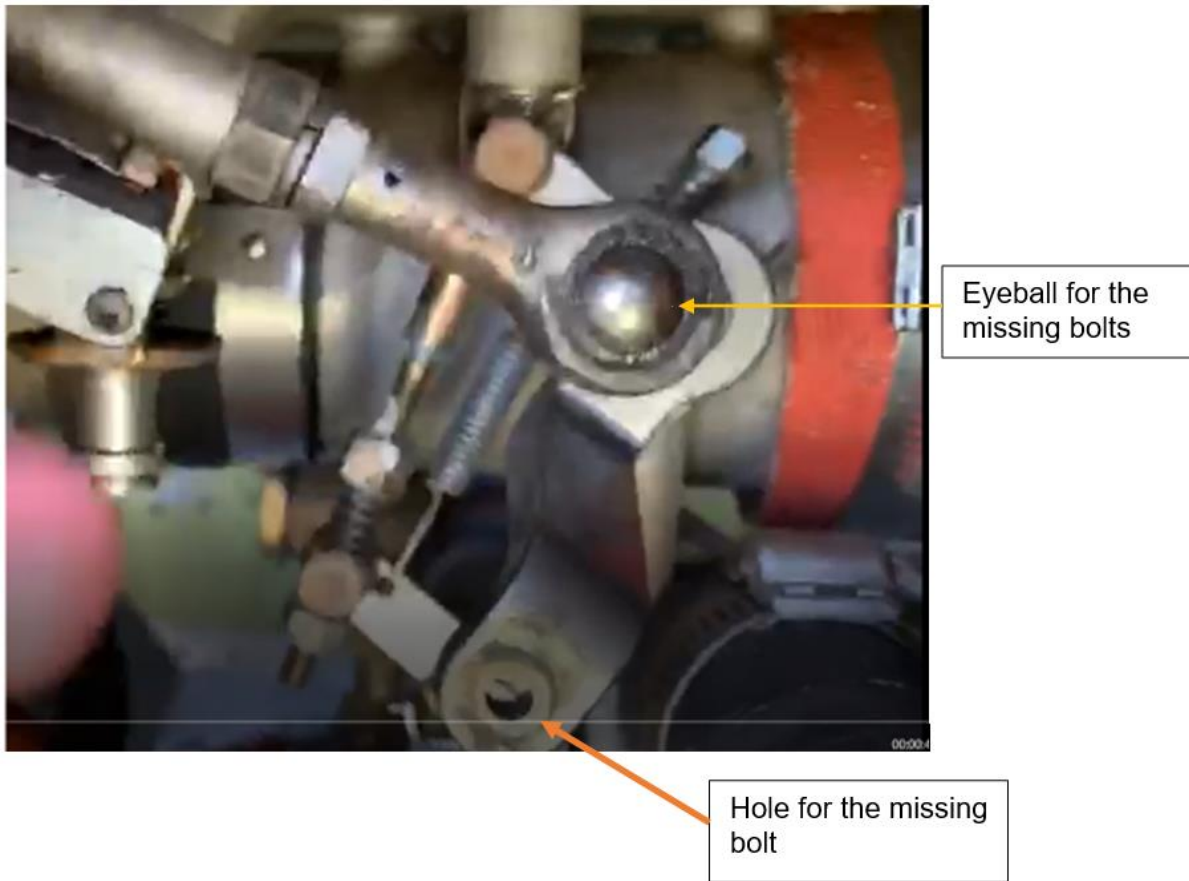
- 1.1.2 After disembarking the aircraft, the pilot opened the cowling and found that the bolt, nut and pin connecting the fuel throttle rod end to the fuel control unit arm were missing, which caused the engine to lose power and idle.

1.16.1 After landing the aircraft, the pilot opened the cowling and noticed that the bolt connecting the fuel control throttle rod end and control unit arm was missing. The arm was stuck in the 'closed' position, resulting in the engine idling (see Figure 4).

Figure 4: The rod end and the arm with missing hardware. (Source: video from the pilot)

2.1.3 After landing and disembarking the aircraft, the pilot opened the cowlings and found that the fuel controller rod end and arm were missing a bolt, washer, nut and pin. This indicated that the bolt was not secured with a pin. If the bolt is not secured with a pin, it will get loose over time and eventually separate. This caused the fuel controller to get

stuck on the “off” position, hence, the engine idled. If a bolt is secured with a pin, there is no way of it getting loose because the pin can only be removed using a side cutter.

2.1.4 The engine was installed on 19 May 2011 and had never been overhauled. The fuel control unit was also installed on the same date and had never been removed since its installation. On 12 July 2019 during the MPI, the fuel metering unit inlet screen was removed, cleaned, inspected and re-fitted. The fuel control unit was not removed, only the fuel metering unit inlet screen was removed. During the 100-hour MPI, the fuel control unit is not required to be removed. This indicated that the fuel controller rod end and arm were fitted with a bolt, washer lock and nut, but not with a pin as shown in Figure 6. It is probable that the bolt, washer lock and nut were secured without a pin during installation in 2011. Over time, they got loose because of vibration during flights until they finally separated.

- 3.2.4 The aircraft idled on final approach, glided and landed on a field short of Runway 10 at FALO.
- 3.2.5 The fuel controller rod end bolt was not properly secured with a pin and eventually got loose over time and, thus, separated. This caused the engine to lose power and idle during final approach at FALO.

3.3.1 The investigation revealed that the engine lost power and went into idle because of the separation of the throttle control cable and the fuel control arm. This was a result of the bolt connecting the fuel throttle rod end to the fuel control unit arm separating from the nut. The bolt, nut and pin were never located.

4.2.1 Safety message: It is recommended that the aircraft maintenance organisations ensure that necessary dual inspections and manufacturers' maintenance instructions are always followed by maintenance personnel.

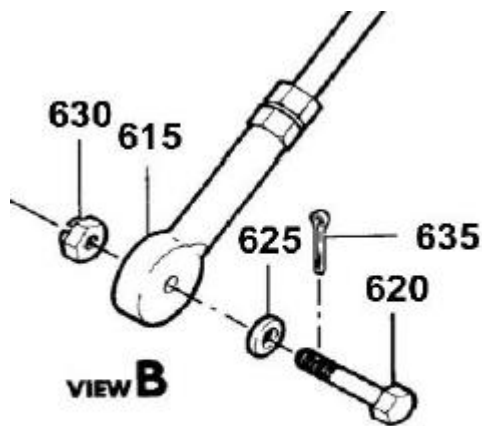
1.16.3 According to the illustrated parts catalogue (IPC) in view B (below); the bolt (620), a washer-lock (625), nut (630) and pin (635) connecting the rod end (615) to the fuel control unit arm were missing.

Figure 5: IPC view B showing the rod-end and missing items.

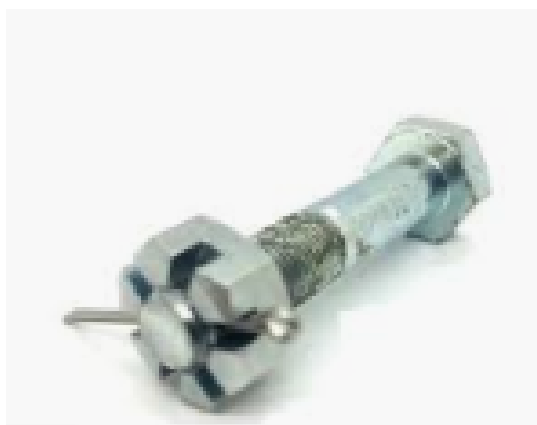
1.16.4 When the bolt is not secured with a nut and pin, it will get loose over time. This will cause the bolt to fall off (separate), resulting in loss of fuel control as well as cause the engine to idle. See Figure 6 for a properly secured bolt.

Figure 6: Bolt, nut and pin of a properly secured bolt. (Source : <https://www.prs356.co.uk/porsche-356-parts/steering-damper-hex-head-bolt-with-castle-nut-split-pin-356a-356b-356c/>)
