AIRCRAFT ACCIDENT REPORT AND EXECUTIVE SUMMARY

Reference:	CA18/2/3/9848	
Aircraft Registration	ZU-EWD	Date of Accident	12 January 2020		Time of Accident	1612Z
Type of Aircraft	FK 14B POLARIS		Type of Operation	NTCA (Part 94)		
Pilot Licence Type	National Pilot Licence		Age	54	Licence Valid	Yes
Pilot Flying Experience	Total Flying Hours		787.2		Hours on Type	377.6
Last Point of Departure		Springs Aerodrome (FASI) – Gauteng Province				
Next Point of Intended Landing		Springs Aerodrome (FASI) – Gauteng Province				
Location of the accident site with reference to easily defined geographical points (GPS readings if possible)						
In an open area north of FASI, approximately 450m from the threshold of Runway 21, at GPS co-ordinates 26°14'22.42" South 028°24'04.34" East and at a field elevation of 5328ft AMSL						
Meteorological Information	Wind: 340° at 09kts; Temperature: 24°C; Dew Point: 11°C; Clouds: Few at 4000ft; Visibility: 9999m; QNH: 1023hPA

DESCRIPTION OF ACCIDENT

Reference Number : CA18/2/3/9848
Manufacturer : B & F TECHNIK VERTRIEBS GMBH
Model : FK 14B POLARIS
Nationality : South African
Registration Marks : ZU-EWD
Place : Springs Aerodrome (FASI)
Date : 12 January 2020

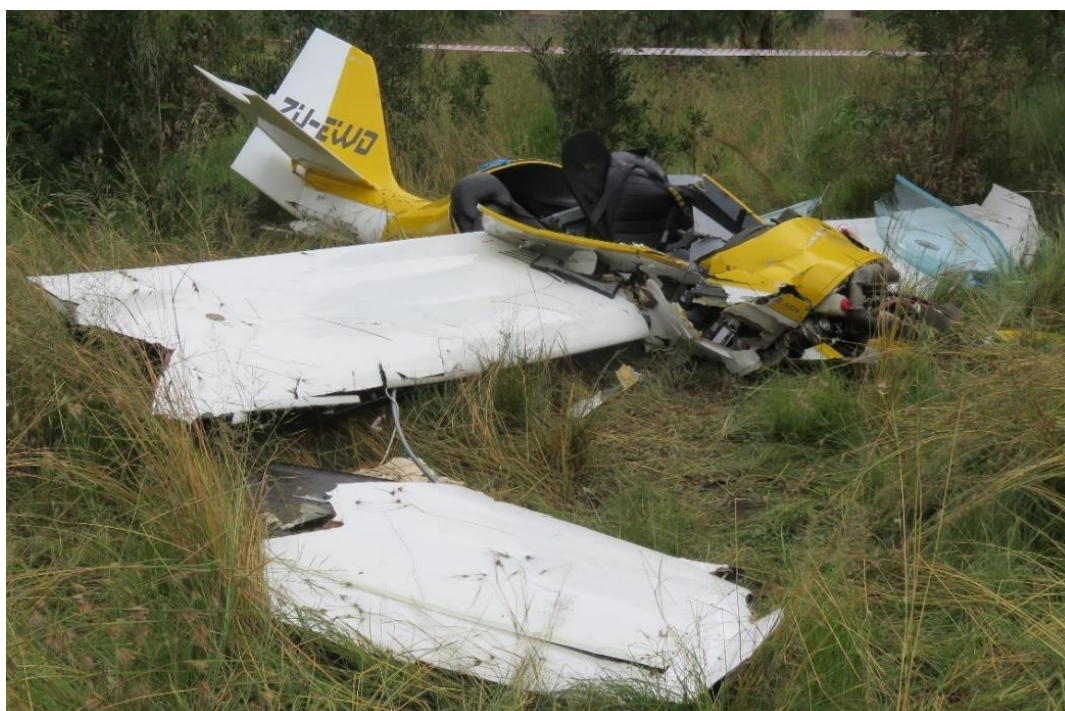
1.3.1. The aircraft was destroyed on impact.

Figure 4: The aircraft post-accident.

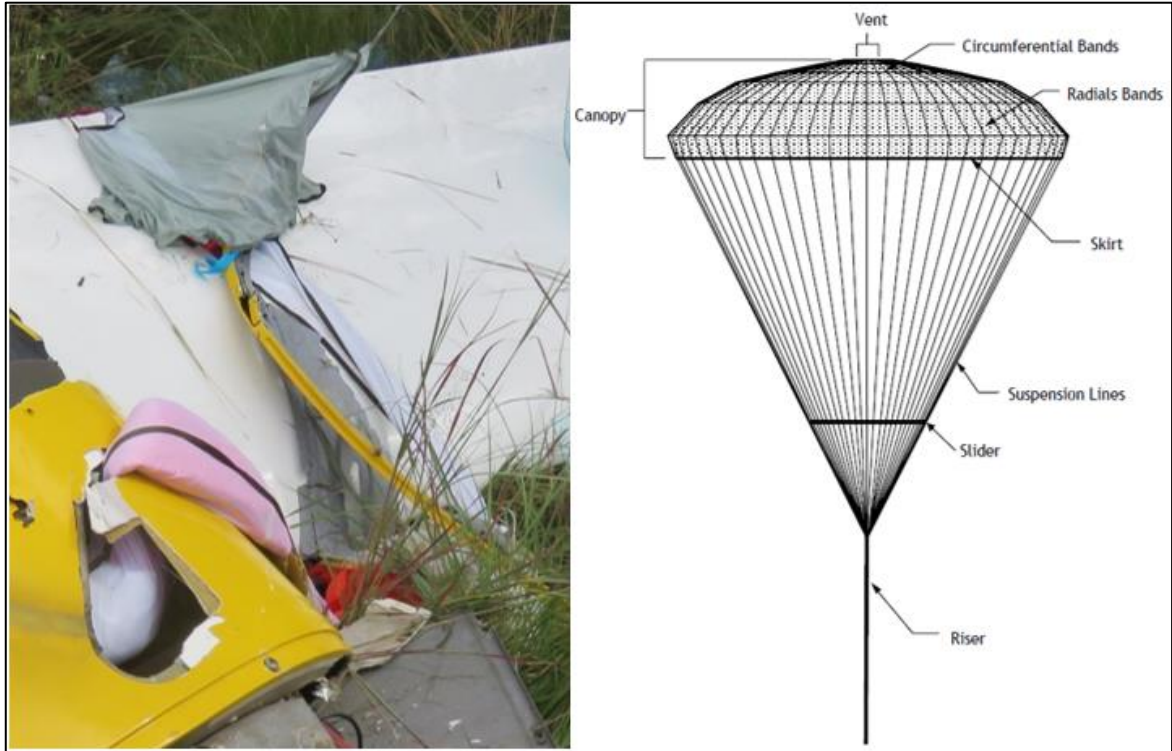
1.6.12.1. The aircraft was equipped with an internally mounted Ballistic Recovery system (B.R.S.-5™), model 1050, which the pilot actuated prior to impact; however, the parachute failed to deploy. It was still in the sleeve and was lying over the left-side wing (see Figure 5).

Figure 5: The parachute canopy still in the sleeve (left); and an illustration of the failed B.R.S. parachute assembly (right).

- 3.2.4. At the time of the accident, the B.R.S. parachute unit was unserviceable. Although the B.R.S. parachute was actuated at a low altitude, the failure of the B.R.S. parachute to fully deploy could be attributed to the lack of maintenance which was exacerbated by the fact that the B.R.S. parachute unit had passed its use-by date by 2 years and 10 months.

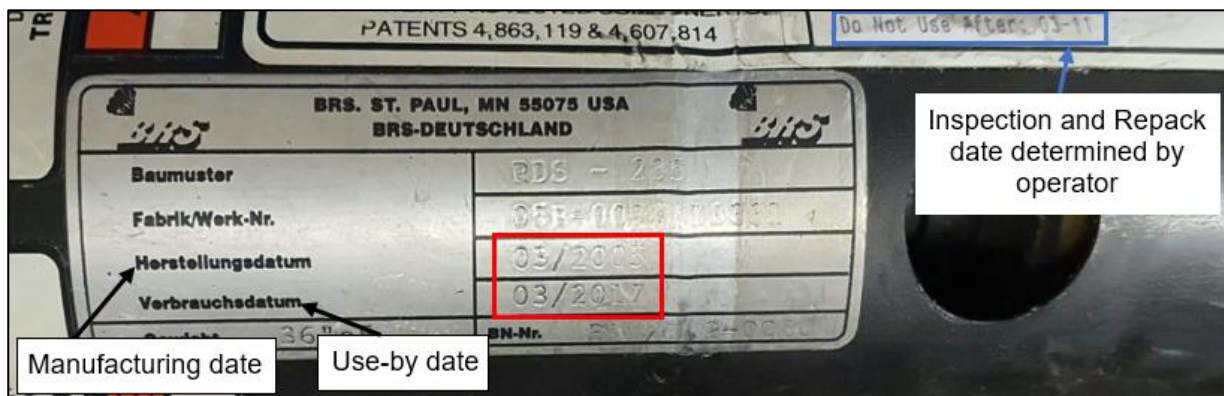
1.6.12.7. According to the data label, the B.R.S. unit was manufactured on "03/2005" with an expiry date of "03/2017" (see Figure 6).

Figure 6: B.R.S. unit data label.

1.6.12.8. On 24 August 2007, B.R.S. issued a mandatory SB 07-05. According to B.R.S., the B.R.S. unit was deemed inoperable until compliance with the SB was met. There was no record of SB 07-05 in the Service Bulletin/Letters/Instructions (One Time Action and Repetitive) sections of the airframe logbook.

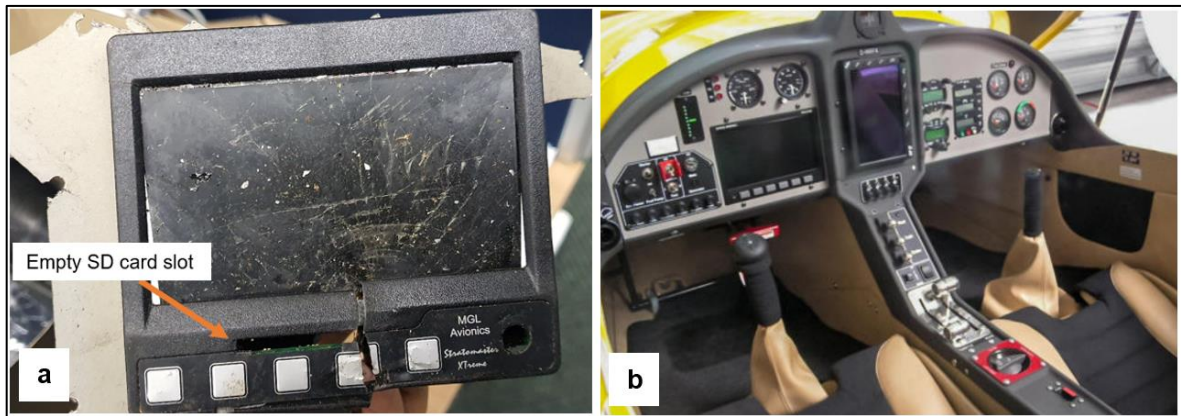
1.11.4. At the time of the wreckage inspection, there was no SD card found inside the EFIS and, as a result, it was not possible to retrieve the last flight's log data.

Figure 7: a) The damaged EFIS XTreme with an empty SD card slot. b) Example of a complete control panel from a similar aircraft. (Source: <https://www.fk-aircraft.com/fl14%20polaris.htm>)

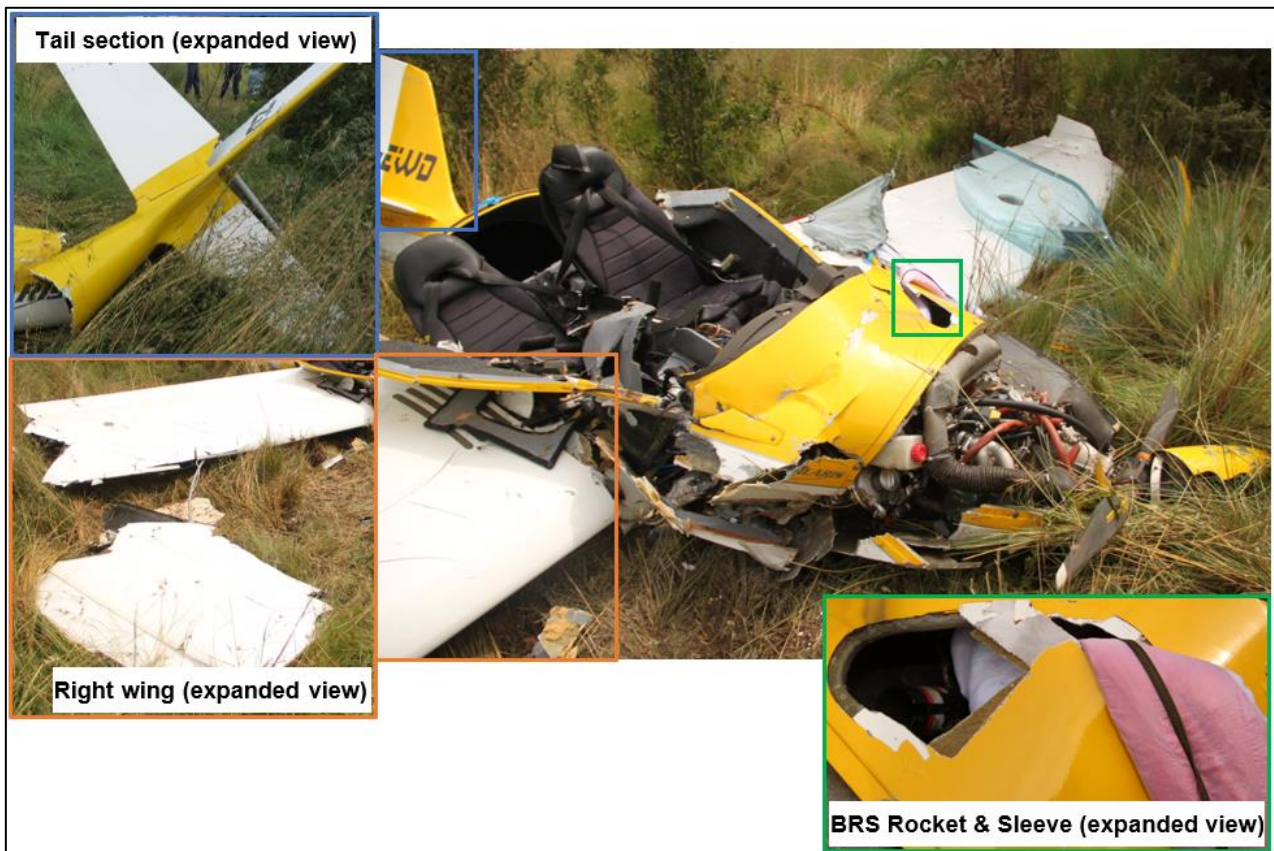
1.12.1. The accident occurred on an open grass surface area near a residential complex, approximately 450m north of the threshold of RWY 21. The fuselage was orientated with the nose facing towards the north-west.

Figure 8: Aircraft wreckage showing the broken tail section, right-side wing and orientation of the B.R.S. rocket and sleeve.

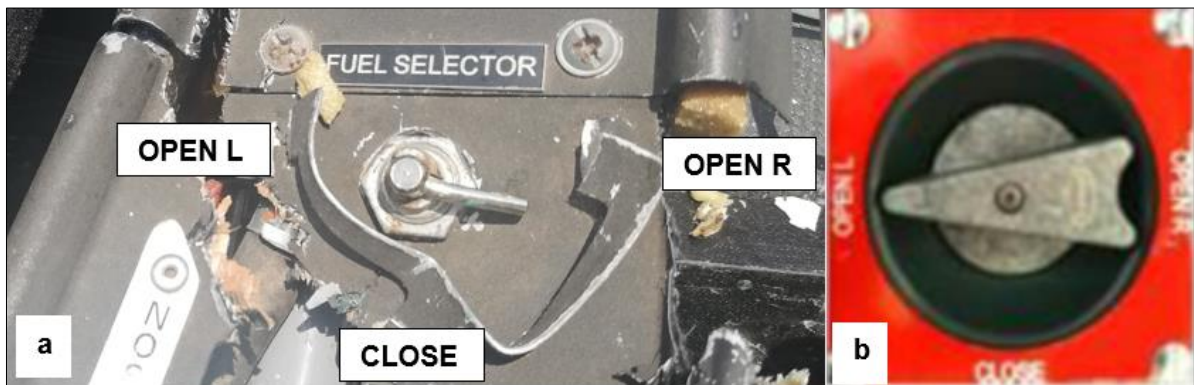
- 1.12.7. The fuel valve selector was found set to the right of the fuel tank. The left-side fuel filter had some fuel; however, the right-side fuel filter was found empty/dry with some contaminated residue present. There was no evidence of fuel on the ground nor was there fuel smell at the accident site on the day of the accident. A fuel sample could not be retrieved from either fuel tank during the on-site investigation, which was conducted the following day; however, there was still no smell of fuel.

Figure 9: a) Fuel valve selected to the Open R position. b) Example of a fuel selector from a similar aircraft. (Source <http://www.aviastock.com/Aircraft/AD14441>).

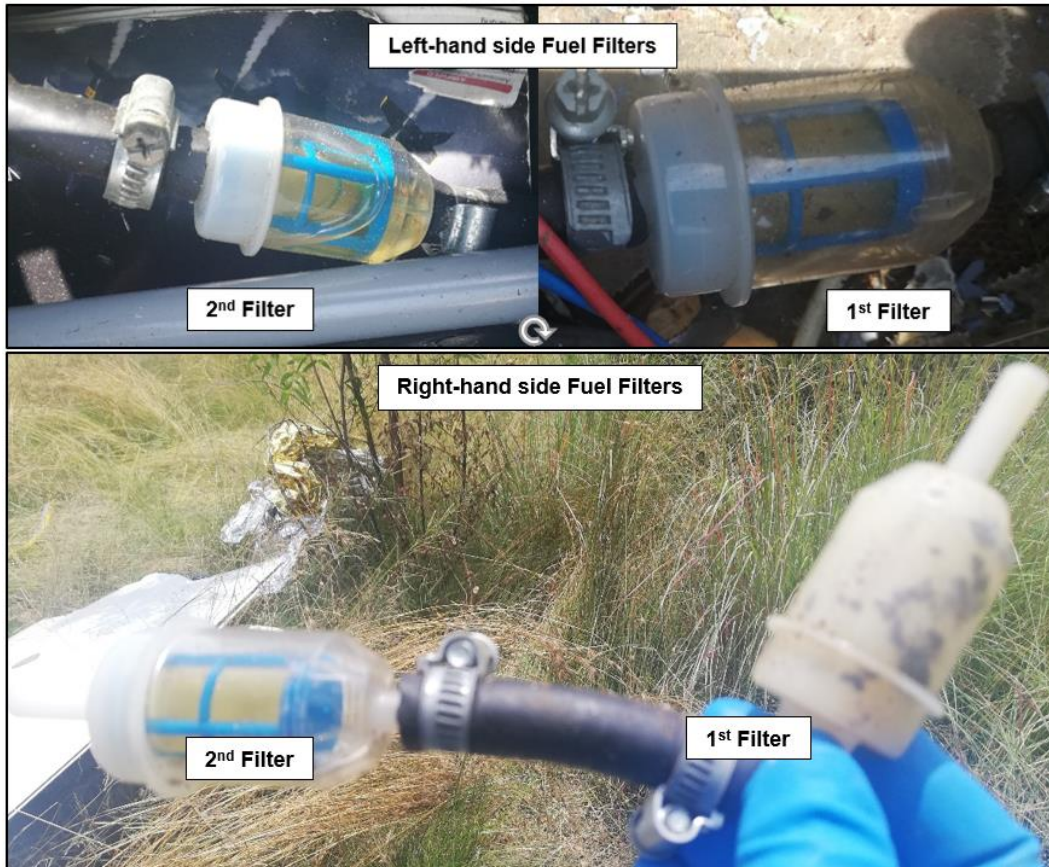
- 1.12.8. The aircraft was found with four fuel filters, two on the left side and two on the right side. One of the fuel filters on the right-side did not have the inner separator as found in the other three filters. Figure 10 shows the left-side fuel filter with fuel (half full).

Figure 10: Two left-side fuel filters, the second one with fuel (top) and two right-side fuel filters, both empty /dry (bottom).

- 2.1.8. Post-accident investigation on site revealed that the aircraft had no fuel in the right tank as indicated by the filters of the right tank that had no fuel, as well as the engine right carburettor bowl that also had no evidence of fuel. The pilot had selected the right tank prior to take-off; thus, it is most likely that the insufficient fuel had been the cause of the engine stoppage.

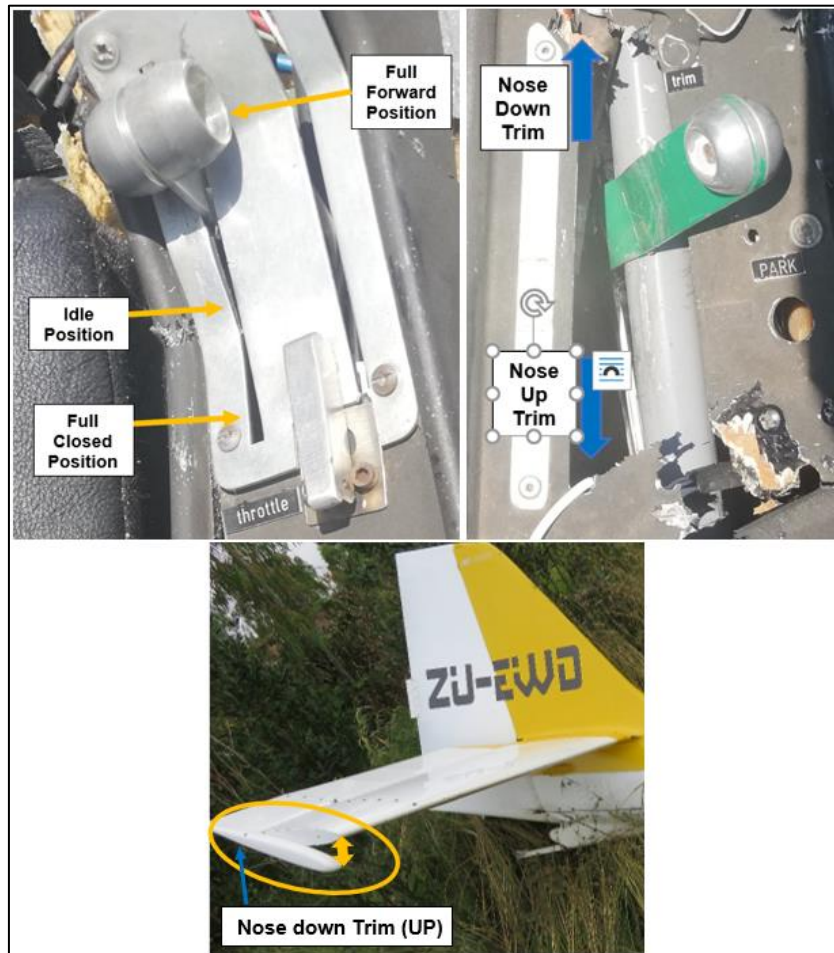
- 1.12.9. The throttle lever was found in the full forward position. The elevator trim was found in a significantly nose-down position (set significantly forward = nose down position).

Figure 11: Throttle lever position (top left); elevator trim position (top right and bottom centre) as found at the accident site.

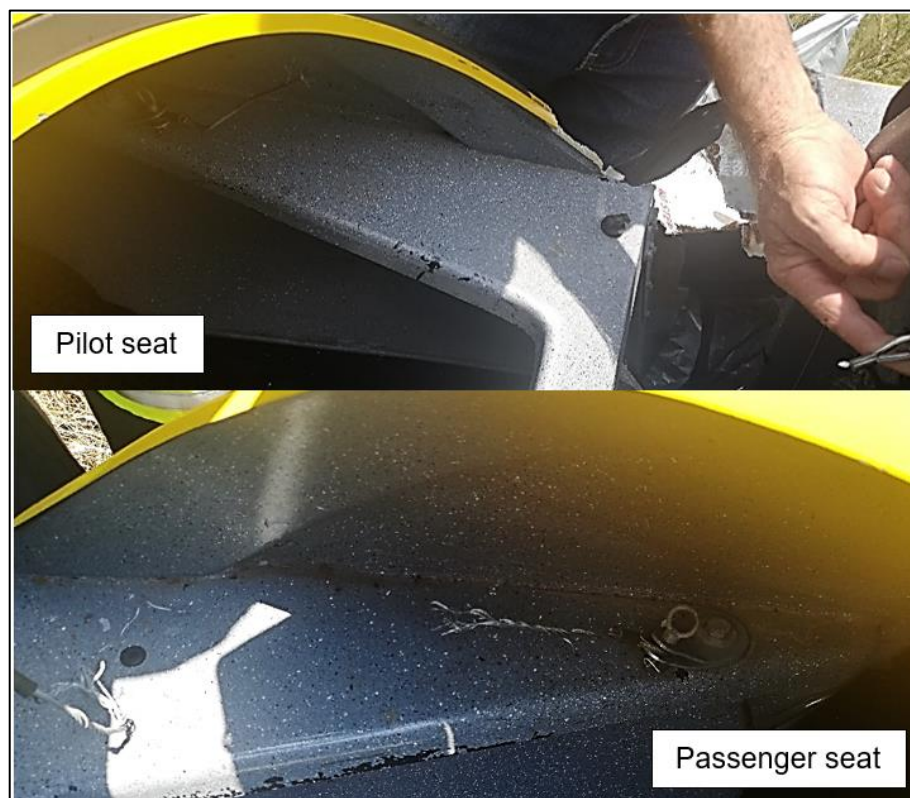
1.15.2.2. The steel cables that connect the shoulder harness to the structure of the fuselage were found broken for both occupants (2.5 millimetres (mm) diameter cables).

Figure 12: Broken steel cables.

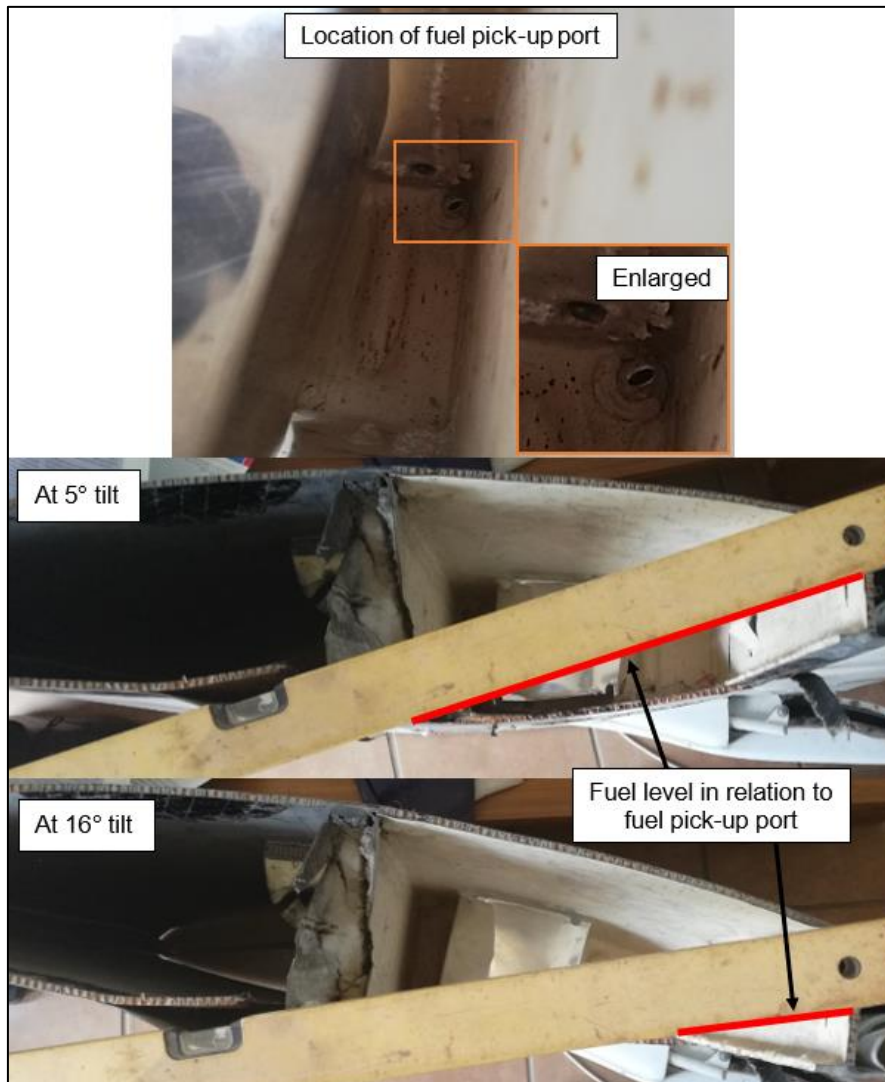
1.16.4.4. Based on the information presented above, it is of the investigators' opinion that the potential for "unporting" of the right-side fuel tank pickup outlet as the aircraft took off with lower than permitted fuel levels in the selected fuel tank could have occurred, which could have resulted in the engine flaming out. Figure 13 shows an illustration of the possible scenarios that could have occurred when considering that the aircraft could have taken off with less than permissible fuel in the selected right-side fuel tank.

Figure 14: Red lines show the assumed fuel level in relation to the fuel pick-up port of the right-side fuel tank at 5° compared to 16° angle of attack.
