AIRCRAFT ACCIDENT SHORT REPORT

CA18/2/3/9873 :The left-side main landing gear wheel axle separated from the gear strut due to failure of the attachment bolts as a result of a hard landing.

Date and time	: 8 March 2020 at 1430Z
Aircraft registration	: ZS-TIO
Aircraft manufacturer and model	: Cessna Aircraft Company, C180
Last point of departure	: Baragwanath Aerodrome (FASY), Gauteng Province
Next point of intended landing	: Baragwanath Aerodrome (FASY), Gauteng Province
Location of accident site with reference to easily defined geographical points (GPS readings if possible)	: FASY S26°52'49" E027°46'38" Elevation 5419ft
Meteorological information	: Surface wind: 5 knots; Temperature: 25°C; Visibility: >10km
Type of operation	: Private
Persons on-board	: 1+1
Injuries	: 0
Damage to aircraft	: Substantial

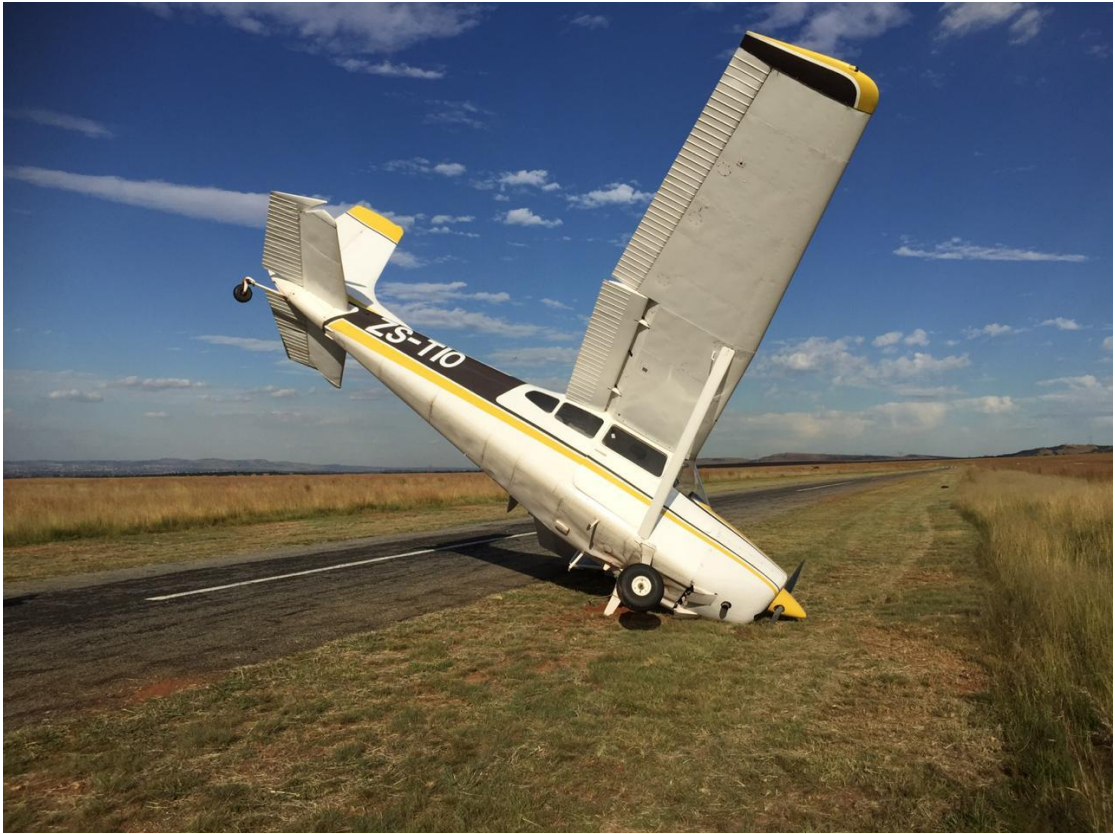
- 2.1.2 The aircraft sustained damage to the left main landing gear, left wing, propeller, fuselage and the lower engine cowling. No injuries were reported by the pilot and the passenger.

Figure 1: The aircraft as it came to rest on the right side of Runway 13 at Baragwanath Aerodrome.

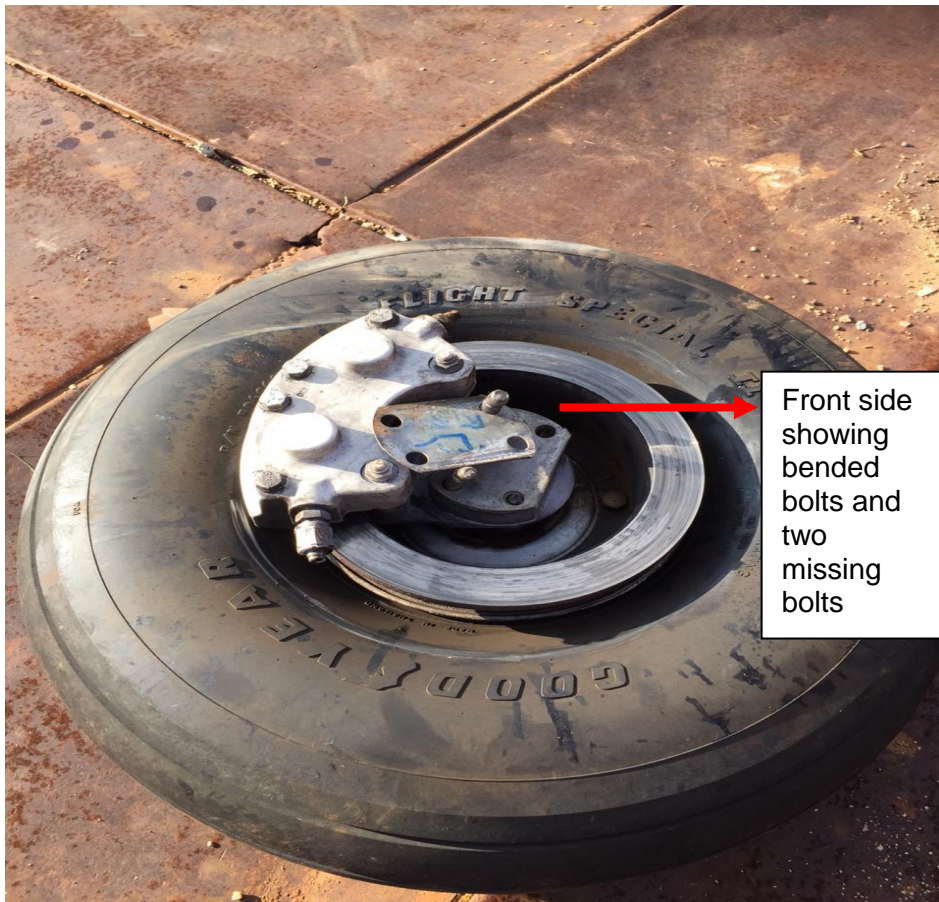
- 1.1.4 Post-accident examination of the left main gear assembly revealed that the bolts and nuts that secured the axle to the left gear struts had failed.

Front side showing bended bolts and two missing bolts

Figure 2: The wheel assembly showing two rear sheared bolts, the missing front top bolt, and the snapped bottom bolt.

- The wheel assembly was correctly installed to the axle by a castellated nut and secured by a split pin
- The axle was secured to the strut by four bolts and nuts
 - Two nuts and two bolts were still attached to the landing gear strut
 - The third bottom nut broke off (snapped) and its bottom half was still on the wheel assembly
 - The fourth front top bolt was missing
- The two rear bolts were visually inspected and were found sheared and slightly bent. The two attachment bolts were bent aft (backwards), and the fractured surface was consistent with an overstress fracture.

- 4.1 The aircraft landed hard on Runway 13 at FASY, resulting in the failure of the left-side main landing gear axle attachment bolts and nuts, and the subsequent separation of the main wheel and axle assembly from the left main landing gear.

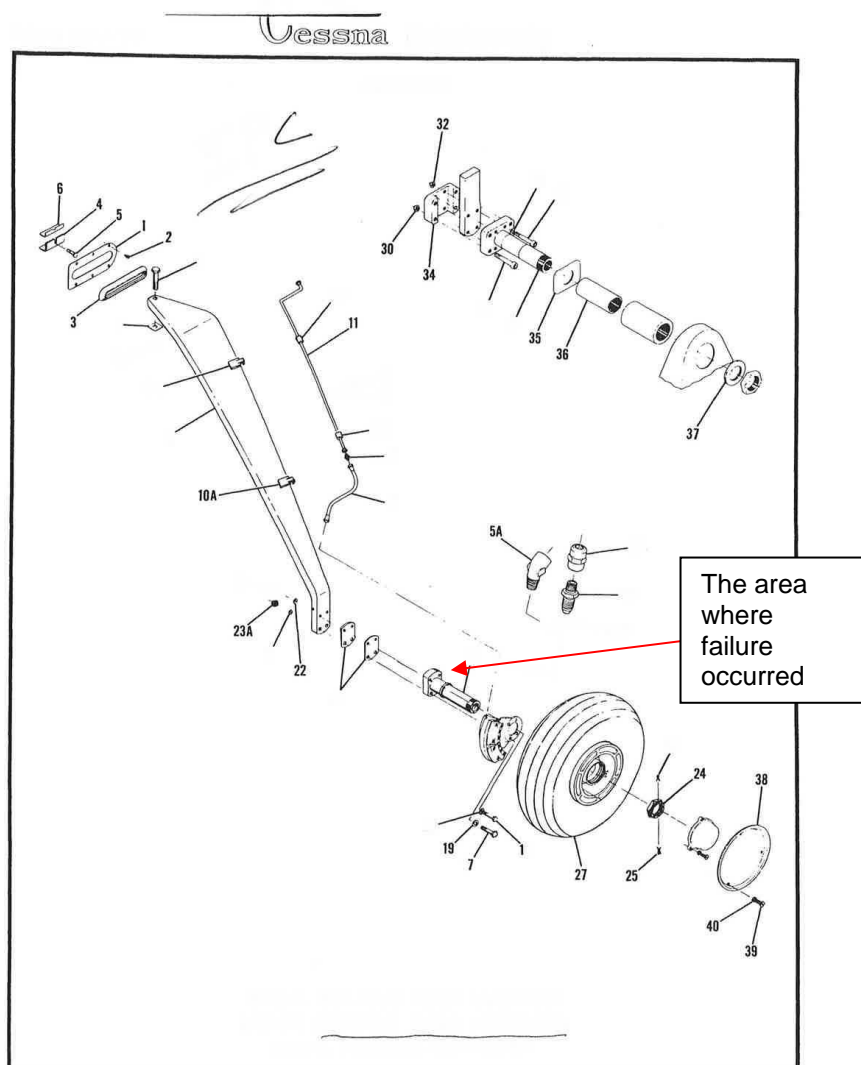
Figure 3: Illustrated parts catalogue of the main gear strut and wheel assembly.

- 2.1.8 The Cessna Aircraft Service Manual Model 180 *requires the inspection of the main landing gear spring axle attach bolts holes. Initial 4000 hours or 10 years, whichever comes first. Repeat 1000 hours or 3 years, whichever comes first.*

- 3.7 The aircraft had a certificate of registration (CoR) which was issued on 30 May 2018.
- 3.8 The Cessna Aircraft Service Manual requires an inspection for corrosion, corrosion pits and cracks. The AMO only visually inspected the components without subjecting them to a non-destructive testing (NDT).
