Final report RL 2021:03e

Accident at Stockholm/Skavsta Airport, Södermanland County, on 6 April 2020 involving the aeroplane SE-MKV of the model TB 9, operated by Skies Airline Training AB.

File no. L-27/20

30 March 2021

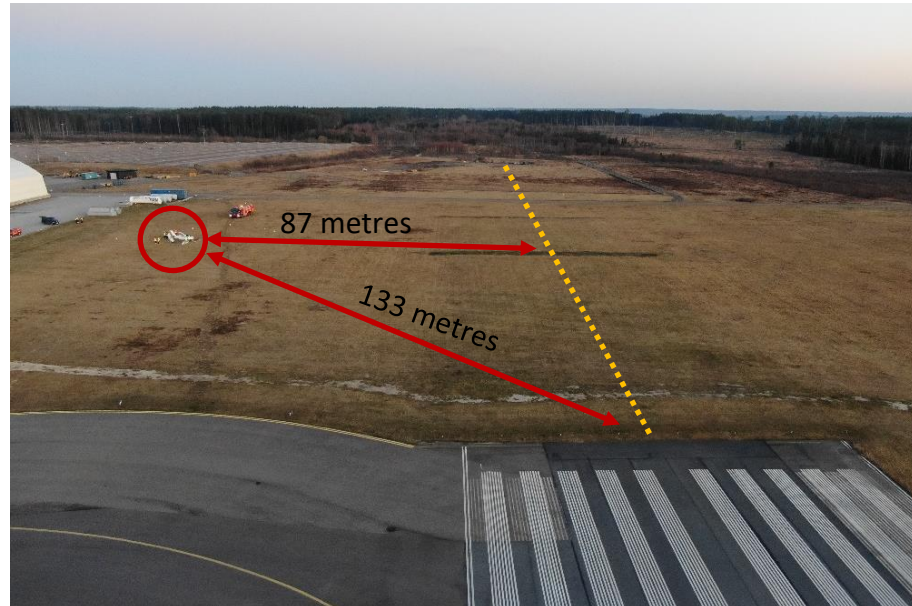
The final position was 87 metres from the runway centre line and 133 metres from the end of the runway. The distance from the end of the runway to the wooded area was 380 metres.

Figure 9. The aeroplane at the accident site in relation to the end of runway 16.

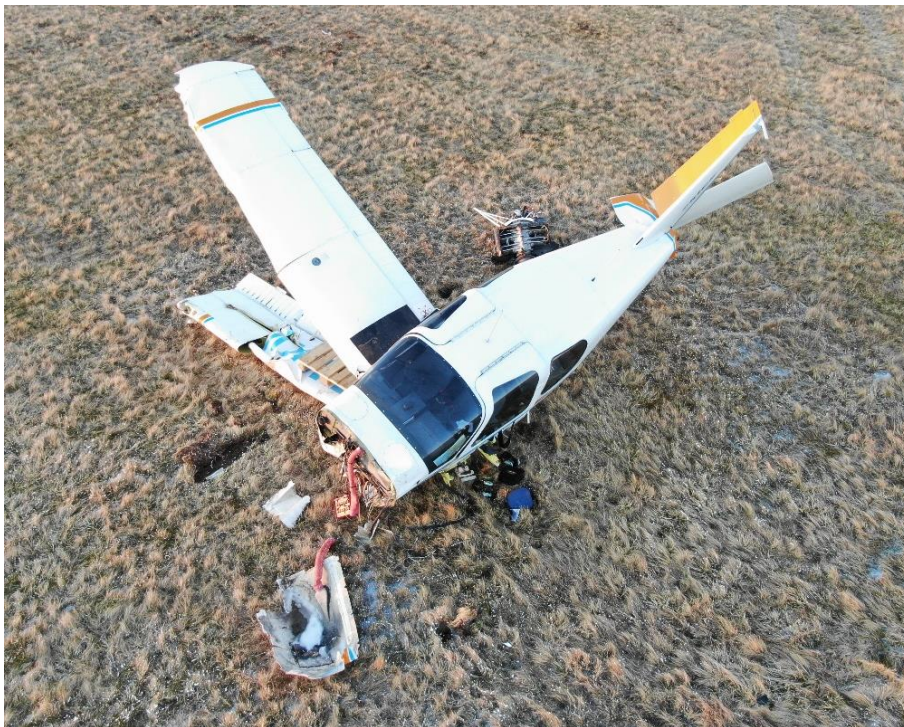
The aeroplane's left wing was broken off at the wing root and ended up under the fuselage. The right wing had major damage on its leading edge. Upon impact, the engine was torn off where the engine mounting attaches to the firewall, continuing in the direction of travel and ending up beyond the aeroplane. The stabiliser and its attachments had been partially torn loose from the structure. The cabin was basically intact.

Inside the cabin, panels from the luggage compartment had come loose. The left shoulder strap and its upper attachment had been torn off, together with surrounding structures.

Figure 11. Aeroplane wreckage at the accident site.

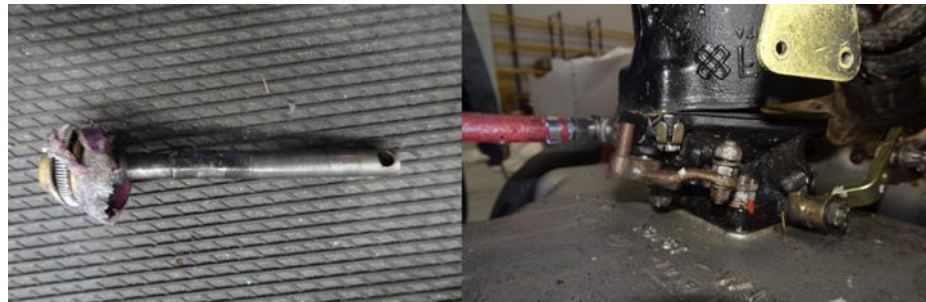
Before the tests were conducted, bolts to the float chamber and the piston of the accelerator pump were replaced as the original bolts had been damaged in the accident, see Figure 13.

Figure 13. Damaged piston of accelerator pump (left) and part of the carburettor (right).

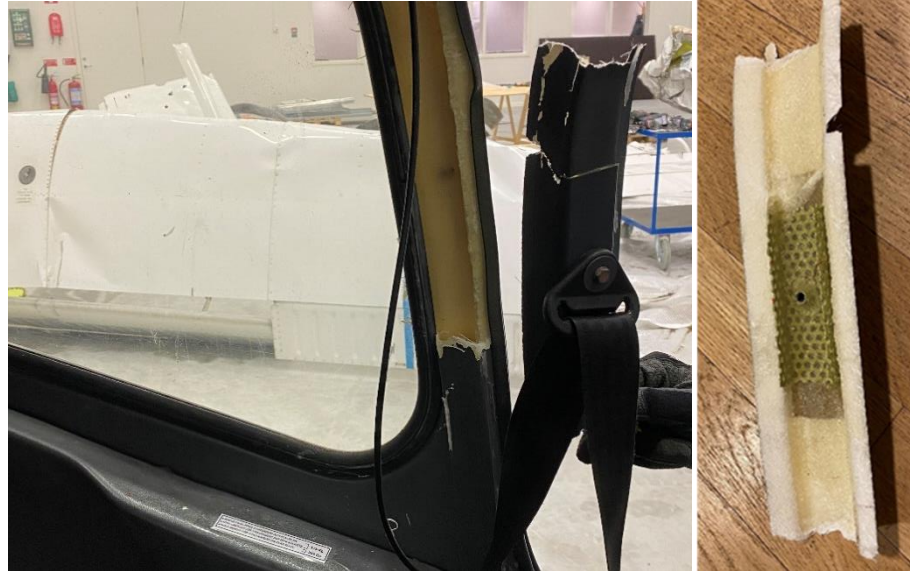
The bracket of the left pilot's shoulder strap had been broken off the doorpost behind the pilot. The bracket was mounted on a fibreglass structure that consisted of a laminate that was thinner than one millimetre. The design of the bracket results in the laminate being subjected to combined tractive, bending and shearing forces.

In the event of a forward load, the bracket is subjected to an equally large downward force because the bracket only transfers the force to the reel for the inertia-reel belt, which is attached to the floor. This means that the bracket is subjected to a load of over 350 kP.

Figure 15. The seat belt attachment on the left side.

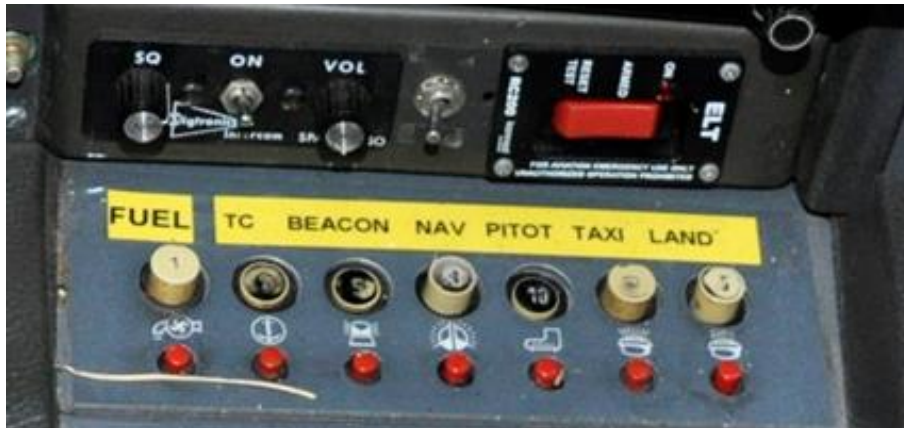
could be established that the switch for the fuel pump and landing lights were in the out position and therefore off. Other controls were in the on position. The flaps were in the extended position for take-off. The probability that only the switches for the fuel pump and landing lights had been switched off during the crash while other switches had remained in their original position is very low.

Figure 23. The electrical panel for switches on SE-MKV at the time of the accident. Note that switches for memory items are turned off (pushed out position).

For this reason, it is likely that the engine fault occurred in conjunction with the student beginning the memory items. The instructor may have failed to notice this because he was busy dealing with the situation that arose. The student was probably interrupted while performing the memory items as the flaps were in a partly extended position when SHK examined the aeroplane following the accident. The order of the memory items is first the fuel pump, then the landing lights and finally retraction of the flaps.
