DUTCH
SAFETY BOARD

Fly-away after compass malfunction

DJI Inspire 2 Unmanned Aircraft System

Den Haag, February 2023

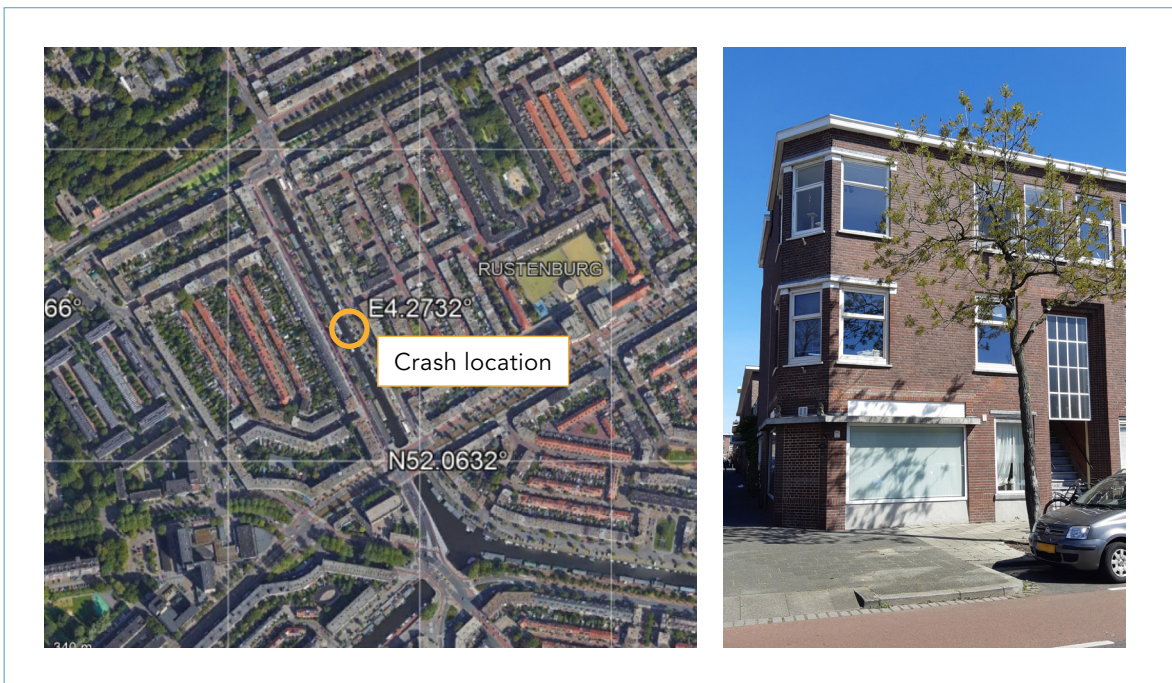
The aircraft was found powered off and with lowered landing gear. First inspection learned that there were green traces on the propeller blades. Additionally, the rear landing gear legs and mounted camera were damaged. When the two batteries were removed, both had one of the four indicator lights flashing, indicating that the battery charge level was between 0 and 13%.

Roughly 700 metres north of the take-off location and intended area of operation, the Rustenburg Oostbroek neighborhood is situated, an urban residential area consisting of mostly three-story walk-up flats. At the end of its flight, the Inspire 2 crashed in this area on a sidewalk between a building and the Soestdijksekade, a busy combined cycle and roadway. See Figure 2. The tree adjacent to the location where the UA was found showed signs of contact with the UA.

Figure 2: The crash location on the Soestdijksekade (left) and photo of the crash site (right). (Source map: Google Earth, source photo: National police)

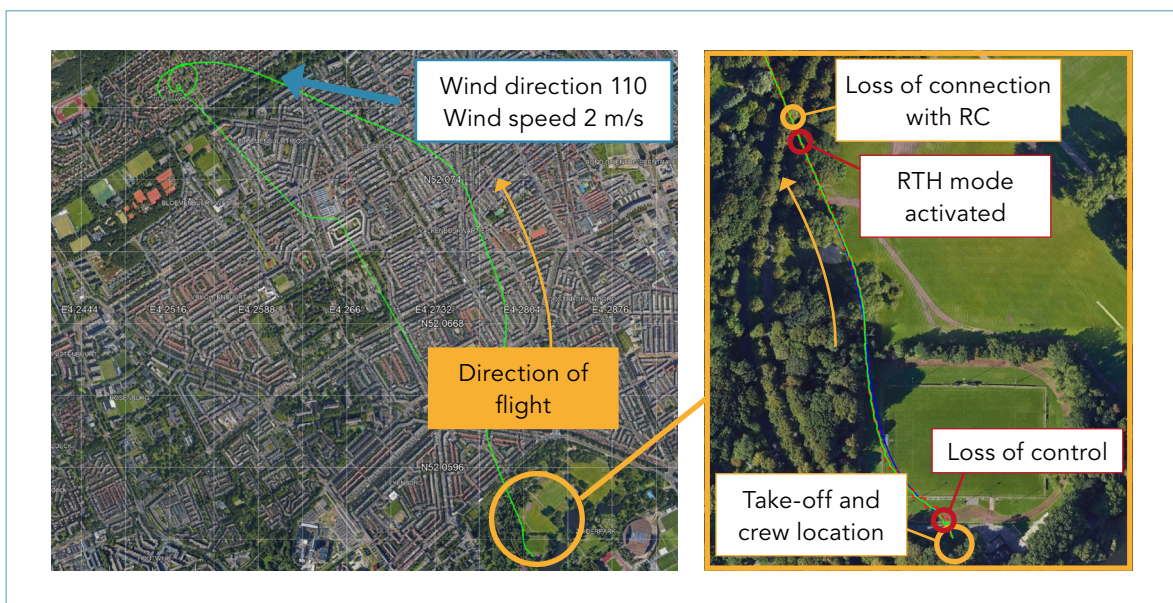
Initial data analysis by the Dutch Safety Board and an analysis by the manufacturer have indicated that the connection between the UA and Remote Controller (RC) was lost at about 27 seconds into the flight. Activation of the Return-To-Home (RTH) occurred before the loss of connection. Figure 7 depicts the ground track of the UA during the first 30 seconds of the flight. To determine to what extent the pilot of the unmanned aircraft was in control, and to establish the (probable) cause of the loss of control, an analysis of the inputs for the first 30 seconds of the flight is presented below.

Figure 7: The ground track of the UA obtained from the recorded data together with the wind direction. The orange inset shows the ground track for the first 30 seconds of the flight. The colors of the traces in the right figure represent the different data sources from which the track was obtained. (Source map: Google Earth)

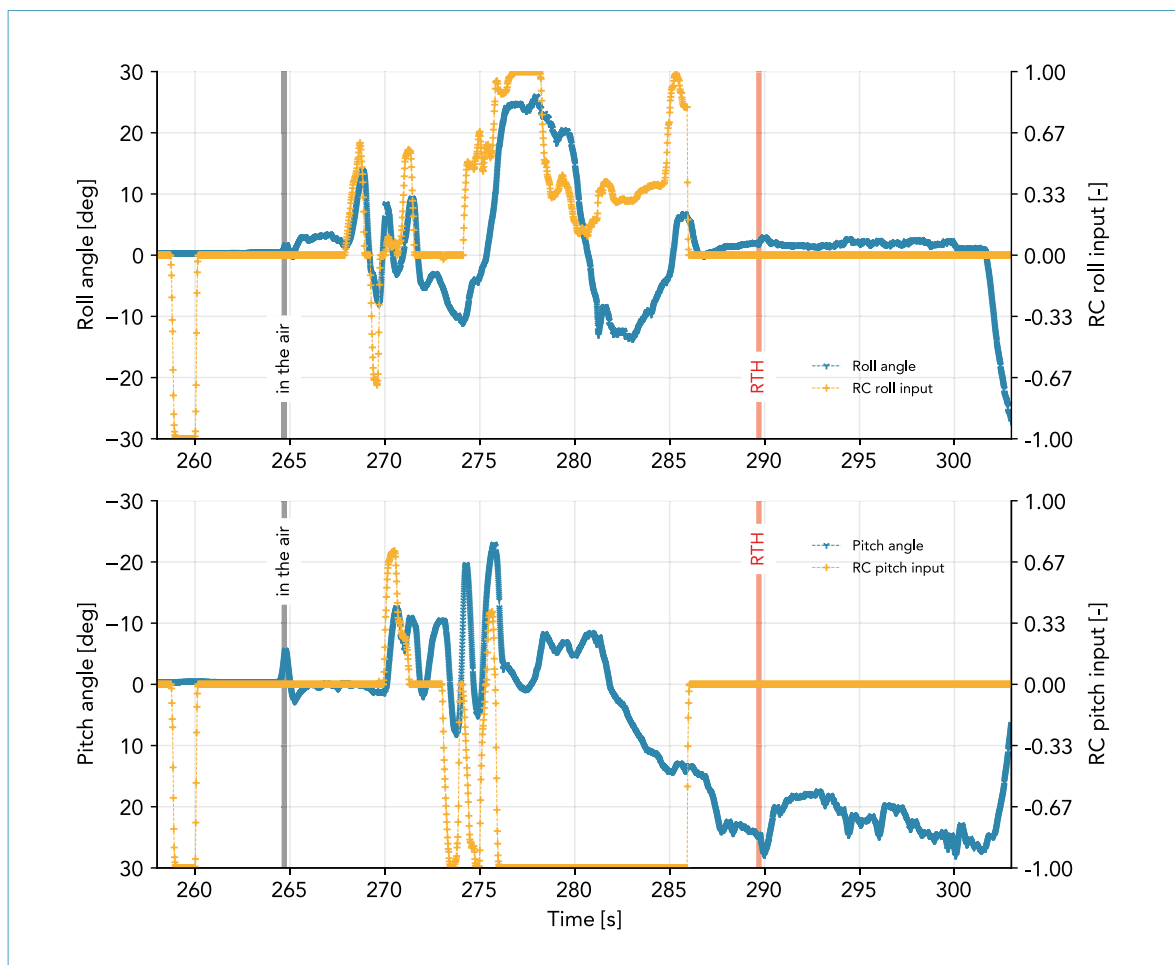
For roll and pitch, the relation between the recorded angle and the input was not always consistent. This is shown in Figure 9. Some deviation of the roll and pitch angle from the input is generally expected in the P-mode⁵², as the flight computer autonomously tilts the UA to generate lateral forces that can compensate for wind drag. As there was little wind on the day of the flight (mean wind speeds up to 3.0 m/s, see Section 2.5), the roll and pitch angles associated with autonomous control are expected to be relatively small. During the first five seconds of the flight that was generally the case, yet from 270 seconds onward, the pitch and roll angles increased up to ten degrees without corresponding input. During the second half of the shown timespan, the correlation between the pitch and roll angles and the provided input was low in magnitude and sign.

Figure 9: The roll angle of the UA and the remote controller roll input versus time (top) and pitch angle of the UA and the remote controller pitch input versus time (bottom). The input from the right RC stick (in orange) is compared with the corresponding UA response (in blue). Also indicated are the moments when the UA was in-flight and when the RTH functionality was activated. A positive roll input corresponds to a positive, rightward roll angle. A positive pitch input corresponds to a negative, forward pitch angle.

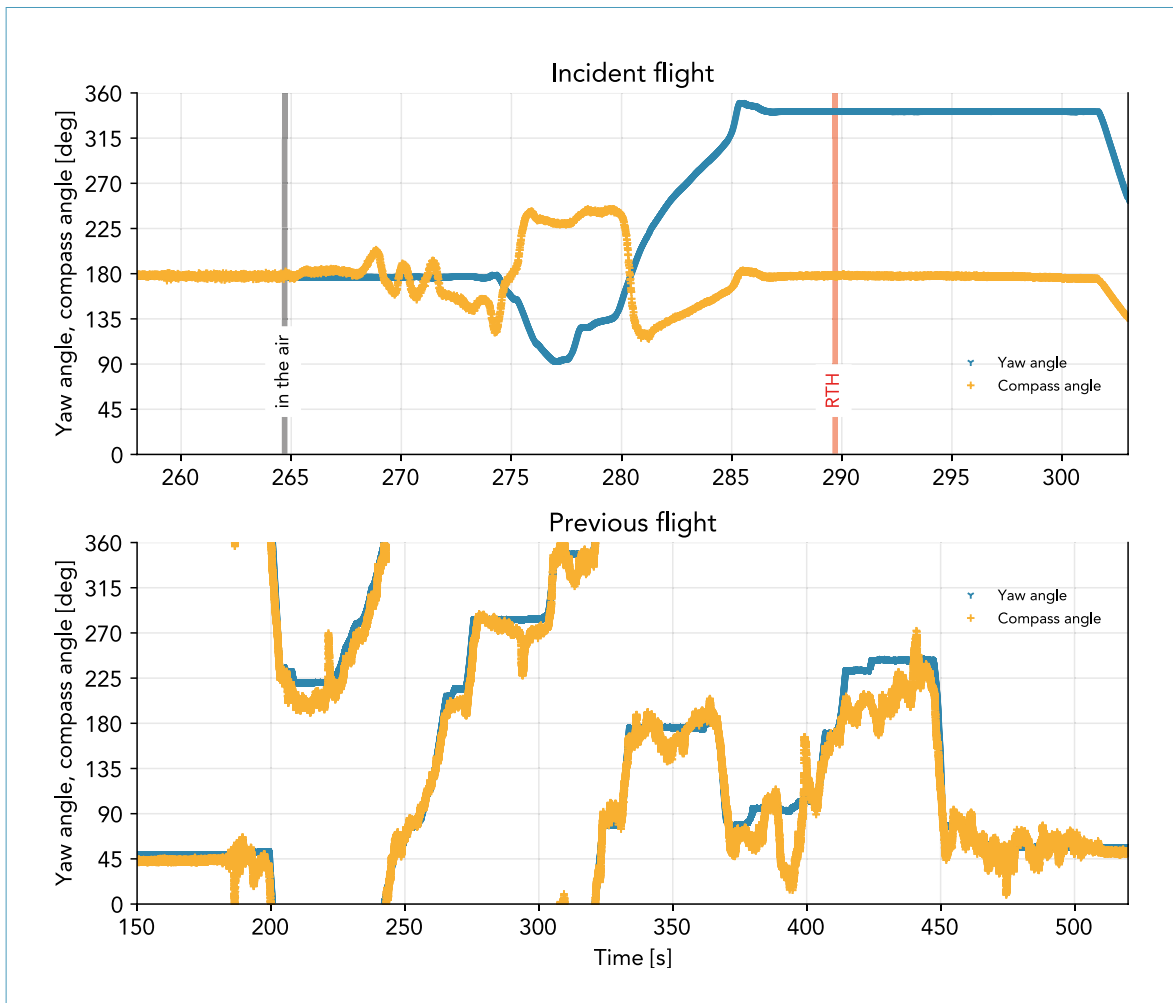
The data of the first 30 seconds of the flight contains a discrepancy related to the heading, in particular between yaw and compass angle⁵⁷, see Figure 10 (top). Both angles start at roughly 180 degrees, but several seconds into the flight, the angle of the compass vector starts to deviate from the yaw angle. The discrepancy increases after a flight time of about 10 seconds, reaching a more or less constant difference of roughly 180 degrees. The flight data of the previous flight of the same UA reveals no such discrepancy, see Figure 10 (bottom).

Figure 10: Yaw angle and the magnetic heading indicated by the compass versus time for the incident flight (top) and for a previous flight (bottom). The yaw angle (in blue) is normally consistent with the compass angle (in orange).

The compass faults and the compass angle deviation indicate that the compass most likely influenced the UA response. Because no details regarding the working of the compass, the processing of its output or the registration of its values in the flight data are available, it was not possible to analyze this in more detail. Given the absence of power supply infrastructure close to the take-off location, it is considered unlikely that the interference caused by it led to a compass deviation. In any case, it can be said that the deviation was not the result of disturbances to the earth's geomagnetic field by solar particle radiation, given the low Kp factor (see Section 2.5).

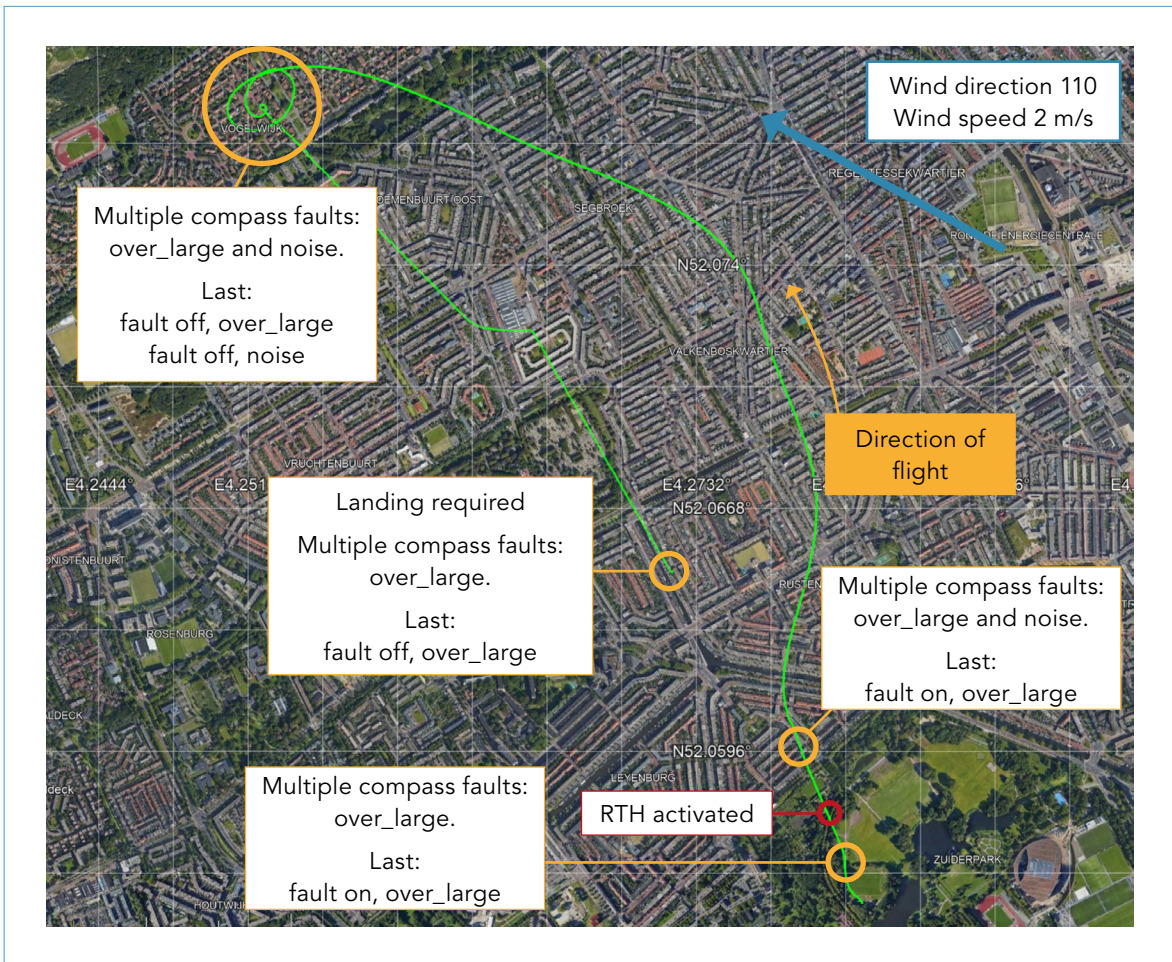
After the connection with the RCs was lost, the UA flew over the city of The Hague for about 18 minutes. During this part of the flight, additional compass faults were registered. The GPS-based ground track of the aircraft, annotated with the locations of the compass faults and RTH activation, is shown in Figure 11. The orientation data for this part of the flight is considered to be insufficiently accurate because of multiple compass faults and was therefore not used for further analysis.

Figure 11: Ground track of the Inspire 2, annotated with the locations of compass errors. (Source map: Google Earth)

The ground track is characterized by multiple straight segments combined with a curved trajectory. Most notably, the UA also performed two orbits. According to the data, these orbits coincide with a portion of the flight during which multiple compass faults were registered. The simultaneity of the orbits and multiple compass errors is another indication of serious compass malfunctioning.
