AIRCRAFT SERIOUS INCIDENT SHORT REPORT

CA18/3/2/1314: The nose landing gear failed to extend during a systems evaluation flight.

Aircraft registration : ZS-ISD

Aircraft manufacturer and model : Piper Aircraft Company, Piper PA-34-200

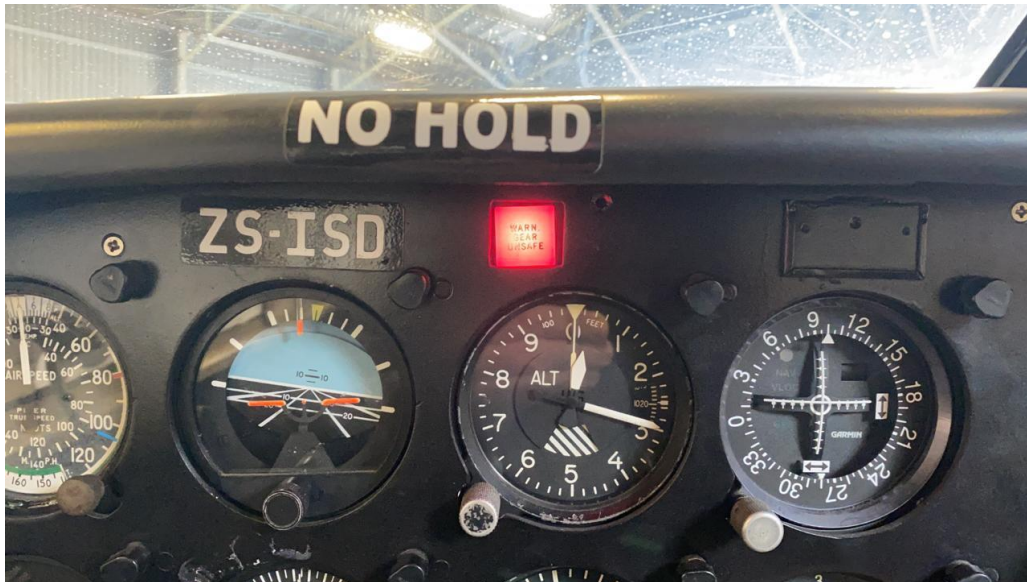
Figure 1: “Warning Gear Unsafe” light on the instrument panel of ZS-1SD. (Photograph courtesy of the AMO)

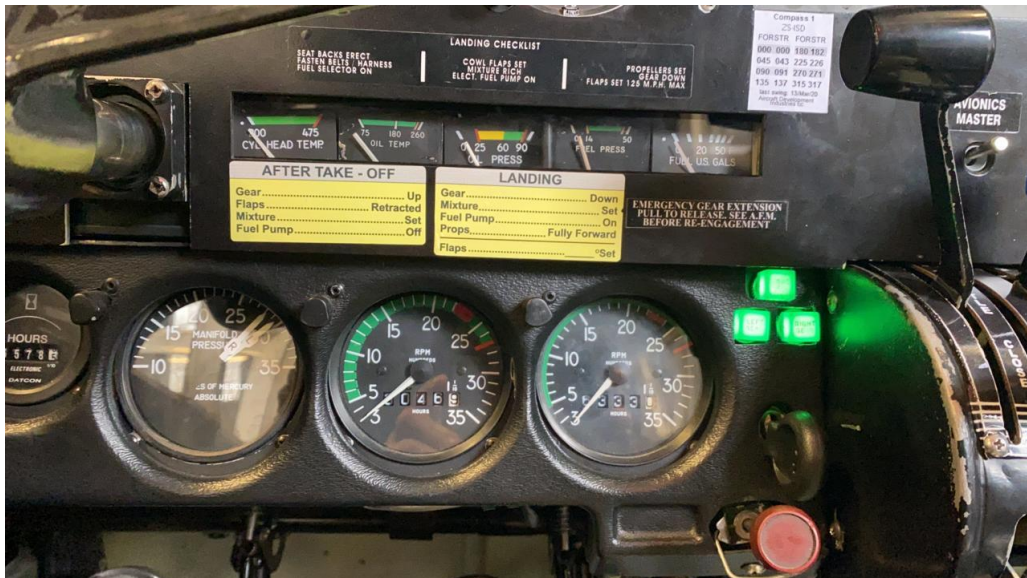
Figure 2: Gear down indication (3 greens) on the instrument panel of ZS-1SD. (Photograph courtesy of the AMO)

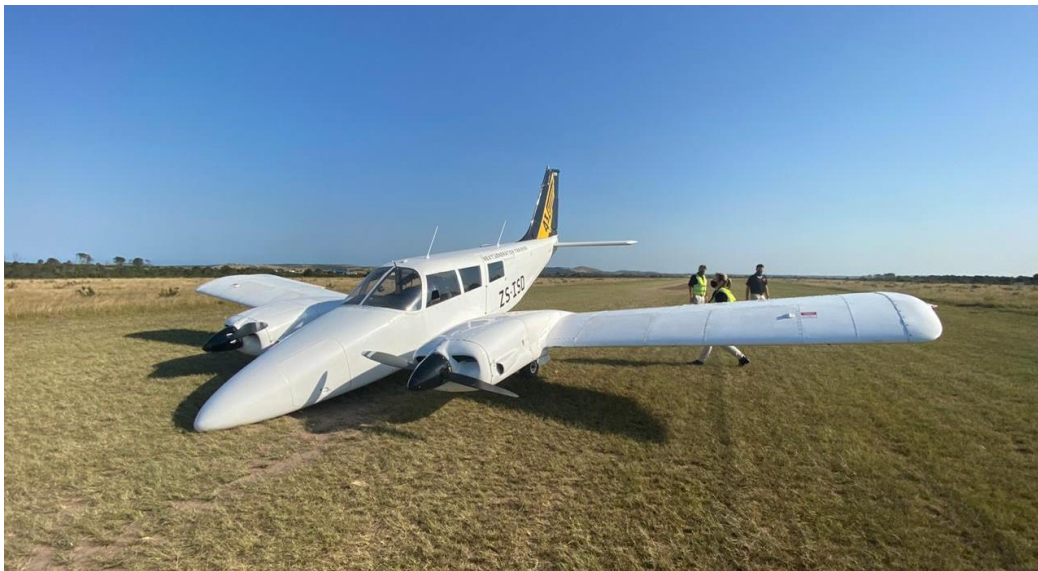
2.1.5 The pilot then conducted several low-level fly pasts over Runway 07 where several AMEs visually inspected the nose gear from the ground. They later confirmed that the nose gear had failed to extend. The decision was made to continue with landing with the nose gear in the retracted position. Once the aerodrome rescue and fire-fighting (ARFF) personnel were in position, the pilot approached for landing on Runway 10L, which is a grass-surface runway that is 1 828 metres long. The weather was fine, with a reported surface wind from 100° at 25 knots. Full flaps were selected (40°) for landing. The pilot stated that at the threshold height of approximately 50 feet above the runway surface, he shut down both engines and the propeller levers were moved to the feather position. He allowed the aircraft to touch down on the main wheels and tried to keep the nose up for as long as possible. As the nose was lowered and made contact with the grass-surface runway, the aircraft skidded for some distance before coming to rest in a nose-down attitude. There was no fire after the incident and the pilot and the AME vacated the aircraft unassisted. The aircraft sustained damage to the lower nose cone, the nose landing gear doors and one propeller blade was bent on the number 2 engine (right) side as it was still wind-milling when the nose was lowered.

Figure 3: The aircraft as it came to a stop on Runway 10L. (Photograph courtesy of the ATO)

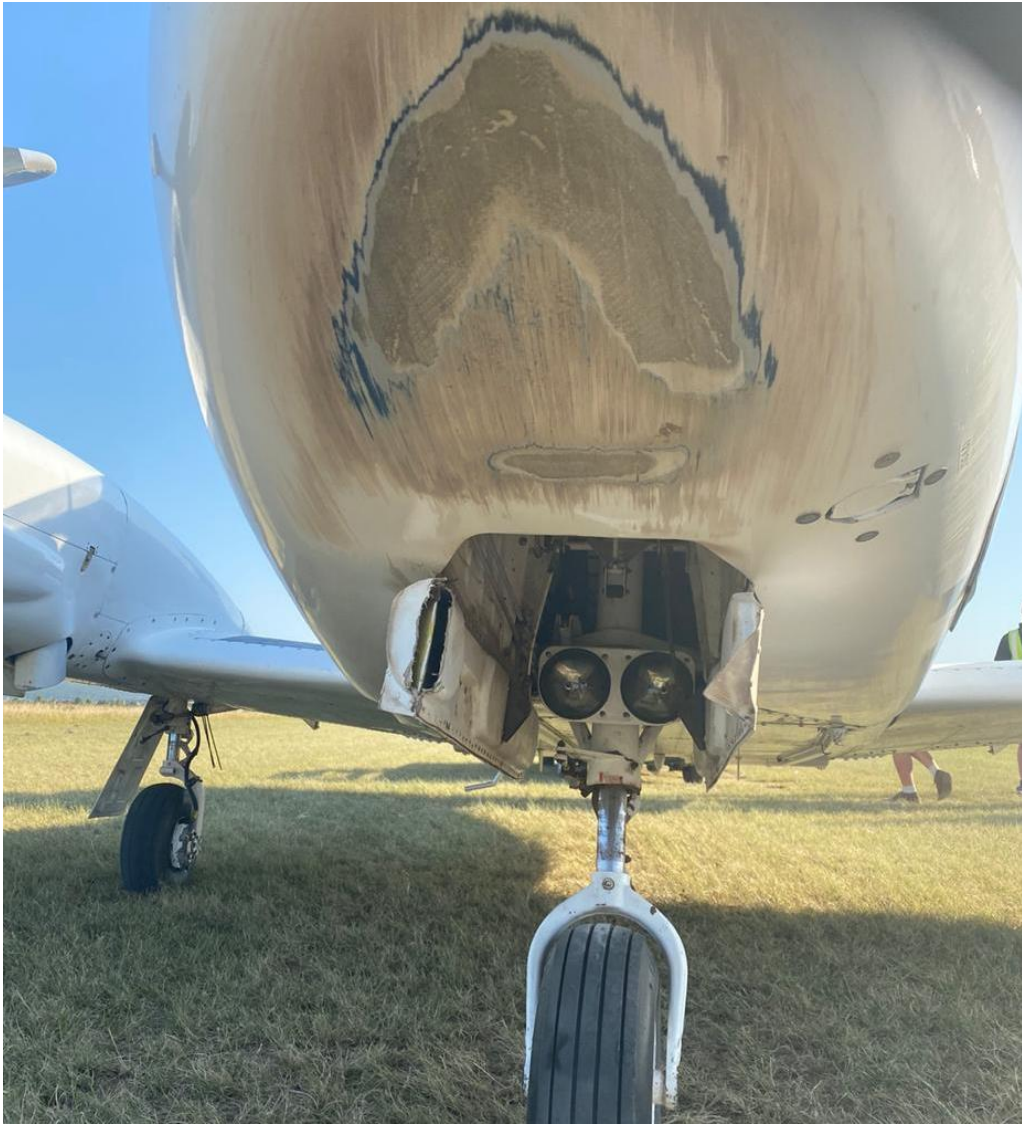
Figure 4: Damage visible to the lower nose cone and nose gear doors. (Photograph courtesy of the AMO)

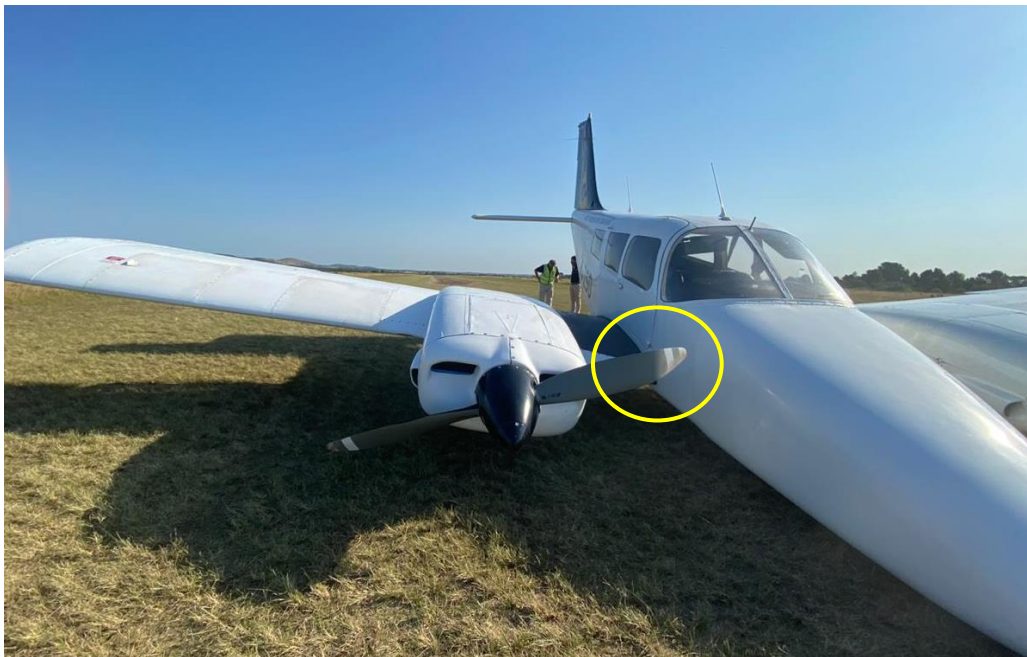
Figure 5: One propeller blade was bent on the right side. (Photograph courtesy of the ATO)

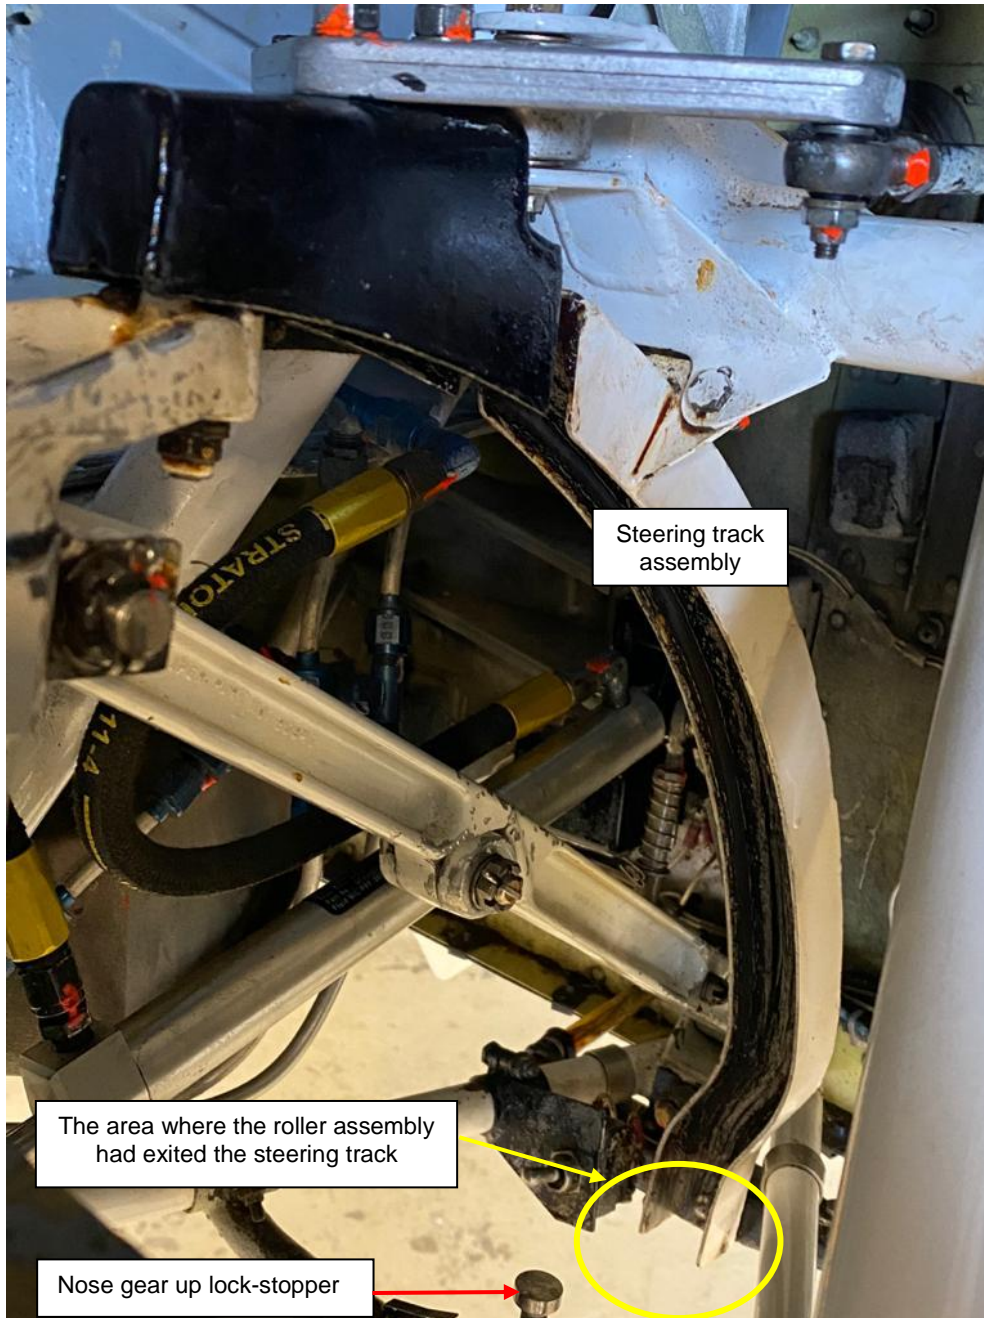
Figure 7: A view of the steering track and the nose gear up lock-stopper (gear in down position).

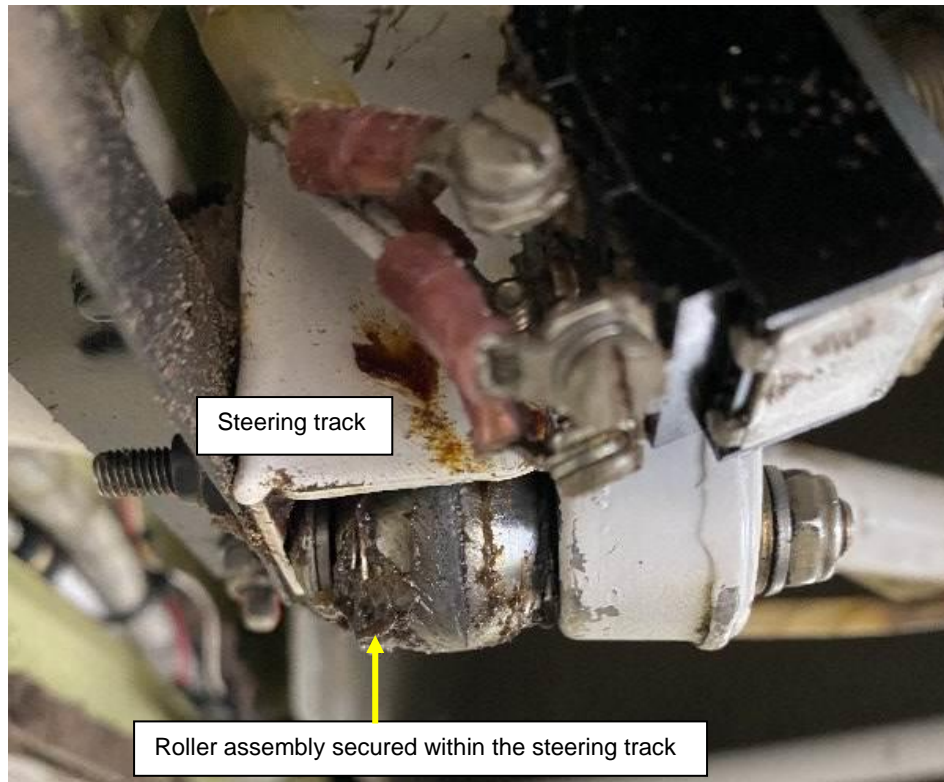
Figure 8: The roller assembly secured within the steering track (nose gear in the up position).

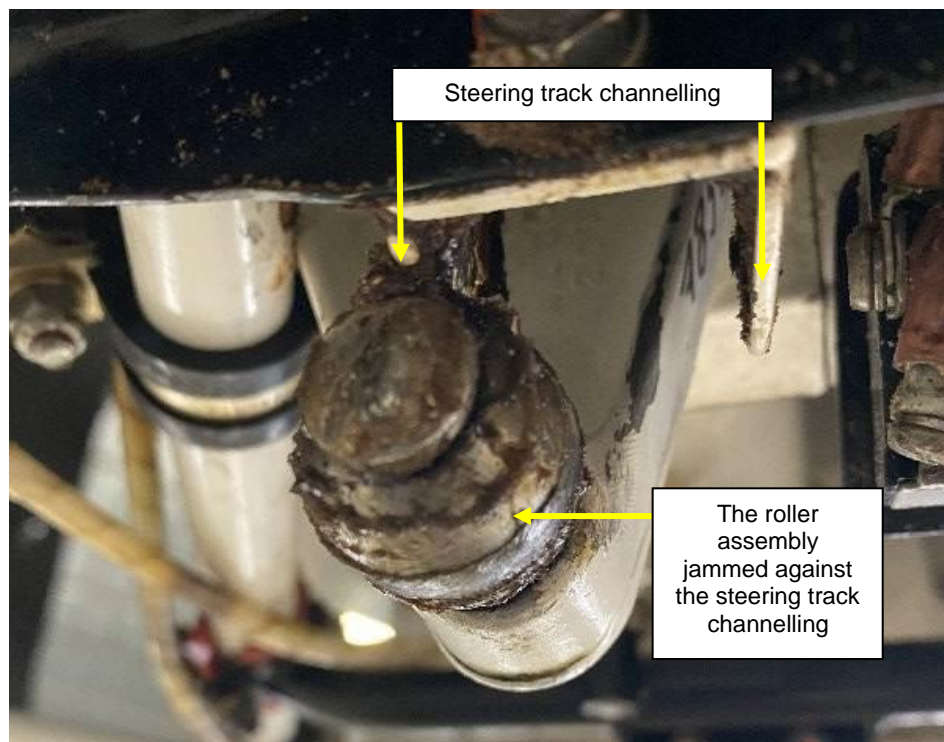
The aircraft was recovered from the runway by lifting the nose section and extending the nose landing gear manually, however, no photographs were taken prior to these actions. A technical report was obtained from the AMO that conducted the recovery. It was found that the roller assembly, which would normally be captive within the steering track assembly (see Figure 7), had left (exited) the track at the lower end and was pushing against the outer side (left side) of the steering track channelling (see Figure 9). This came about after the up lock-stopper (illustrated in Figure 10) became loose during flight. The lock nut was most probably not properly secured, which caused the roller assembly out-of-track condition, and it got jammed against the U-channelling when the landing gear was retracted after take-off, making it impossible to lower the nose gear.

Figure 9: The roller assembly where it had exited the steering track and jammed the nose gear.

- 4.1 The nose landing gear roller assembly exited the steering track when the landing gear was retracted after take-off. This came about after the nose gear up lock-stopper became loose during flight. This made it impossible to lower the nose landing gear by using both the normal and emergency extension systems.

- 7.1 Safety message: It is recommended that the maintenance organisations establish procedures such as dual inspections to ensure that critical aircraft/engine components do not fail, as well as ensure that their maintenance engineers adhere to established procedures.

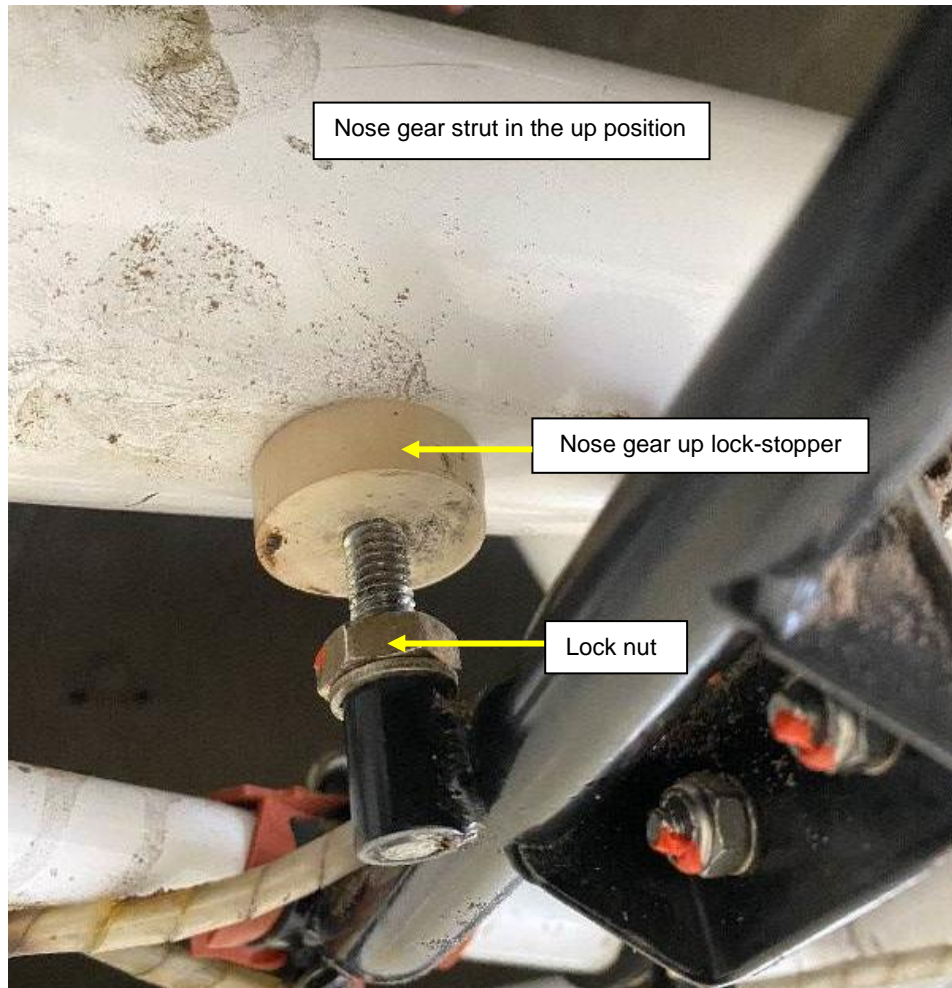
Figure 10: Nose gear up lock-stopper and the lock nut (nose gear in the up position).

- 3.16 The investigation was conducted off site by AIID.
- 3.17 The investigation revealed that the nose landing gear roller assembly exited the steering track when the landing gear was retracted after take-off. This came about after the nose gear up lock-stopper became loose during flight, causing a roller out-of-track condition. This made it impossible to lower the nose landing gear by using both the normal and the emergency extension systems.
