DUTCH  
SAFETY BOARD

# Loss of control after interrupted winch launch, Gilze-Rijen Air Base

*The Hague, May 2021*

Identification number:	2020047
Classification:	Accident
Date, time of occurrence:	12 July 2020, 12.47 hours <sup>1</sup>
Location of occurrence:	Gilze-Rijen Air Base
Registration:	PH-1150
Aircraft type:	Rolladen-Schneider LS8-18
Aircraft category:	Glider
Type of flight:	Pleasure
Phase of operation:	Winch launch
Damage to aircraft:	Nose destroyed, fuselage and cockpit severely damaged, tail broken
Flight crew:	One
Passengers:	None
Injuries:	Pilot fatally injured
Other damage:	Fence
Light conditions:	Daylight

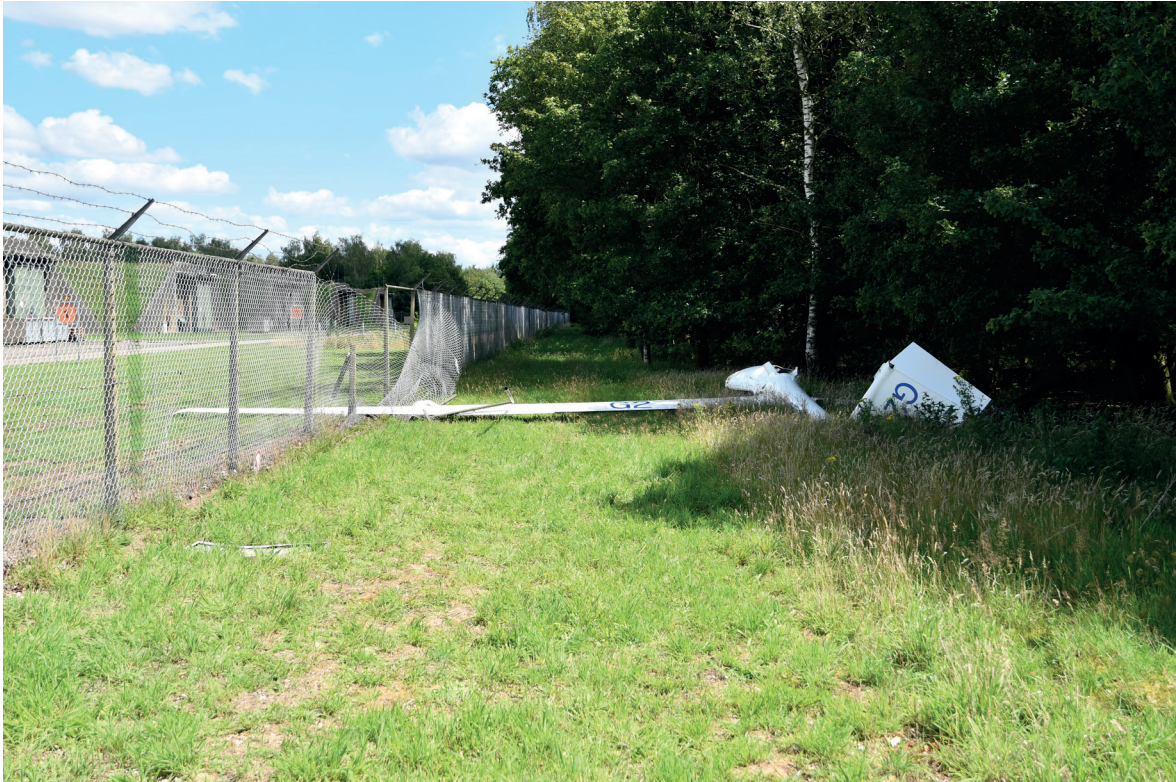
Figure 1: Accident location. (Source: Dutch Aviation Police)

The right wing of the glider ended up on a fence. The fence was damaged as a result (see Figure 1).

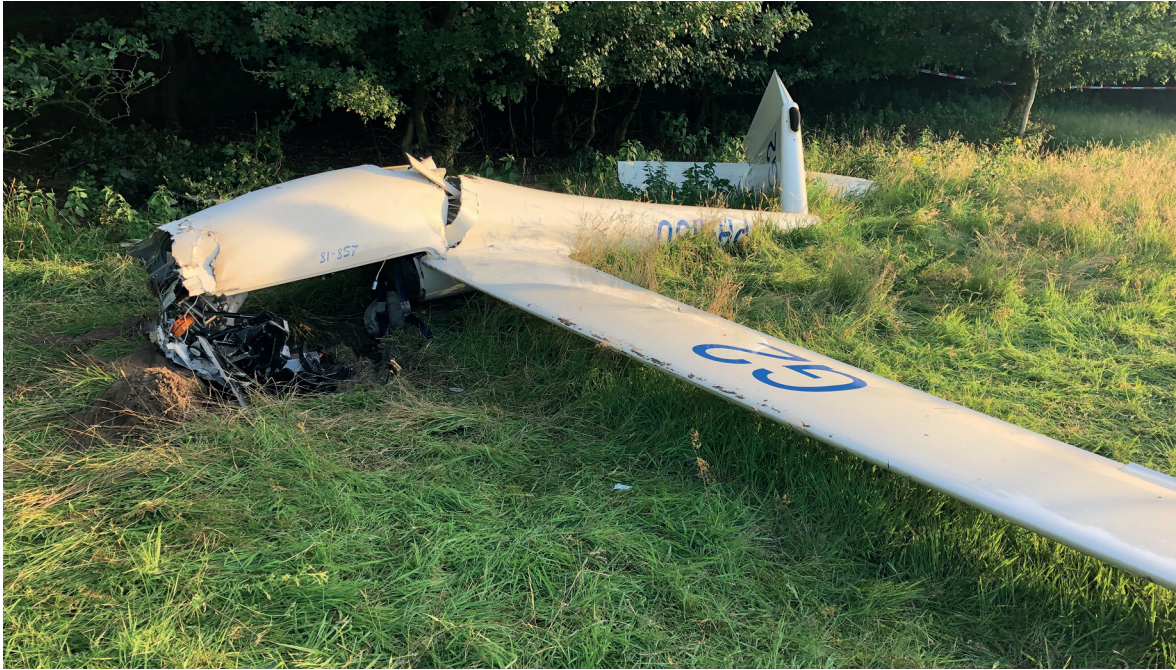
The nose was destroyed and the tail had broken off as a result of the crash. The fuselage was almost broken in half at the level of the wings. The wheel bay and the cockpit were severely damaged (see Figure 2). The right wing was damaged at the point where it hit the fence. The underside of the trailing edge of the left wing was damaged. The glider was beyond repair.

Figure 2: Wreckage of the glider. (Source: Dutch Safety Board)

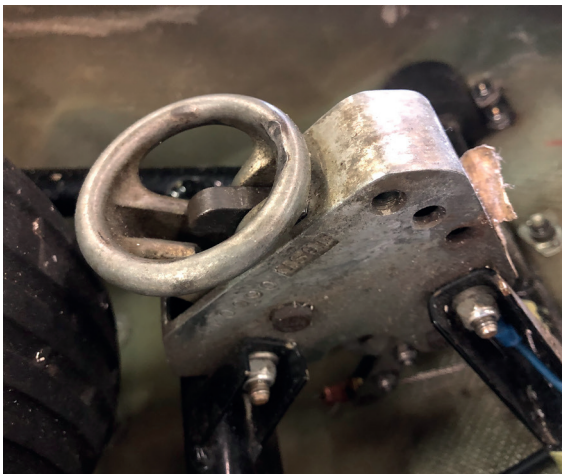
The winch cable is connected to the glider via the centre of gravity release hook (see Figure 3), which is attached to the bottom of the fuselage near the landing gear (see Figure 5). The pilot can release the cable during the winch launch, by pulling the yellow T-shaped handle in the cockpit. The cable release handle in the LS8 is normally guided a little further into the cockpit, via a molded sleeve<sup>17</sup>, to enable the pilot to access it better during flight (see Figure 4).

Figure 3: The centre of gravity release hook of PH-1150. (Source: Dutch Safety Board)

The interruption of the winch launch at approximately 200 metres was caused by a premature winch cable release of the centre of gravity hook.

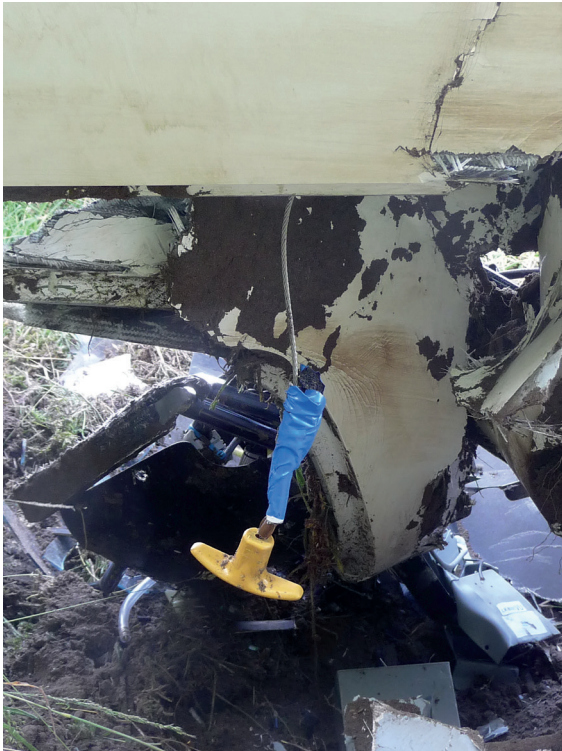
As a result of the broken molded sleeve, the yellow release handle in the cockpit, which is connected to the release cable, hung loosely. Because of this, it was possible that the release handle was hanging outside the cockpit when the canopy was closed. This is undesirable, because then the canopy cannot be closed properly and the handle is also not accessible to the pilot. Hence a repair was carried out. The purpose of the repair was to bring the molded sleeve (and also the yellow handle) more in the pulling direction towards the pilot. In the workshop it was found that the repair of the broken molded

sleeve would take longer than hoped for and it was therefore decided to make a temporary repair.<sup>31,32</sup> See Figure 6.

Figure 6: The temporary repair of the molded sleeve, as found at the accident site.  
(Source: Dutch Safety Board)

The pilot, who experienced the third premature cable release, observed after the next (and last) flight of PH-1150 that day, that the repair to the molded sleeve had broken and detached.

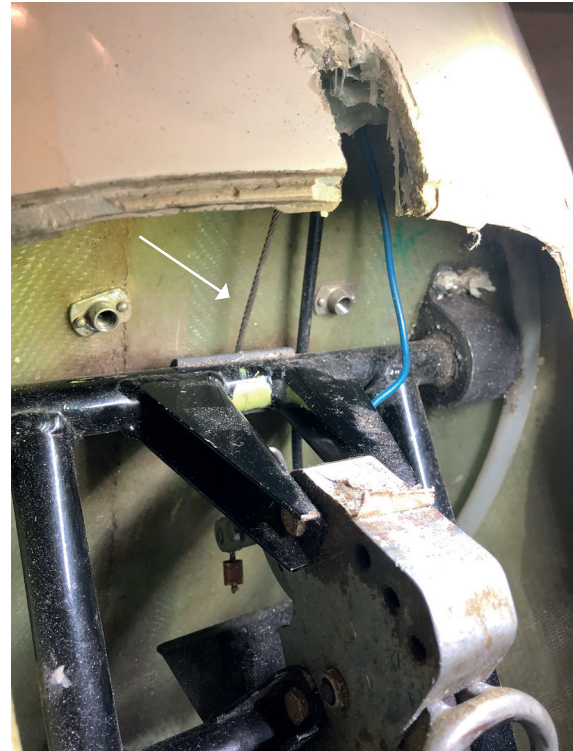
Figure 7 shows the routing of the metal release cable after it had been adjusted on 8 July 2020. As visual, the metal cable runs behind a crossbar of the landing gear. It was found, when the glider was in the workshop, that this routing ran incorrectly along the landing gear on this side of the crossbar, as shown in Figure 7. There was a visible wear spot on the crossbar of the landing gear along which the cable had run.

Figure 7: The metal cable of the release mechanism after the routing adjustment.  
(Source: Dutch Safety Board)

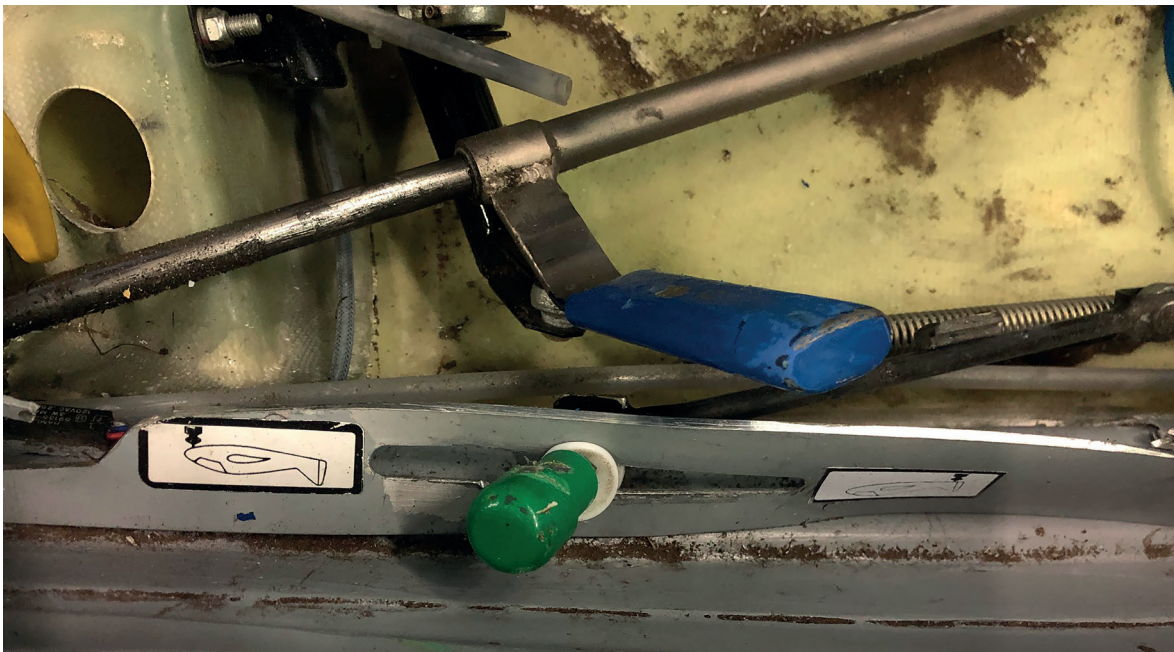
The nose section of the glider was destroyed and the cockpit was severely damaged. The green trim position indicator was found near the neutral position, just a bit forward of it: see Figure 8. The slot in which the indicator moves, was bent. No marking to indicate the neutral position of the indicator was visible along the slot. The lever to operate the retractable landing gear was found in the 'extended' position. Two orange coloured pieces of lead, of which the text 'LS8' was visible on one, were found in the nose of the cockpit.

Figure 8: Green trim position indicator and the blue air brake handle. (Source: Dutch Safety Board)

The green trim position indicator was found near the neutral position, just a bit forward of it. As the slot, in which the indicator moves, was bent, it is possible the indicator had moved as a result of the impact forces. This could not be determined. According to the Flight Manual, the trim should have been set to slightly nose heavy. As the manual is not clear about the exact position the trim should be set to during takeoff, it could not be established if the trim position may have contributed to inadequately lowering of the nose, after the cable disconnected. However, it is unlikely that the trim position had a significant influence on this.

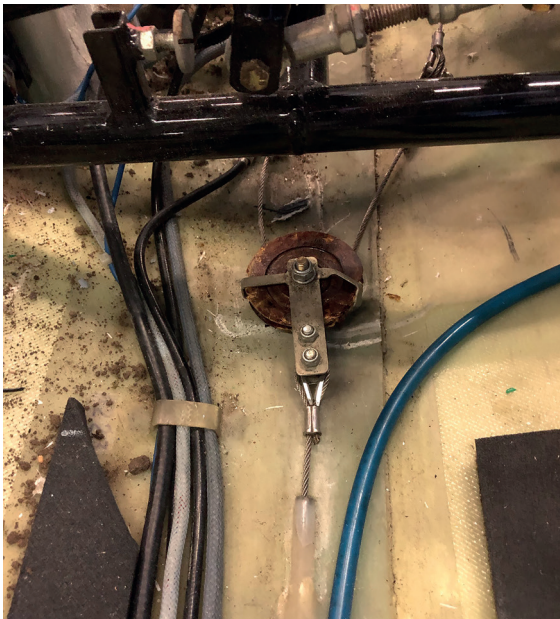
On the inside of the cockpit, under the seat, there is a pulley, made of a synthetic resin<sup>38</sup>, around which a cable runs towards the nose hook.<sup>39</sup> This cable and the pulley are part of the cable release mechanism. The pulley is also connected to a cable that runs backwards and is connected to the centre of gravity hook.<sup>40</sup> See Figure 9. The cable that runs through the pulley to the nose appeared to have come loose from the pulley. See Figure 10. The edge of the pulley was found damaged in some places. A technician stated that no peculiarities of the pulley and cable were found during the last maintenance in the winter.

Figure 9: Pulley and release cable at the bottom of the cockpit. (Source: Dutch Safety Board)

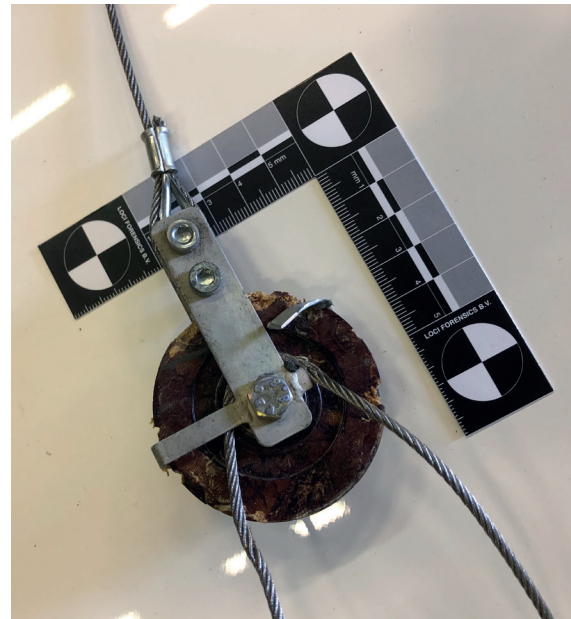
Figure 10: Loose cable around pulley. (Source: Dutch Safety Board)

The cable, which is part of the release mechanism and runs through a pulley to the nose of the glider, appeared to have come loose from the pulley. The edge of the pulley was found damaged in some places. The synthetic resin, from which the pulley is made, becomes brittle over time. This may cause the edges to break. The cause of the damage to the pulley has not been investigated. No peculiarities of the pulley and cable were found during the last maintenance. It is unlikely that the cable came loose while making the repair to the molded sleeve or the adjustment of the routing of the release cable. It is therefore likely that the cable came loose as a result of impact forces during the crash.

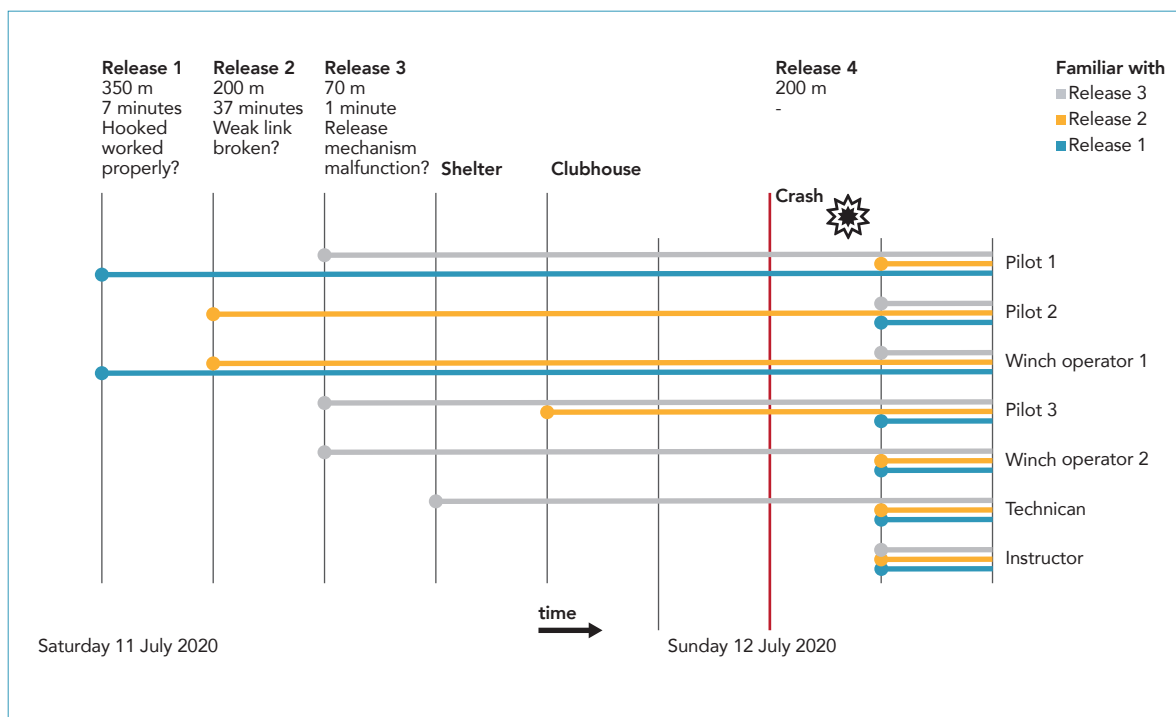
Figure 12: Schematic representation of the times when the main persons involved became aware of the three separate premature cable releases. Pilot 1, 2 and 3 are the pilots involved in respectively the first, second and third premature cable release. Technician is the technician who received the verbal report about one premature cable release. Instructor is the instructor in charge during the accident flight.

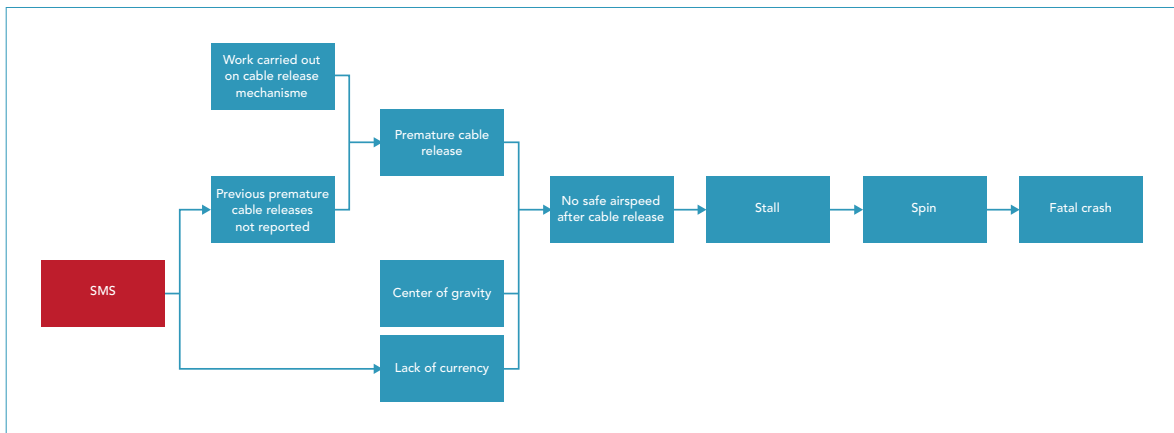
Concluding, a temporary repair had been carried out on PH-1150 and then three times a premature cable release took place. PH-1150 was subsequently not grounded, but made available for flight operations with a malfunction of the cable release mechanism, without

the cause of the cable releases being thoroughly analysed. This in combination with the allocating of PH-1150 to a pilot, with a lack of recent experience on single seater gliders, created a situation in which the accident could occur. The club's safety management system did not ensure that such a situation was prevented from happening.

Figure 14: Schematic representation of the findings. SMS stands for the club's safety management system.
