## *Final report RL 2021:04e*

**Accident North of Örebro Airport, Örebro County, on 22 August 2020 involving the powered sailplane SE-UYA of the model Arcus M, operated by Örebro Soaring Club.**

File no. L-66/20

13 April 2021

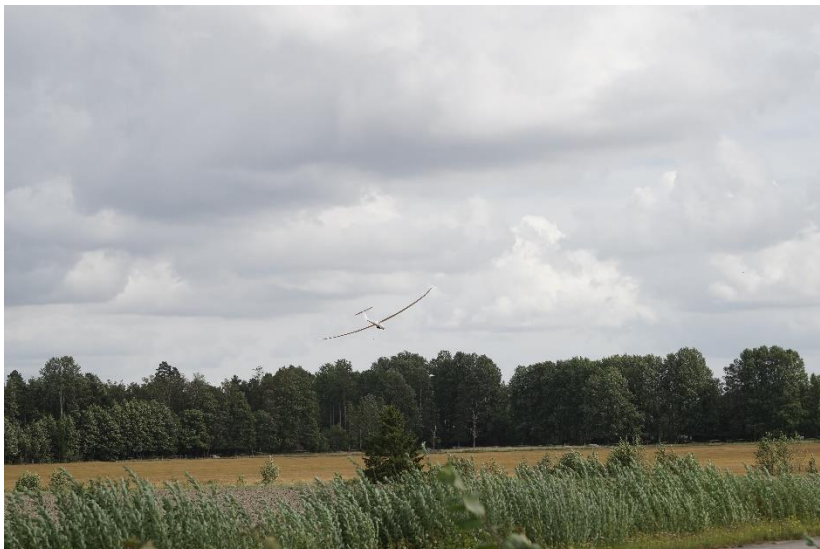
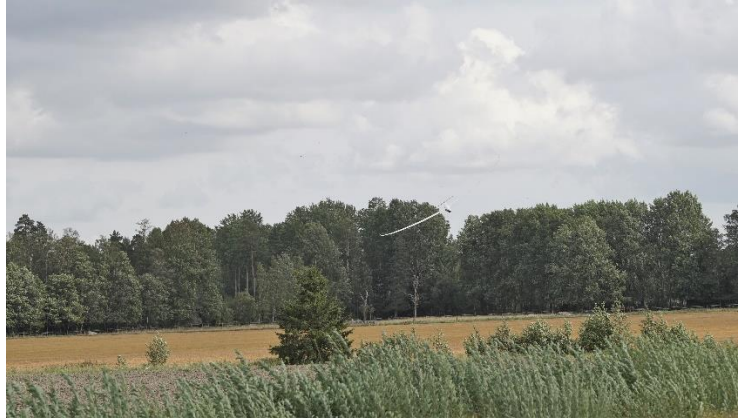
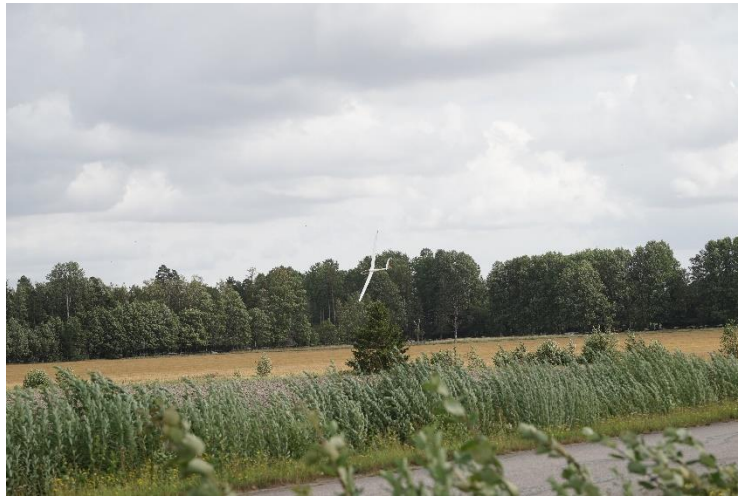
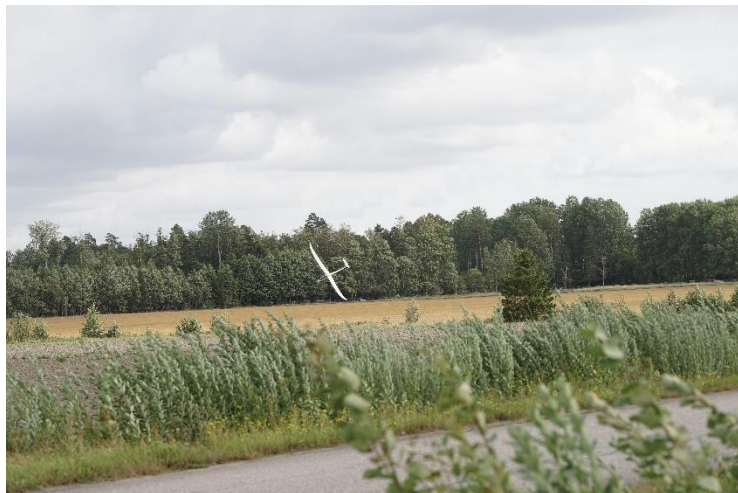
The pictures in Figures 1–4 were taken from the intended landing site.

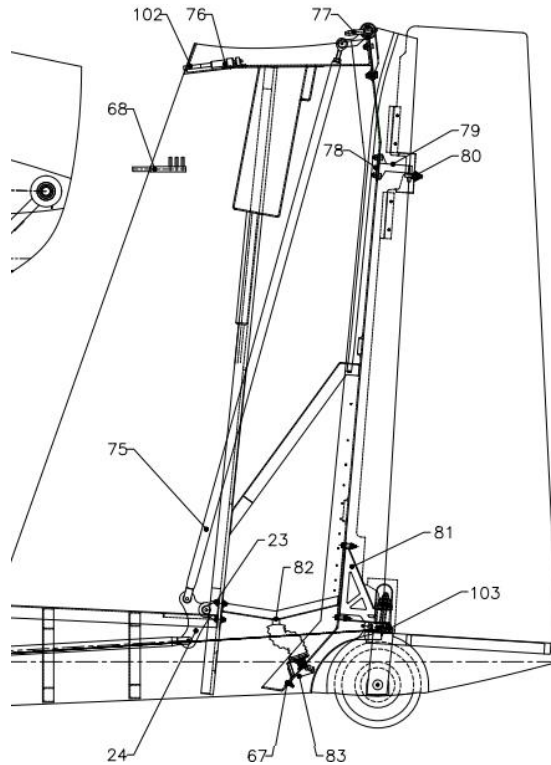
Figure 5. Source: Schempp-Hirth Flugzeugbau GmbH.

The aircraft’s tail wheel is integrated into the rudder, which means that the lower hinge of the rudder also absorbs the forces that act on the tail wheel during take-off and landing.

The aircraft’s checklists for daily inspection and inspection following a hard landing do not contain any specific points concerning inspection of the combined rudder and tail wheel system.

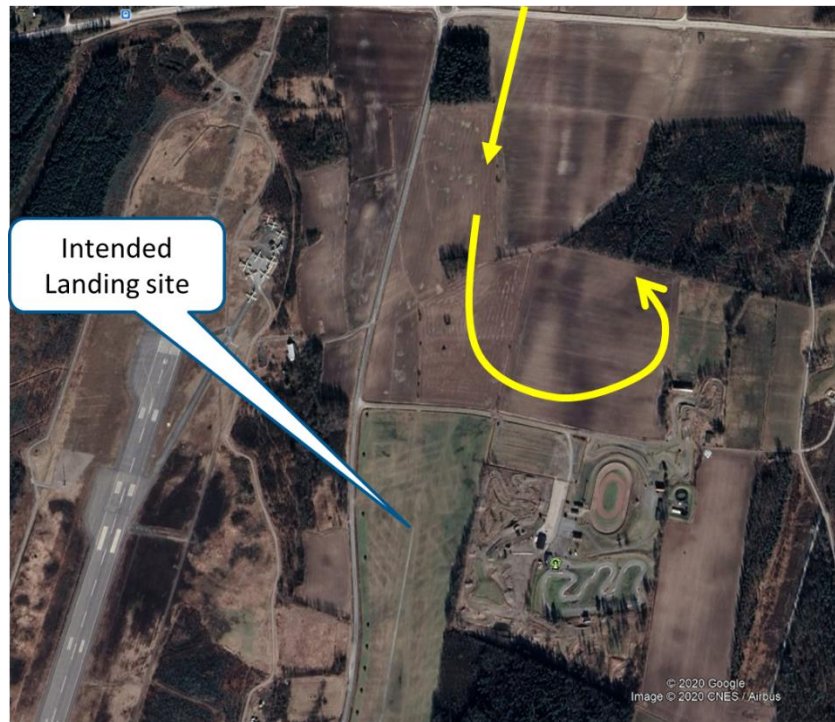
The aircraft crashed into a field of stubble before sliding backwards into the edge of a wooded area (see Figure 6).

Figure 6. The yellow arrow shows the route to the site of the crash. Markings incerted by SHK. Photo: Google Earth. Map data © Lantmäteriet.

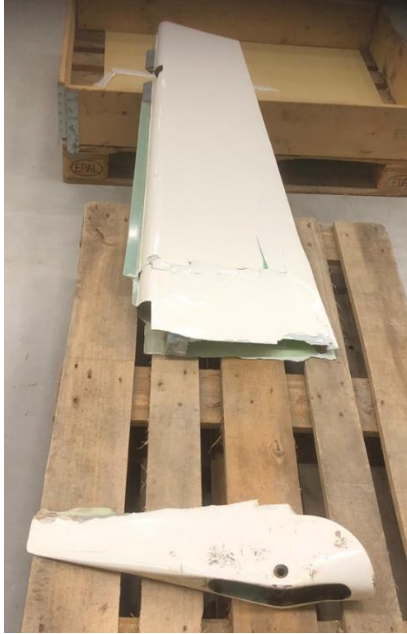
The tail section was broken off at the rear of the engine compartment and in front of the fin and the stabiliser had detached from the top of the fin. The part of the rudder above the tail wheel was detached and was lying by the side of the wreck.

Figure 7. Rudder in two parts. The lower part remained attached to the wreck following the accident.

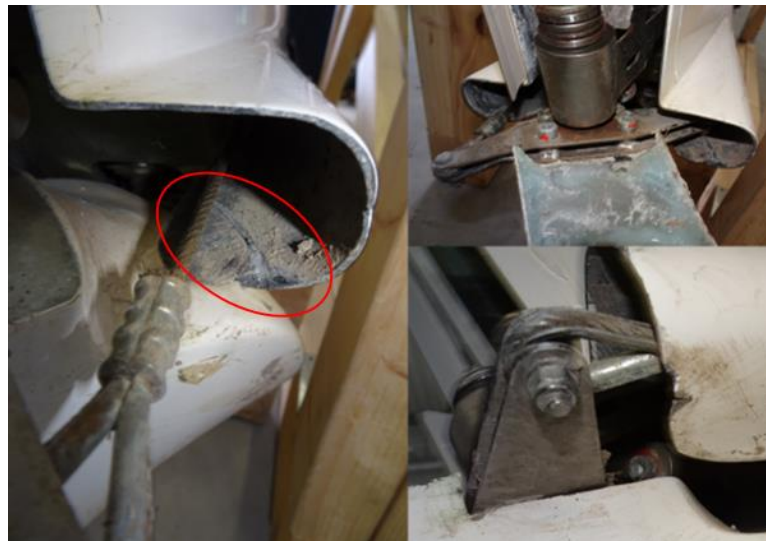
Upon closer examination of the rudder mechanism, it was established that there had been contact between the right bolt for the rudder cable attachment and a fairing on the fuselage.

Figure 8. The picture on the left shows a bow-shaped track of wear on the inside of the fairing. The picture on the top right shows the lower rudder hinge. The picture on the bottom right shows the fairing from below.

The examination showed that it was possible for the rudder yoke to end up in a position in which rudder deflection to the right was completely obstructed as a result of the lower part of the bolt becoming hooked on the fairing.

The shaft of the lower hinge, which consists of an M8 bolt, was bent. It was also possible to tighten this one and a half turns before the join became rigid and gap-free.

It has not been possible to definitively establish the cause of the accident. However, it could be probable that rudder deflection to the right was blocked by the bolt for the rudder cable catching on the edge of the fairing for the rudder cable and becoming stuck, which would explain the sequence of events.

- Take action to ensure that the checklists for daily inspection and inspection following a hard landing are supplemented so as to allow any play or too small clearance between the rudder cable bolts and the fairings to be detected. (RL 2021:04 R1)

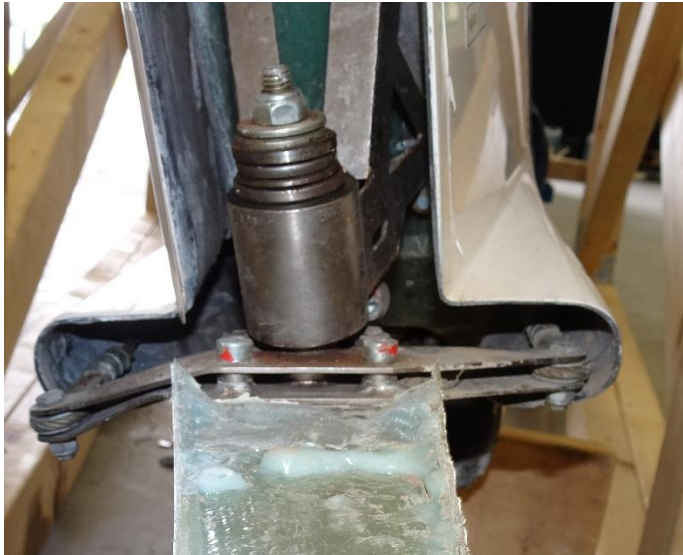
The design is such that if the M8 bolt is firmly tightened, the yoke cannot move, but if the nut for the bolt becomes a bit loose, the yoke is able to move in a rolling motion (see Figure 9).

Figure 9. The picture shows the top of the hinge shaft, which consists of an M8 bolt. The rudder is attached to the yoke using the four M6 bolts, two of which are marked in red.

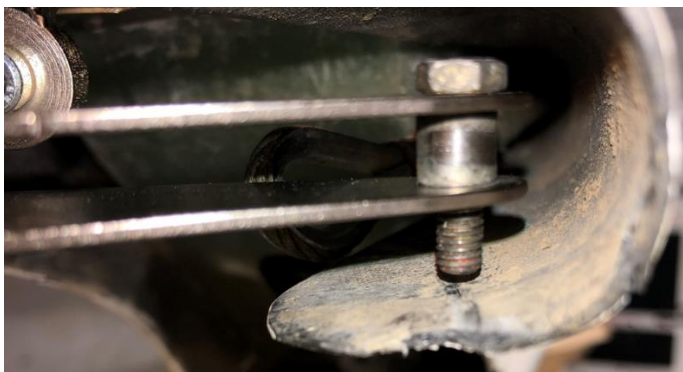
When the nut for the hinge bolt was loosened one and a half turns, the rudder cable bolt was able to make contact with the fairing.

Figure 10. The M8 bolt loosened one and a half turns with a new attachment and rudder yoke mounted.

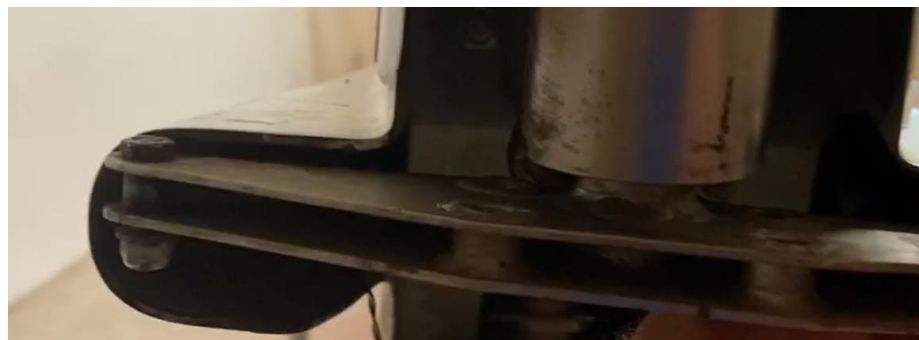
On the other aircraft, after the rudder had been removed, it was noted that it was possible for the rudder bell crank to move freely in a rolling motion such that the bolts were able to come into contact with the fairings (see Figure 11).

Figure 11. The rudder yoke on another aircraft of the same type. Photo: Thomas Jobs.

The type certificate holder has stated that there have been incidences of bent hinge shafts on other aircraft following hard landings.

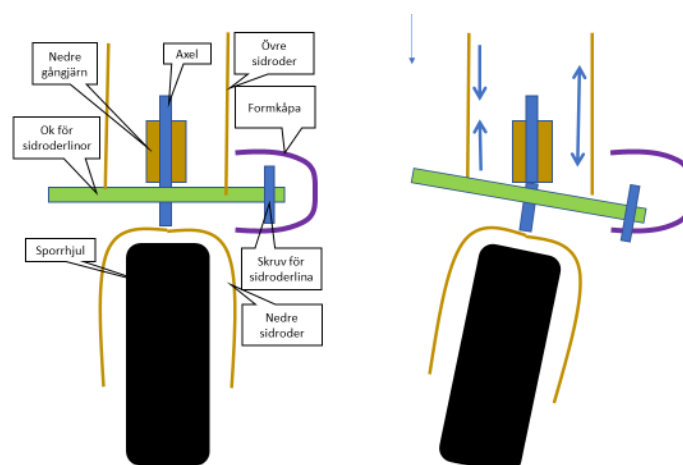
As a result of the investigation it is possible to conclude that the hinge shaft was also bent on other aircraft of the same type. A shaft that is bent can result in the lower part of the rudder, with the tail wheel and the yoke for the rudder cables, being tilted. If this tilt is assumed to be one degree ( $1^\circ$ ), the bolt for the rudder cables will end up one and a half millimetres lower, which can result in an obstruction. A potential counter argument is that the upper part of the rudder counteracts such a tilt. However, the upper part of the rudder has relatively long flexible sides that would probably be able to take on a small deformation without much resistance.

If the bolt is bent such that the bolt is lowered by one and a half millimetres, the upper rudder only needs to be deformed by a millimetre on either side because it is closer to the hinge shaft in order for it to be possible for contact between the rudder cable and the fairing to occur. Consequently, the shell on the left must be compromised by one millimetre and the right elongated by one millimetre, which is not judged to require a large force (see Figure 12).

Figure 12. A sketch of the structure of the rudder, seen from the rear, and the consequences of a bent hinge shaft.
