AIRCRAFT ACCIDENT SHORT REPORT

CA18/2/3/9906: Right main gear collapsed during landing roll on Runway 35 at FAGC.

Aircraft registration : ZS-DVD

Aircraft manufacturer and model : Piper Aircraft Corporation, PA-30-160

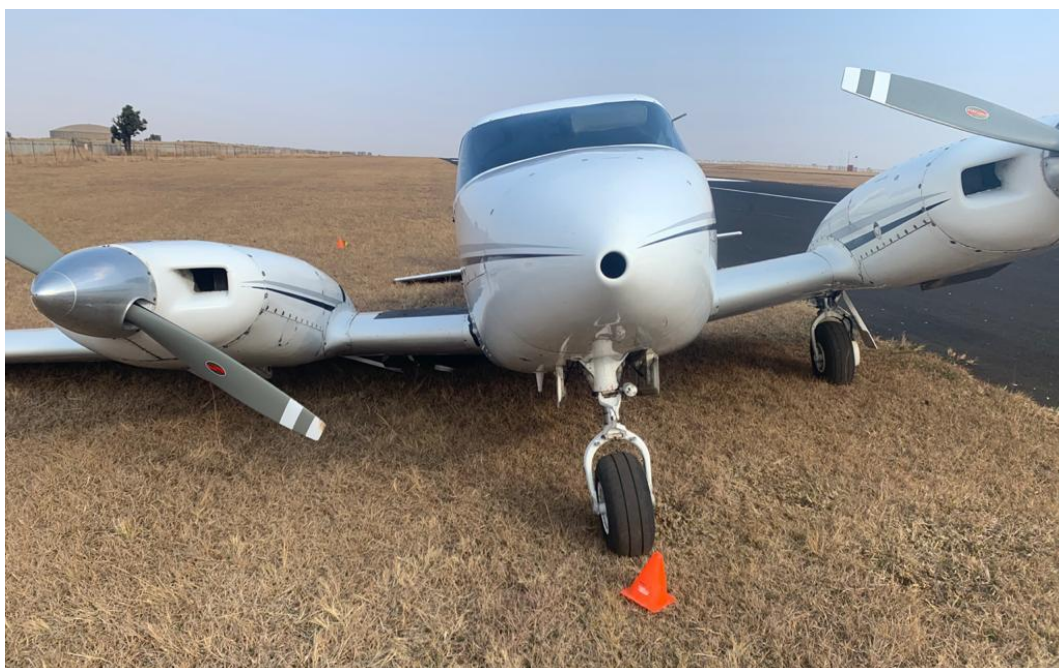
Approximately 300m after touch down, the aircraft veered off to the right of Runway 35 and came to rest in a right-wing low position following the collapse of the right main gear during the landing roll. The right-wing outer section, forward of the main spar, was damaged when the wing collided with a runway landing light (see Figure 3). The right-wing tip tank's lower surface displayed damage as the wing tip tank had scraped along the runway surface (see Figure 4). The right aileron also displayed evidence of deformation. The outer section of the right flap displayed evidence of contact with the runway surface. The PF had selected 15° flap for landing. The push-pull rod on the left main gear displayed substantial bending (see

Figure 1: The aircraft as it came to rest on the right side of Runway 35 at FAGC.

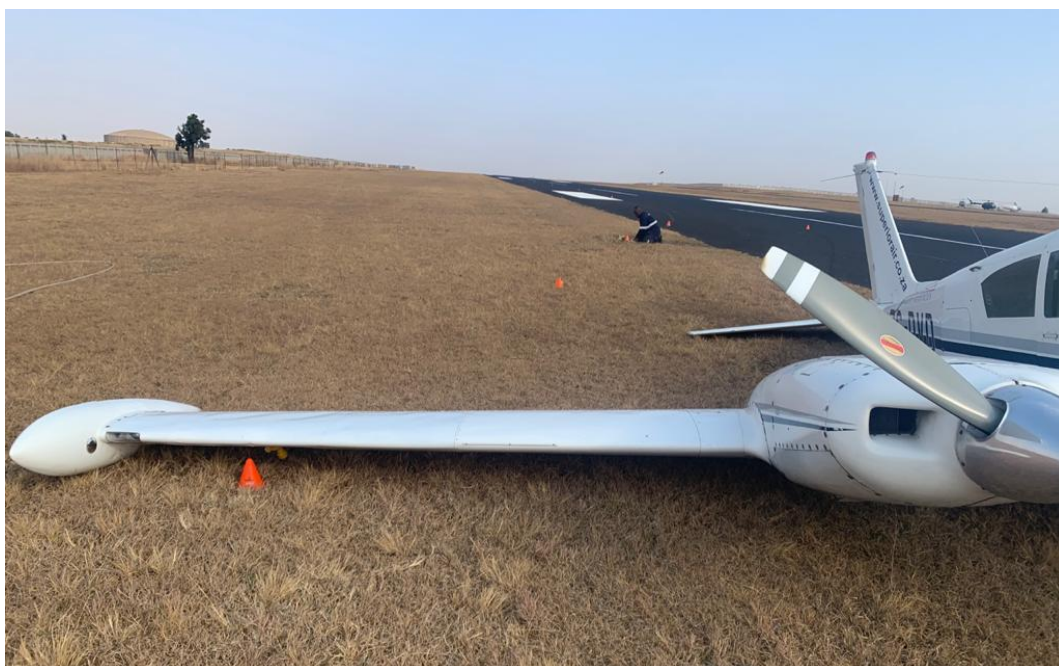
Figure 2: The right-wing tank that came into contact with the ground during the accident sequence.

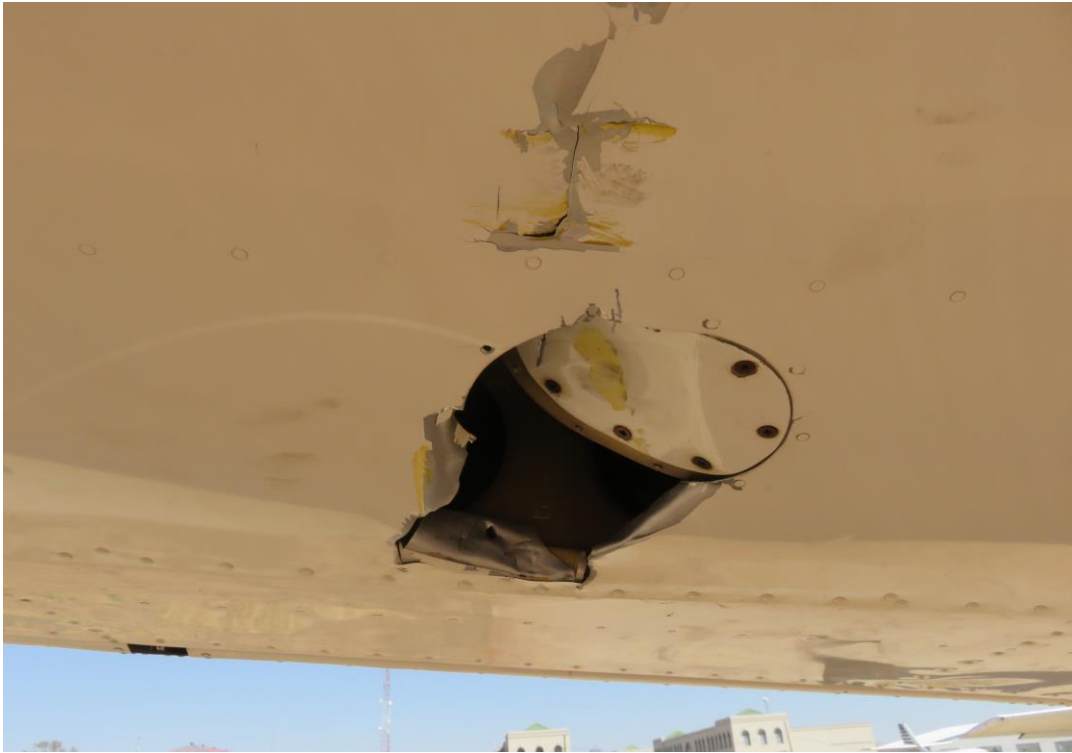
Figure 3: Damage caused to the right-wing lower skin following impact with a runway light.

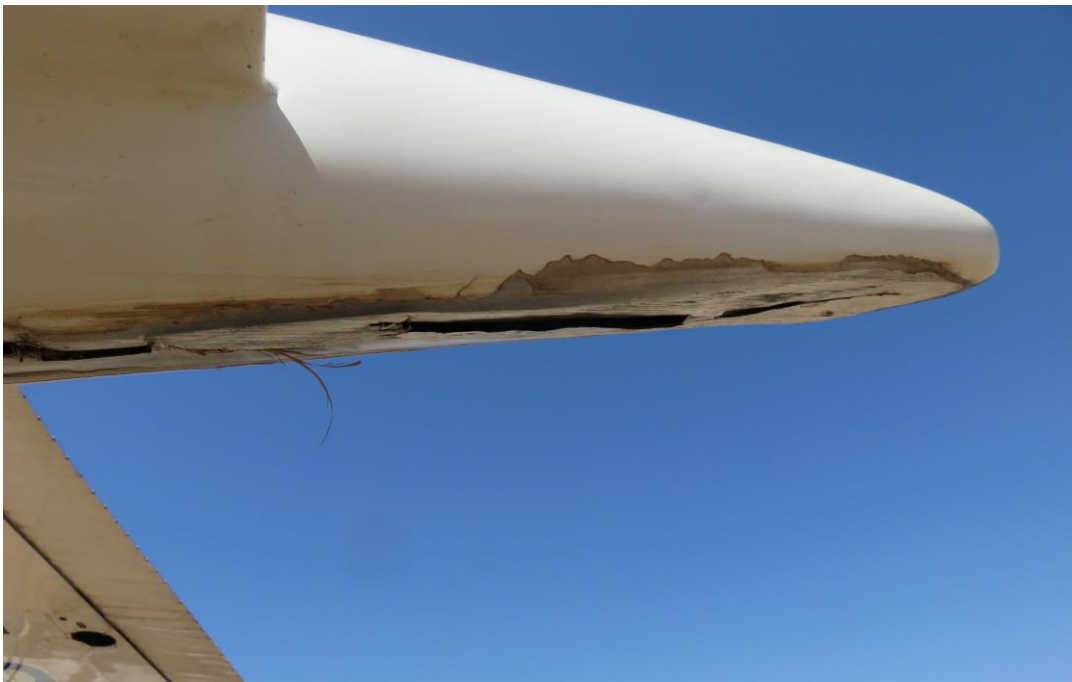
Figure 4: Damage to the lower right-wing tip tank as it scraped along the runway surface.

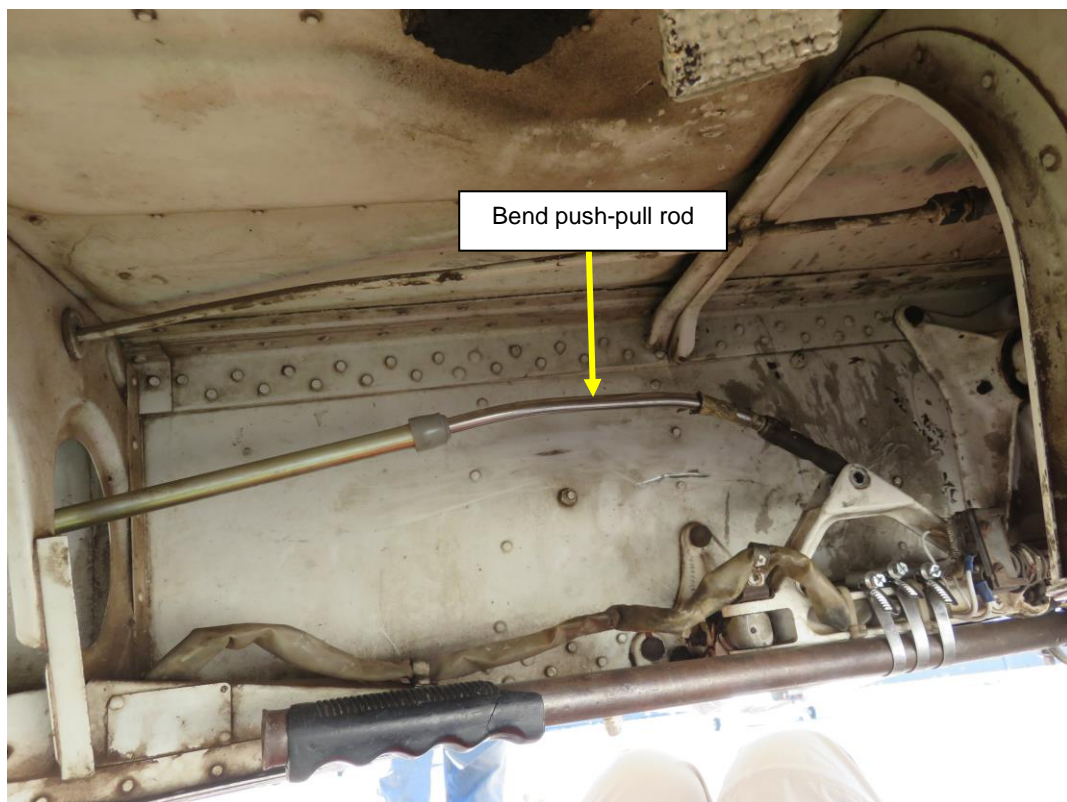
The investigator had conducted an inspection of the aircraft after it was recovered. The landing gear system was visually inspected in the presence of an aircraft maintenance engineer (AME) who was rated on the aircraft type. It was not possible to perform a retraction test. It was found that the push-pull rod on the right main gear (see Figure 5) displayed evidence of substantial bending associated with lateral forces being applied on the aircraft during the landing roll. This was supported by the statement of the commercial pilot that she had to make several rudder inputs during the landing roll to remain on runway centreline due to a strong crosswind from the left of the aircraft. The left main gear push-pull rod also displayed evidence of bending but to a much lesser extent in comparison to the right side (see Figure 6). The left main gear, however, did not collapse (remained in the extended position).

Figure 5: Substantial bending visible to the right main gear push-pull rod.

- 3.10 The right main landing gear collapsed during the landing roll, resulting in the aircraft veering off to the right of the runway.
- 3.11 The right main gear push-pull rod displayed substantial deformation (bending) after the accident. Bending on the left main gear push-pull rod was also observed, but not to the same extent as on the right side.

- 4.1 The right main gear push-pull rod was unable to withstand the lateral forces that were applied to it during the landing roll. This caused the push-pull rod to bend to an extent that it was not possible to support the right main gear, and the gear subsequently collapsed.

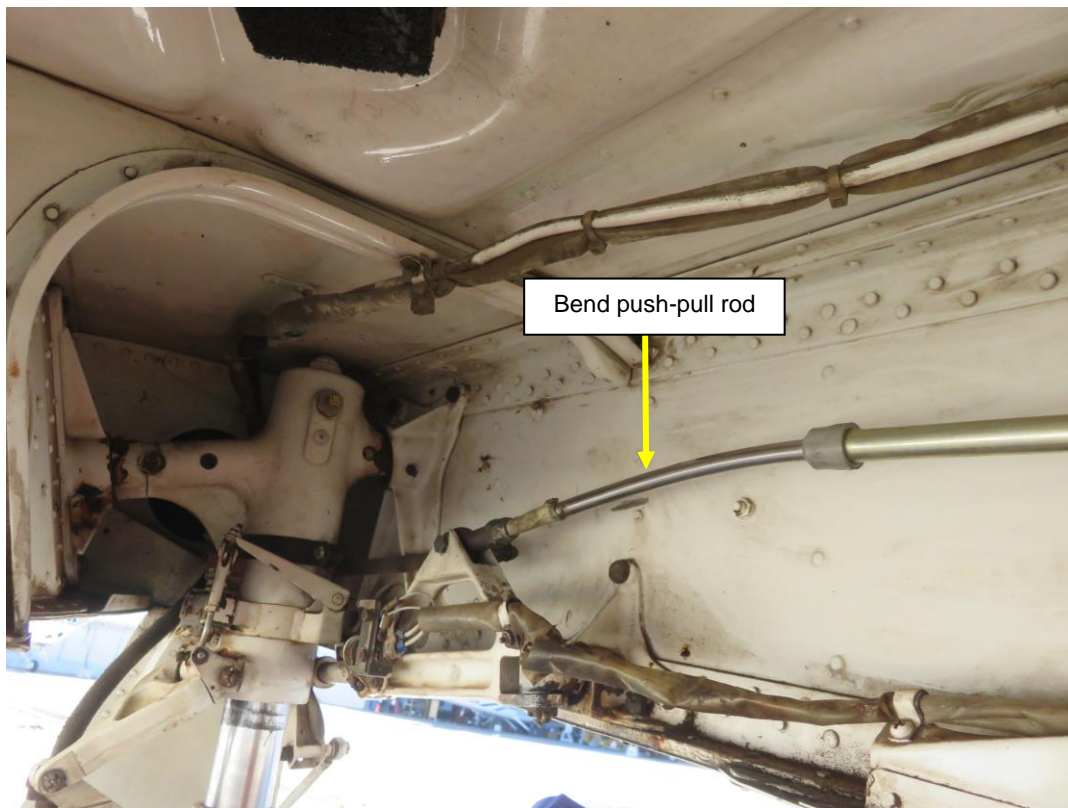
Figure 5). The push-pull rod on the right main gear also displayed evidence of bending (see Figure 6).

Figure 6: The left main gear push-pull rod also displayed evidence of bending.
