AIRCRAFT ACCIDENT SHORT REPORT

CA18/2/3/9924: Engine stoppage during descent, followed by an unsuccessful forced landing in an open field close to Paradise Beach Aerodrome.

Aircraft registration : ZU-IIJ

Aircraft manufacturer and model : Zenith Aircraft Company, Zenith CH650B

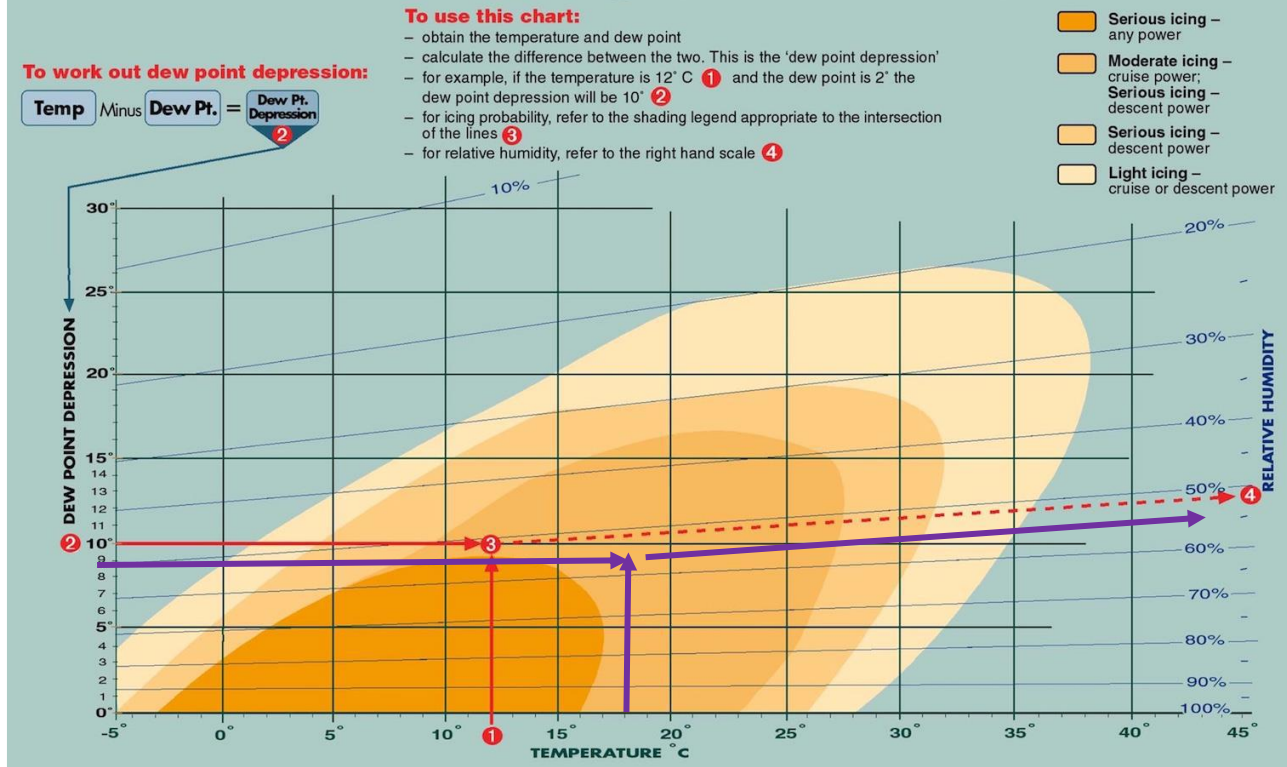
Figure 2: The carburettor icing chart showing a calculated icing probability in the FAPI area.

1.1.8 According to the chart (Figure 2), the relative humidity in the area around FAPI was at approximately 52% with the temperature of 18°C, and dew point depreciation of 9°C, the result will be a moderate icing condition at cruise power with serious icing on descent.

- 6.1 **Safety message:** In the interest of safety for operators of similar type aircraft, careful attention must be taken in weather conditions likely to cause carburettor icing during cruise or descent.

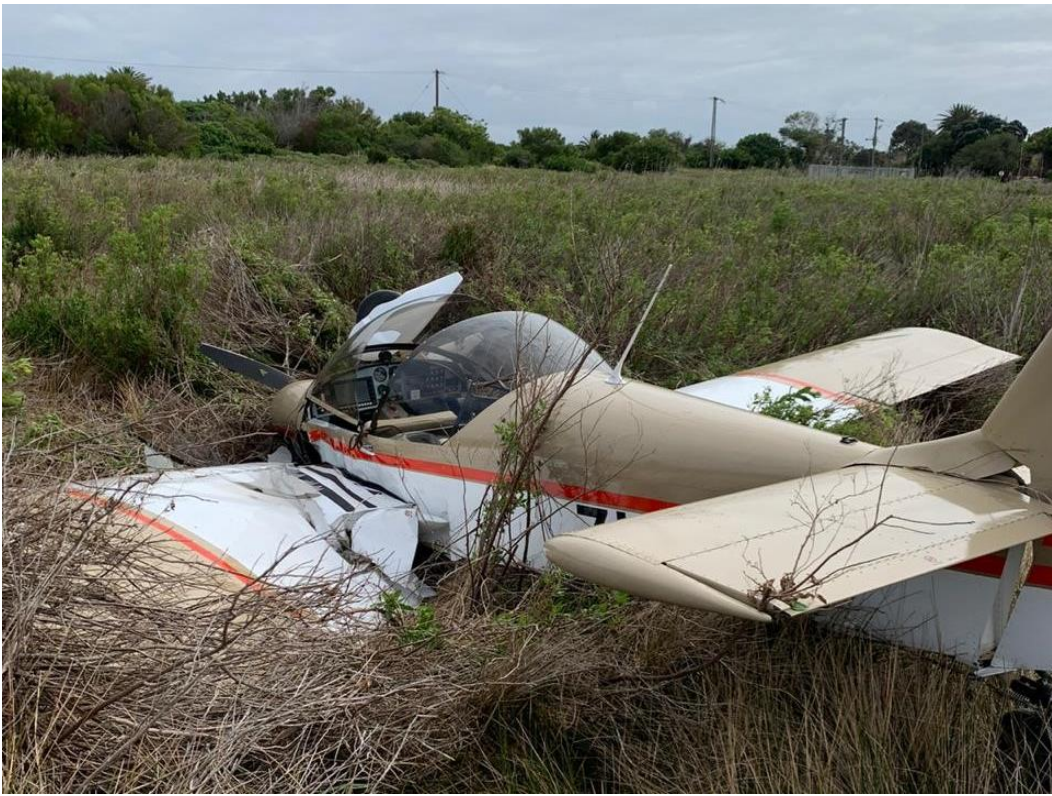
The pilot executed a forced landing and touched down on dense vegetation (fynbos). The aircraft came to rest in an upright position, approximately 325 metres (m) short of the threshold of Runway 26 at FAPX. The one propeller blade fractured on impact. The main landing gear broke off and the left wing was severely deformed. The cockpit/cabin area remained intact. The aft fuselage and empennage sustained minor damage.

Figure 3: The aircraft came to rest in an upright position. (Source: Pilot)

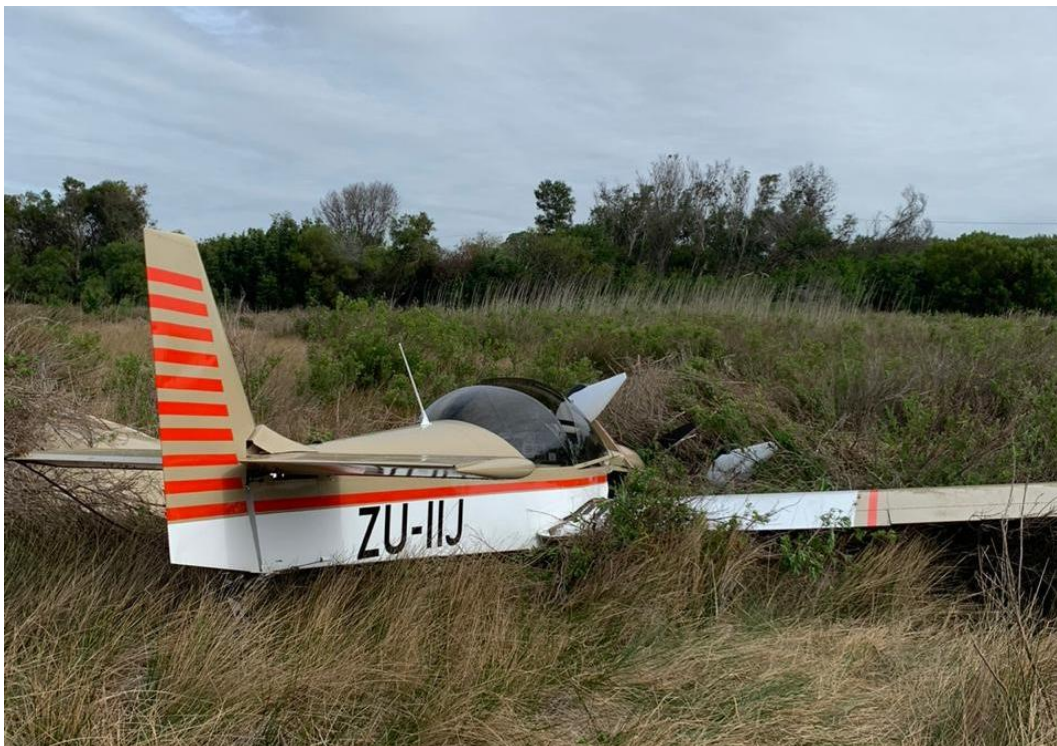
Figure 4: The aircraft at the accident site. (Source: Pilot)

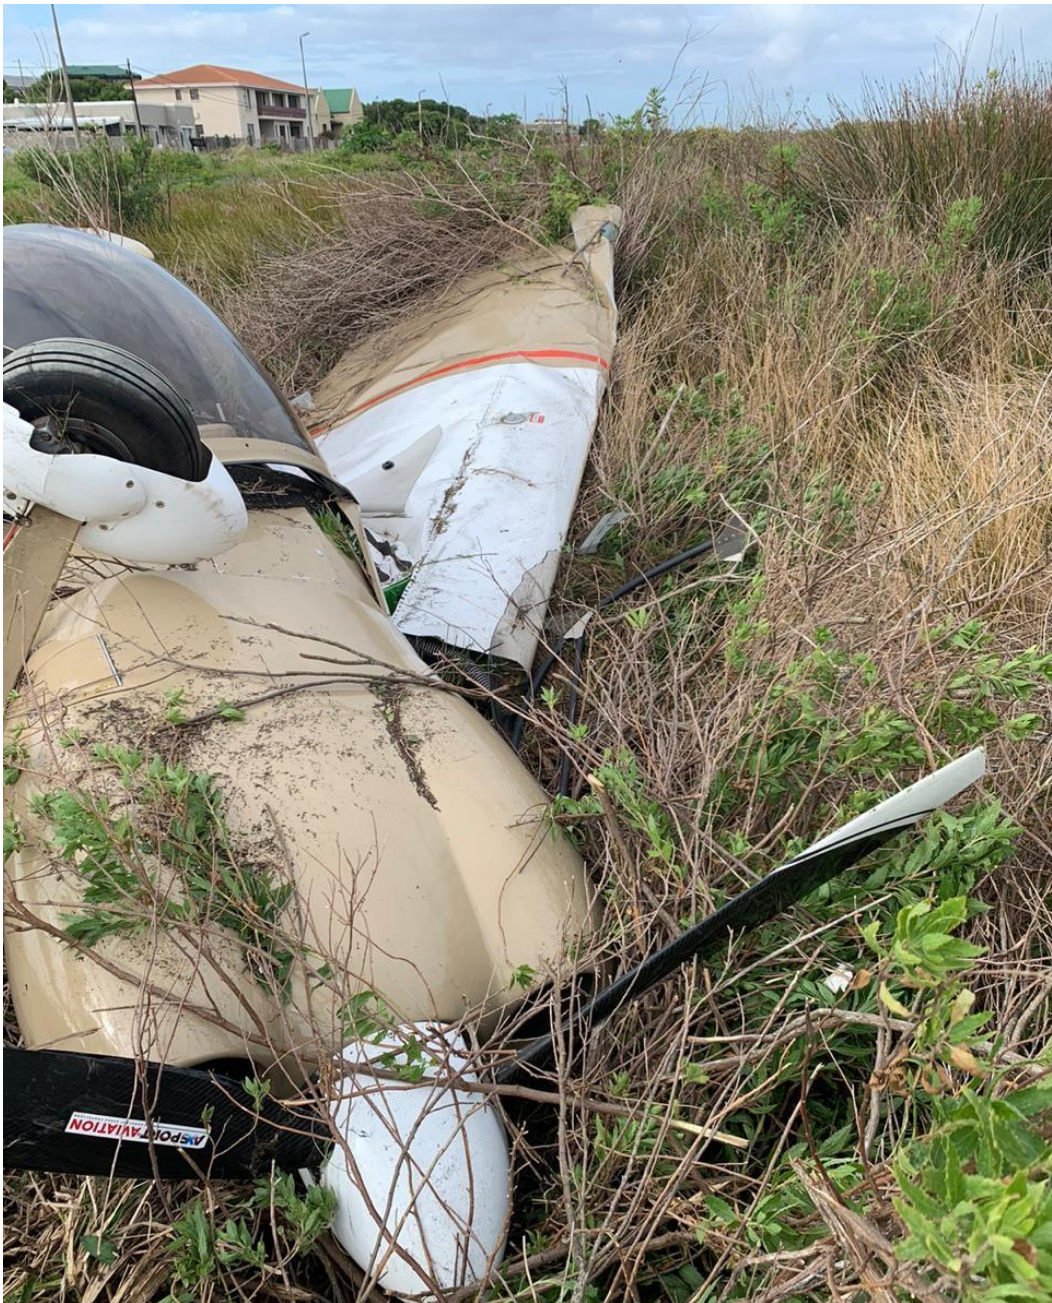
Figure 5: The dense vegetation on which the aircraft was force-landed. (Source: Pilot)

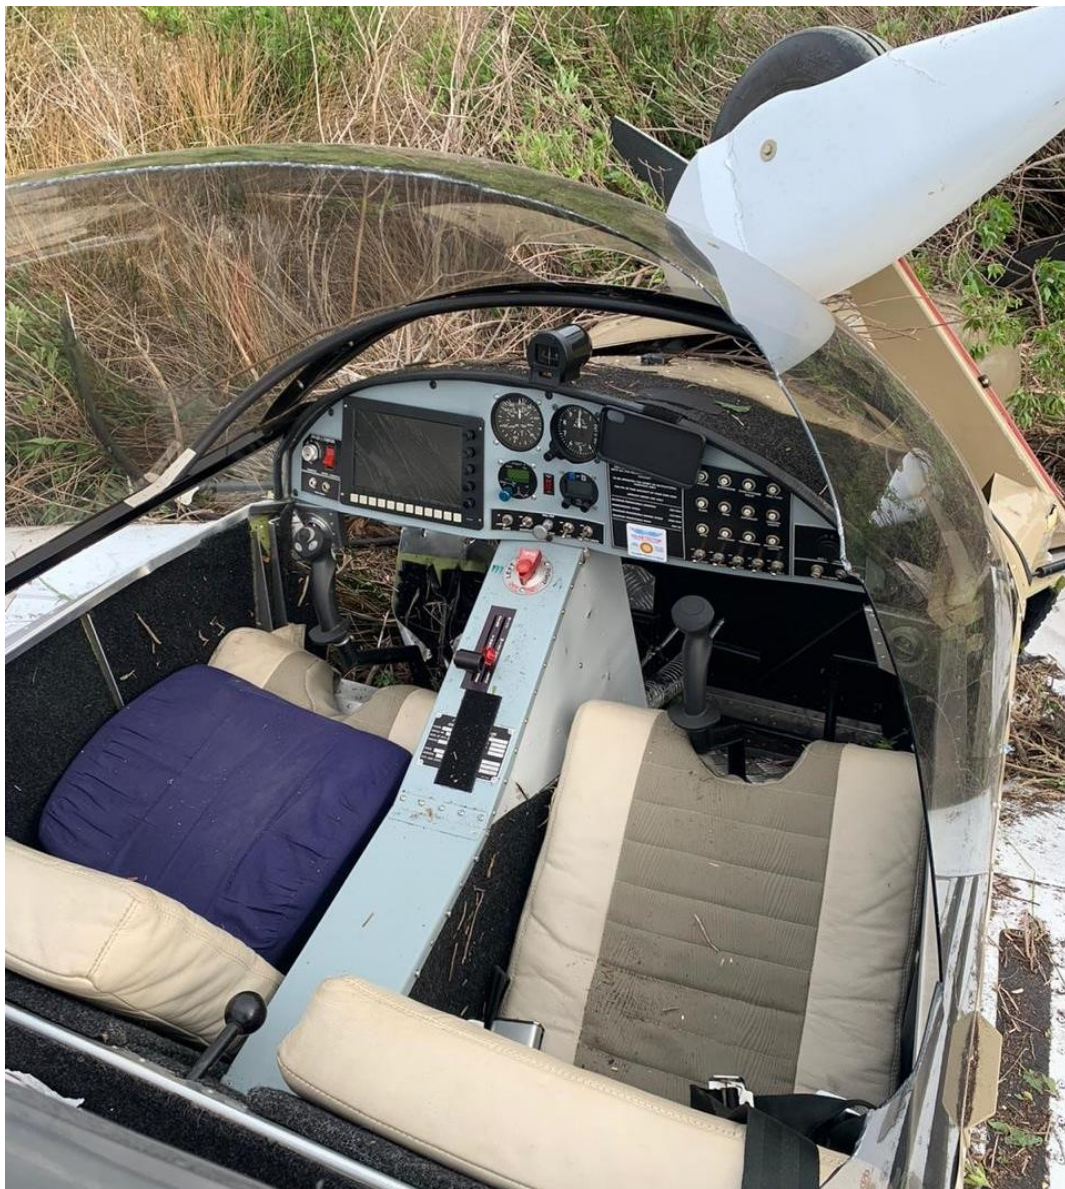
Figure 6: A view of the cockpit that remained fairly intact. (Source: Pilot)

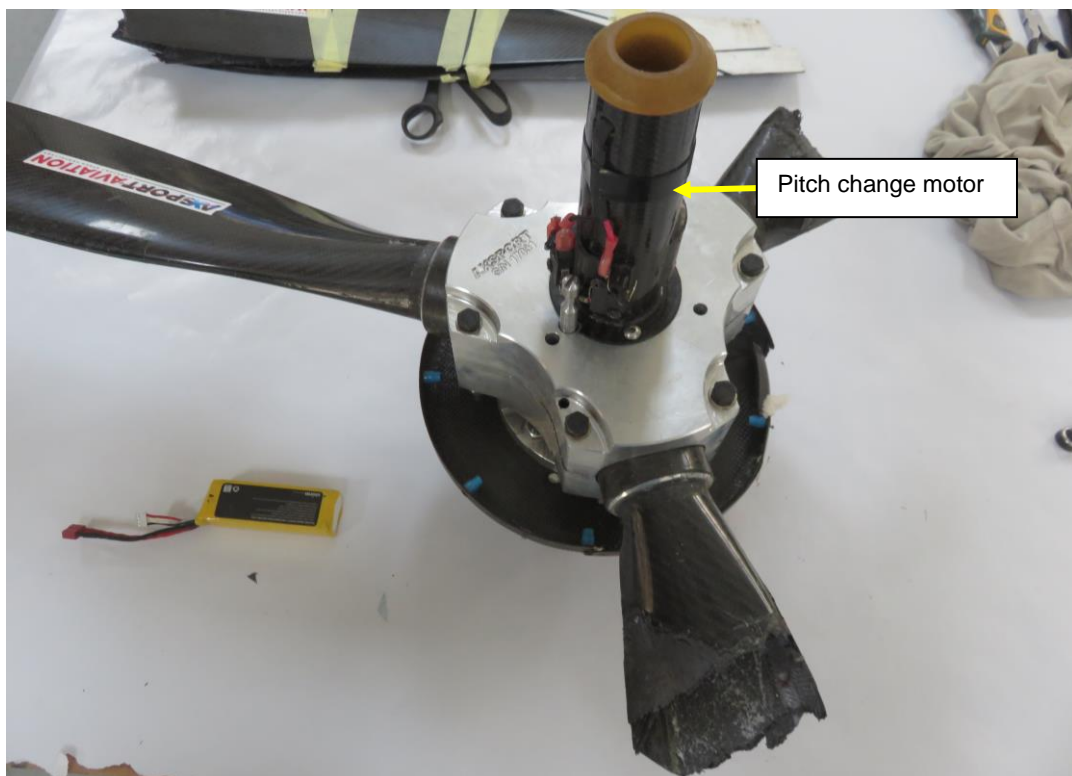
Figure 8: The propeller assembly as it was received, with no damage to the hub.

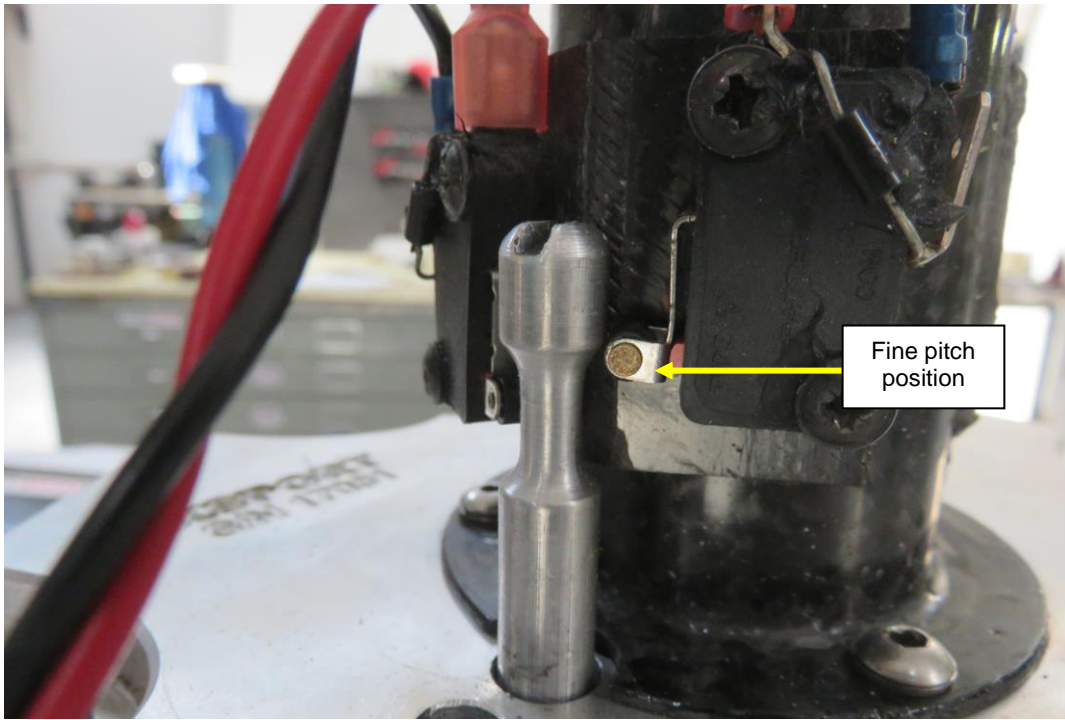
Figure 9: All three propeller blades were in fine position as indicated in the image.

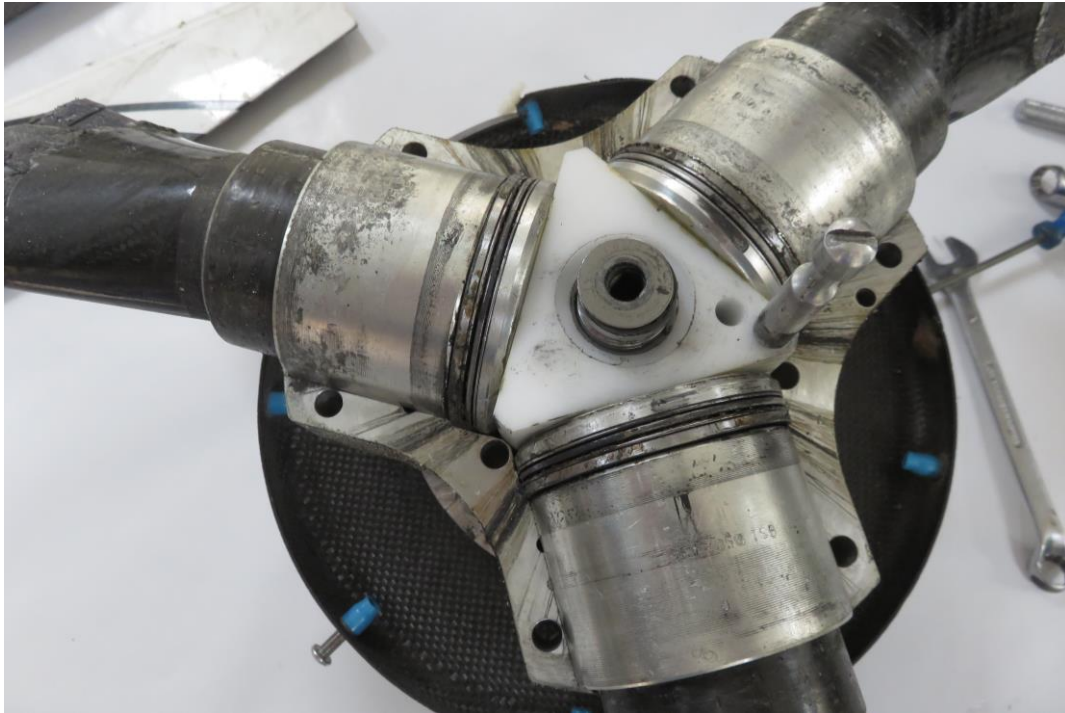
Figure 10: All three propeller blade ferrules were found to be in position.

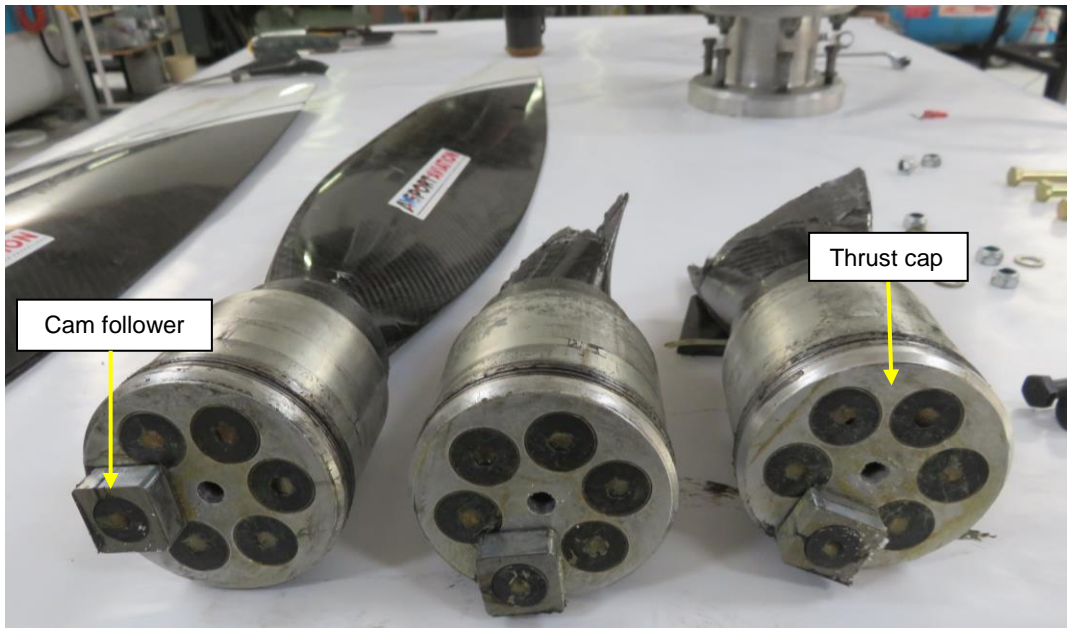
Figure 11: The cam followers and thrust caps of all three propeller blades were secured.

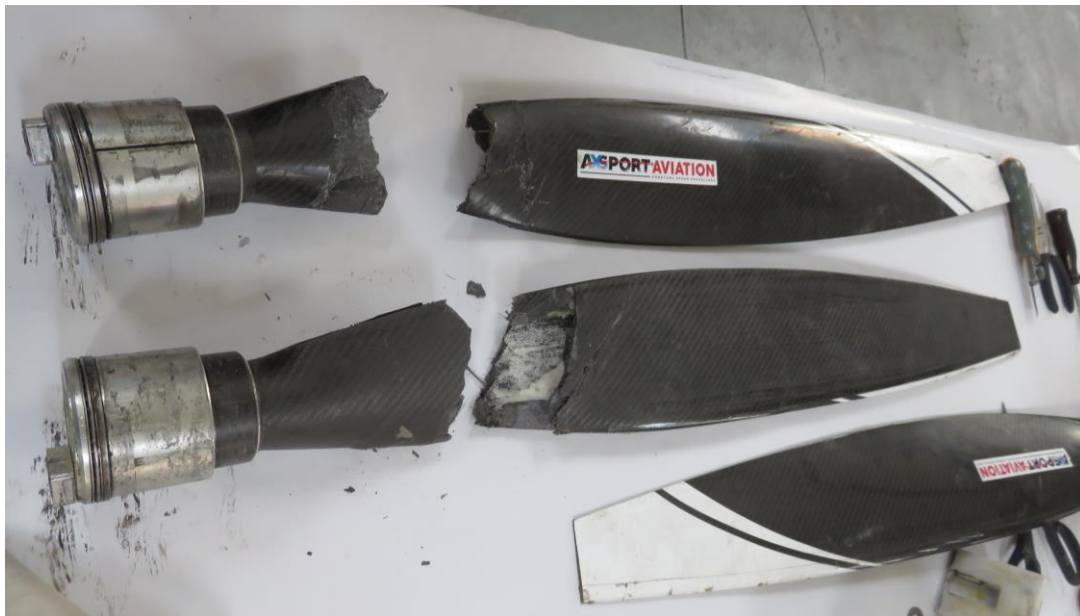
Figure 12: The two blades that fractured during impact.

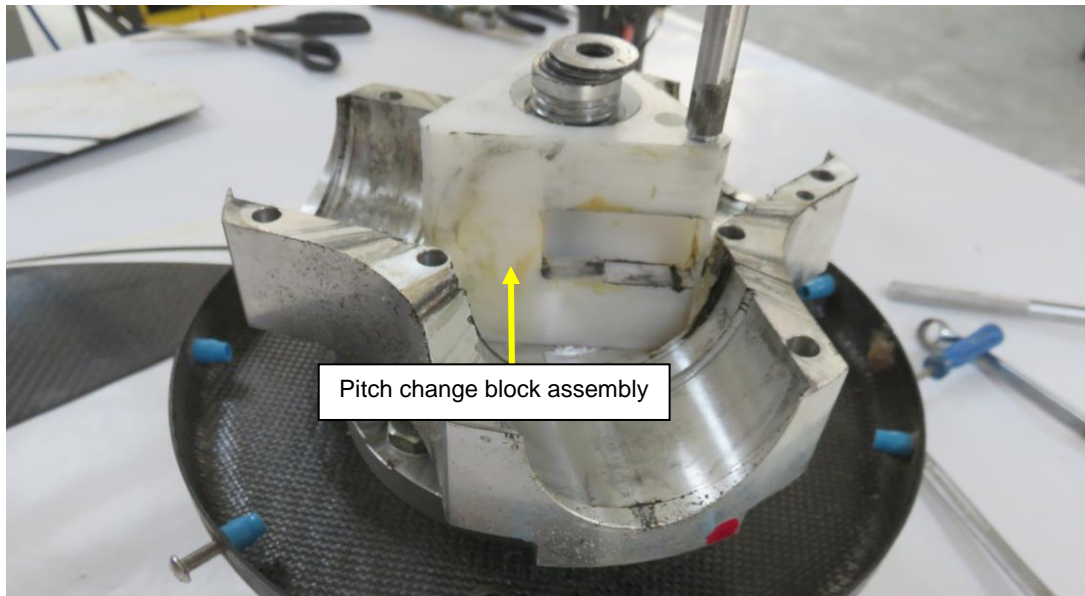
Figure 13: The pitch change block assembly was found to be intact.

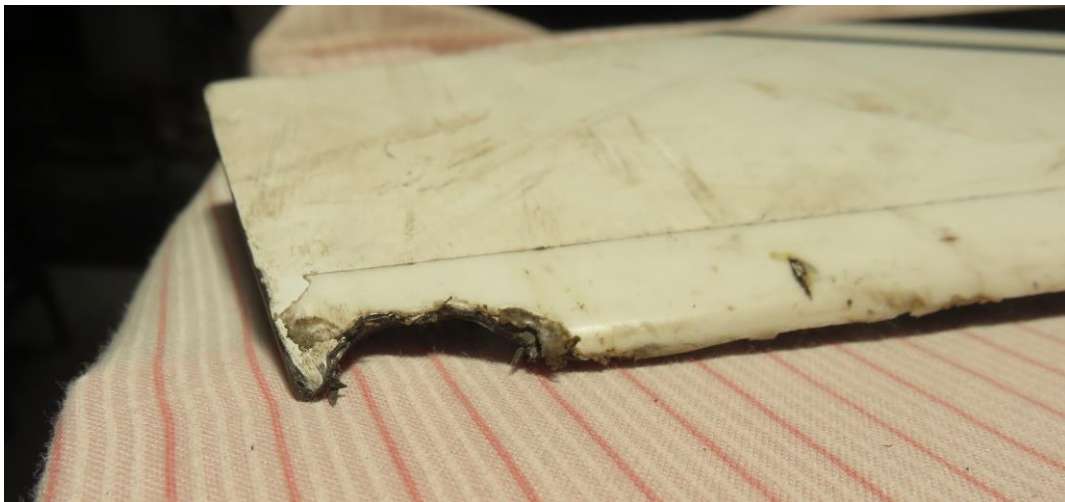
One of the propeller blades displayed evidence of damage on the leading-edge tip area. The dimensions were as follows: length, 18 millimetres (mm); and width, 4mm (see Figures 14 and 15). It could not be determined when this damage was caused.

Figure 14: The one blade presented damage on the leading tip.

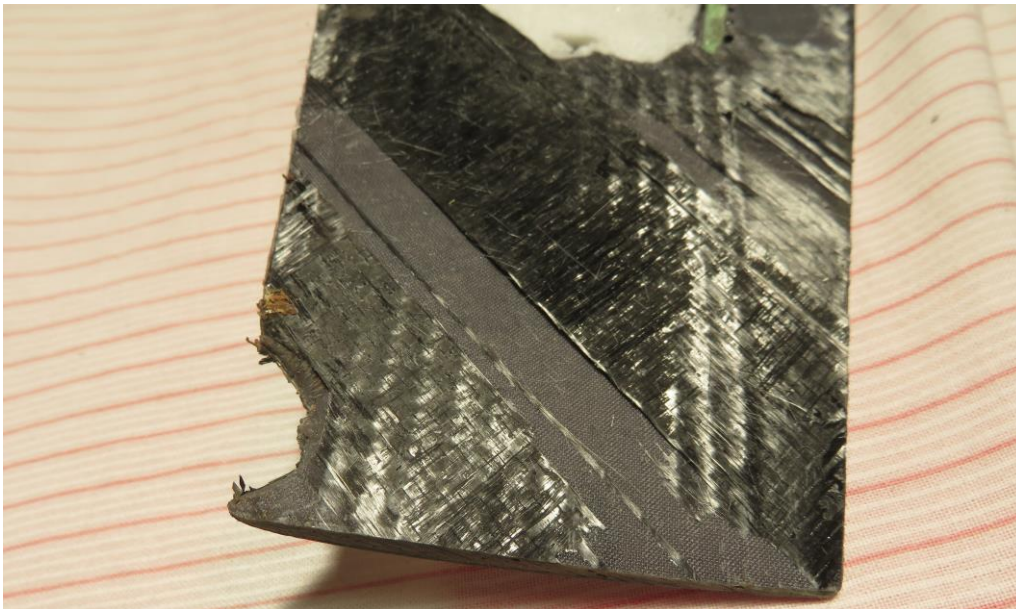
Figure 15: The blade was split in half in order to take this photograph.
