AIRCRAFT ACCIDENT REPORT AND EXECUTIVE SUMMARY

Reference:		CA18/2/3/9926	
Aircraft Registration	ZS-MAD	Date of Accident	31 October 2020		Time of Accident	0429Z	
Type of Aircraft	Piper Pawnee PA-25-235D		Type of Operation		Agriculture (Part 137)		
Pilot-in-command Licence Type	Commercial Pilot Licence (CPL)		Age	51	Licence Valid	Yes	
Pilot-in-command Flying Experience	Total Flying Hours		4128.29		Hours on Type	Unknown	
Last Point of Departure	Private airstrip, Kirkwood, Eastern Cape Province						
Next Point of Intended Landing	Jacaranda farm, Kirkwood, Eastern Cape Province						
Damage to Aircraft (Substantial/Destroyed)	Destroyed						
Location of the accident site with reference to easily defined geographical points (GPS readings if possible)							
Jacaranda farm at Global Positioning System (GPS) co-ordinates determined to be 33°25'09.4" South 025°27'58.7" East and at an elevation of 330 feet (ft)							
Meteorological Information	Wind direction: 230°, Wind speed: 5kt, Temperature: 14°C, Dew Point: 11°C, Cloud Cover: CAVOK, Cloud Base: 4800ft, Visibility: 9999m, QNH: 1028hPa

Reference Number : CA18/2/3/9926
Name of Owner/Operator : SHEASBY AVIATION
Manufacturer : Piper Aircr

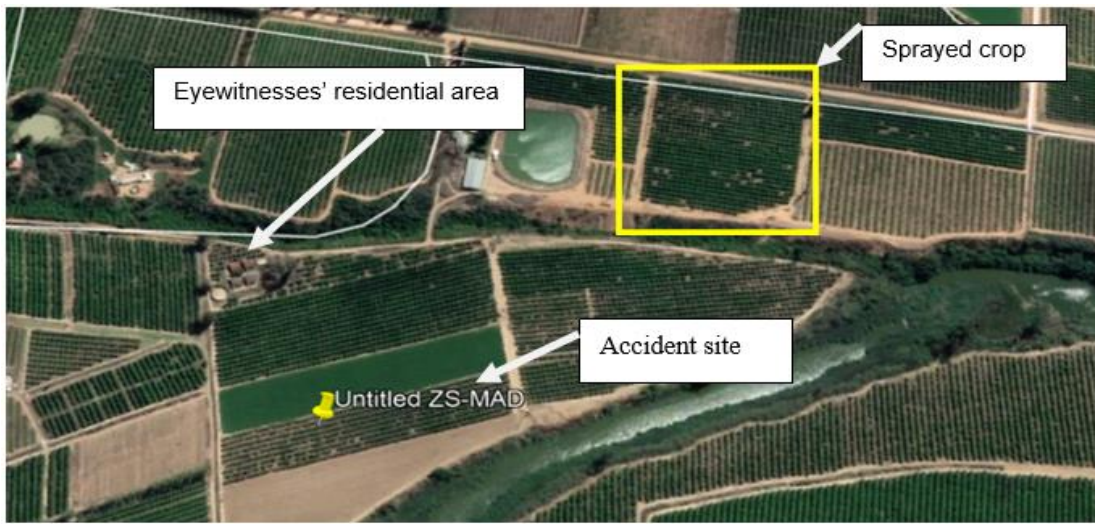
- 1.1.3 Approximately 30 minutes into the operation and after the second spray application run, the aircraft turned right to reposition for the third application run. A witness who is a resident at the farm and was, at the time, inside her house, stated that the aircraft flew over her house twice and, during the third turn, the aircraft sounded like it was flying at a low height. A few seconds later, she heard a loud bang. She quickly went outside to investigate. This was when she saw a cloud of black smoke coming from the east side of her house (the accident site). A second witness who was working on the farm stated that she saw the aircraft making a right turn at a low height of approximately 50ft. Thereafter, the aircraft's right-side wing suddenly collided with a tall tree, which was approximately 50ft. She then saw debris from the aircraft falling as the aircraft went down in a nose-down attitude. Moments later, she saw a cloud of smoke coming from the direction of the accident site. Following impact with the tree, the aircraft impacted terrain (this was out of sight of witnesses). Both witnesses stated that they had rushed to the site of the accident and, on arrival, found the aircraft engulfed in flames. They could not rescue the pilot due to the intensity of the flames. They then called the owner of the farm who contacted the Aircraft Rescue and Fire-fighting (ARFF) team. Witnesses described the local weather conditions at the time of accident as fine with no wind at ground level.

Figure 1: The accident site and the sprayed crop section. (Source: Google Earth)

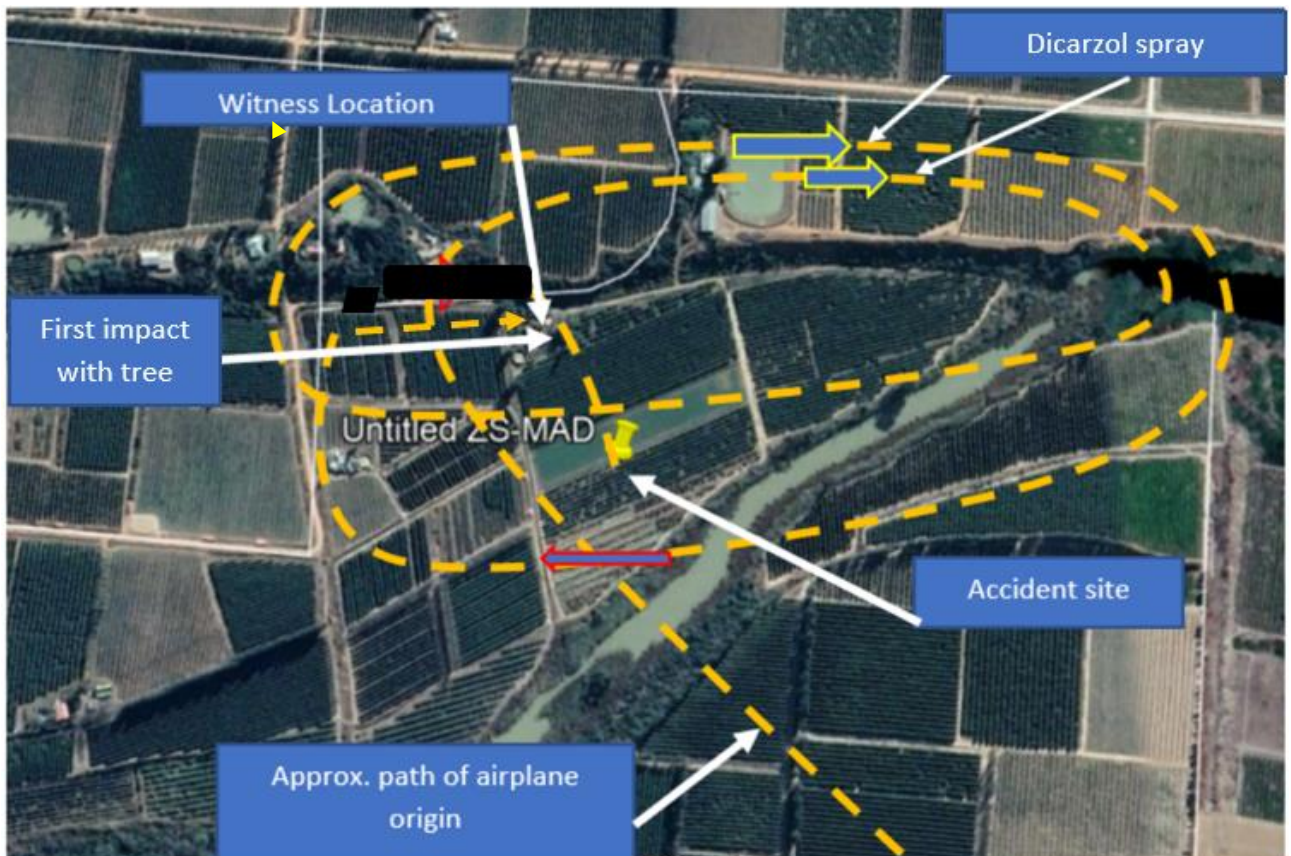
Figure 2: Flight path and accident/witness location. (Source: Google Earth)

2.2.2 A probability exists that as the pilot was operating at a height of approximately 50ft and during a right turn to reposition for the third spray run, he misjudged the aircraft's proximity to the trees he was flying over, resulting in a collision with one of the trees and the subsequent loss of control before crashing. The challenges or contributing factors to this accident are that his aircraft was a low-wing, which made it difficult to see objects under the wing (blind spot); and even if he could have seen that there was a tree, it would have been difficult to judge the height of a tree from the sky: *all trees seem to have the same height from the sky*. The other challenge was the fact that as he was making the steep right turn, he was also to make a descent to approximately 50ft to begin spraying. Fifty feet is the approximated height of the tree (that he collided with) and, as the aircraft was travelling at high speed, it was not easy to initiate an evasive manoeuvre (see Figure 2).

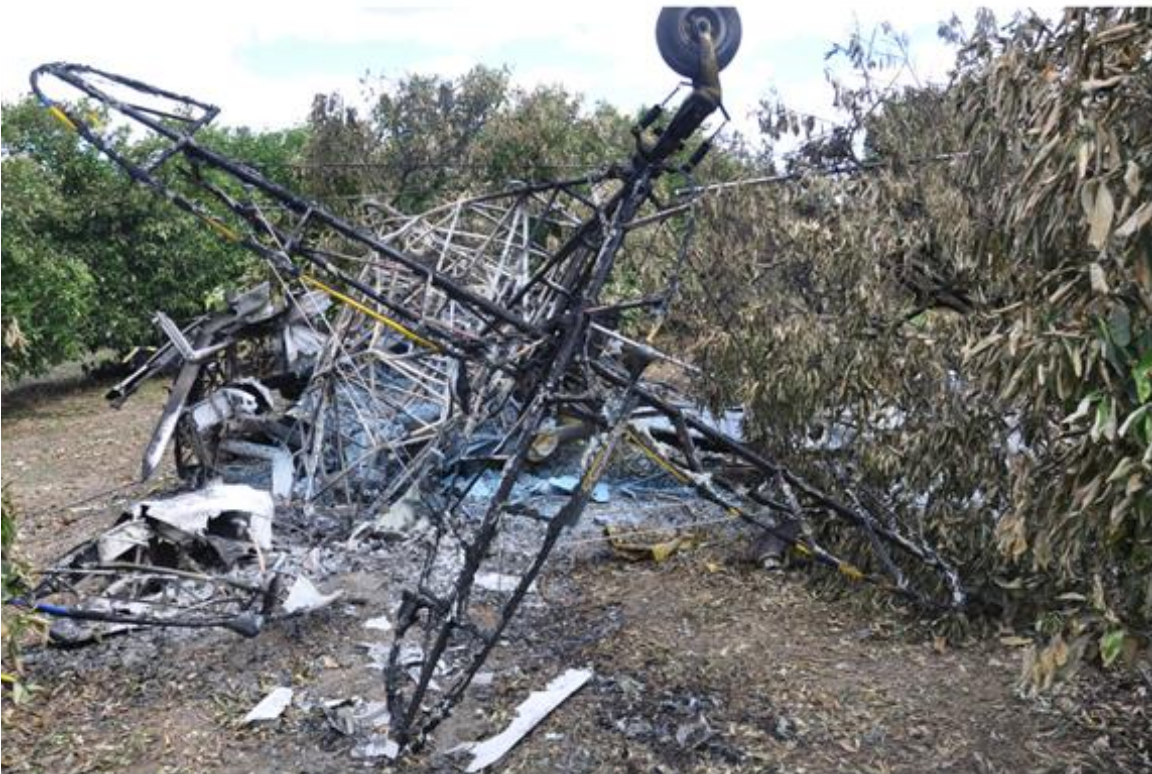
1.3.1 The aircraft was destroyed by impact and a post-impact fire that ensued.

Figure 3: The burnt wreckage post-accident.

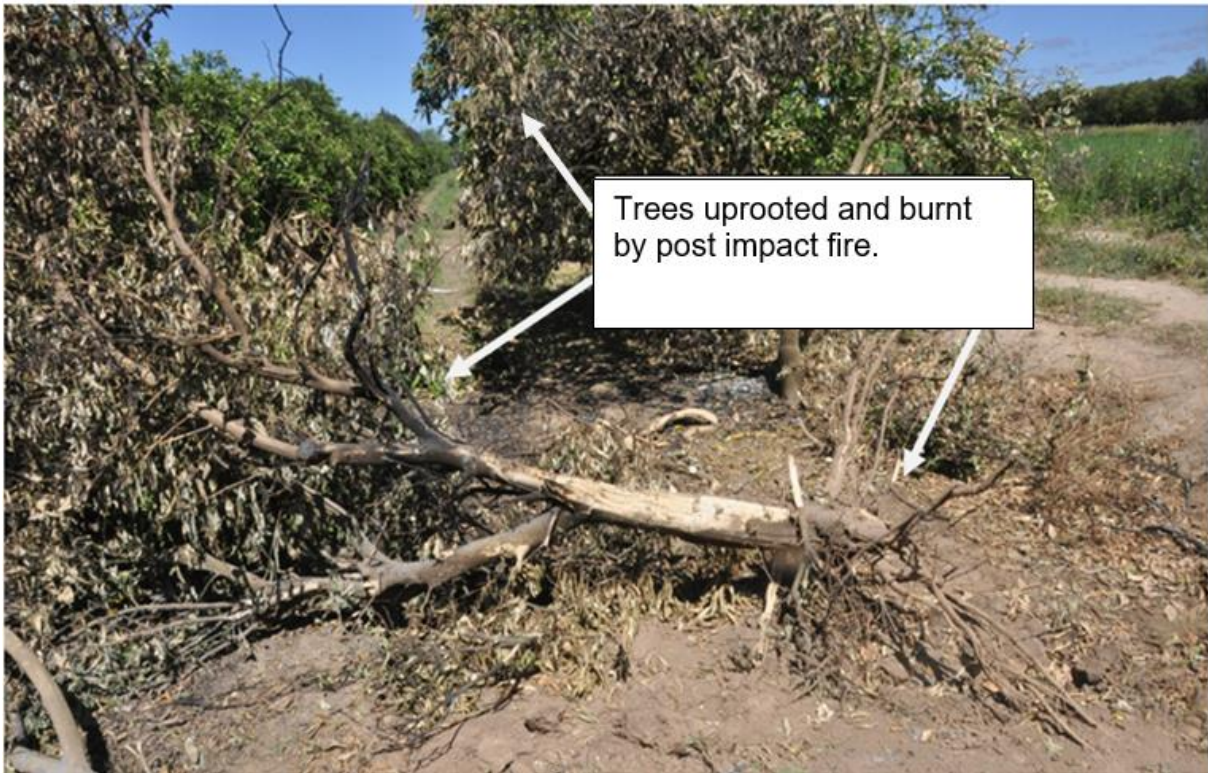
1.4.1. Some lemon trees were uprooted after the aircraft impacted the ground and were also torched by post-impact fire.

Figure 4: Uprooted and burnt trees.

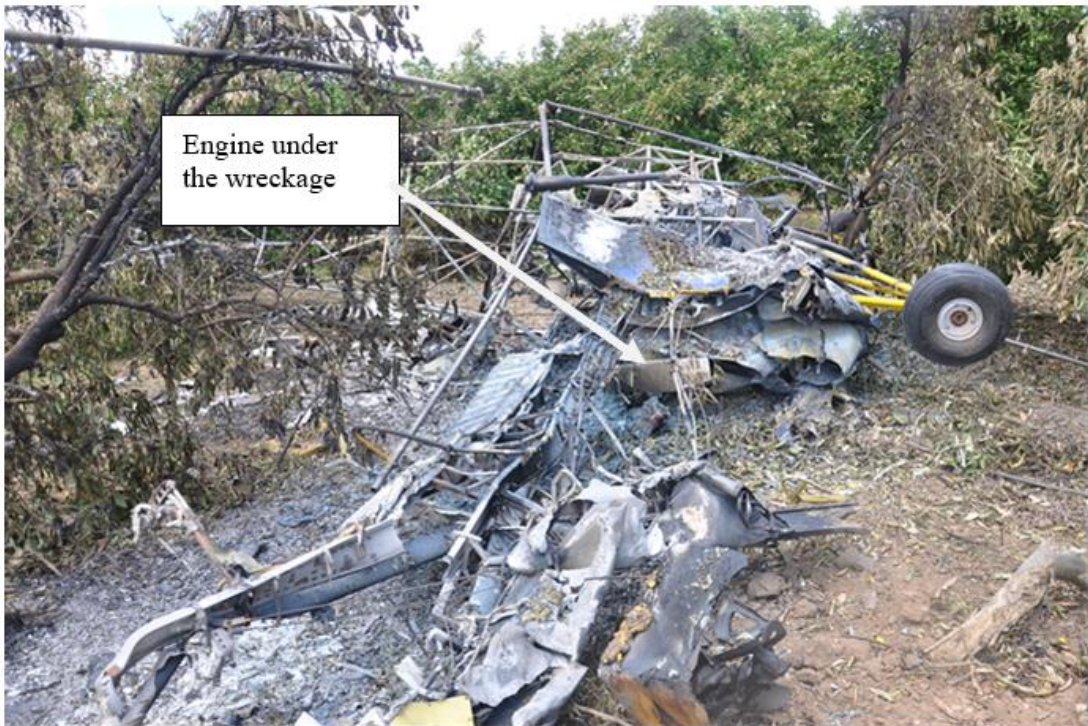
1.12.1 On the third spray pattern, the pilot misjudged the tree height and impacted a tree that was approximately 50ft high which caused the right-side wing to bend downward. The aircraft continued in a nose-dive attitude and collided with the lemon trees of an approximate height of 7ft.

Figure 6: The engine under the front part of the wreckage.

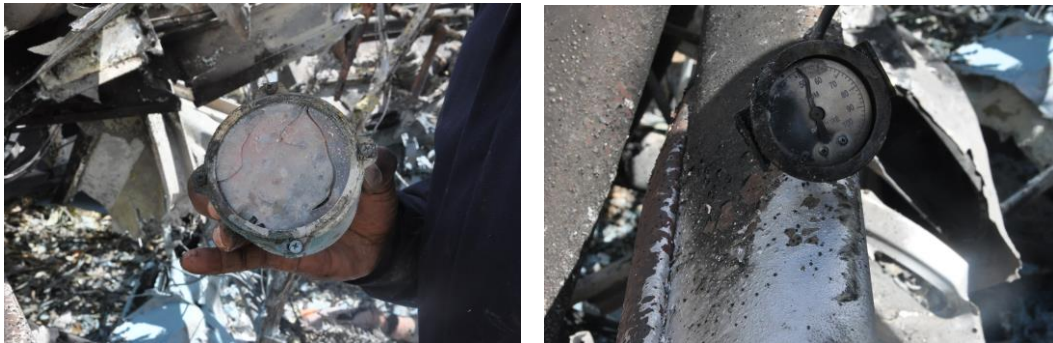
1.12.2 The instruments panel was destroyed by post-impact fire.

Figures 7 & 8: Damaged instruments.

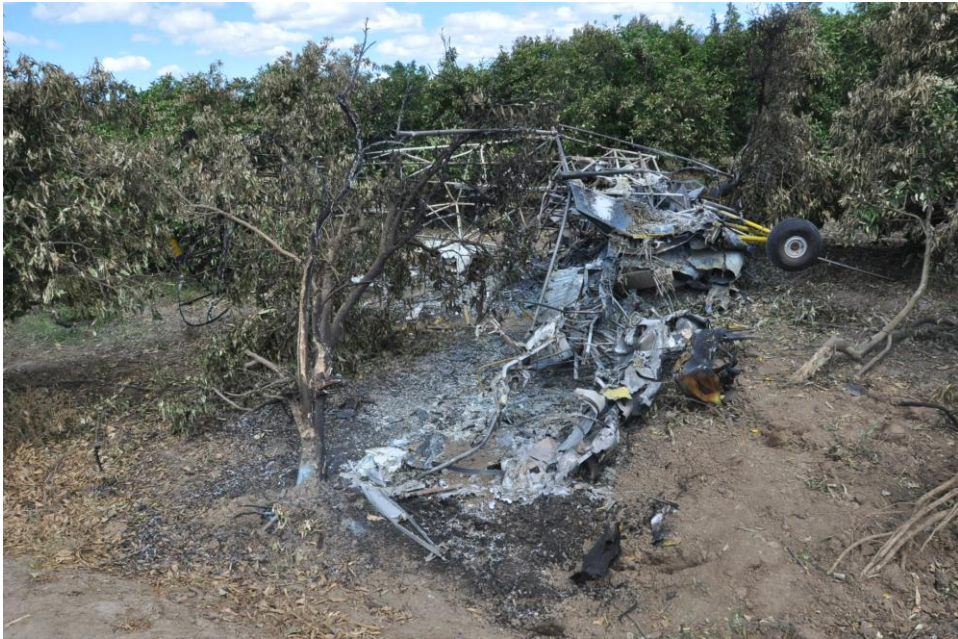
1.12.3 The aircraft was made of fibre cloth, which was destroyed by post-impact fire.

Figure 9: Wreckage at the scene of the accident.

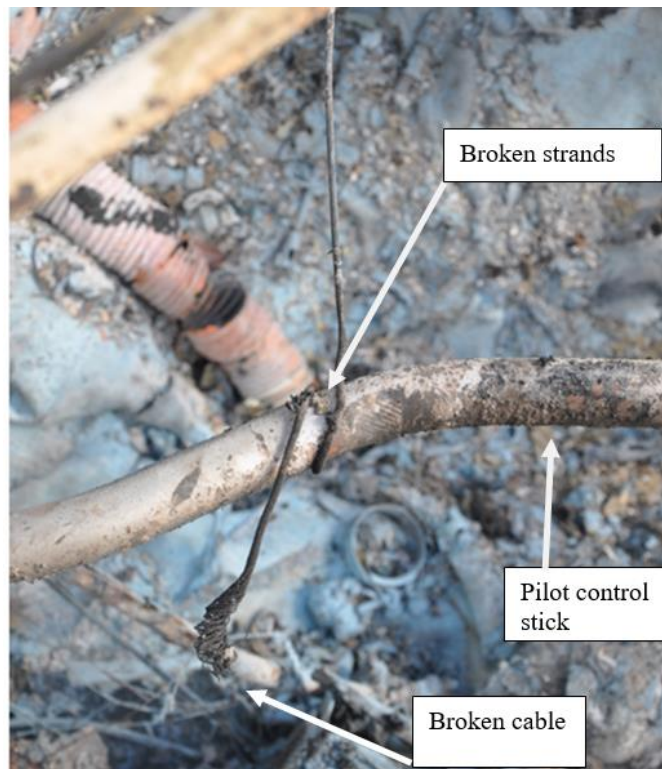
1.12.4 The on-site investigation found the following: the right rudder cable had broken strands approximately four inches adjacent to the pilot seat. The same rudder cable was wrapped around the pilot's control stick and end points attached normally. Pulleys could not be checked for serviceability due to fire damage. The left-side rudder cable was still connected, and continuity was confirmed to the front connection.

Figure 10: Damaged rudder cable.

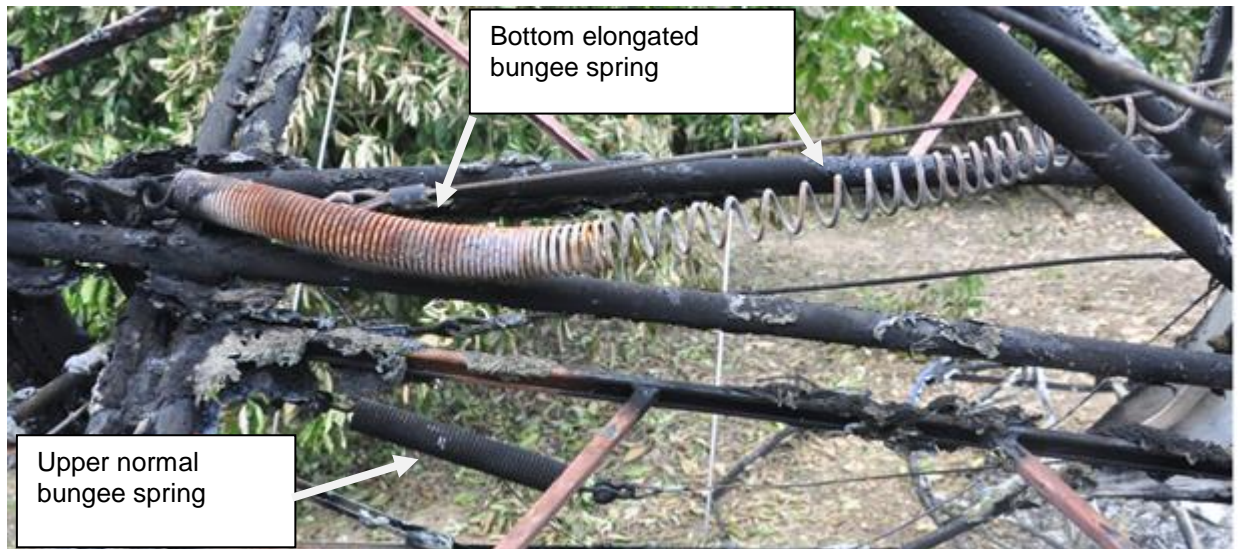
1.12.5 The bottom elevator bungee spring that assists the elevator to stay at the desired angle was elongated; the top one had no anomalies. Continuity on both springs was confirmed to the front connection with no broken strands on the cables, and the elevator frame could be moved up and down.

Figure 11: Elevator bungee spring cables.

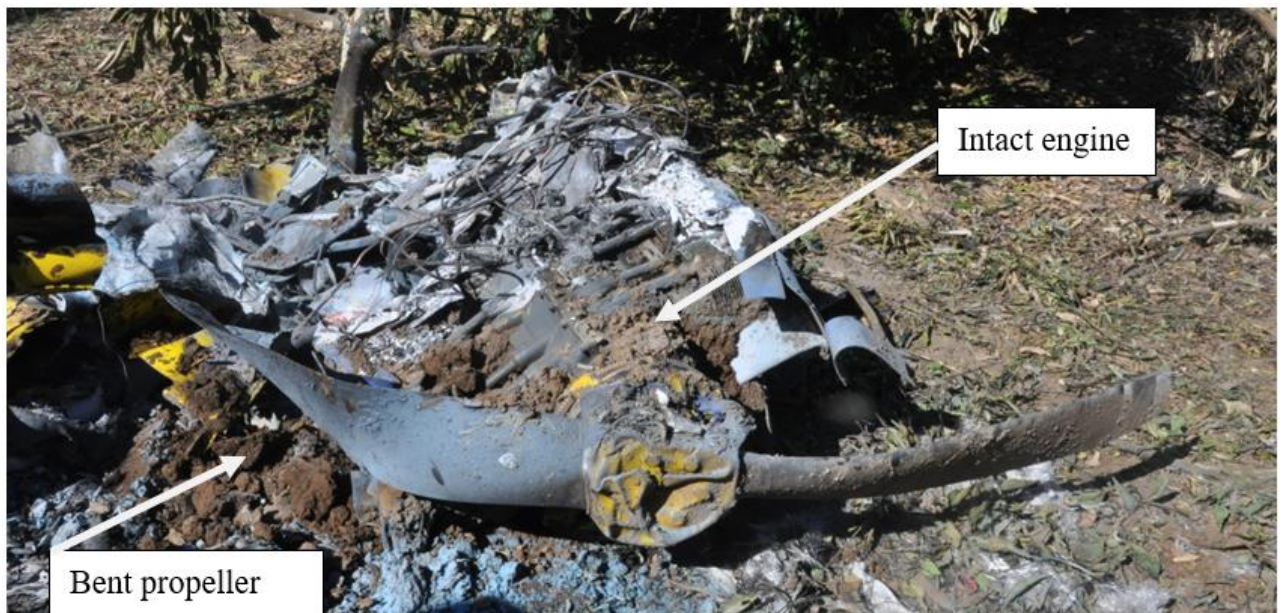
1.12.6 The engine was still intact except for wires that were burnt. The engine could only be turned 90° by hand due to propeller hub damage. One of the propeller blades had a small “S” bent; no other anomalies were detected. The engine fire-extinguisher lever was found in the “OFF” position.

Figure 12: Engine and propeller post-accident indicate that the engine was producing power at time of impact.

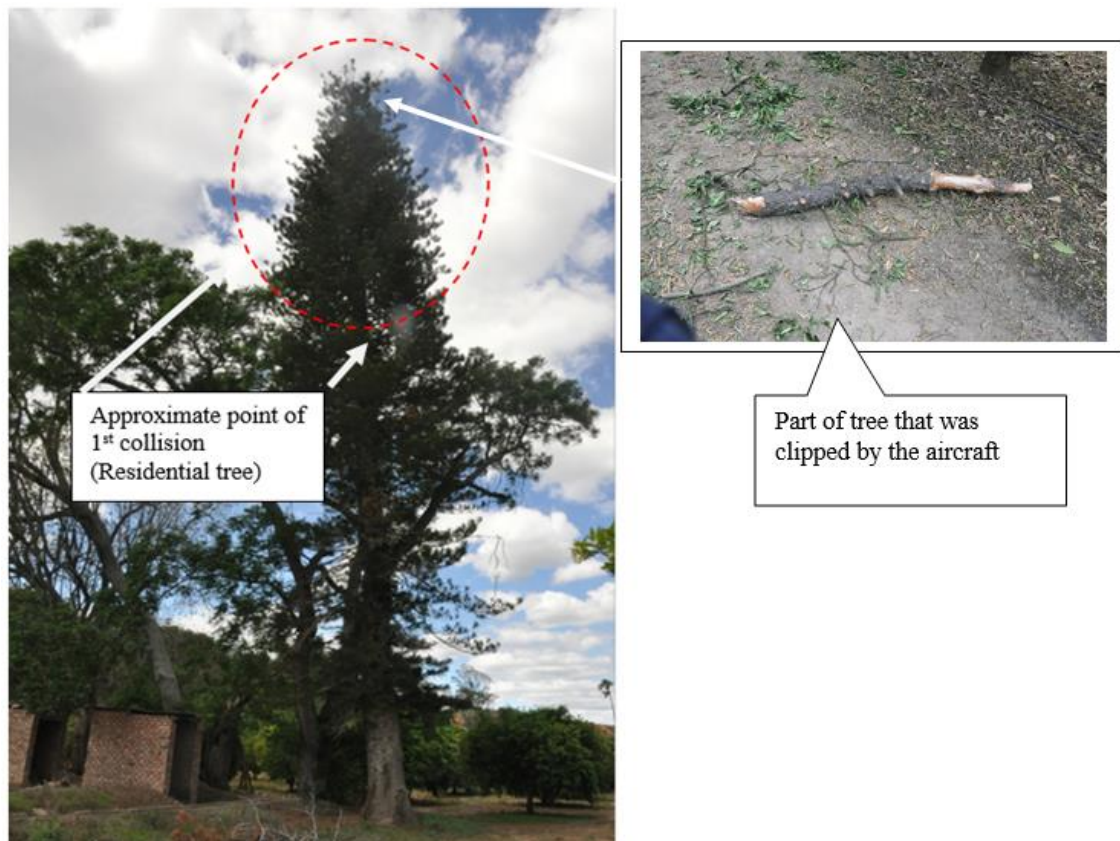
Figure 13: The first tree that the aircraft impacted.

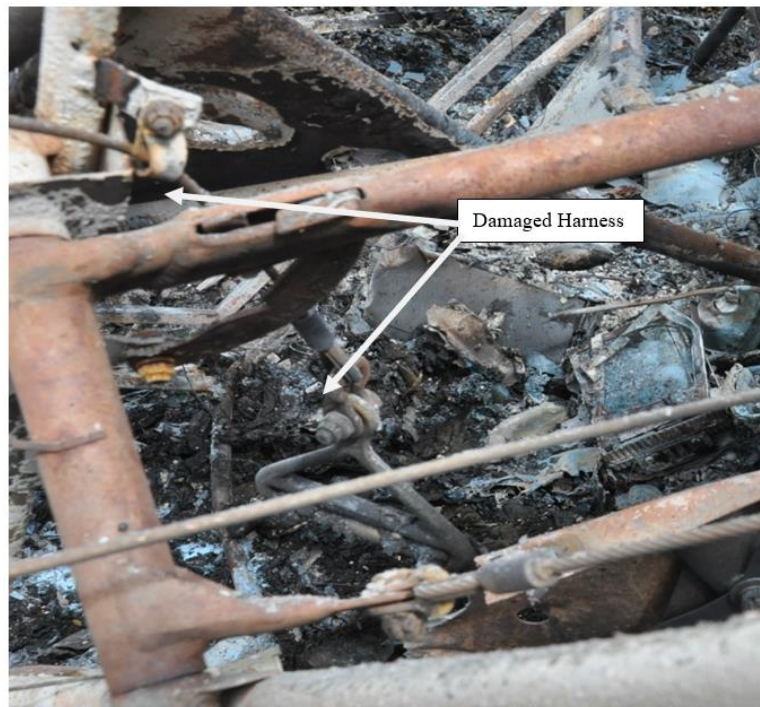
1.15.2 The pilot seemed to have been restrained by a four-point harness. The airframe harness attachment points were intact; however, the post-impact fire had consumed the harness webbing and inertia reel, precluding any further assessment of the restraint system integrity.

Figure 14: The damaged harness in the wreckage.

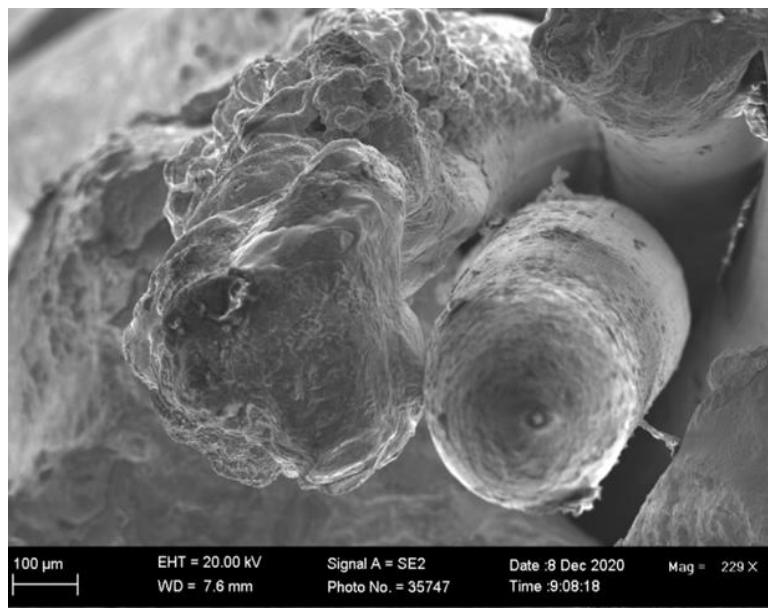
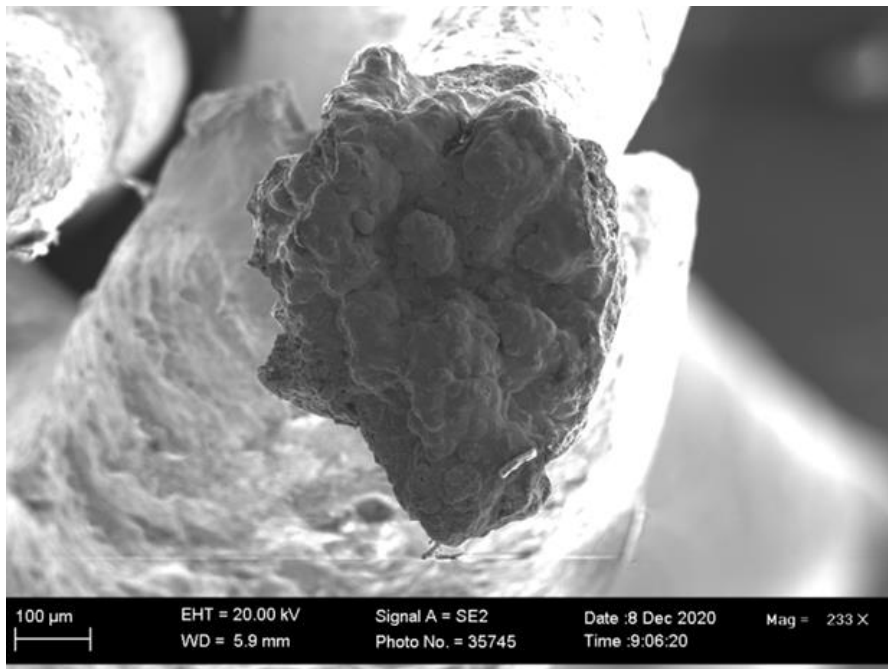
No clear evidence of pre-existing fracture initiation. All damages are impact-related with some temperature induced indications. (photos 1 and 2)

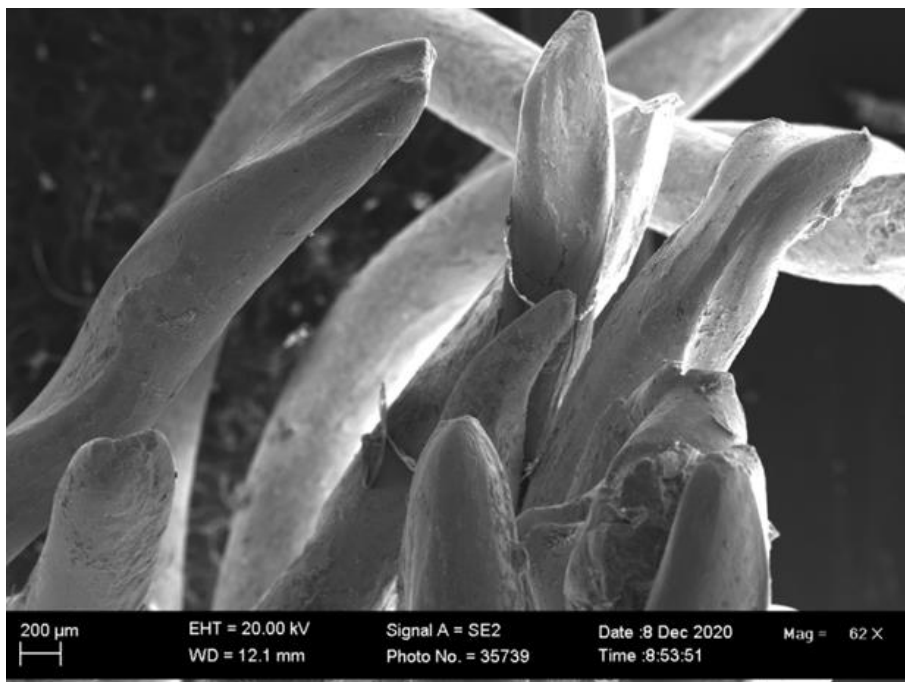
Photo 3

*Right-hand Rudder Control Cable:
No clear evidence of pre-existing fracture initiation. All damages are impact-related with some temperature-induced indications. (Photo 3).*

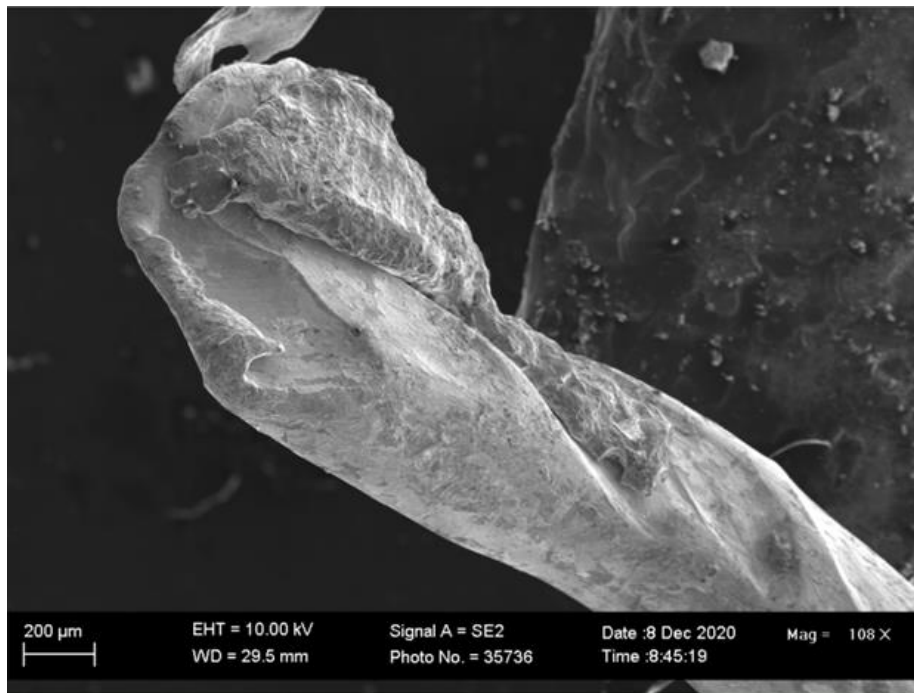
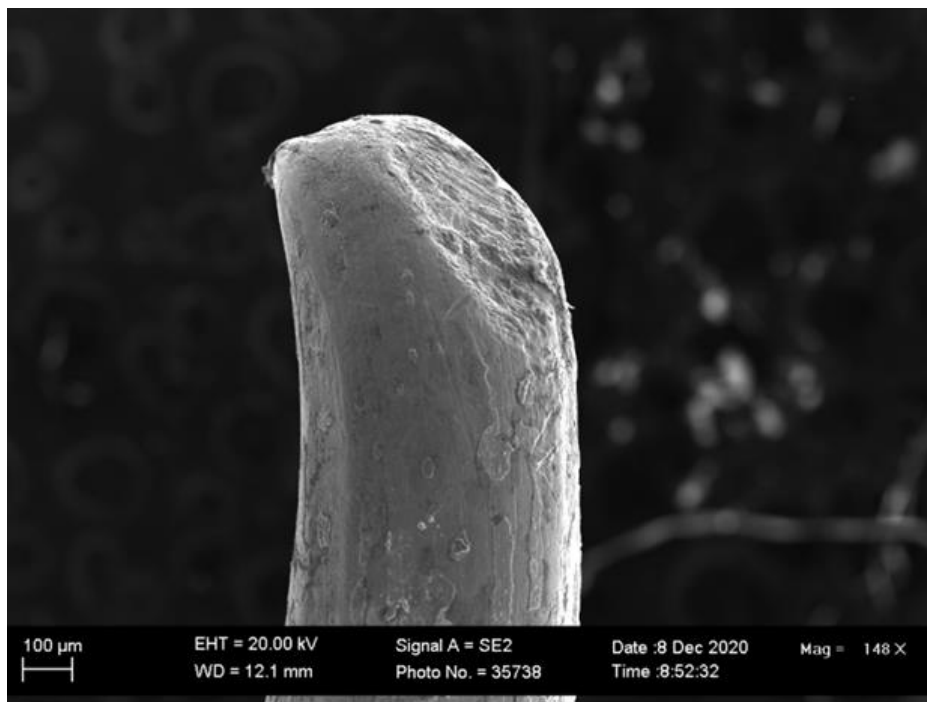
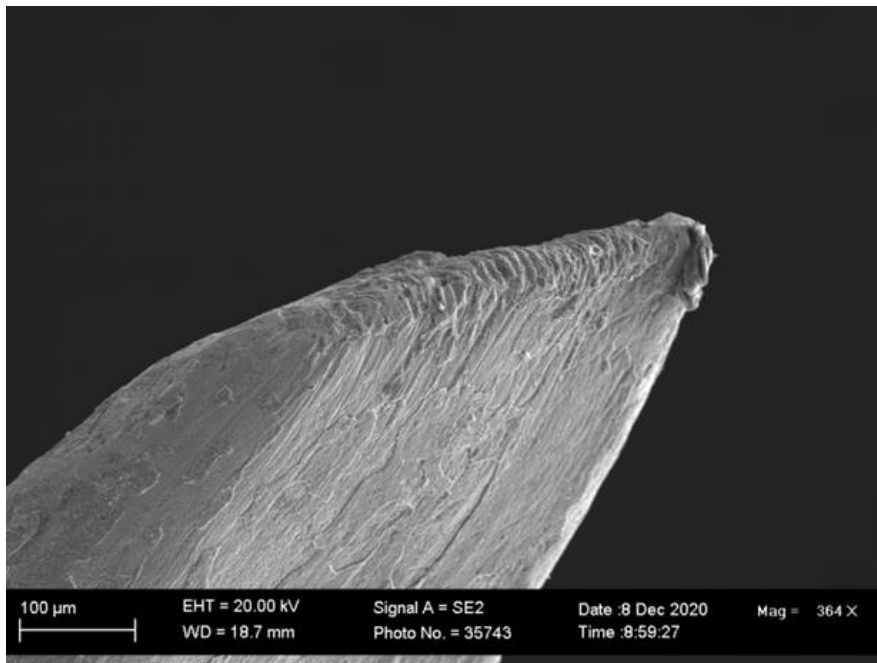
The lack of clear necking at the fracture positions suggest that the cable was severed and not exposed to a tensile overload. The localised inter-cable strand indentations confirm a side load (during impact) to be the primary cause of cable failure (photos 4, 5 and 6).
