AIRCRAFT ACCIDENT REPORT AND EXECUTIVE SUMMARY

Reference:	CA18/2/3/9930	
Aircraft registration	ZS-CNM	Date of accident	6 November 2020		Time of accident	1352Z
Type of aircraft	Cirrus SR22T (Aeroplane)		Type of operation		Part 91 (Private)	
Pilot-in-command licence type		Commercial	Age	63	Licence valid	Yes
Pilot-in-command flying experience		Total flying hours	3 533.3		Hours on type	5.0
Last point of departure		Hazyview Aerodrome (FAHW), Mpumalanga Province				
Next point of intended landing		Nelspruit Aerodrome (FANS), Mpumalanga Province				
Damage to the Aircraft		Destroyed				
Location of the accident site with reference to easily defined geographical points (GPS readings if possible)						
Pecan nut orchard next to FANS (GPS position: 25°30'04.05" South 030°55'00.30" East), elevation 2792 feet						
Meteorological information		Surface wind: 329°/9kts gusting 17kts; Temperature: 32°C; Visibility: CAVOK				
Number of people on board	1 + 0	No. of people injured	0	No. of people killed	1

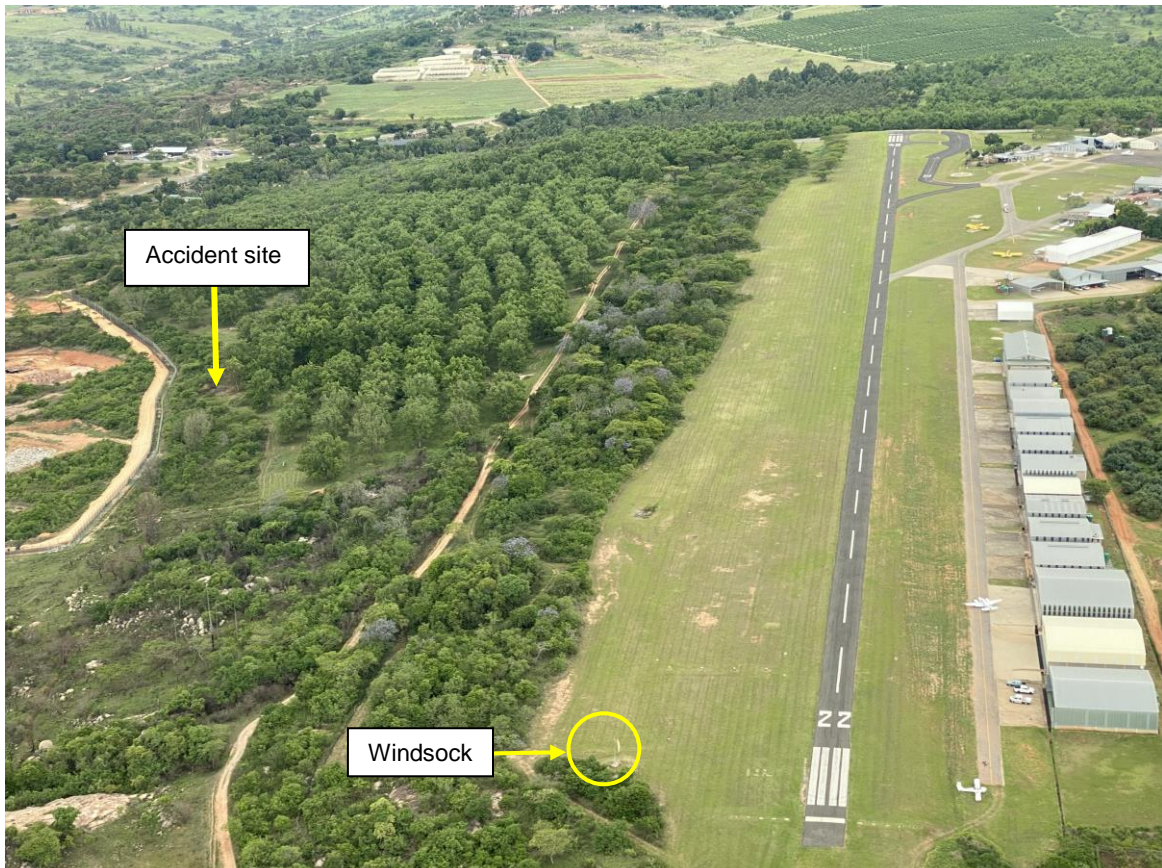
From the wreckage trail, it was evident that the right-wing impacted a large pecan nut tree and approximately 1m of the outer section of the wing was severed. The pilot lost control of the aircraft and it impacted terrain in a steep left-wing low attitude. Once the main wreckage came to rest, a post-impact fuel-fed fire erupted. The pilot was fatally injured during the accident sequence.

Figure 1: Aerial view of Runway 22 at FANS and the accident site. (Source: Kishugu Aviation)

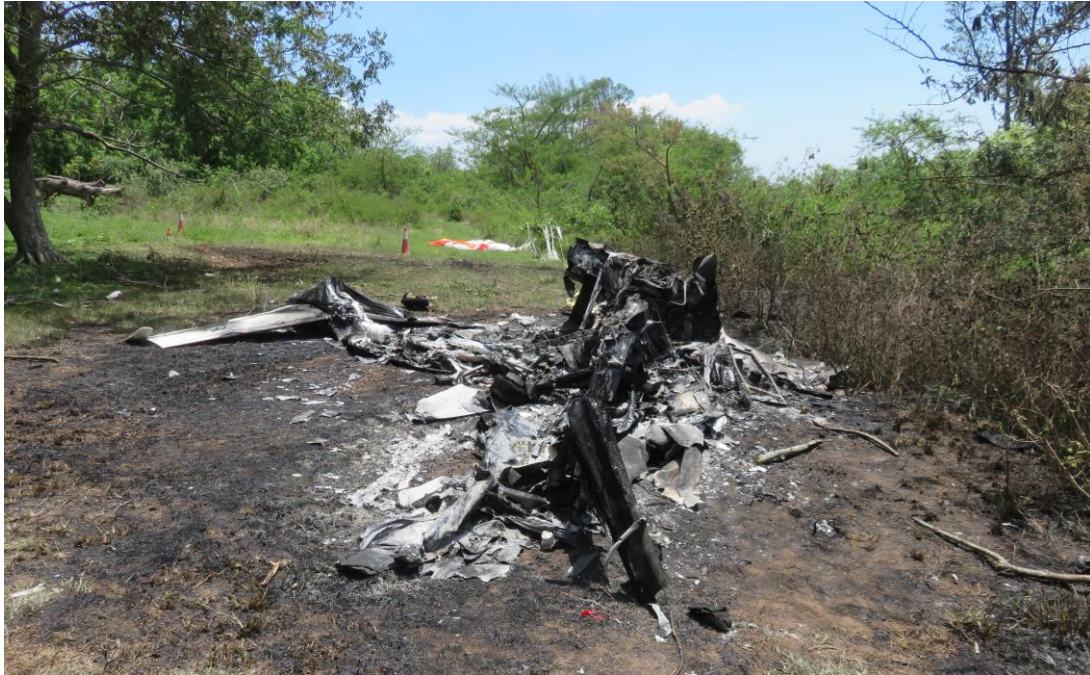
1.3.1 The aircraft was destroyed by impact and post-impact fuel-fed fire.

Figure 2: The wreckage was consumed by post-impact fuel-fed fire.

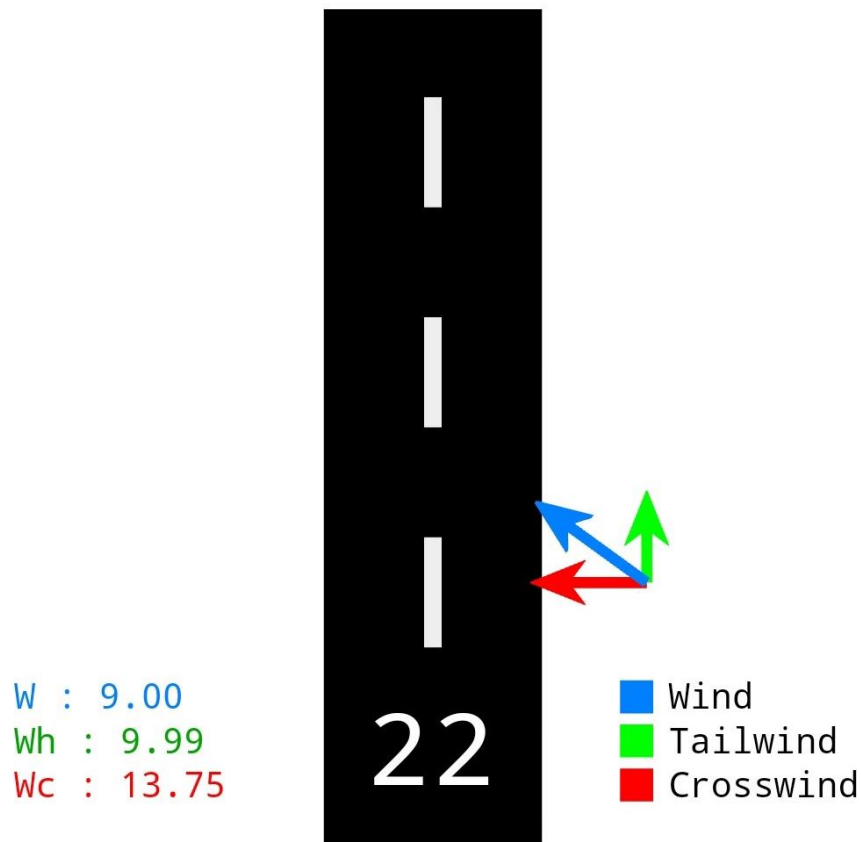
1.7.2 Prevailing winds at the time of the accident.

The variation of 17° west (as contained in the aerodrome chart in Annexure B) was added to the true heading of 329° for the purpose of this calculation in order to standardise the wind direction to a magnetic heading so that it is in line with the runway heading.

9.99

13.75

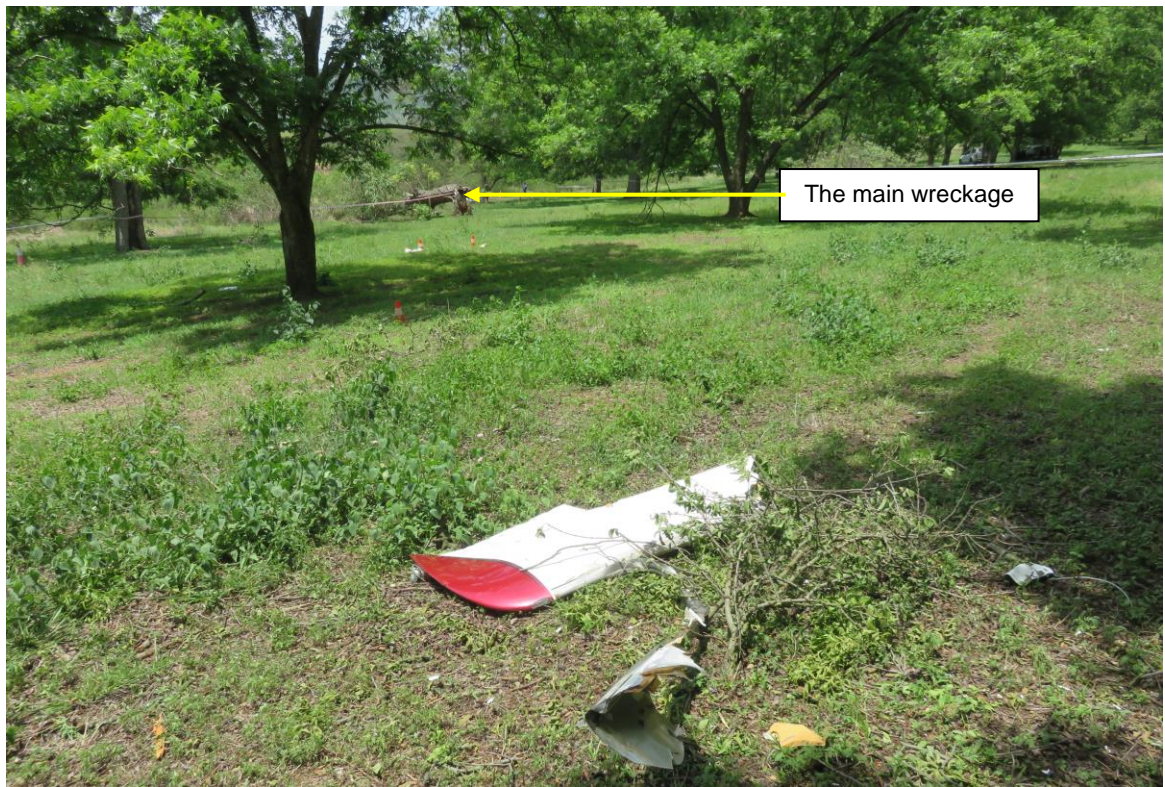
1.12.1 The aircraft struck several large pecan nut trees on a heading of 180° magnetic. Approximately 1m of the outer section of the right wing was discovered below the second tree, which was 36m from the first tree with which the aircraft collided. From there onwards, small pieces of debris consisting mainly of composite material were found along the impact line. The first ground impact mark was caused by the left-wing tip which impacted the ground at an angle of approximately 60° left bank. This was 63m from where the outer right-wing section was located. The main wreckage, which was consumed by post-impact fuel-fed fire, was found located 25m further on from the first ground impact mark. The last piece of the wreckage was the right-wing aileron. The debris was spread over 142m. The Cirrus Airframe Parachute System (CAPS) had not been deployed by the pilot but was activated by the intense heat of post-impact fire.

Figure 4: The outer section of the right wing, lying underneath one of the large pecan nut trees.

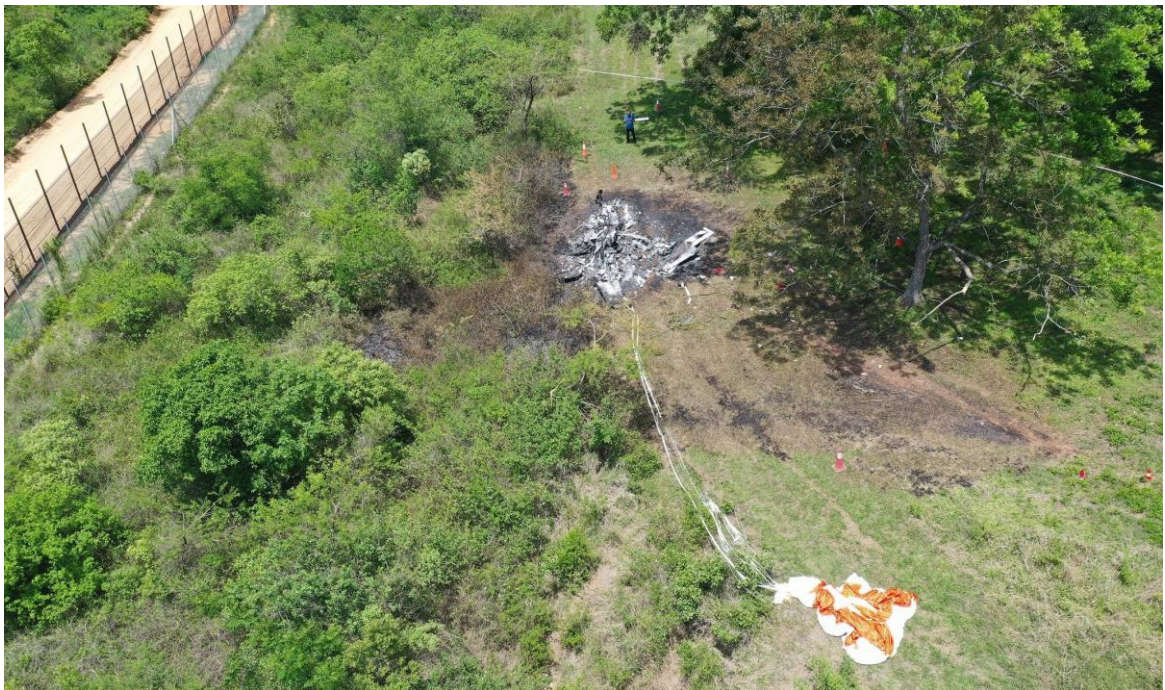
Figure 5: Aerial photograph of the main wreckage area.

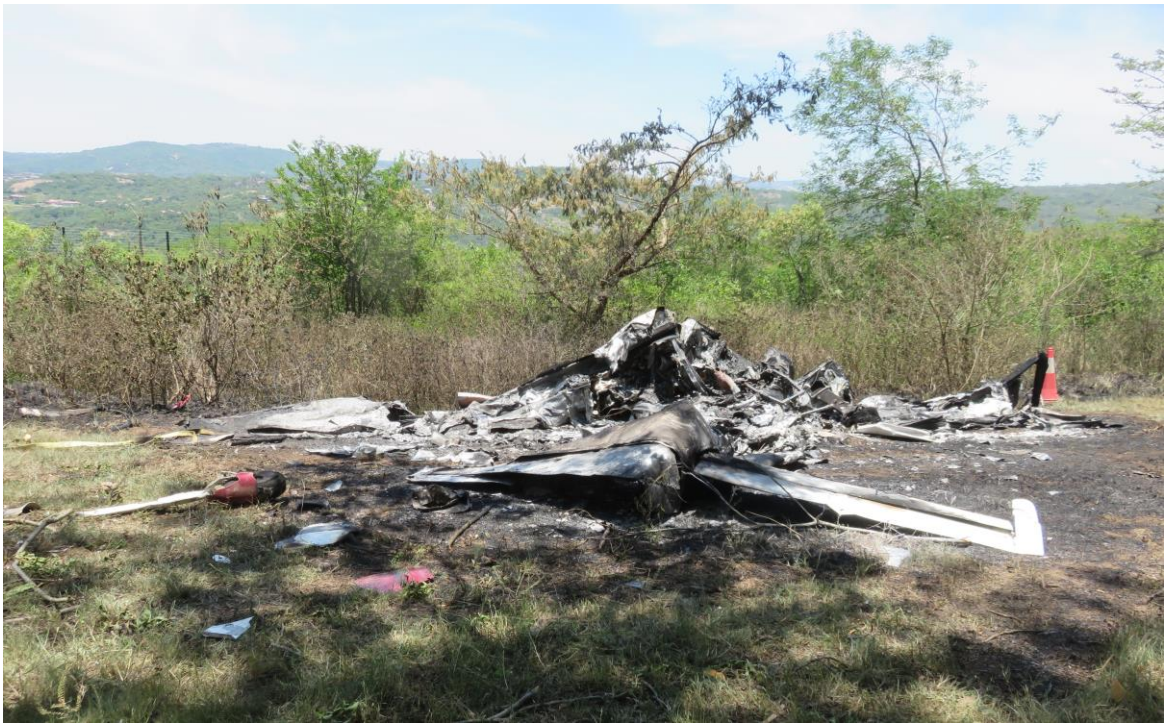
Figure 6: The main wreckage was consumed by post-impact fire.

1.14.1 The aircraft was destroyed by impact and post-impact fuel-fed fire that erupted.

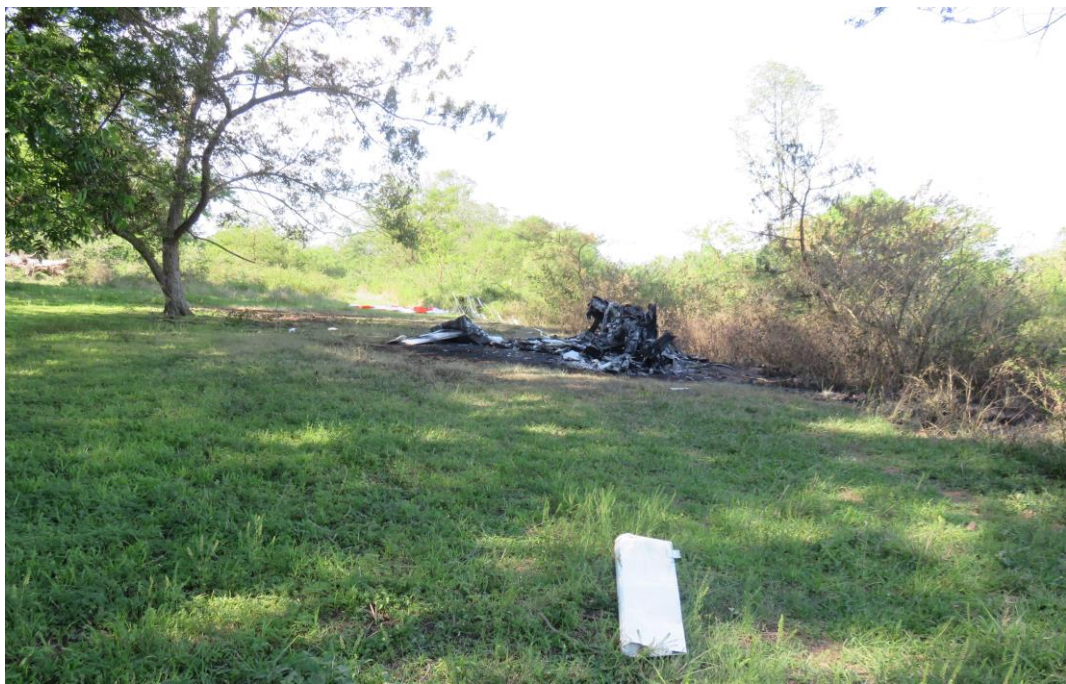
Figure 7: The right-wing aileron in the foreground.

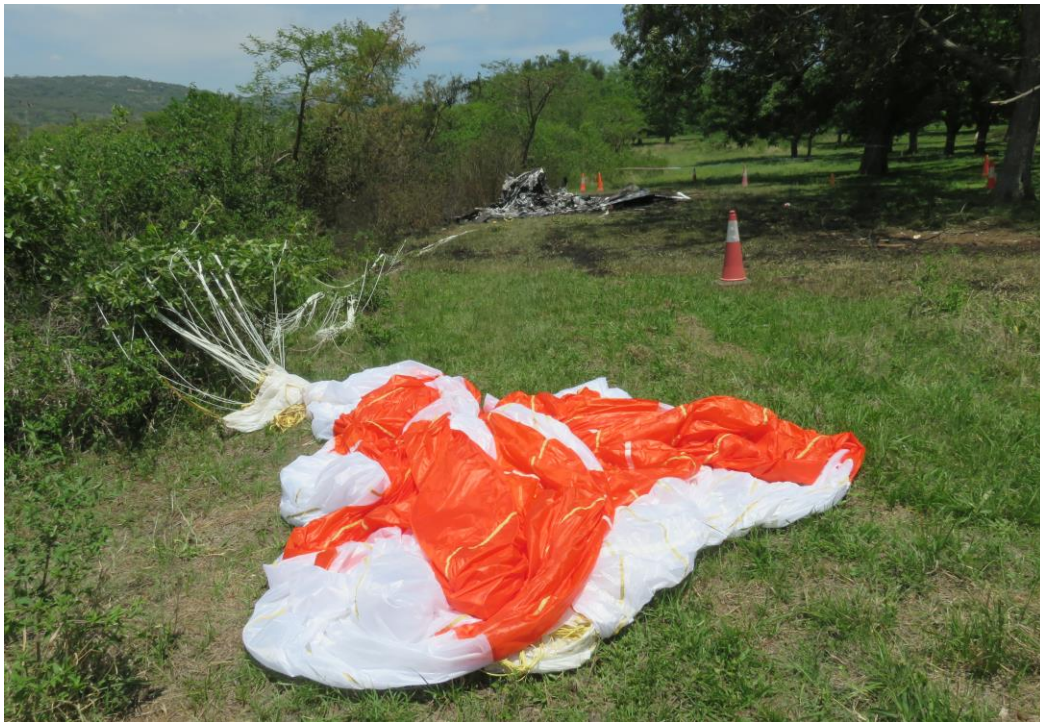
Figure 8: The CAPS was found activated by heat of post-impact fire.

The CAPS system was not activated by the pilot. However, the intense heat caused by post-impact fire activated the ballistic system, and the CAPS deployed. It was found next to the main wreckage, undamaged.

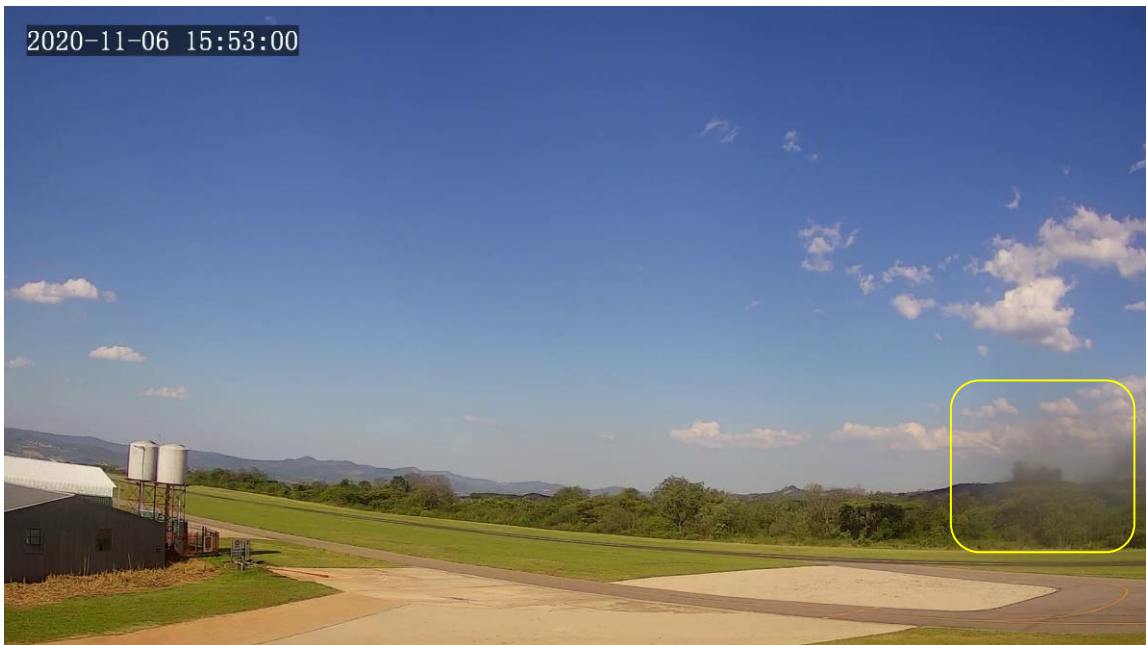
9. At 15:52:21, the aircraft disappears behind the tree line to the left of Runway 22.
10. At 15:53:00, black smoke is seen emerging from behind the trees.

Figure 17: Black smoke from the accident site.

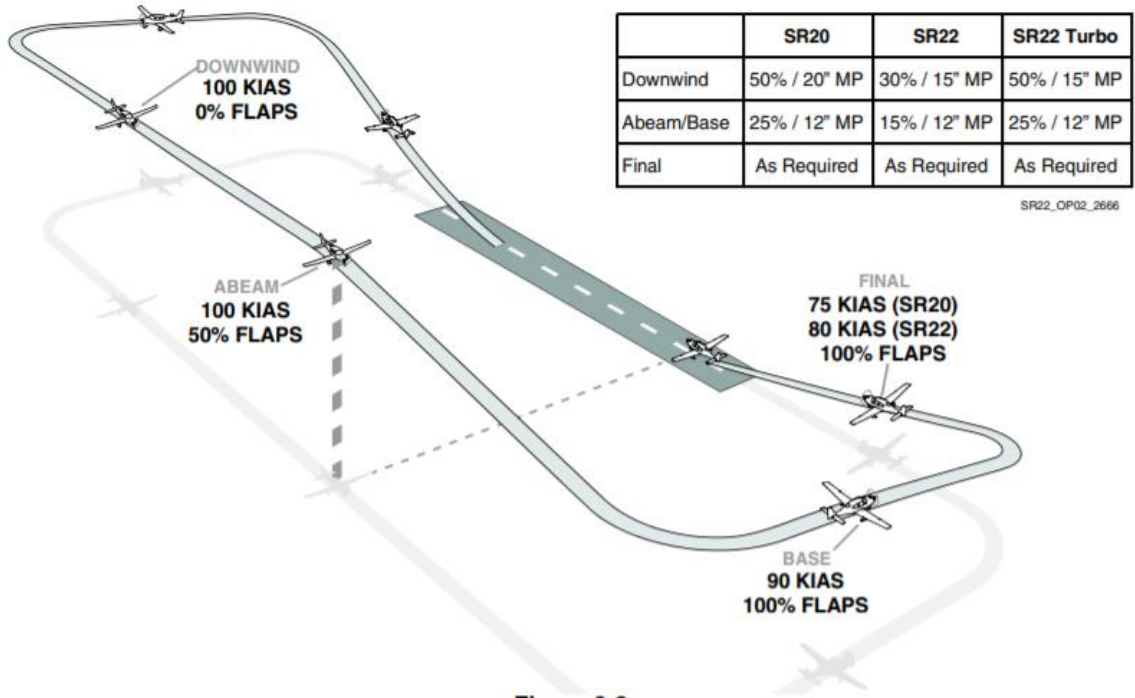
Figure 3-2
Traffic Pattern Profile

The pilot flying the aircraft did not comply with the traffic pattern profile when he joined overhead FANS as outlined in the FOM of the aircraft. He first flew an approach for Runway 04, which was not in line with the FANS chart guidance; this was pointed out to him by the crew flying the ZS-KNE who landed on Runway 22 while he was on approach for Runway 04. He then flew a teardrop approach for Runway 22 and, again, he did not follow the traffic pattern profile as provided.
