Final report RL 2021:10e

**Accident at Skövde Airport, Västra
Götaland County, on 19 December 2020
involving the aeroplane SE-MDN of the
model Cessna 172N, operated by Skövde
Aeroclub.**

File no. L-97/20

15 December 2021

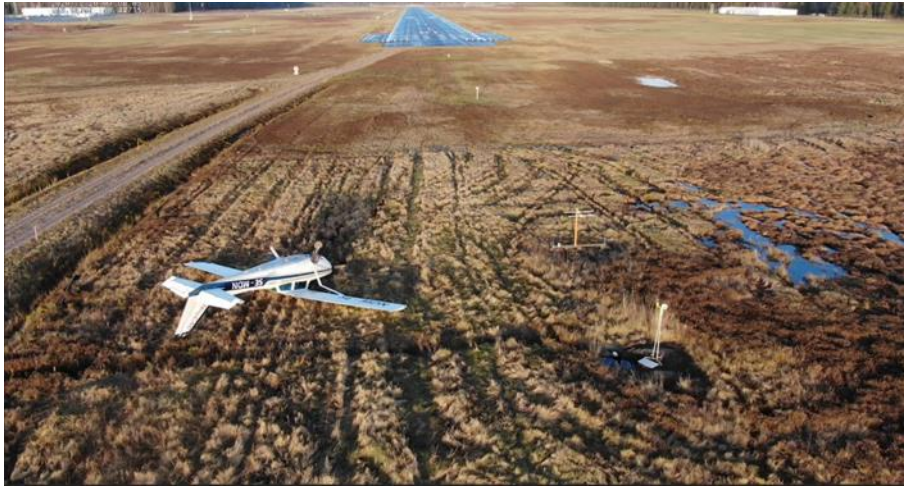
The aircraft's final position was 175 metres from the runway end. At the time of the accident, the runway was damp.

Figure 10. The aircraft at the accident site in relation to the runway. Photo: Swedish Police.

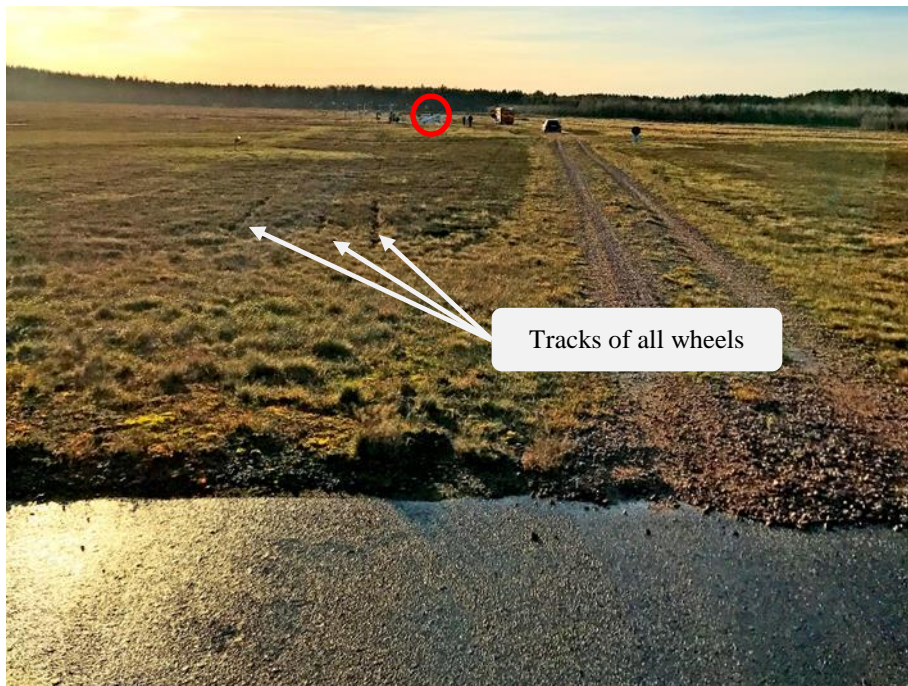
Tracks could be seen after the runway (see Figure 11).

Figure 11. The image from the runway end with clear tracks. Accident area circled. Text has been inserted by SHK. Photo: Swedish Police.

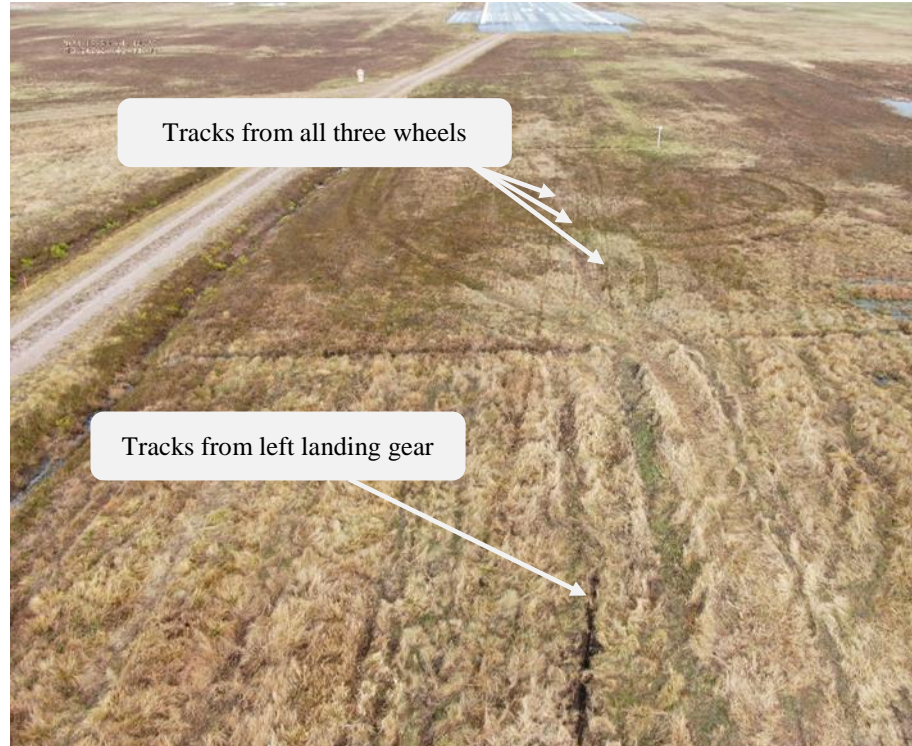
Just before the aircraft's final resting position, deep tracks could be seen in the ground from the left main landing gear. Figure 12 is taken the day after the accident directly over the accident site in the direction of the runway.

Figure 12. Tracks in the grass after the plane.

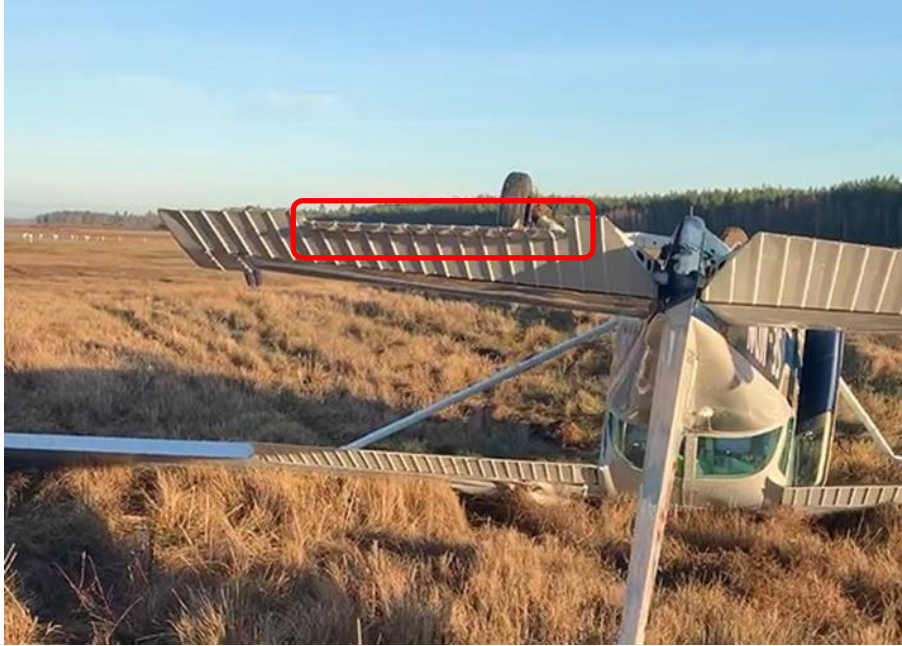
The position of the elevator trim and the indicator for trim position in the cockpit show that the aircraft's elevator trim was trimmed for nose down at the time of the accident (see Figures 13 and 14). The wing flaps were in the retracted position.

Figure 13. The position of the rudder trim at the accident site. The elevator trim marked by SHK. Photo: Swedish Police.

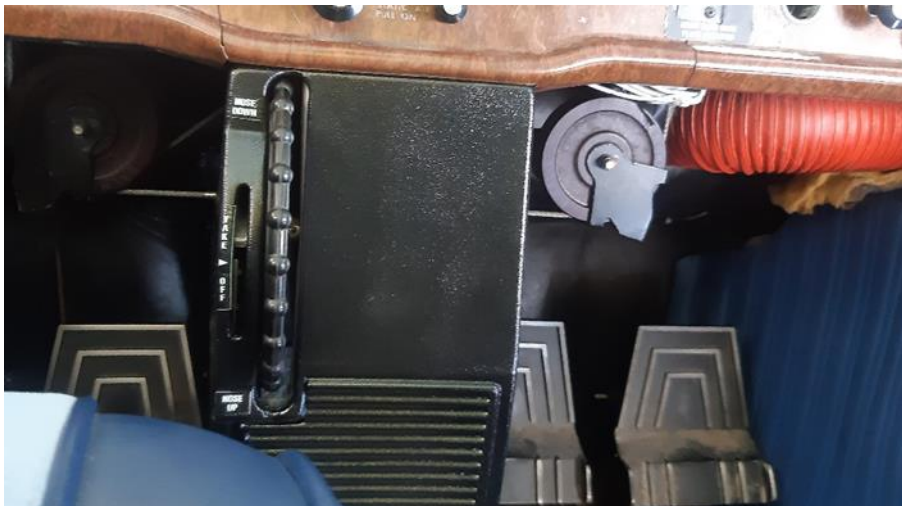
Figure 14. The position of the trim indicator after the accident. Photo: Tord Södergård.

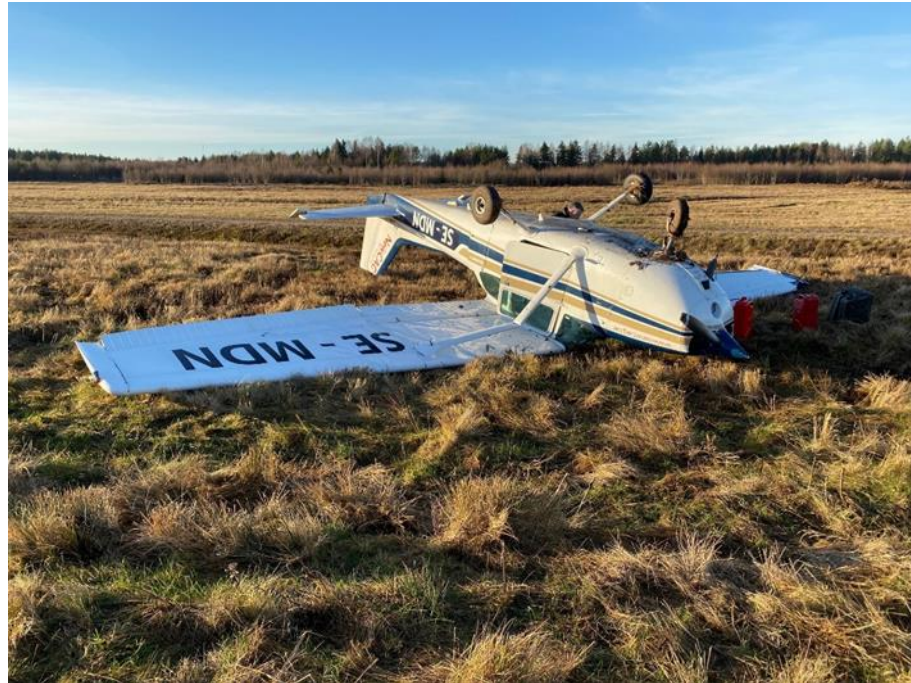
The aircraft had significant structural damage, mainly to the wings, where the left wing strut was broken. Damage was also found to the fuselage, fin, nose landing gear and propeller.

Figure 15. The aircraft at the accident site. Picture Marcus Larsson.

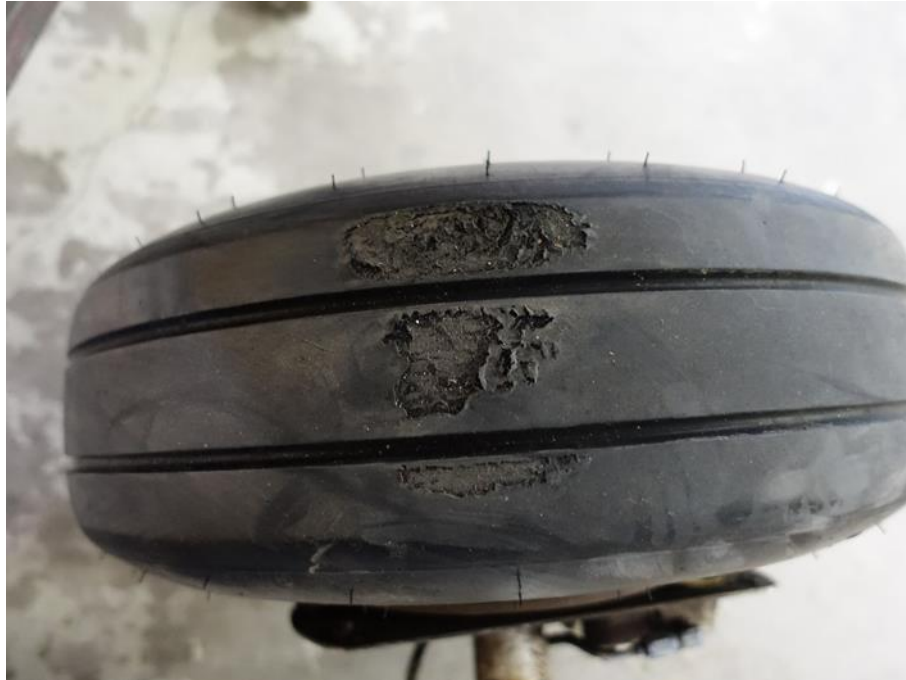
The left main wheel showed damage from aquaplaning of the type “Reverted Rubber Hydroplaning” (see Figure 16).

Figure 16. Damage to the left tire of a so-called “Reverted Rubber Hydroplaning”.

This type of aquaplaning can occur when a wheel is locked during hard braking and a thin film of water is present on the runway. The friction heat causes the water in the contact surface between the tire and the ground to evaporate. The water vapor prevents direct contact between the tire and the ground and the braking effect becomes insignificant.

The increase in temperature has damaged the rubber in the tire (see Figure 16).

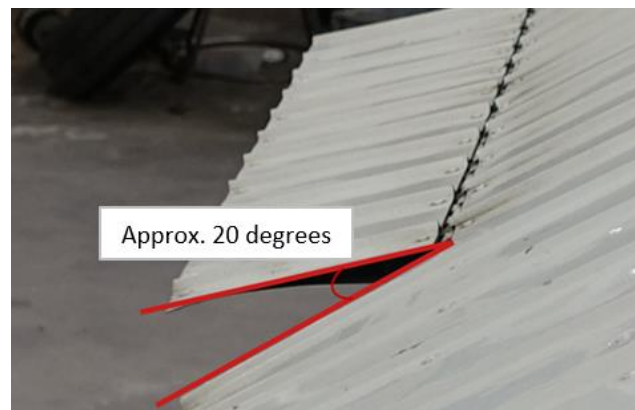
Measurement of the movement of the trim rudder showed a deflection of 30 degrees upwards and 15 degrees downwards, respectively. According to the manufacturer, the movement of the trim rudder should be in the range 28 to 29 degrees upwards and 13 to 14 degrees downwards.

During interviews with the pilots, information has emerged that the trim indication is normally set to the letter "E" at the "Take-Off" marking. Measurement of this position shows a deflection of nine degrees upwards. Measurement of the position of the trim rudder similar to indication after the accident shows a deflection of 20 degrees upwards (see Figure 17).

Figure 17. Trim rudder position after the accident.
