AIRCRAFT ACCIDENT REPORT AND EXECUTIVE SUMMARY

Reference:	CA18/2/3/9939	
Aircraft Registration	ZS-OXK	Date of Accident	2 January 2021		Time of Accident	0500Z
Type of Aircraft	AS350-B3 (Airbus H125)		Type of Operation		Commercial (Part 127)	
Pilot-in-command Licence Type	ATPL (H)		Age	49	Licence Valid	Yes
Pilot-in-command Flying Experience	Total Flying Hours	6 854.0		Hours on Type	260.9	
Last Point of Departure	Cape Town International Airport (FACT), Western Cape Province					
Next Point of Intended Landing	Cape Peninsula National Park, Western Cape Province					
Location of the accident site with reference to easily defined geographical points (GPS readings if possible)						
Cape Town International Airport (FACT) taxiway Hotel, Western Cape Province (GPS position: 33°58'38.32" South, 18°35'51.88" East, at an elevation of 140ft)						
Damage to Helicopter	Destroyed					
Meteorological Information	Wind: 200° at 7kt, Temperature: 18°C, Dew Point: 8°C, Cloud Cover: CAVOK, QNH: 1019 hPa, NOSIG

Probable Cause and/or Contributory Factors						
It is probable that the pilot lost control following loss of hydraulic pressure as he omitted to release the "HYD TEST" push-button on the front

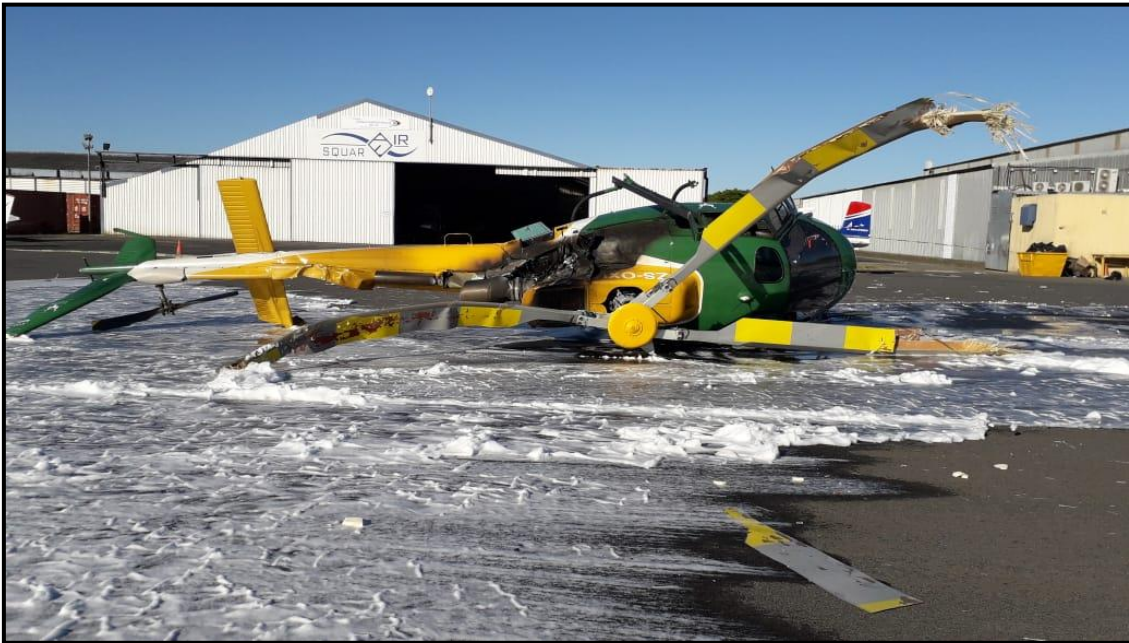
1.3.1 The aircraft was destroyed by impact and post-impact fire during the accident sequence.

Figure 2: The helicopter post-accident. (Source: Operator)

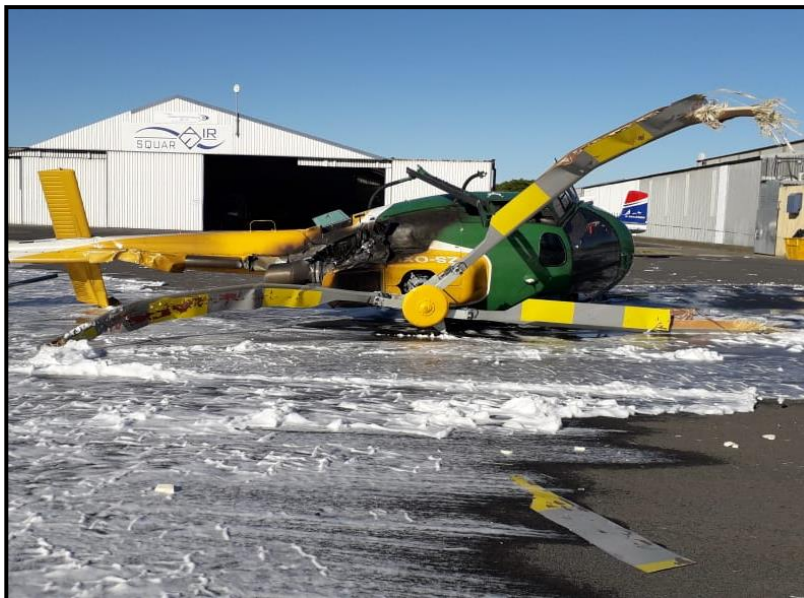
All main rotor blades showed signs of impact damage on the tips but were still attached to the hub via rigid sleeves. All three arms of the Starflex were severed due to the impact of the rotor blades with the ground. All three frequency adapters had cracks on them due to impact forces.

Figure 3: The main rotor blades post-accident.

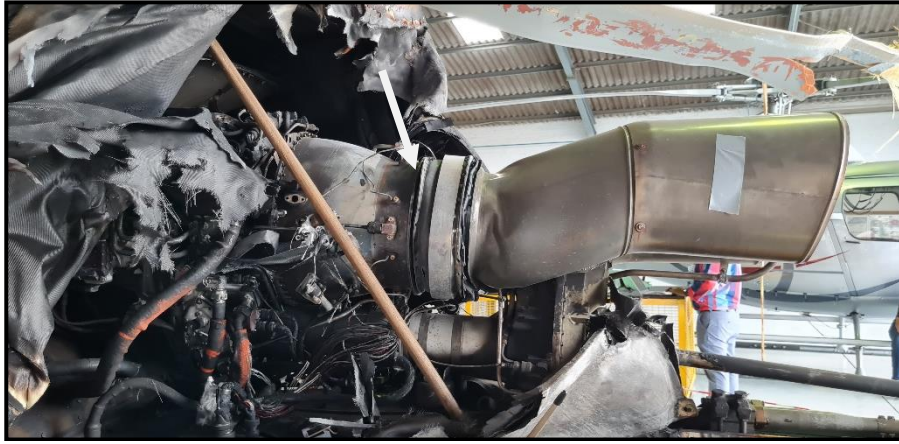
The engine was still attached to its mounts and showed signs of fire damage. The oil and fuel pipes were still intact and there were no visible ruptures or punctures. Some of the attachment bolts of the exhaust were severed due to impact forces. Most of the post-impact fire was contained within the engine bay.

Figure 4: The engine compartment after fire damage.

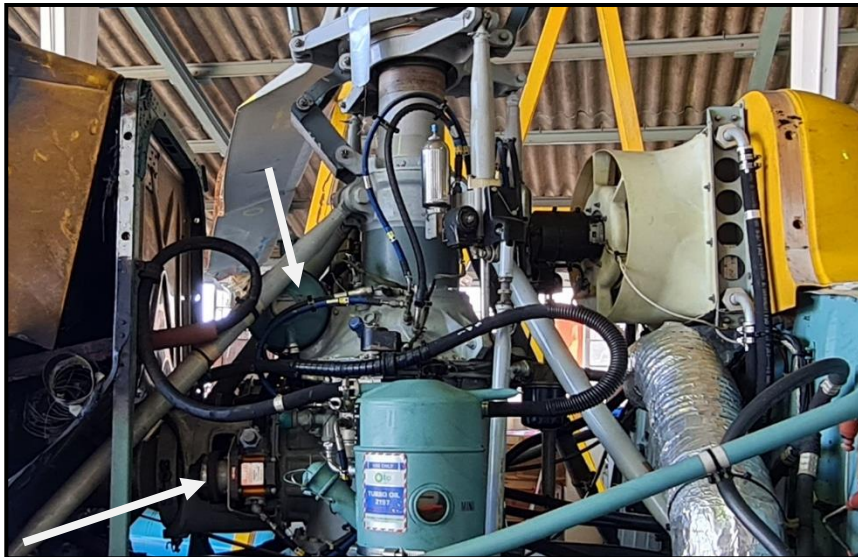
The hydraulic pump and reservoir were both found intact with no signs of impact damage. The hydraulic oil within the tank was 600 millilitres out of a total of 3 litres because most of the oil seeped out of the tank when the helicopter was resting on its right side.

Figure 5: Hydraulic reservoir and pump found intact post-accident.

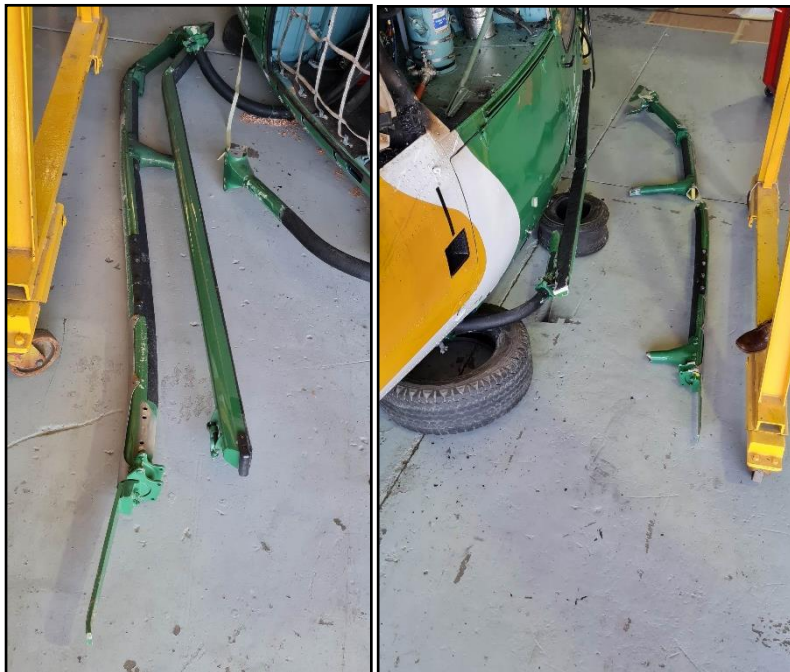
The entire left skid broke off from the attachments, but the right skid was still partially attached to the helicopter with the upper section and was bent upwards.

Figure 6: The left skid gears (left image) and the right skid gear (right image).

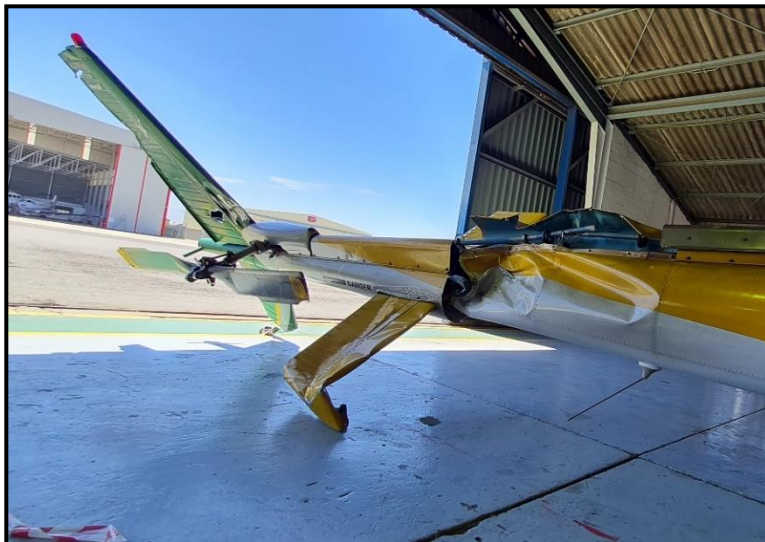
The tail drive shaft assembly was severed by the main rotor blade at its mid-section. The right horizontal stabiliser was bent during impact and the vertical stabiliser showed signs of impact damage caused by the main rotor blades. The tail rotor blades were still attached to the tail rotor output shaft but showed signs of impact with the ground on both tips.

Figure 7: Damaged tail boom and tail rotor.
