LIMITED OCCURRENCE INVESTIGATION

Reference Number	CA18/2/3/9940						
Classification	Accident	Date	10 January 2021	Time	0745Z		
Type of Operation	Private (Part 94)						
Location							
Place	Crocodile River, Brits, North West Province			Elevation	3 555 feet		
GPS Co-ordinates	Latitude	S 25°35'37.5"	Longitude	E 027°45'28.5"			
Aircraft Information							
Registration	ZU-RAJ						
Model/Make	Aerospatiale						
Damage to Aircraft	Destroyed		Total Aircraft Hours	8517			
Pilot-in-command							
Licence Type	Private Pilot Licence (PPL)	Gender	Male		Age	56	
Licence Valid	Yes						
Total Hours on Type	429.9		Total Flying Hours	936.4			
People On-board	1 + 2	Injuries	2	Fatalities	1	Other (On Ground)	0
What Happened							
<p>On Sunday 10 January 2021, the pilot and two passengers on-board a SE 3130-Aloutte II single-engine helicopter with registration ZU-RAJ took off on a scenic flight from Brits Aerodrome (FABS) in the North West province to Roodekoppies Dam, which is approximately 12.5 nautical miles (nm) from FABS. The flight duration was approximately 20 minutes. The flight was conducted under visual flight rules (VFR) by day and under the provisions of Part 94 of the Civil Aviation R

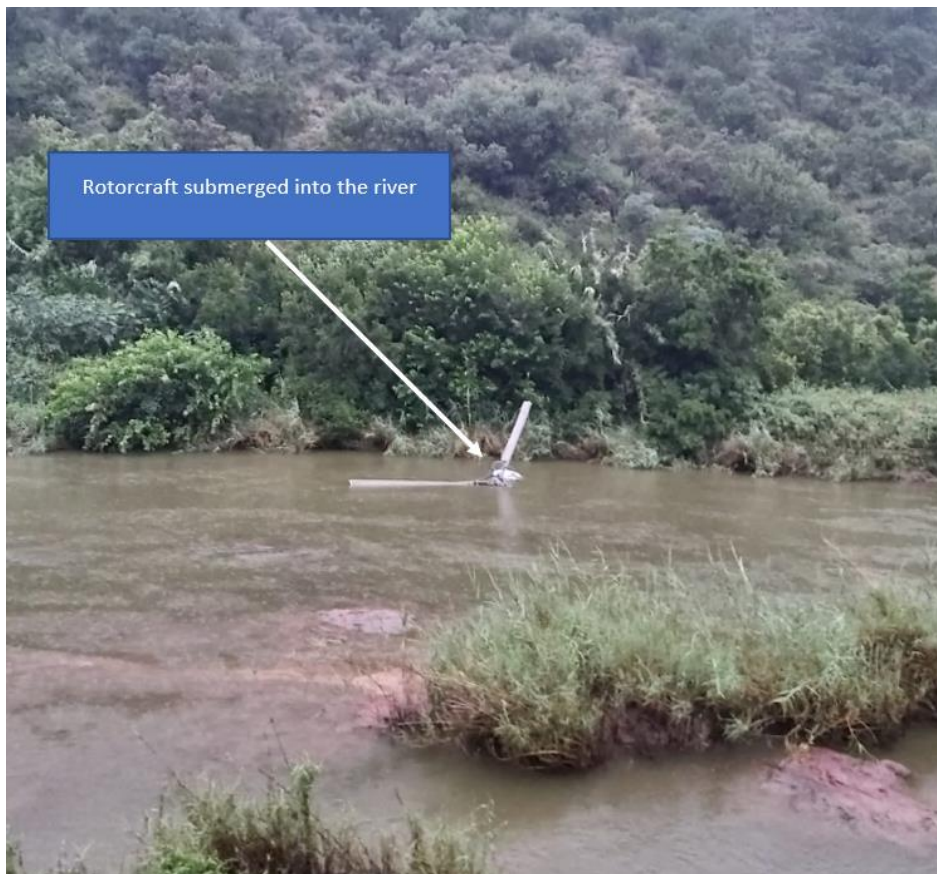
Figure 1: Accident helicopter in the river.

The pilot swam out of the river and walked approximately 2 kilometres (km) to seek help. The Helicopter Emergency Medical Services (HEMS) and the South African Police Service (SAPS) were called to the scene. On their arrival, they found one passenger who had succumbed to his injuries while the other passenger was clinging to one of the main rotor blades which was sticking out of the submerged helicopter.

The probable cause of this engine failure could be attributed to the helicopter having had inadequate amount of fuel on-board to complete the three scenic flights. It is likely that the helicopter was being flown at a low altitude to enable the passengers to have a better aerial view of the Crocodile River. When the engine failed, the pilot did not have time to follow the engine failure procedures, which led to a crash.

Safety messages 1: Pilots are advised to ensure the correct amount of fuel for every flight they undertake (double check with a fuel dipstick where possible).

Safety messages 2: When engaged in a scenic flight, pilots should ensure a safe altitude to enable a better chance of a safe forced landing should an emergency or engine failure occur.
