<b>AIRCRAFT ACCIDENT REPORT AND EXECUTIVE SUMMARY</b>
---

<b>Reference:</b>		<b>CA18/2/3/9941</b>	
<b>Aircraft Registration</b>	<b>ZU-IJZ</b>	<b>Date of Accident</b>	11 January 2021		<b>Time of Accident</b>	0920Z	
<b>Type of Aircraft</b>	Safari LSA		<b>Type of Operation</b>		Private (Part 94)		
<b>Pilot-in-command Licence Type</b>	National Pilot Licence		<b>Age</b>	67	<b>Licence Valid</b>	Yes	
<b>Pilot-in-command Flying Experience</b>	<b>Total Flying Hours</b>		65.6		<b>Hours on Type</b>	65.6	
<b>Last Point of Departure</b>		Kroon Airfield, Gauteng province					
<b>Next Point of Intended Landing</b>		Kroon Airfield, Gauteng province					
<b>Damage to Aircraft</b>		Substantial					
<b>Location of the accident site with reference to easily defined geographical points (GPS readings if possible)</b>

**Reference Number** : CA18/2/3/9941  
**Name of Owner/Operator** : Pieter Furter  
**Manufacturer** : Kit Planes for Africa  
**Model** : Safari LSA  
**Nationality** : South African  
**Registration Marks** : ZU-IJZ  
**Place** : Kroon Airfield, Gauteng Province  
**Date** : 11 January 2021  
**Time** : 0920Z

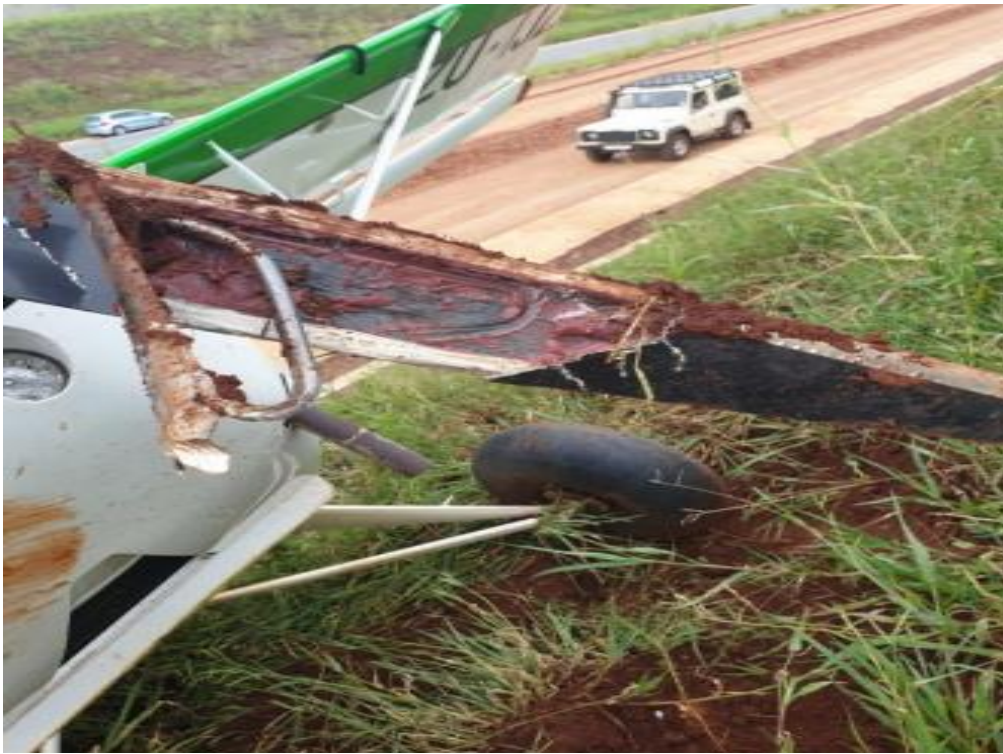
1.3.1. The aircraft sustained substantial damage during the accident sequence.

**Figure 2:** The aircraft post-accident. (Source: Pilot)

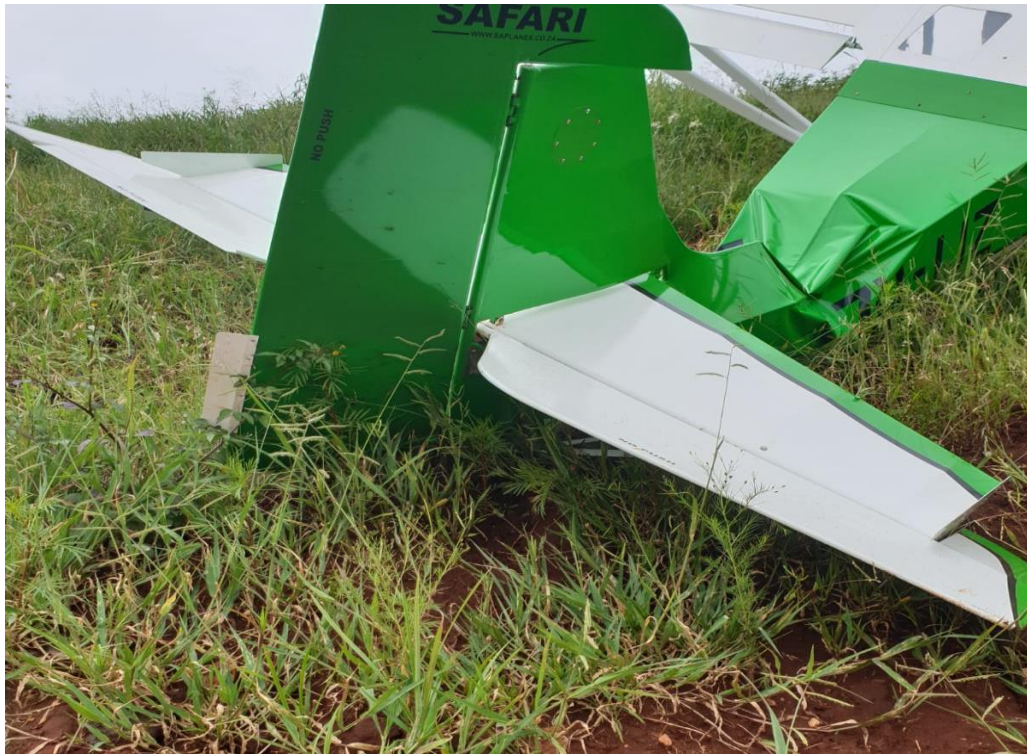
1.12.2 The right main landing gear strut was damaged, as well as the propeller blades which struck the ground (during the accident) and the tail section, including the tail wheel.

**Figure 4:** Damage to the tail section.

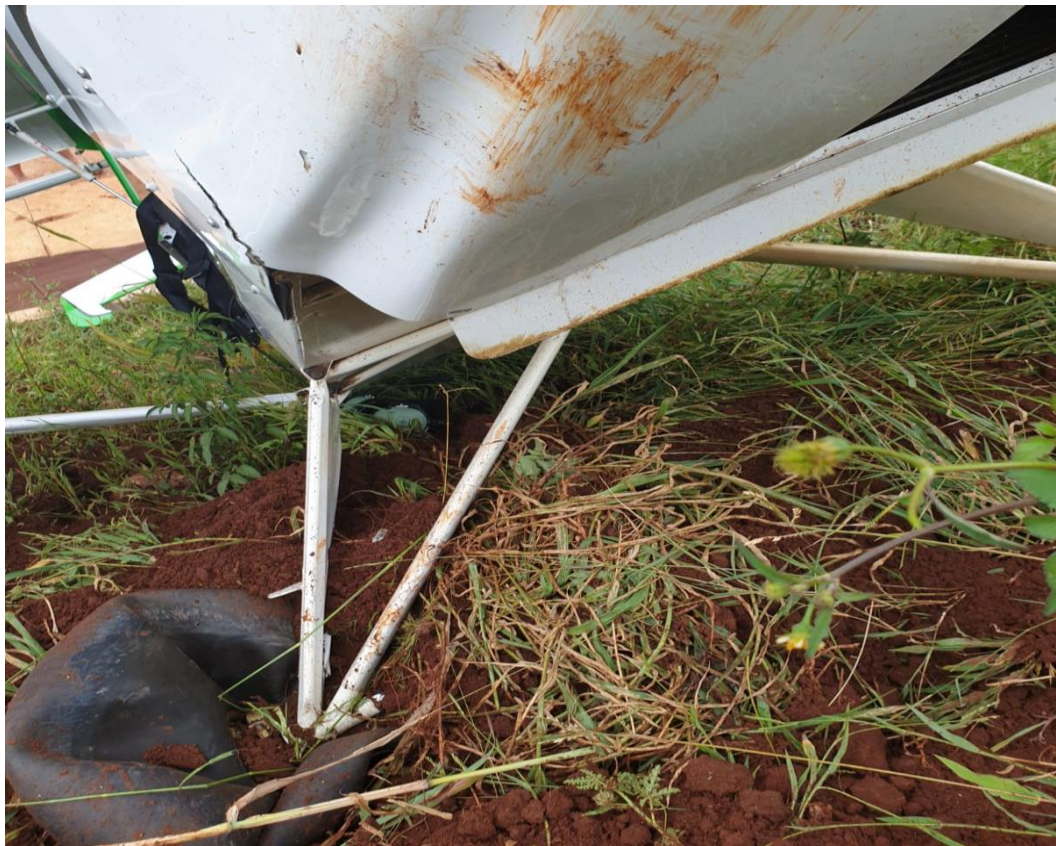
**Figure 5:** Damage to the right main landing gear.

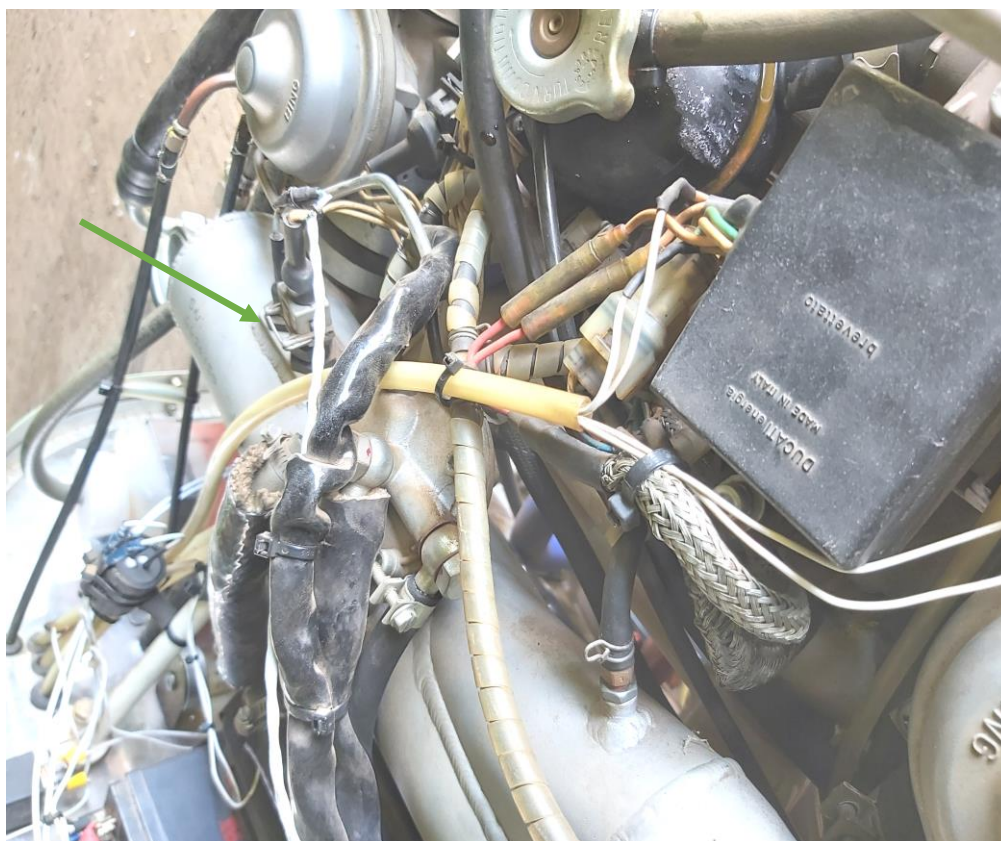
The second possibility is from the manual which states that there should be an orange caution light that would illuminate which would be an indication of the failure of the sensor on the airbox (see Figure 10).

**Figure 7:** Green arrow shows airbox pressure sensor.

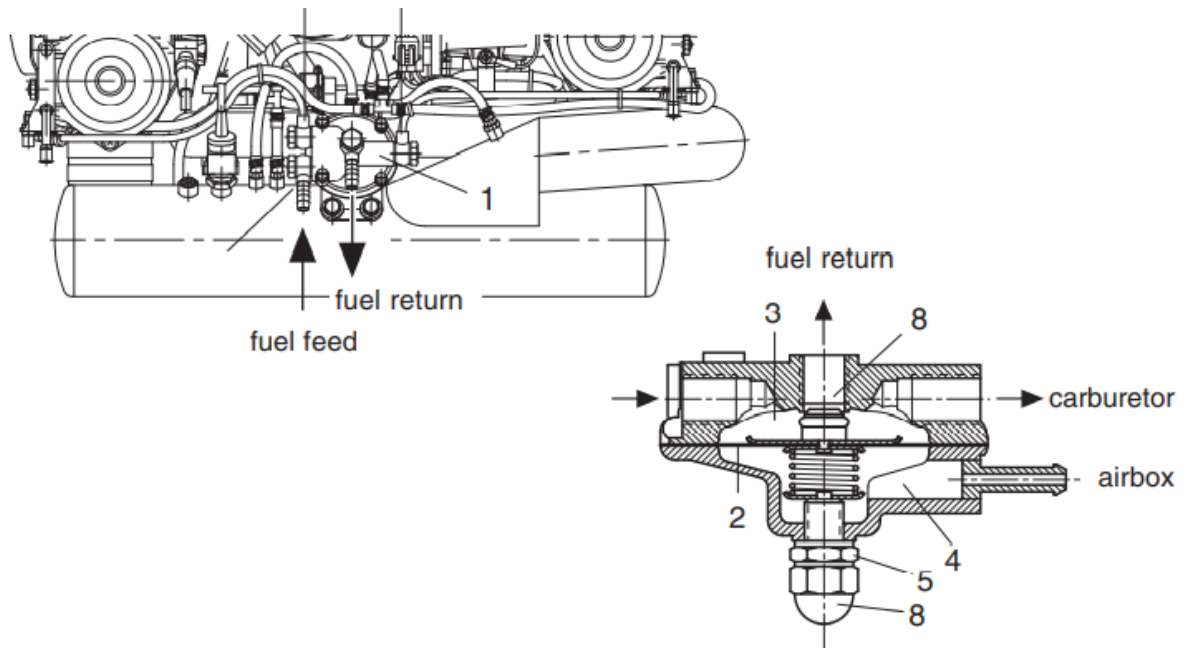
The third possibility, which is more likely, is that the fuel pressure regulator had failed, resulting in less fuel in the engine.

**Figure 8:** Fuel pressure regulator. (Source: Rotax 914 Maintenance Manual)

- 3.3.1 It is likely that during take-off, the fuel pressure regulator failed, resulting in a drop of fuel pressure to below 0.25 bar and, thus, the engine was unable to provide sufficient power to sustain flight. The cause of the fuel pressure regulator failure could not be established as the tests did not reveal any abnormalities.
