LIMITED ACCIDENT/INCIDENT INVESTIGATION
--

Reference Number	CA18/2/3/9944					
Classification	Accident	Date	19 January 2021		Time	0550Z
Type of Operation	Agricultural (Part 137)					
Location						
Place of Departure	Ross Air Hangar, Wellington, Western Cape Province		Place of Intended Landing	South Africa, Silverstroom Farm, Wolseley, Western Cape Province		
Place Accident	South Africa, Silverstroom Farm, Wolseley, Western Cape Province					
GPS Co-ordinates	Latitude	33°25'32.80" S	Longitude	019°14'37,62" E	Elevation	932 ft
Aircraft Information						
Registration	ZS-HUC					
Model/Make	BELL 206 B					
Damage to Aircraft	Destroyed		Total Aircraft Hours	9029.5		
Pilot-in-command						
Licence Type	Commercial Pilot Licence (CPL) Helicopter	Gender	Male		Age	25
Licence Valid	Yes					
Total Hours on Type	486.8		Total Flying Hours	1360.8		
People On-board	1+0	Injuries	0	Fatalities	1	Other (On Ground) 0
What Happened						
<p>On Tuesday 19 January 2021, a pilot on-board a Bell 206B II Jet Ranger helicopter with registration mark ZS-HUC was carrying out crop-spraying (using fruit fly baiting chemical) duties at Silverstroom farm in Wolseley, Western Cape province. The crops that were bein

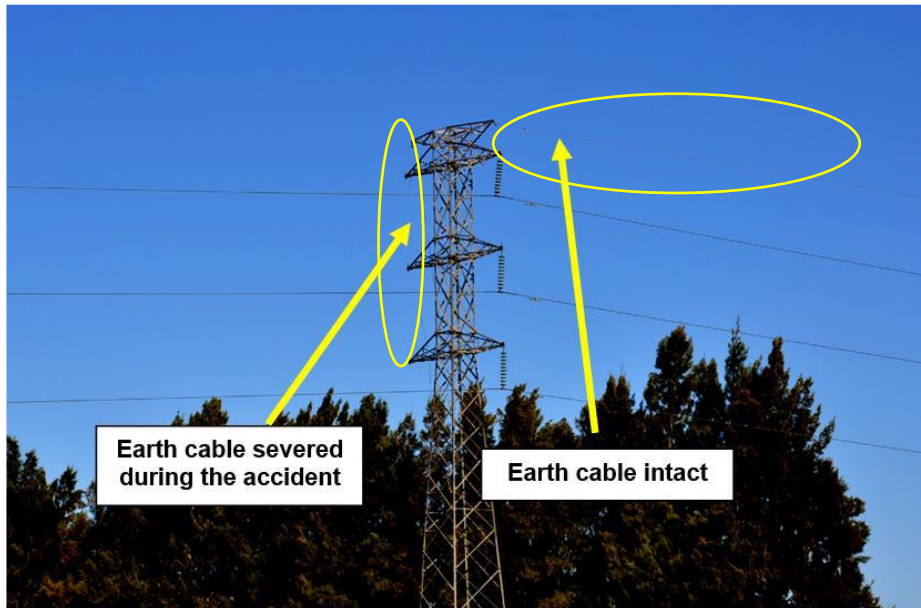
It was reported that according to the orientation, location and distribution of the helicopter wreckage, the helicopter collided with the top wire (earth conductor) of the high-tension electrical cables while flying in an easterly direction. The high-tension wires were span across the helicopter’s flight path. Later, it was observed that the earth conductor of the high-tension power cable was missing, which resulted in power outage in the neighbouring town (Ceres).

Figure 1: An electrical pylon with the severed earth cable (left), and the undamaged earth cable (right).

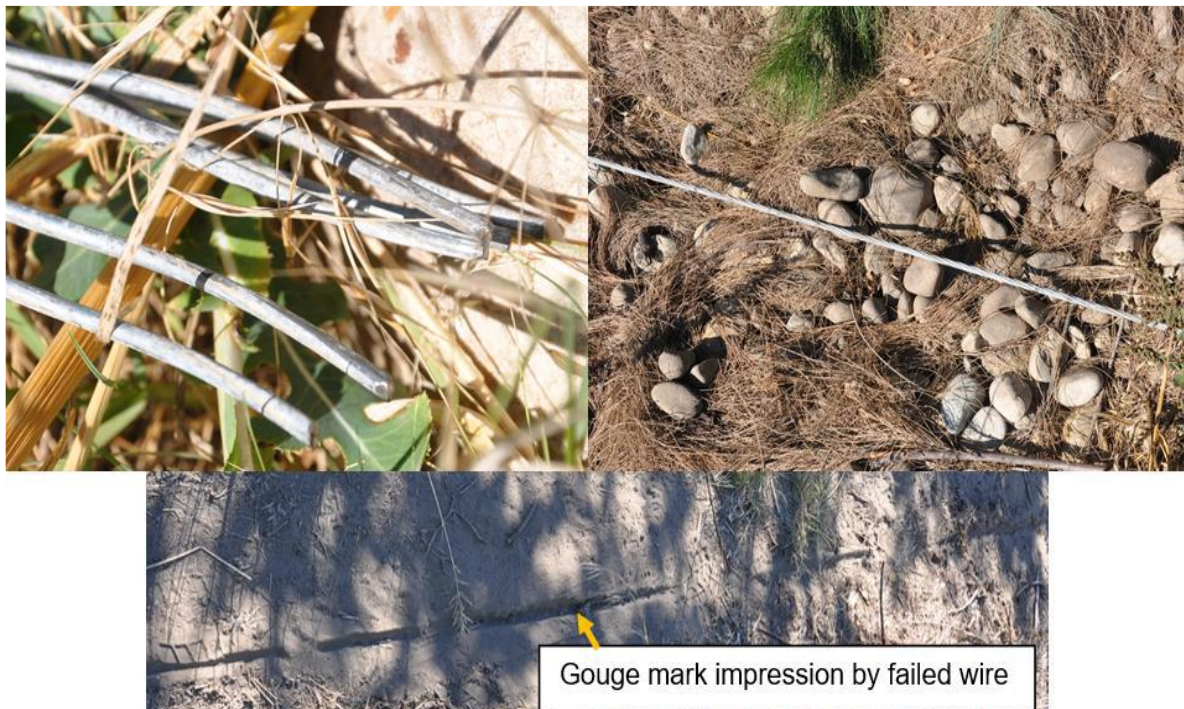
Figure 2: Top-left image: The failed earth conductor. Top-right image: The earth conductor found near the trees. Bottom image: The gouge mark made by the earth conductor.

The collision of the helicopter with the earth conductor resulted in tension stress, which caused the wires to break. The “popping” sound heard by the farm owner was most probably the sound of the main rotor blades impacting the left-side of the fuselage, which resulted in the hot section of the engine separating from the fuselage.

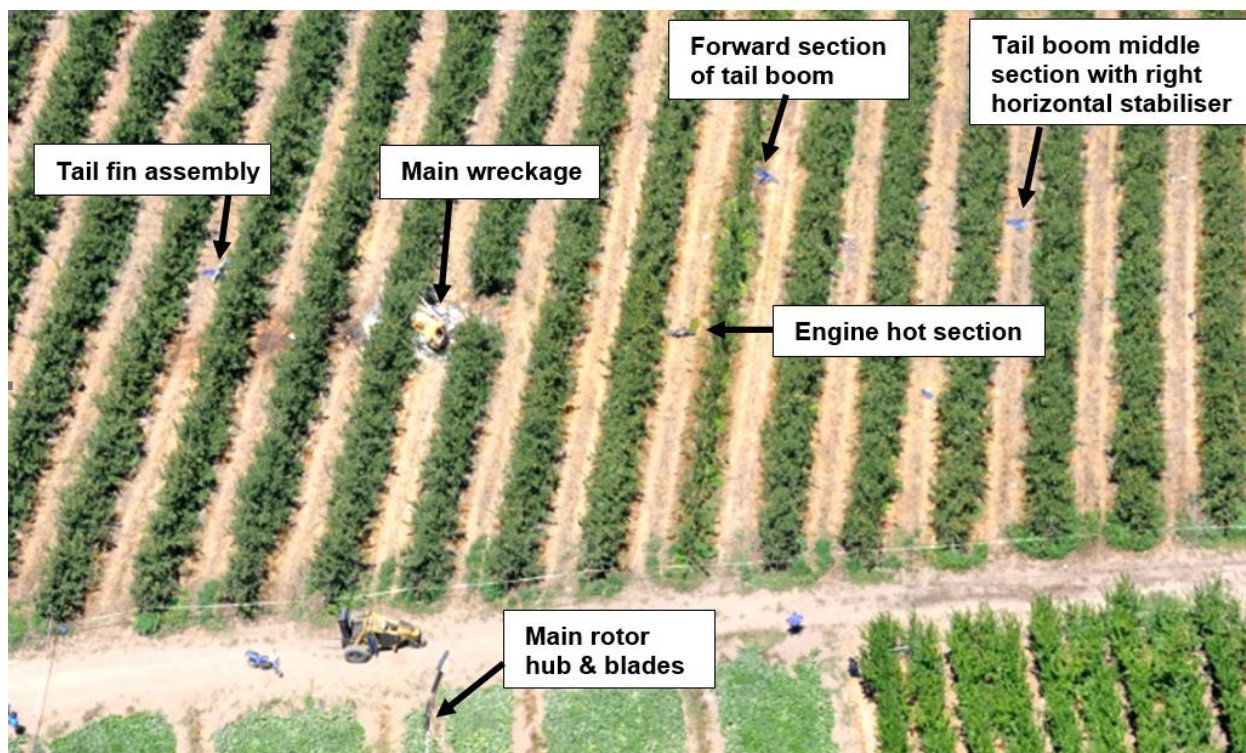
Figure 3: Wreckage distribution of main components.

The distribution of the wreckage is indicative of loss of control, which resulted in in-flight break-up following the main rotor impact with the fuselage and engine. This led to the helicopter’s debris being scattered in a diameter of about 80 metres (m) around the main wreckage.

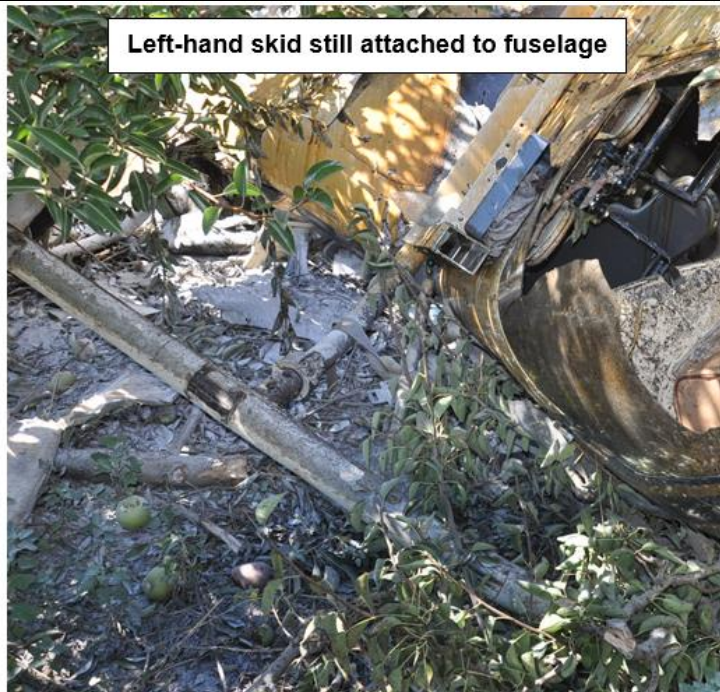
Left-hand skid still attached to fuselage

Figure 4: Top image: The left skid attached to the main wreckage. Bottom image: The front section of the right skid showing striation marks.

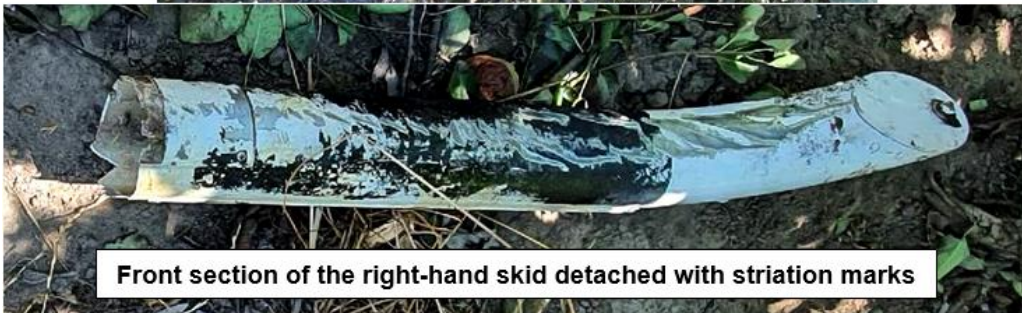
On-site investigation revealed that the helicopter collided with the top earth conductor of the high-tension electrical cables before crashing. Damage observed on the wreckage indicated that the helicopter was caught on its right skid by the cable, which was exhibited by the metallic striation marks, indicative of a wire strike on the upper surface of the skid’s front section. It is likely that the helicopter anchored on the right skid and rolled to the right, thus, the pilot moved the stick abruptly to the left. This resulted in the main rotor disk being disturbed, reaching its tether blocks and cutting the tail boom. As the main rotor was getting damaged, it severed the hot section of the engine.

Front section of the right-hand skid detached with striation marks

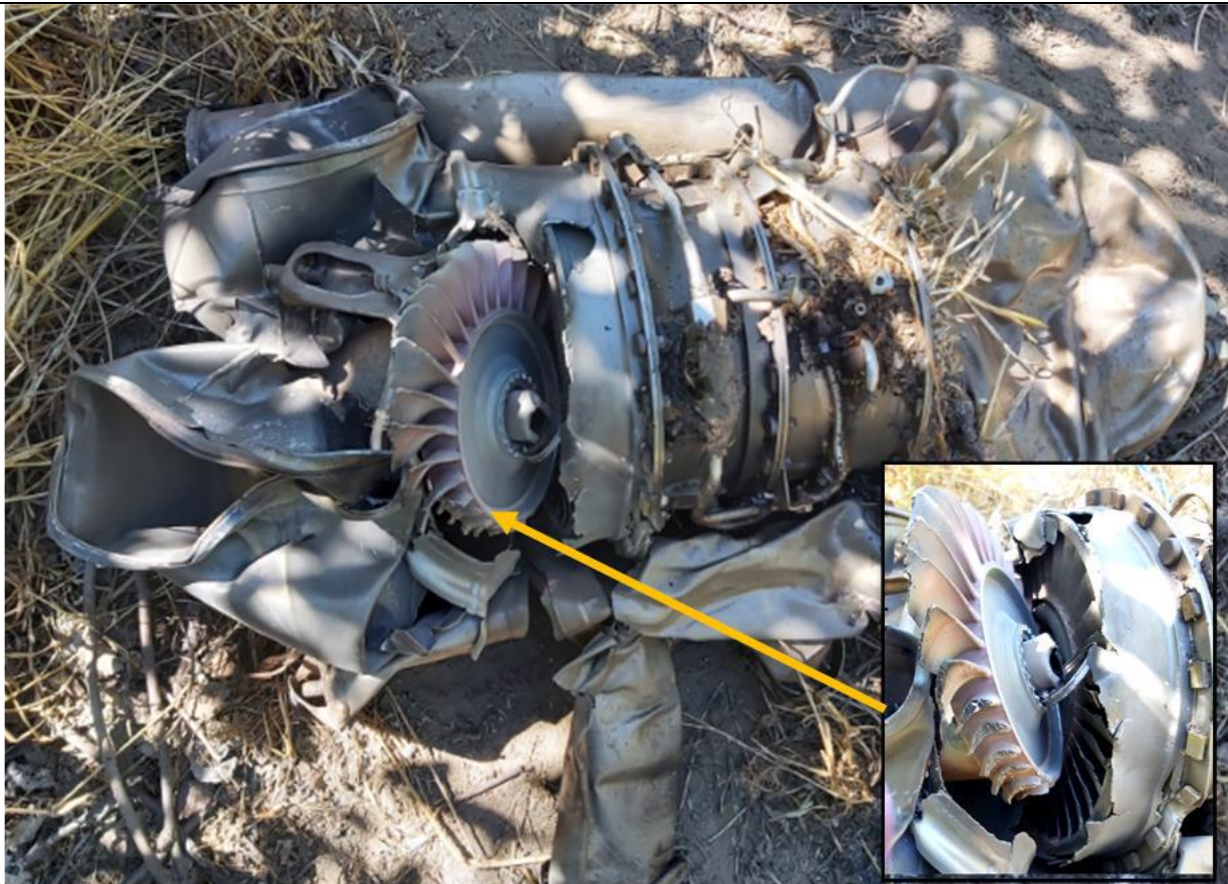
The inspection of the engine on site indicated that it was running at the time of impact. This is indicated by the rotary marks in the power turbine disk area and the broken blades in the direction of rotation. The engine exhaust duct was located forward of the engine position and was damaged.

Figure 5: Damaged engine assembly.
