HELICOPTER ACCIDENT REPORT AND EXECUTIVE SUMMARY

Reference:		CA18/2/3/9946	
Helicopter Registration	ZT-RRT	Date of Accident	21 January 2021		Time of Accident	1118Z	
Type of Helicopter	BELL 430		Type of Operation		Commercial (Part 138)		
Pilot-in-command Licence Type	CPL(H)		Age	40	Licence Valid	Yes	
Pilot-in-command Flying Experience	Total Flying Hours		2680.3		Hours on Type	561.7	
Last Point of Departure		Ultimate Heli, Midrand, Gauteng Province					
Next Point of Intended Landing		Hillcrest Hospital, Pietermaritzburg, KwaZulu-Natal Province					
Damage to Helicopter (Minor/Substantial/Destroyed)		Destroyed					
Location of the accident site with reference to easily defined geographical points (GPS readings if possible)							
8nm north-east of Winterton at GPS coordinates S28° 46' 52.66" E29° 40' 28.09";m Elevation at 3301 feet (ft)							
Meteorological Information	Surface wind 260° at 04kts; Temperature 29°C; Dew point 18°C; Visibility 9999m; Nil cloud; QNH 1020

Reference Number : CA18/2/3/9946
Name of Owner/Operator : National Airways Corporation (Pty) Ltd
Manufacturer : Bell Helicopter Textron
Model : Bell 430
Nationality : South African
Registration Marks : ZT-RRT
Place :

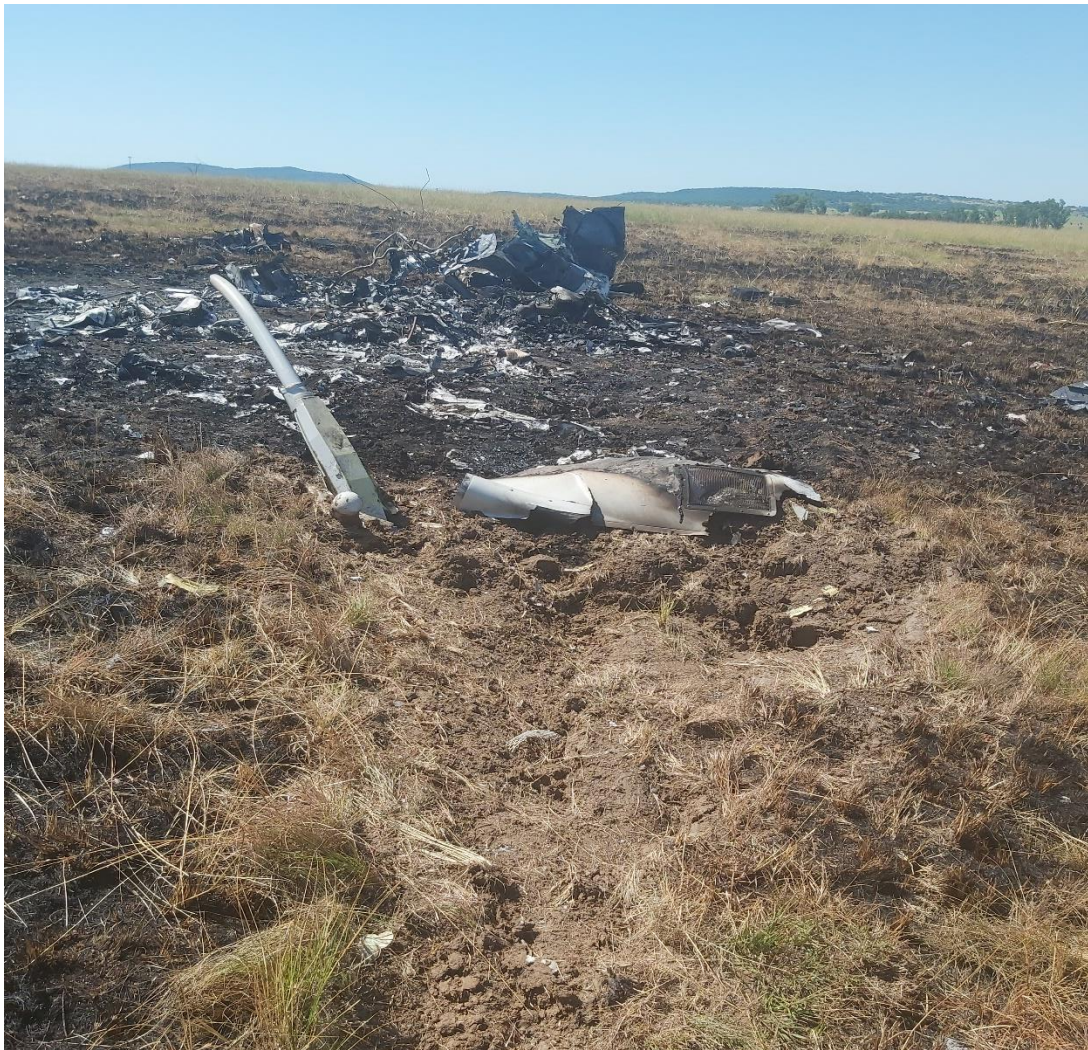
1.3.1 The helicopter was destroyed.

Figure 2: The helicopter's main wreckage at the site.

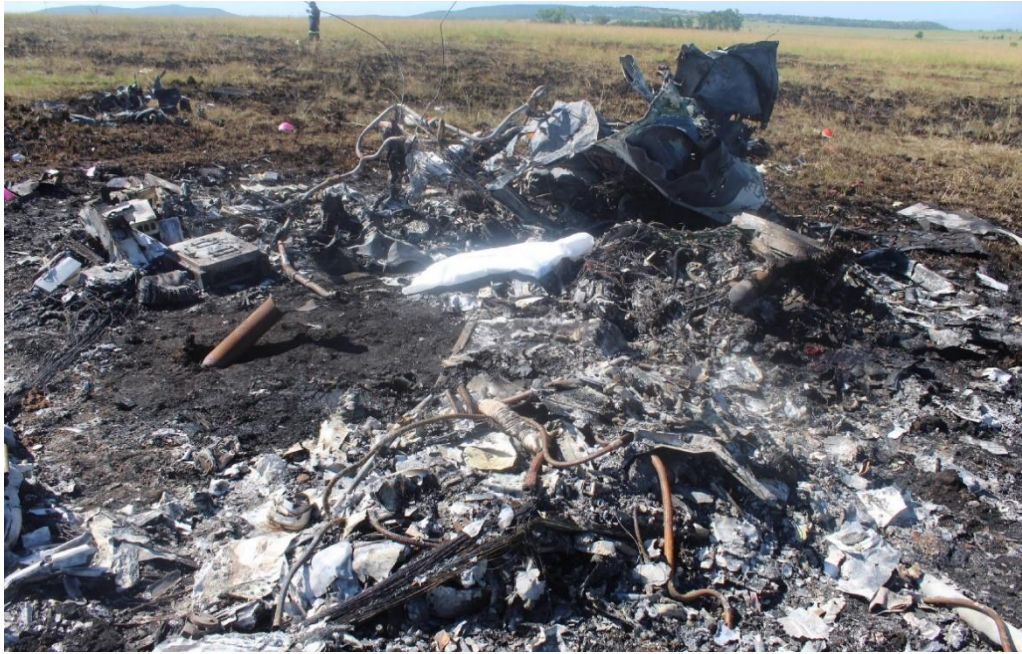
The main wreckage was characterised by the remaining parts of the helicopter which were damaged by fire after impacting the ground. The cockpit and cabin section along with the entire airframe had fire damage. Components of the instrument panel were scattered around the main wreckage. The engine fire extinguishers were among the components lying next to the instrument panel. The engine compartment, with engines still attached, was one of the major components that were identifiable from the burned wreckage. The engine cowling and the nose cone were some of the airframe parts found furthest from the main wreckage. The engine driveshaft indicated that it failed due to overload. The left fuel tank and main transmission assembly with two of its main rotor blades separated from the airframe and did not have any sign of fire damage. The green main rotor blade broke off from the main rotor head and was located 148m from the main wreckage. There were 12 pressurised oxygen bottles on site and one of the bottles had some indication of fire damage which caused it to explode; however, 11 of the bottles were accounted for. Debris from the damaged main rotor blade(s), pieces of Perspex from the helicopter windows and windshield (still attached to the overhead circuit breaker panel) were found north of the main wreckage.

Figure 6: Main wreckage post-accident.

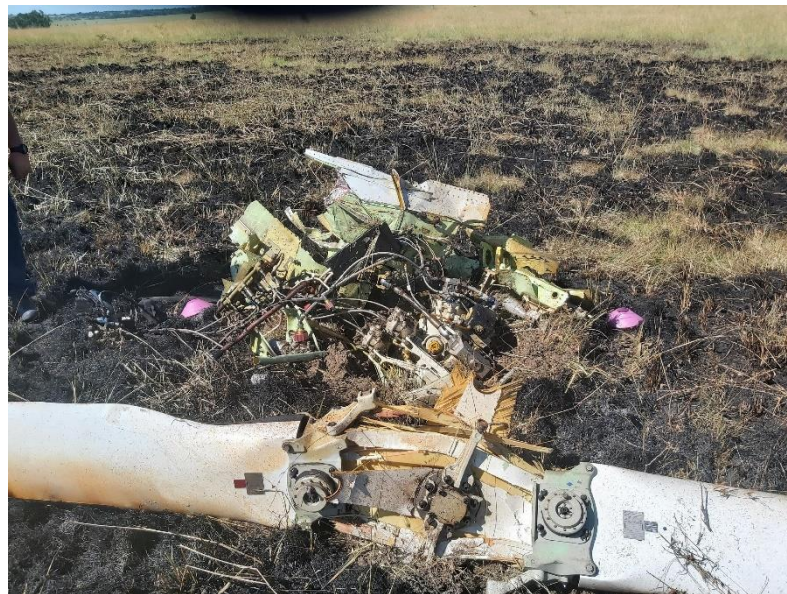
Figure 7: The main transmission assembly.

1.12.5 In Figure 7, the two blades marked Red and Blue were still attached to the upper yoke and rotor hub. The two upper stops aligned with them were broken off during the accident

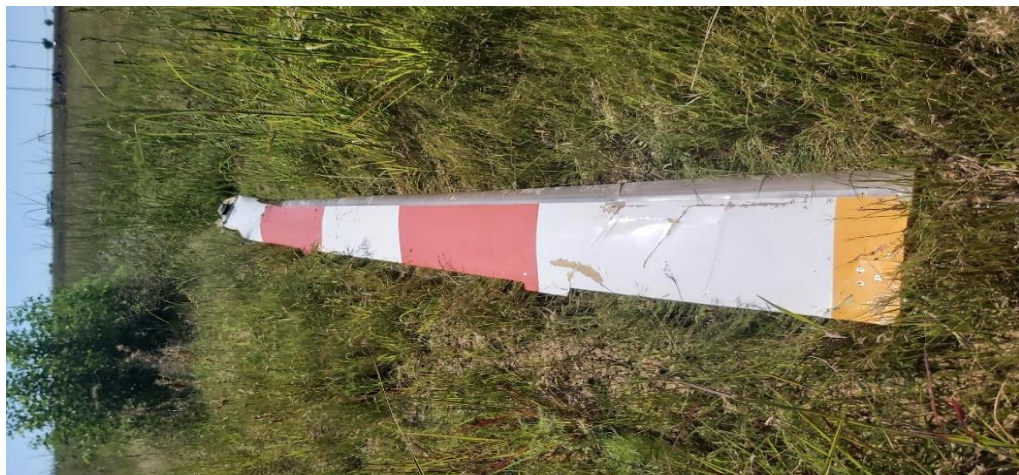
Figure 8: Green main rotor blade.

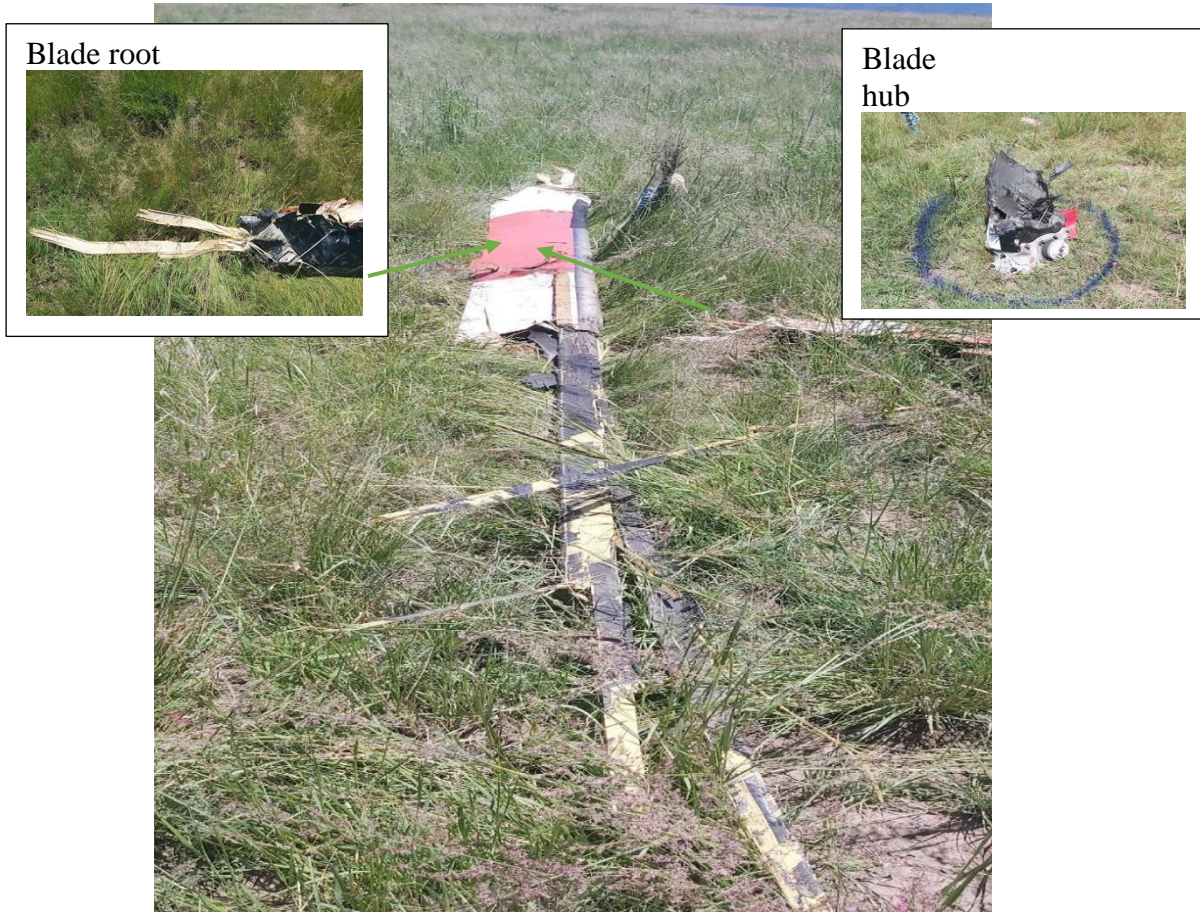
Figure 9: Orange main rotor blade located 94m from the tail boom.

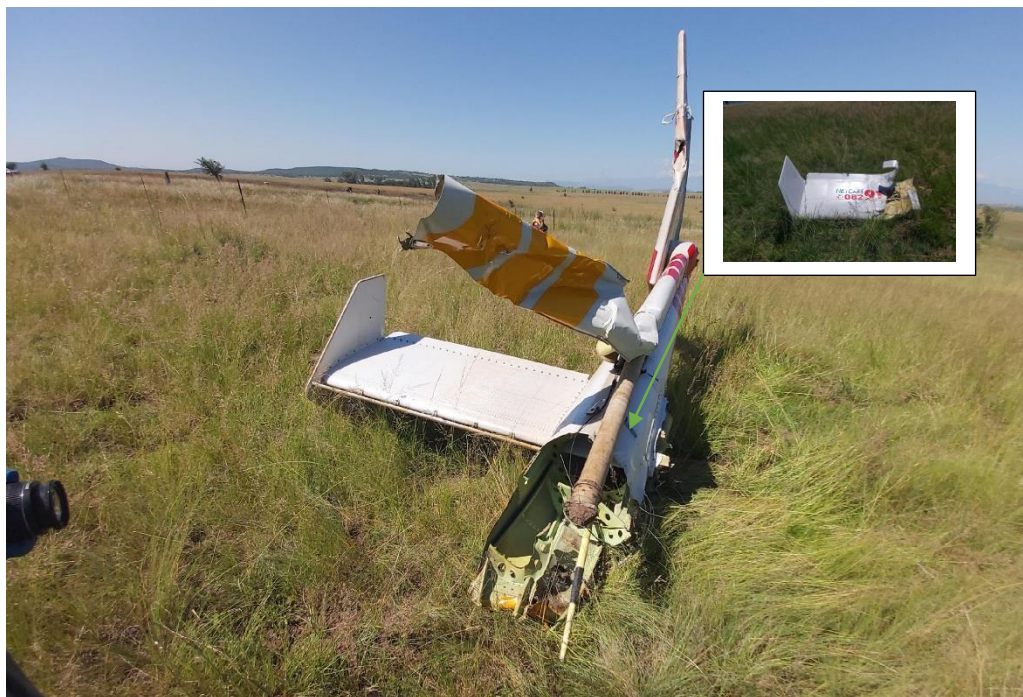
The tail boom, right horizontal stabiliser and vertical stabiliser were found north of the road, approximately 90m from the main wreckage. The damage observed to the tail boom was indicative of a main rotor blade contact on the left side and on the top side as indicated by the blade profile indentation mark on the tail rotor shaft cover. The tail driveshaft middle shaft was still attached to the tail boom. The driveshaft was observed to have rotational marks (in the direction of rotation) indicative of normal operation before impact. The left horizontal stabiliser had separated from the tail boom and was found 100m from the tail boom. Damages observed on the left horizontal stabiliser were indicative of an object which was severed by contact with the main rotor blade as the top-half of the vertical fin was missing. Two main rotor pitch link controls (one marked orange and the other blue) were also found closer to the tail boom. The tail rotor assembly was missing one blade, which had broken off from the tail boom and landed 79.3m from the main wreckage after separating from the tail boom. Damaged observed on the tail gearbox was as result of sudden stoppage. There was continuity observed on the 90° output shaft.

Figure 10: The tail cone assembly repositioned upright was located 129.9m from the main wreckage.
(Inset): Left horizontal stabiliser.

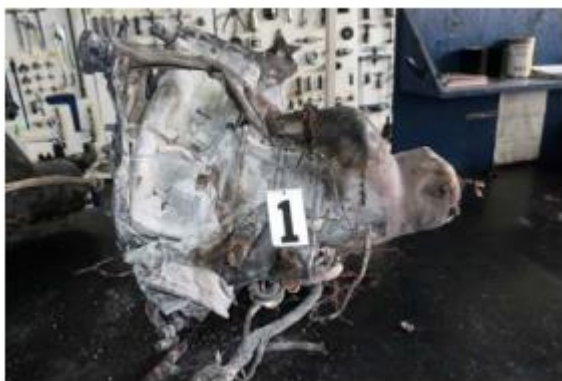
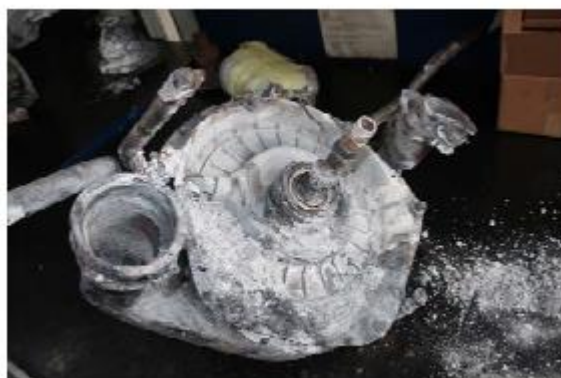
Figure 11: (Engine No.1) gearbox and turbine. **Figure 12:** (Engine No.1) compressor.

- *The gearbox of engine No1 was consumed by the post-crash fire and two gears were recovered - the Torque meter gear assembly and an idler gear. Neither gear displayed missing teeth or other pre-impact anomalies. The fuel system hydromechanical unit (HMU), which is normally mounted on the gearbox, was not recovered. The engine electronic control unit (ECU) suffered extreme thermal damage, so it was not interrogated.*
- *Several of the compressor impeller blades displayed mechanical damage to include bending opposite the direction of normal rotation. The outboard portions of the blades and aft side of the impeller were discoloured and scored consistent with contact between the rotor and surround stationary hardware while rotating. Corresponding rub indications were observed on the compressor rear support and shroud.*

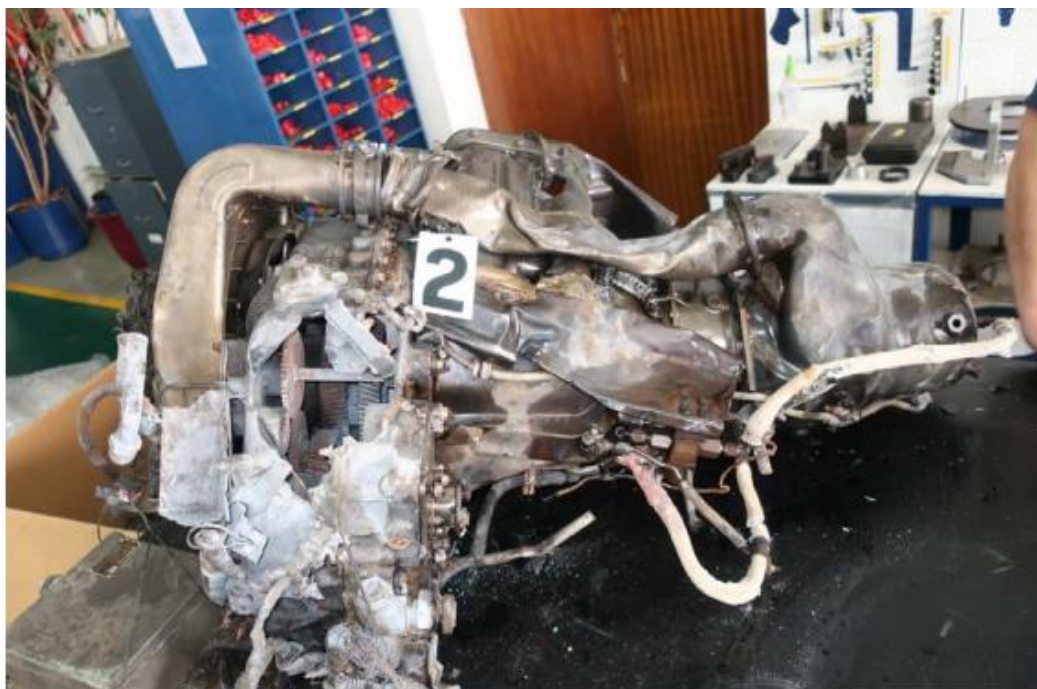
Figure 13: (Engine No.2) As it was recovered.

- *A field data download of the engine No.2 ECU was executed during the engine examination. The ECU includes an incident recorder function, which begins capturing engine and input parameters upon trigger actuation and records a line of data (“record”) every 1.2 seconds. The incident recorder, although functional, did not retain data in this event likely due to a sudden electrical power interruption as the aircraft broke up in flight. The ECU system also retains routine maintenance information throughout the life of the engine which is retained in the maintenance terminal section. The maintenance terminal data from engine No.2 indicated that there were no pre-event abnormalities which would have affected engine operation during the event. In the twin engine installation, the ECU also captures data when one engine is inoperative (OEI). As the engine No2 ECU data did not reflect any OEI events, it can be inferred that the engine No1 was operating normally prior to the event as well.*

- *No abnormalities were observed during the engine exam which would affect engine operation during the accident flight. The damage noted to both power turbine sections was consistent with a loss of load during the impact sequence and subsequent overspeed of the power turbine rotors. Multiple rotational and operational signatures were observed in both engines which confirm engine operation during the accident sequence.*

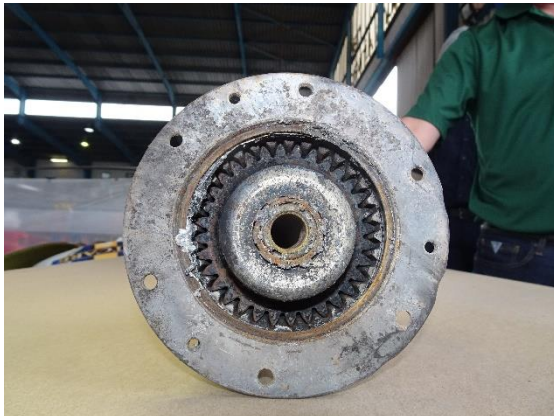
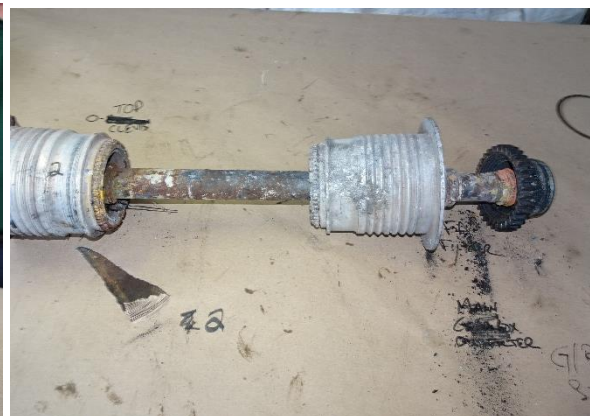
- *Both driveshafts got separated from the engine and transmission, and on examination they were found in good condition. On both ends of the two driveshafts, the inner spherical gears and outer gears were lined up perfectly, indicating no damage at all.*

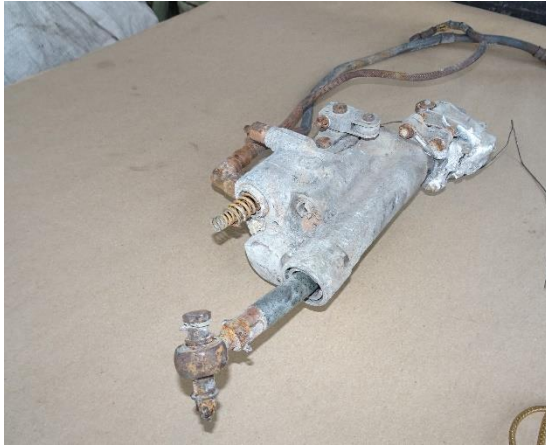
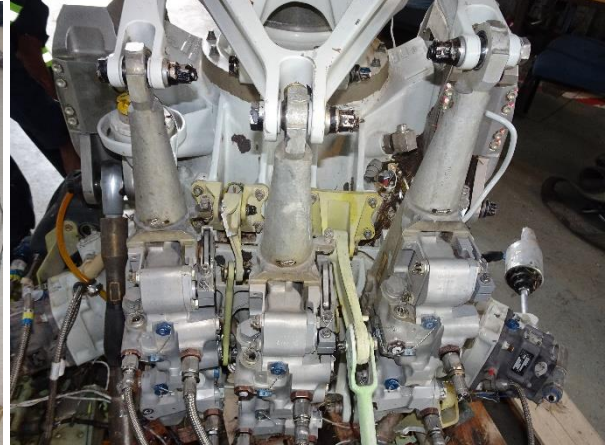
- *The tail rotor servo was completely burnt and could not be tested. The three dual hydraulic servos attached to the transmission that were removed from the transmission assembly were attached to a hydraulic rig to test their functionality. The left-side servo S/N HR673AB and right-side servo S/N HR619AB were tested on both systems and the piston extended and retracted to its full length of 6 inches. The middle servo S/N HR671AB could only be tested on one system because the other system had accident damage on the return line. The tested system also extended and retracted the piston to its full length.*

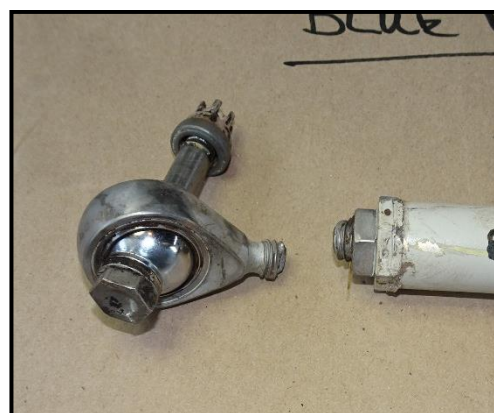
Diagram 3: Universal bearing assembly. **Figure 21:** Bottom rod end/bearing.

The comparative torque test results obtained shows the bottom bearing from the ORANGE Universal Bearing assembly (TTSN ~1705.5h) to have the highest resistance to rotation with a clear “ratchet” effect during rotation. “The “ratchet” effect can be attributed to the preferential positioning (stationary relative to outer raceway) of the bearing rollers during operation resulting in extensive localised wear. This noted resistance to rotation will affect the applied mean (average) stress profile on the clevis during operation. The noted “binding” at the ORANGE Pitch Horn inserts/top bearing interfaces can be a resultant effect of this resistance to rotation.

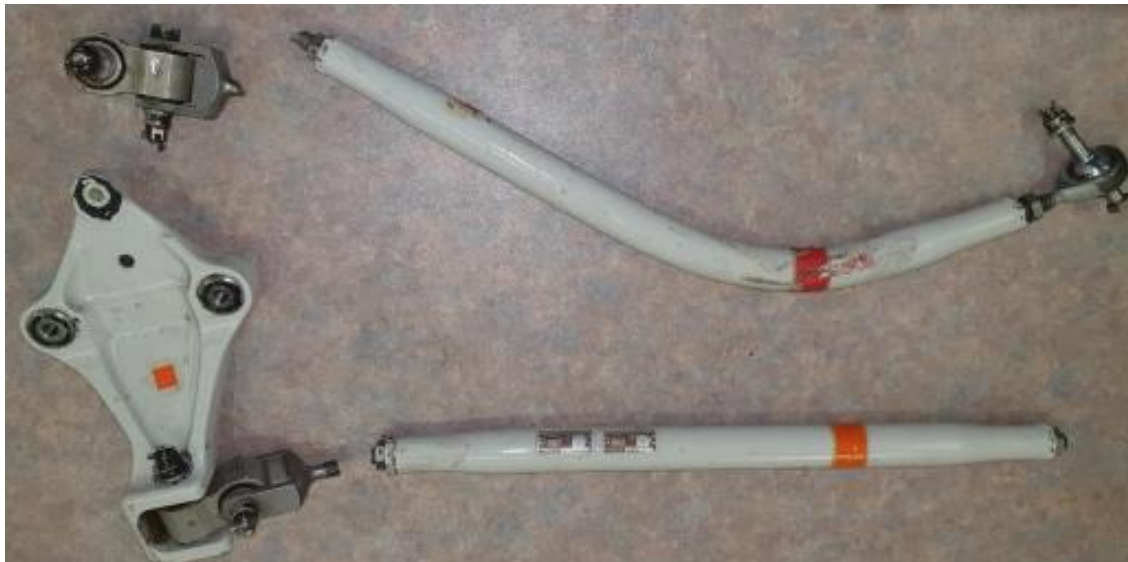
Figure 22: Orange and Red PCL.

The ORANGE and RED Clevises revealed fractures within the protruding threaded sections (Figure 22). The remaining BLUE and GREEN units revealed bending and impact damages only (Figure 23). The visual inspection of the ORANGE Clevis fracture surface revealed indications of a fatigue failure mode (Figure 24) suggesting it to be the primary failure initiating the accident sequence of events. The variation in impact damages between the ORANGE and the remainder of the M/R PCL Tubes (Figure 18) support this hypothesis. The RED Clevis as well as all the bottom PCL ends/bearings fractures and damages can be attributed to impact forces.

ORANGE Clevis: The fracture initiated within thread root between the shank and the lock-nut position. The fracture surface revealed clear inter- and trans-granular features at the two opposing initiation areas suggesting corrosion attack to be the primary contributing factor. On reaching the critical flaw size, the fracture progressed in fatigue failure mode up to final (fast) fracture. The fatigue fracture progression geometry conforms to a high cycle/low stress regime and with final fracture surface representing ~15% of the total area.

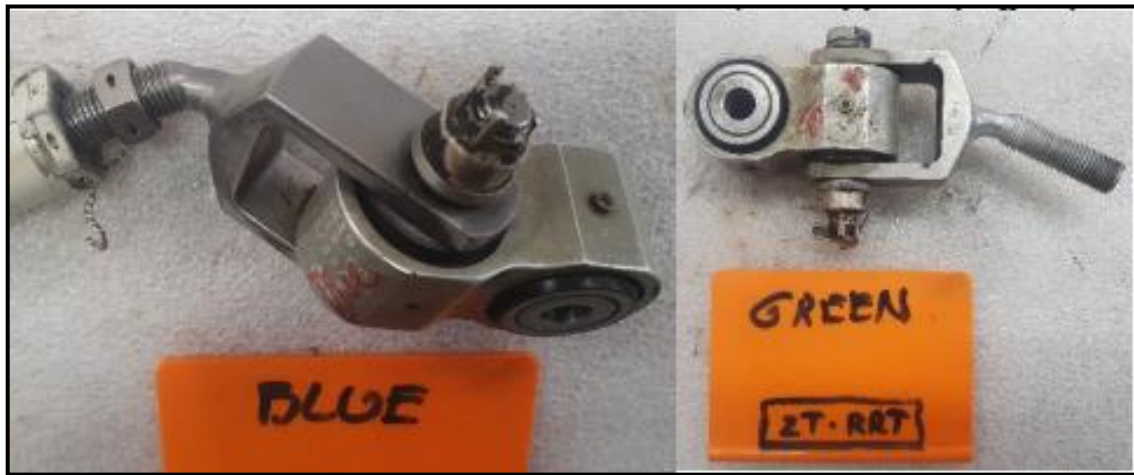
Figure 23: Clevises from the blue and green PCL.

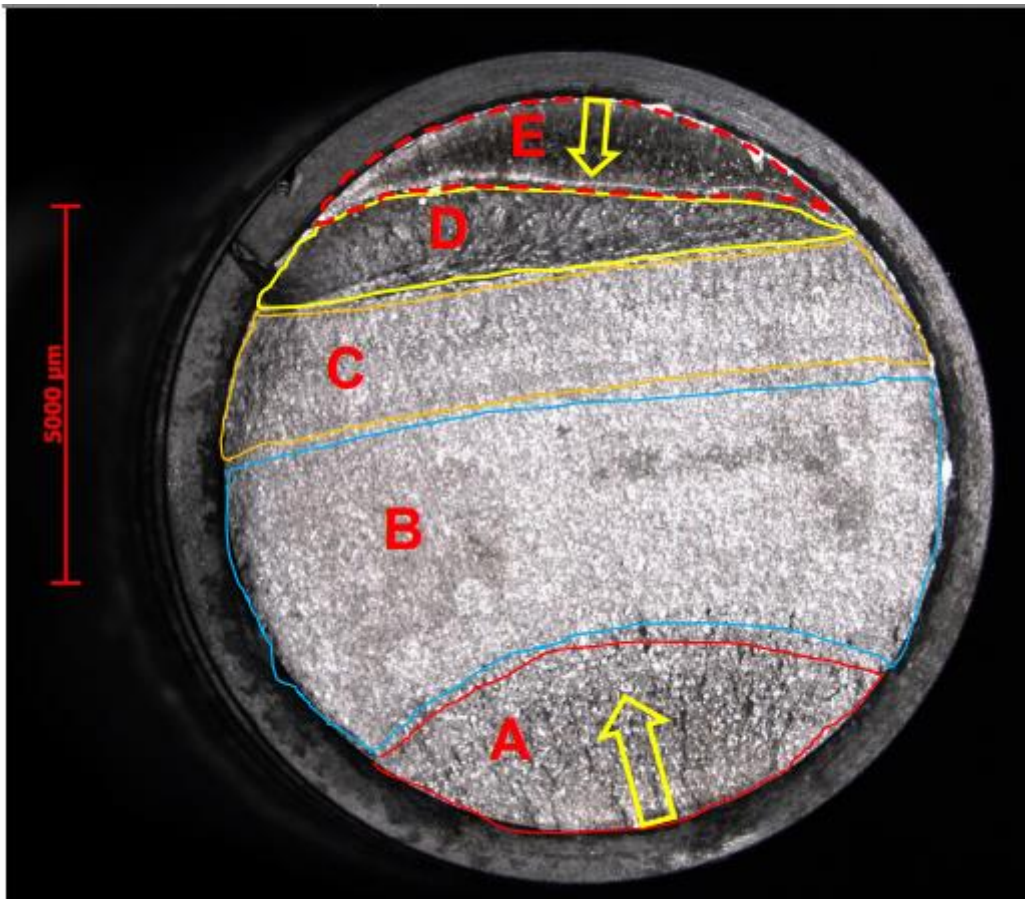
Notwithstanding, in the operating environment of the MR PCL Clevis under investigation, the initiation of a fatigue fracture due to the corrosion induced damages proved to be the predominant causational factor.

Figure 24: The Stereo-microscope inspection revealed a fracture surface geometry with distinct zones. The fatigue fracture initiated at opposing positions at the thread root and within Zones A and E, suggesting an alternating and opposing but unequal applied bending stress during operation.

Zone D depicts the fast (final) fracture position. The fatigue fractures progressed towards Zone D as indicated (Yellow arrows). Zone A represents the initial fracture start area, Zone B a stable fracture progression rate with Zone C indicating an increased progression rate due to the increasing nominal stress (applied stress/remaining thickness). The break-up of the protective cadmium (Cd) coating, acting both as a barrier to environmental exposure and as cathodic protection, will be detrimental to the corrosion resistance properties of the base alloy. The fracture surface morphology at the initiation area, Zone A, revealed extensive inter-granular attack with intermitted trans-granular. Both these morphological features are consistent with HE and/or SCC corrosion attack. Extensive post-fracture initiation pitting corrosion was evident (Yellow circles, in report) suggesting exposure to a corrosive environment for an extended period. Once the minimum flaw/crack size were reached at the end of Zone A, a fatigue fracture morphology became predominant in Zones B and C with the striation geometry suggesting a high cycle/low stress exposure with a clear progression direction (Yellow arrows). Zone D corresponds with fast, final fracture displaying the typical micro-void coalescence dimple morphology. Zone D represents approximately 15% of the total fracture surface area. Zone E displayed similar features to the Zone A's fracture initiation area with clear inter- and trans-granular features. The secondary corrosion attack (Yellow

dashed circles) is more severe than Zone A suggesting that either the fracture progression was arrested for a period following initiation while exposed to the environment, or the clevis was rotated (180°) during maintenance thus relocating the applied stress concentration to Zone A. The remainder of Zone E displays a fatigue fracture mode up to Zone D. Thread roots adjacent to the fracture initiation revealed clear indications of secondary fractures and surface plating break-up.

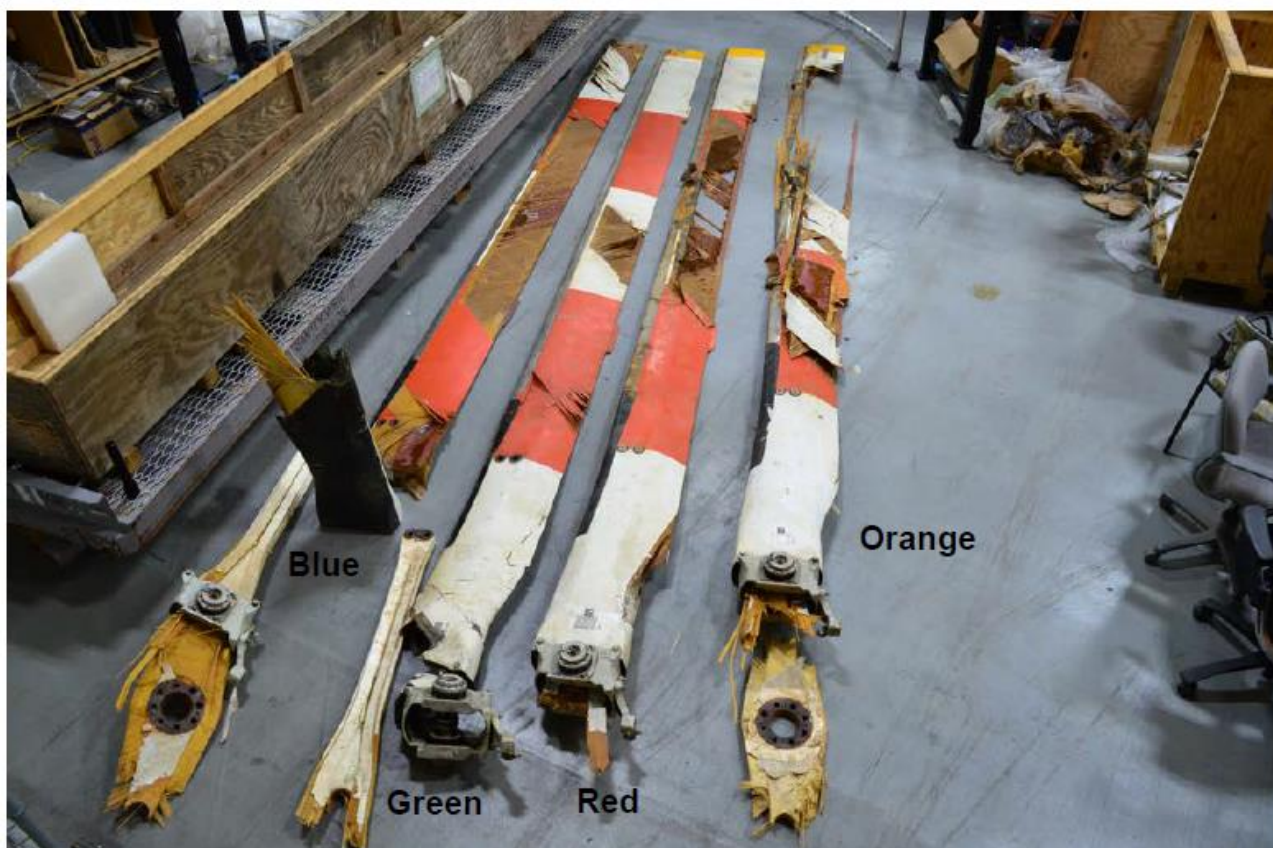
The four blades and yokes were received as shown in Figure 25. All fractures observed on the blades and yokes were consistent with overload. There was no rubbing damage, indicative of a delamination prior to fracture, observed between the plies of the composite yokes.

Orange: *The abrasion strip was missing from the outer third of the Orange blade’s span and the spar had broken from impact damage. The wiring tangled in the fractured spar material*

was reportedly traced to wiring found only in the cabin. The extent of the damage to the blade and the presence of the wiring suggested the Orange blade was the first to strike the cabin.

Red: The Red blade followed the Orange in rotation and had impact damage to its leading edge in a similar location (span-wise), but to a lesser extent.

Green: The Green blade fractured from the portion attached to the leading-edge blade adapter bolt. The blade remained attached to the yoke and adapter at the aft adapter bolt.

Blue: The Blue blade fractured in the cuff portion between the adapter and the blade attachment bolts. The aft tip weight package was missing. It could not be determined if the tip weights were lost during the accident sequence or as part of the recovery process.

Figure 25: The damages sustained by the blades of a Bell 430, registration D2-EYI.
