AIRCRAFT ACCIDENT REPORT AND EXECUTIVE SUMMARY

Reference:	CA18/2/3/9952	
Aircraft Registration	ZS-XAT	Date of Accident	4 February 2021		Time of Accident	0932Z
Type of Aircraft	Air Tractor AT-502B		Type of Operation		Private (Part 91)	
Pilot-in-command Licence Type	CPL	Age	67		Licence Valid	Yes
Pilot-in-command Flying Experience	Total Flying Hours	21 932.3		Hours on Type	8560.0	
Last Point of Departure	Lanseria International Airport (FALA), Gauteng Province, South Africa					
Next Point of Intended Landing	Hosea Kutako International Airport (FYWH), Namibia					
Location of the accident site with reference to easily defined geographical points (GPS readings if possible)						
Letsatsi Game Lodge, North West province (GPS position: 25°40'4.0" South, 026°53'7.8" East at an elevation of 4500ft)						
Damage to Aircraft	Destroyed					
Meteorological Information	Wind: 270° at 1kt; Temperature: 22°C; Dew Point: 20°C; Visibility: Unknown; Cloud: Broken at 2000-3000ft AGL; QNH: 1019 hPa

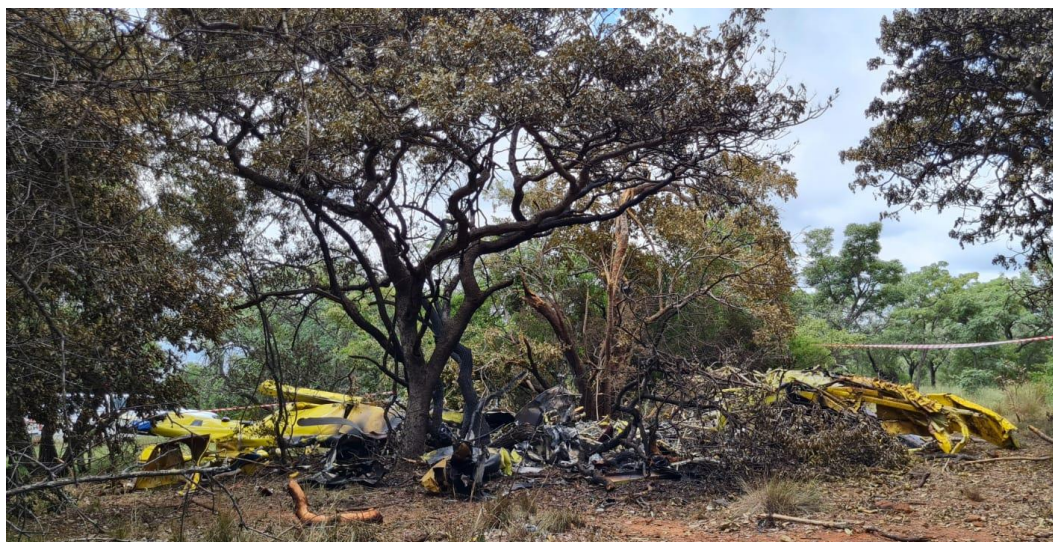
1.3.1 The aircraft was destroyed by impact forces and a post-impact fire during the accident sequence.

Figure 3: The aircraft at the accident site.

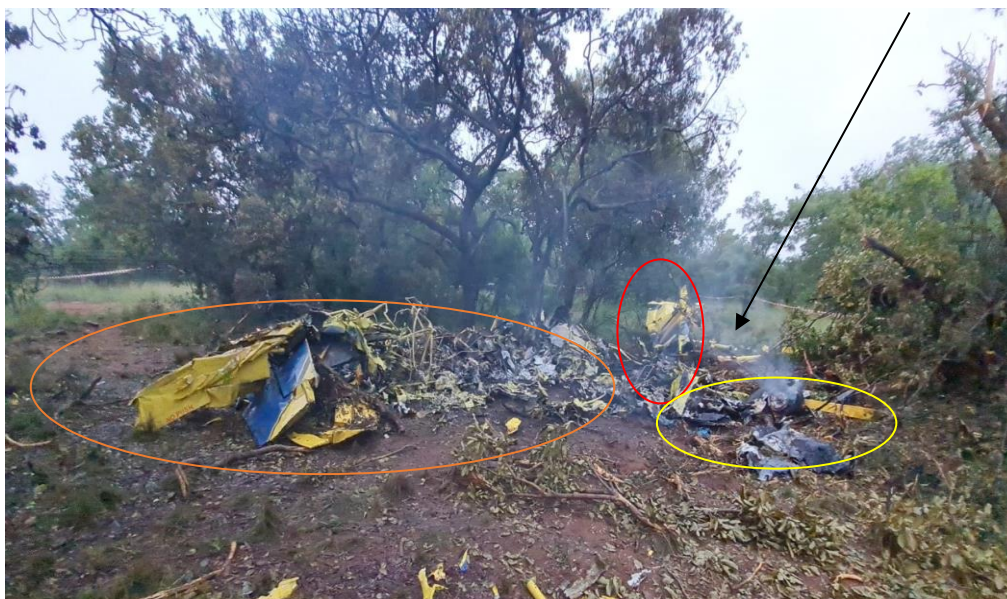
1.12.2 On-site inspection showed signs that the aircraft was in a high rate of descent in a steep angle. It approached from a south-easterly direction and flew in a left bank through the trees, severing the ones on its right-side path (Figure 6). The tail section folded onto the cabin section and the aircraft skidded to the left, leaving behind the severed right wing; the right stinger was still attached at impact point. A post-impact fire ensued and burnt the cabin, some parts of the left wing, engine and the trees on the left-side path (Figure 6). The black arrow (Figure 6) shows the impact direction; the red circle indicates the severed right wing; the yellow circle shows the severed undercarriage; and the orange circle indicates the rest of the aircraft.

Figure 6: The wreckage layout post-accident.

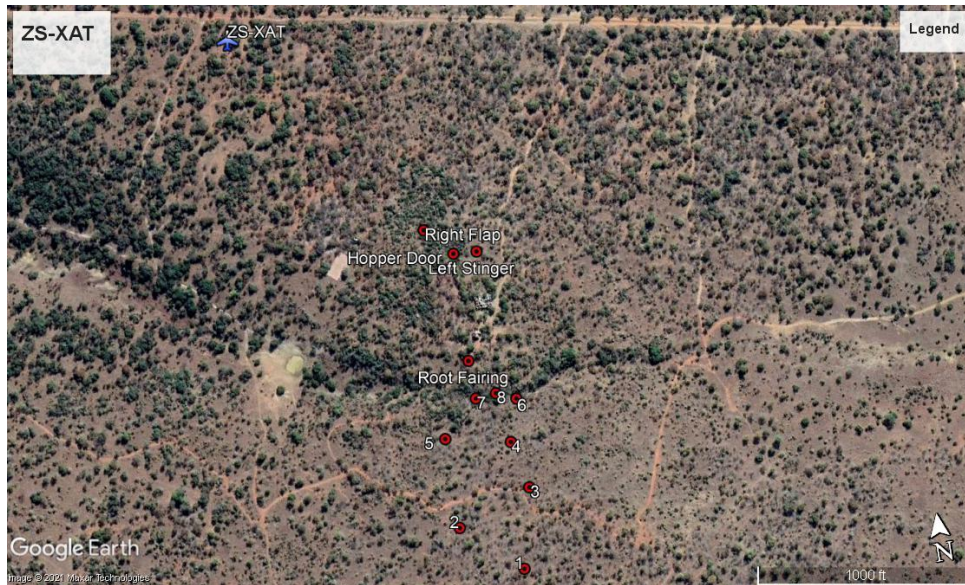
1.12.3 Parts of the left wing tip were found to the south of the main wreckage with the furthest being 1km south. The red dots (1-8) in Figure 7 represent different locations where these parts were found. The left-wing root fairing (Figure 8 top right) was located 550m south of the

Figure 7: The wreckage distribution.

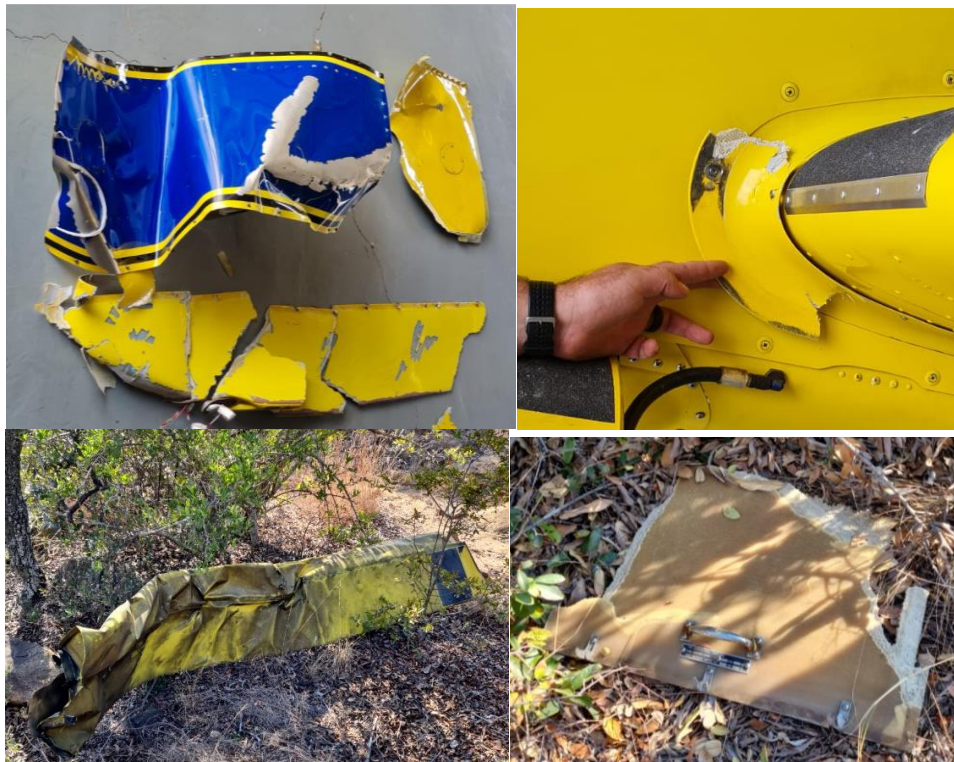
wreckage. The left stinger (Figure 9) and hopper door (Figure 8 bottom right) were located 450m from the wreckage, while the right flap (Figure 8 bottom left) was located 350m south of the wreckage.

Figure 8: Parts of the left wing tip (top left), left root fairing (top right), right flap (bottom left) and hopper door (bottom right).

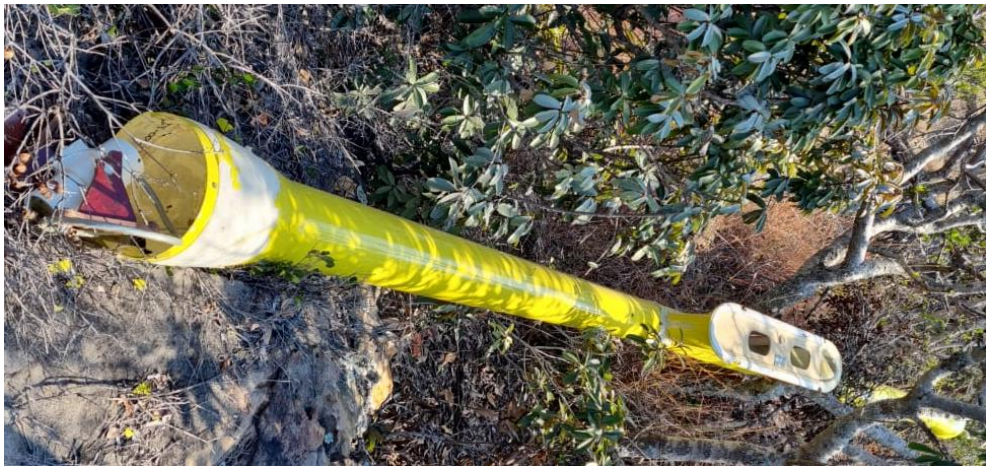
Figure 9: The left-wing stinger.

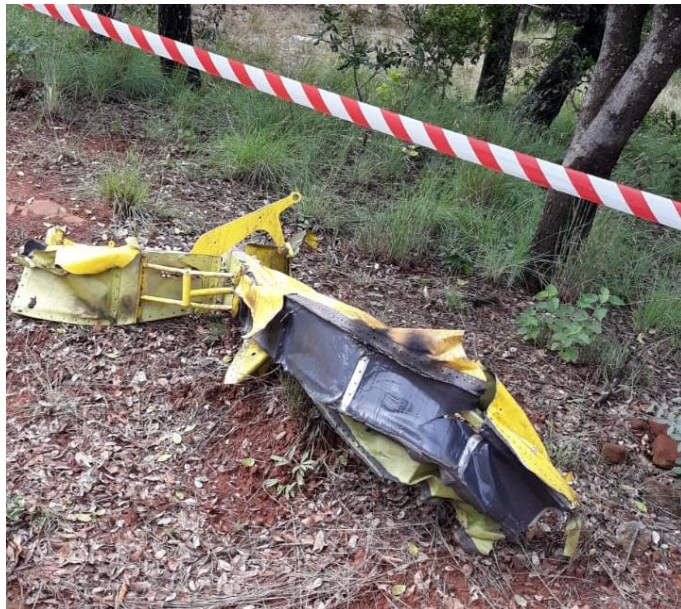
1.12.4 One of the left-wing aileron attachments together with a piece of left-wing main tank projected 15 metres (m) north of the wreckage when the aircraft impacted the ground.

Figure 10: The left-wing aileron attachment.

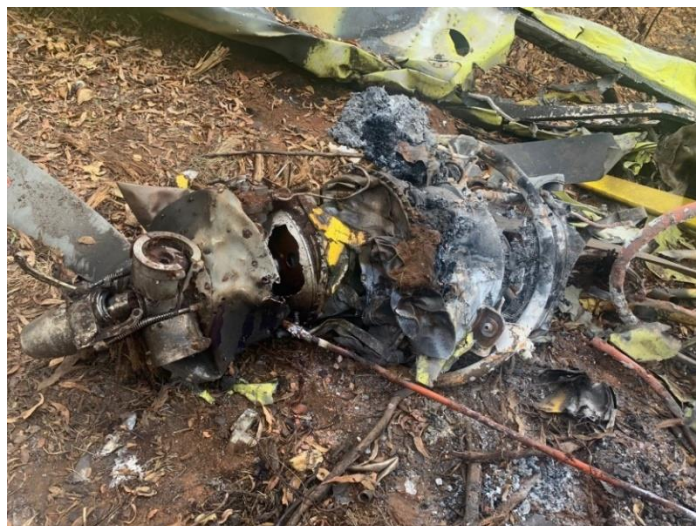
1.12.5 The engine was burnt by post-impact fire. Damage to the engine was due to impact forces.

Figure 11: The engine post-accident.

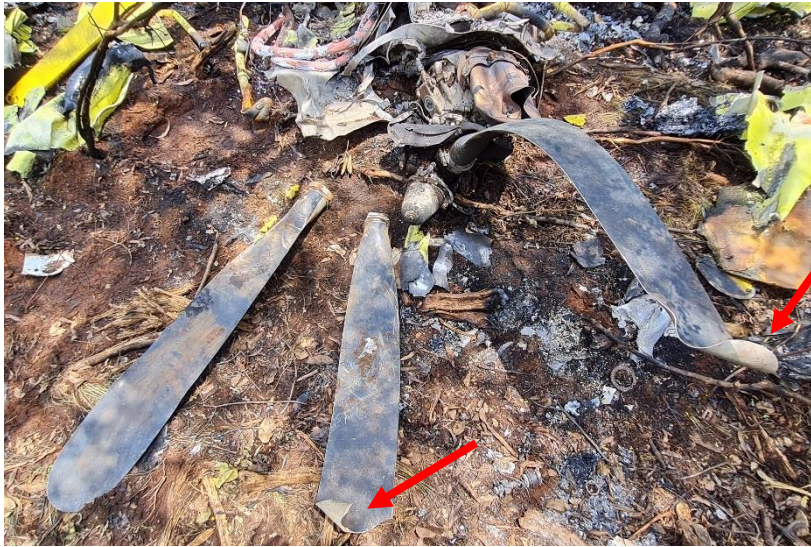
1.12.6 Two of the propeller blades were severed on impact and the third was still attached to the hub. All three blades showed signs of rotation and damage caused by impact.

Figure 12: The propeller blades showing rotation signatures on the tips.

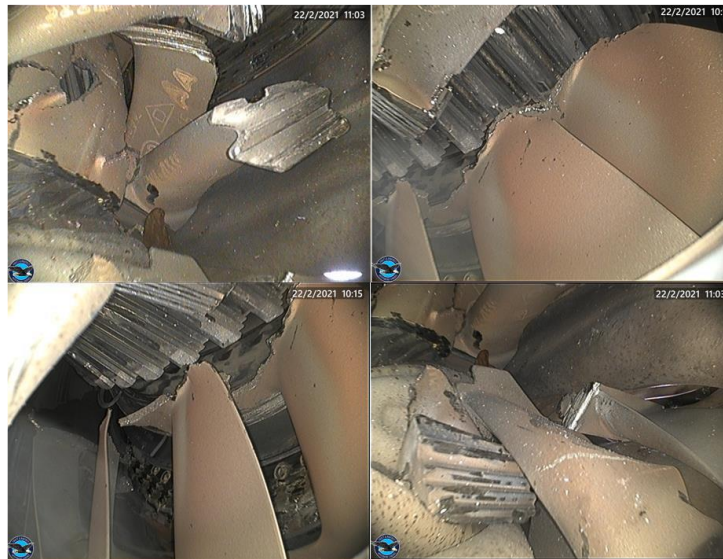
- Borescope inspection showed several PT blades were no longer in the disc fir-trees and several PT blades were in the exhaust case (Figure 12). PT blade shrouded tips showed rubbing wear on the blade fir-tree faces and platform (Figure 13).

Figure 12: PT blades in the exhaust case.

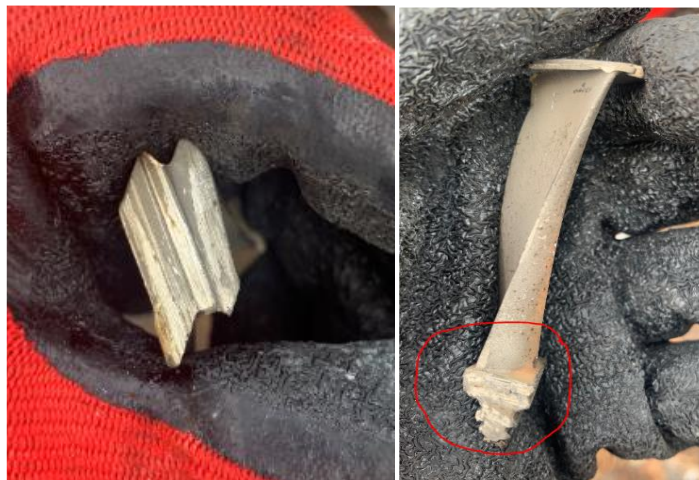
Figure 13: PT Blade shrouded tips.
