DUTCH
SAFETY BOARD

Loss of control after opening of canopy, near Kornhorn

The Hague, February 2023

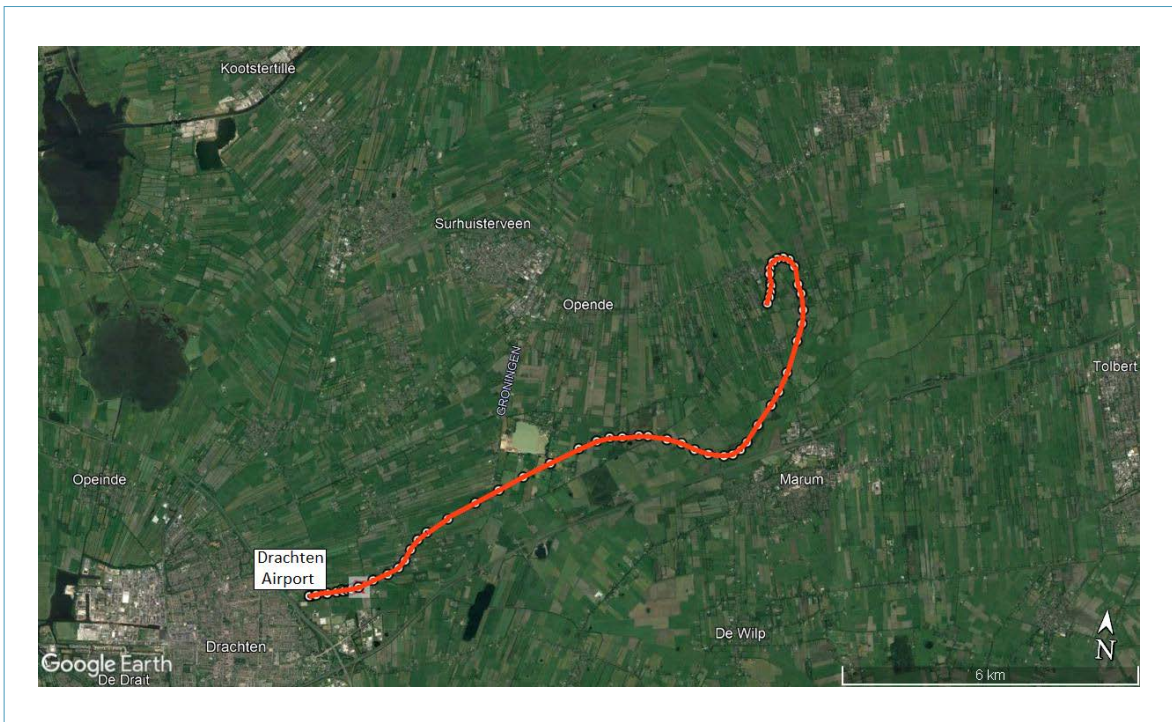
Figure 1: Reconstructed flightpath. (Source: Google and Dutch Safety Board)

altitude of approximately 760 ft, decreasing the airspeed to 70 kts. From the altitude of 760 ft, the aircraft descended until the end of the recordings. The airspeed during the descent increased to around 90 kts. The last recordings of the speed are not considered reliable (see Figure 2).

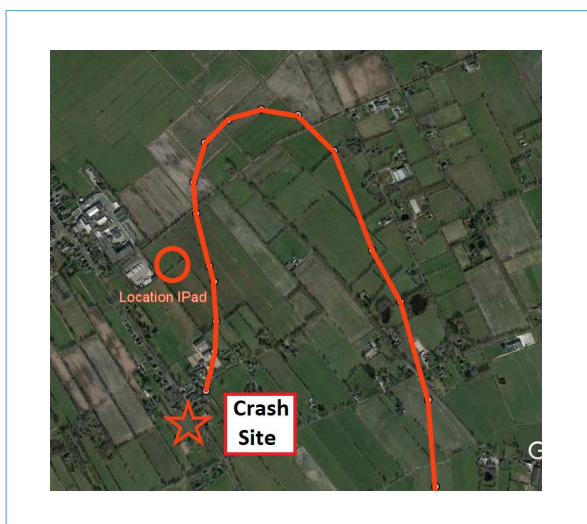
Figure 3: Last part of the flightpath. (Source: Google and Dutch Safety Board)

Eye-witnesses observed the aircraft flying near Kornhorn, about 11 kilometres northeast of Drachten Airport. Several witnesses stated the aircraft pitched down and up, followed by a dive towards the ground. Witnesses saw objects flying out of the cockpit and one witness stated the canopy of the aircraft appeared to be open. Light items, like papers, were found in the wide surroundings along the last part of the flight path. Heavier items, like the iPad, keys and aircraft logbook, were found close to the flight path, around 600 metres before the crash site (see Figure 3).

A witness made a film recording on which the last part of the flight can be seen in the background. When the aircraft appears on screen, it is in a steep dive with an estimated angle of 45 degrees. Slightly later, the nose down pitch decreases slightly after which the aircraft disappears from view. The aircraft is visible in the recording for around four seconds.

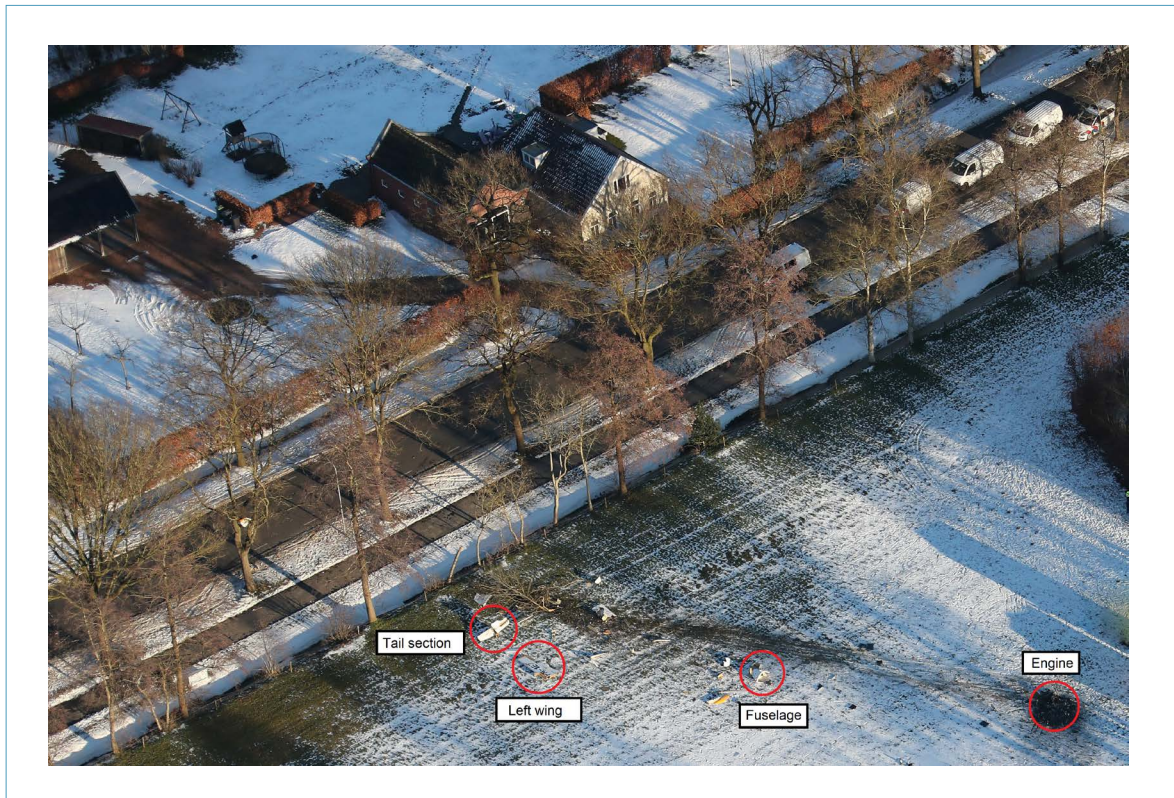
Figure 4: Crash-site. (Source: Aviation Police)

The aircraft was destroyed as a result of the crash and the post-impact fire. Part of the wing was found in a ditch near where the aircraft struck the trees. A large part of the tail-section was found together with the branches that were broken as a result of the impact. A large part of the canopy frame was found near the tail section. Several other aircraft

parts were scattered across the meadow. The engine was found several meters beyond the main aircraft wreckage (see Figure 4).

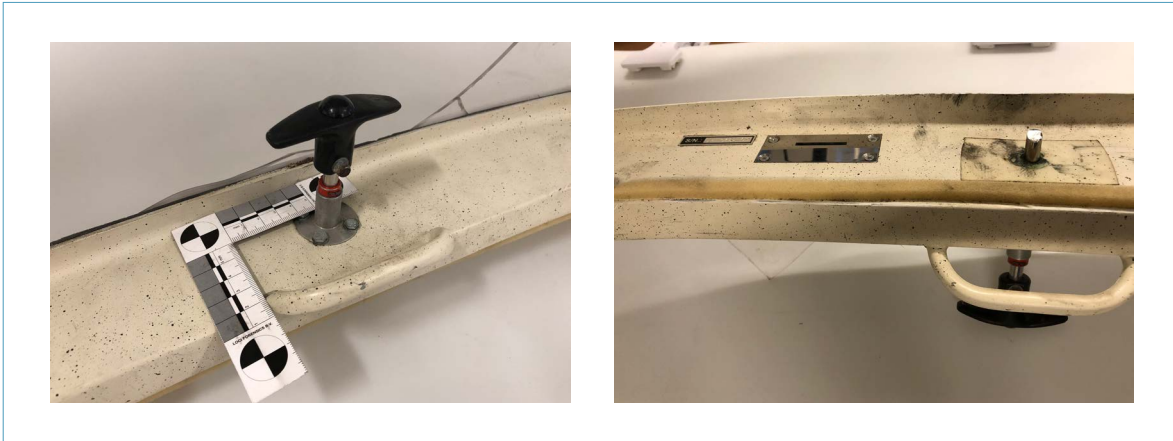
Figures 7a and 7b: Open/closing handle with red ring and locking pin of PH-4E7. (Source: Dutch Safety Board)

The latching and locking system is located in the middle and upper rear section of the canopy. It consists of a handle used to push or pull the canopy towards the open or closed position. This handle has a red ring that indicates whether the canopy is closed properly (see Figure 7a). Further, the locking system consists of the spring-loaded handle which pulls a locking pin (see Figures 7b and 8a) forward and out of the fuselage socket (see Figure 8b) to unlock the canopy or pushes the locking pin rearward into the fuselage socket to lock the canopy. Finally two guiding pins at the rear and to the side of the canopy position the canopy correctly into two slots in the fuselage when in the closed position (see Figures 9a and 9b).

The canopy frame and the relevant part of the fuselage were found damaged. Investigation revealed that the latching and locking system was undamaged and functioned without problems.

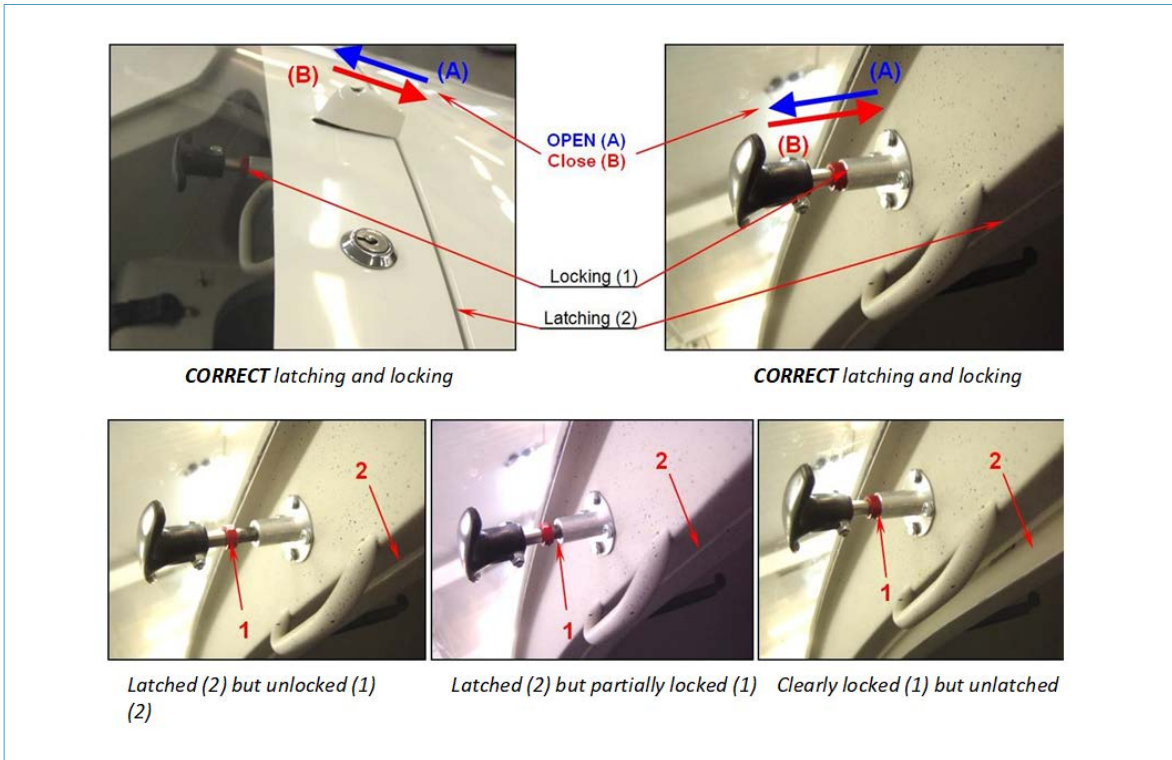
Figure 10: Examples of correctly and incorrectly closed canopies. (Source: POH Aerospool WT9, issued 20 January 2015)

The latching and locking system (handle and indication) is positioned above and behind the pilot's head. The pilot must look up and to the back to check that the handle is in the correct position.

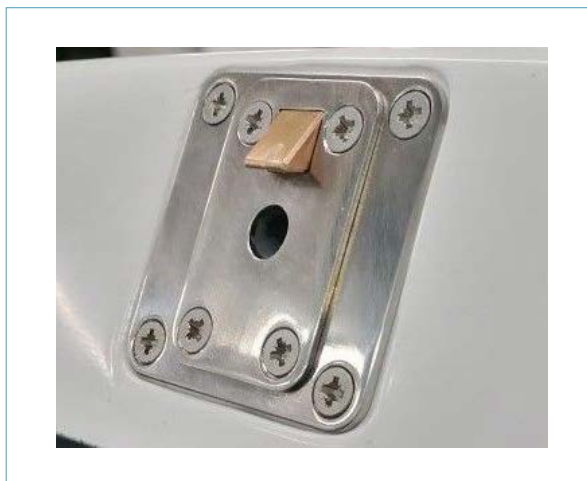
Figure 12: New lock with an additional safety latch. (Source: Aerospool)

Manufacturer Recommendation DV WT9 10B/2019 was issued on 4 April 2019. This recommendation applies to all WT9 Dynamic MLA.⁷ It recommends to install a new canopy lock with an additional safety latch and sensor, which holds the main latch after plug-out from the canopy lock socket and a check lamp on the instrument panel as an indication of insufficient plug-in of the main latch (see Figure 12).

The installation of the canopy lock with safety latch and sensor as recommended by the manufacturer had not been installed on the aircraft at the time of the accident. The board of the flying club was of the opinion that implementation of this recommendation was not necessary. Why and when this decision was made could not be determined.
