Final report RL 2022:02e

**Accident at Skeberg, Dalarna County, on
16 March 2021 involving the helicopter
SE-JVF of the model Robinson R44,
operated by a private individual**

File no. L-15/21

6 May 2022

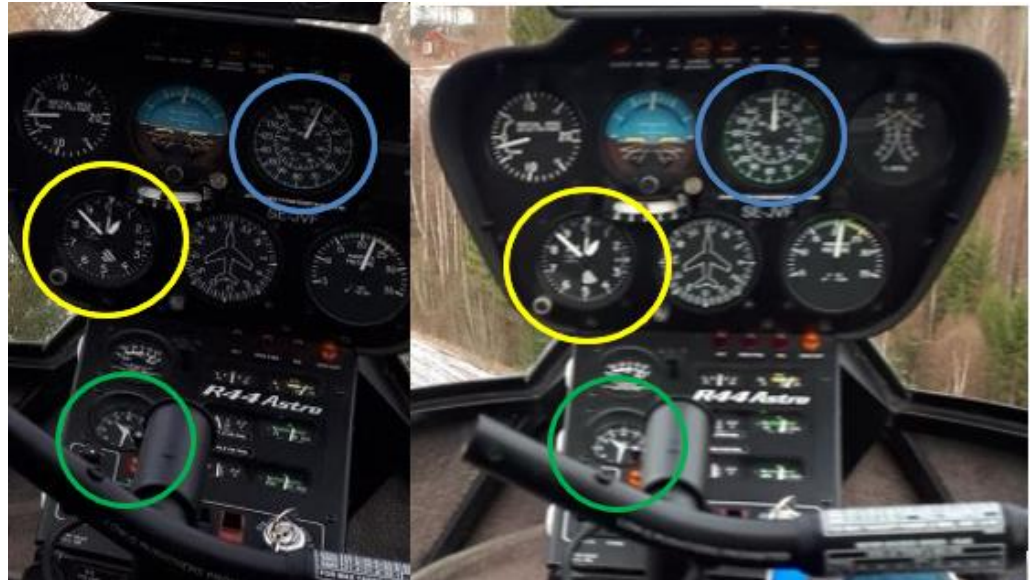
Figure 3. Indicated air speed (blue marking). Altitude (barometric height above sea level in feet, yellow marking) is the same on both occasions. The clock on the instrument panel (green mark) was not set to the correct time. The pictures are cropped by SHK. Photo: Private.

The pictures were taken during the last part of the approach to the field. The second hand on the clock on the instrument panel shows that the right image was taken 50 seconds after the left. The position and altitude were about the same on both occasions. In the left picture the indicated speed was 23 knots and in the right picture the speed was 0 knots and the uncontrolled right yaw had started.

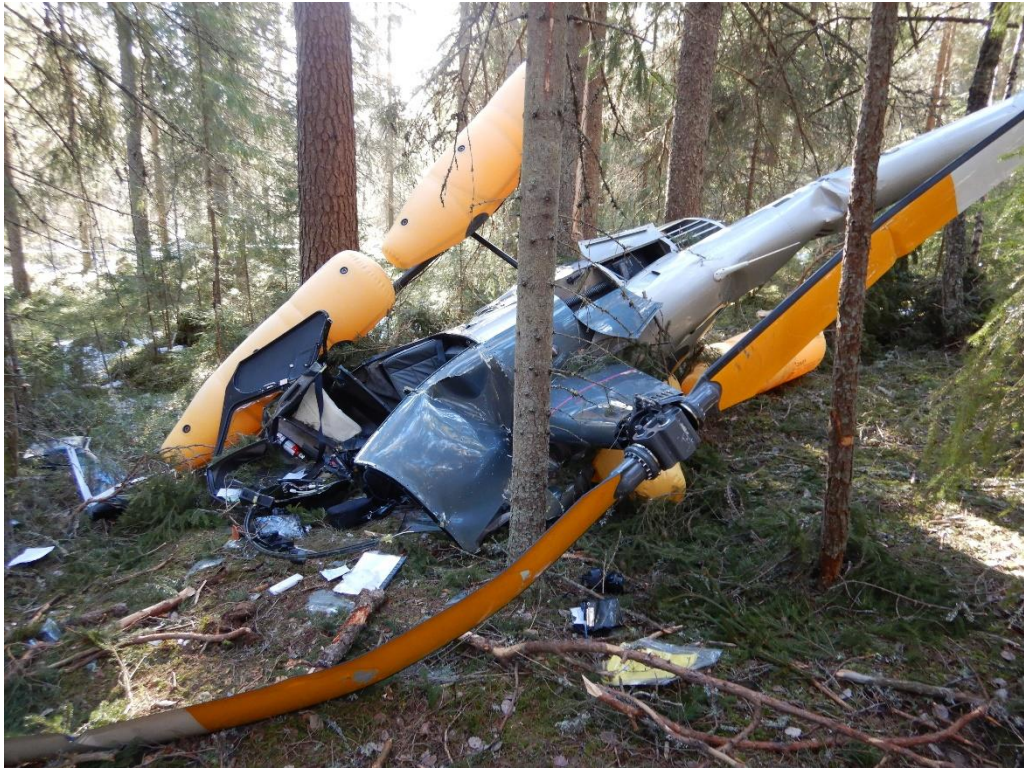
Figure 11. The aircraft wreckage.

The wreckage was located in one place. One main rotor blade was, however found 32 metres from the wreckage. The tail rotor, with stabilizer and the bulk of the tail rotor drive shaft was two metres behind the wreckage. The tail rotor drive shaft was twisted and had broken. The tail rotor blades did not have any damage caused by rotational forces. The tail rotor hub and stabilizer were damaged on the left side.

The cabin was substantially deformed on the left front part and the helicopter was resting on its front left side.

The emergency floats were deployed and the cable to the release mechanism had been stretched in conjunction with the deformation that arose during the crash.

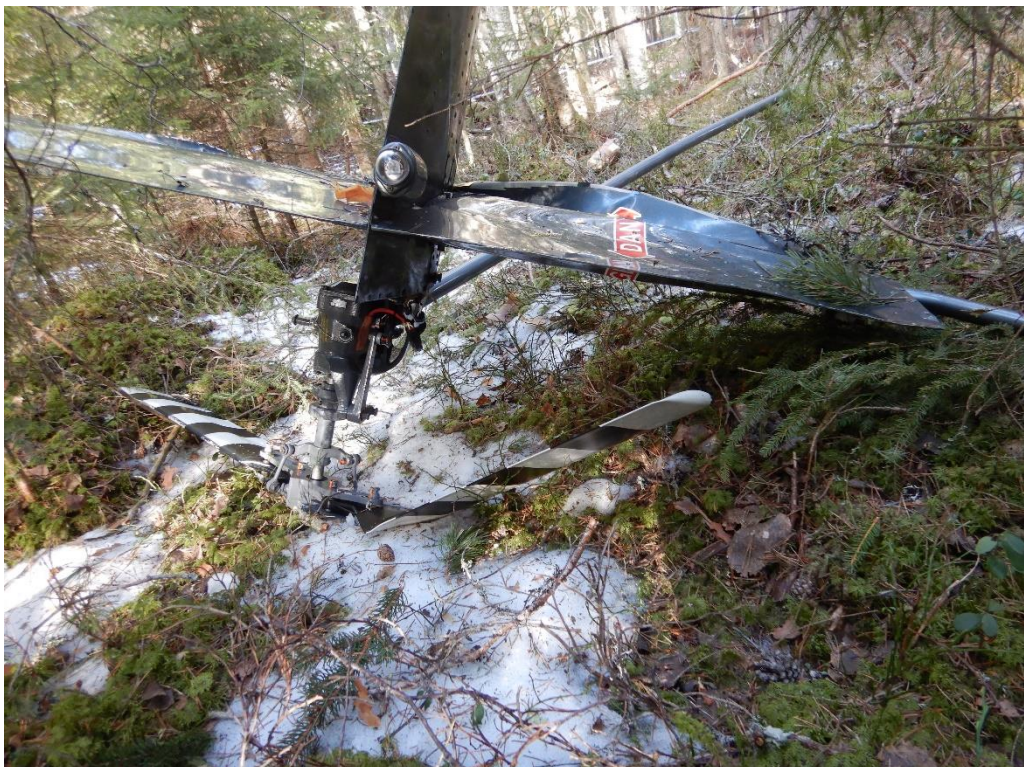
Figure 12. Tail rotor with drive shaft and stabilizer. Damage to the left side of the stabilizer and tail rotor hub.

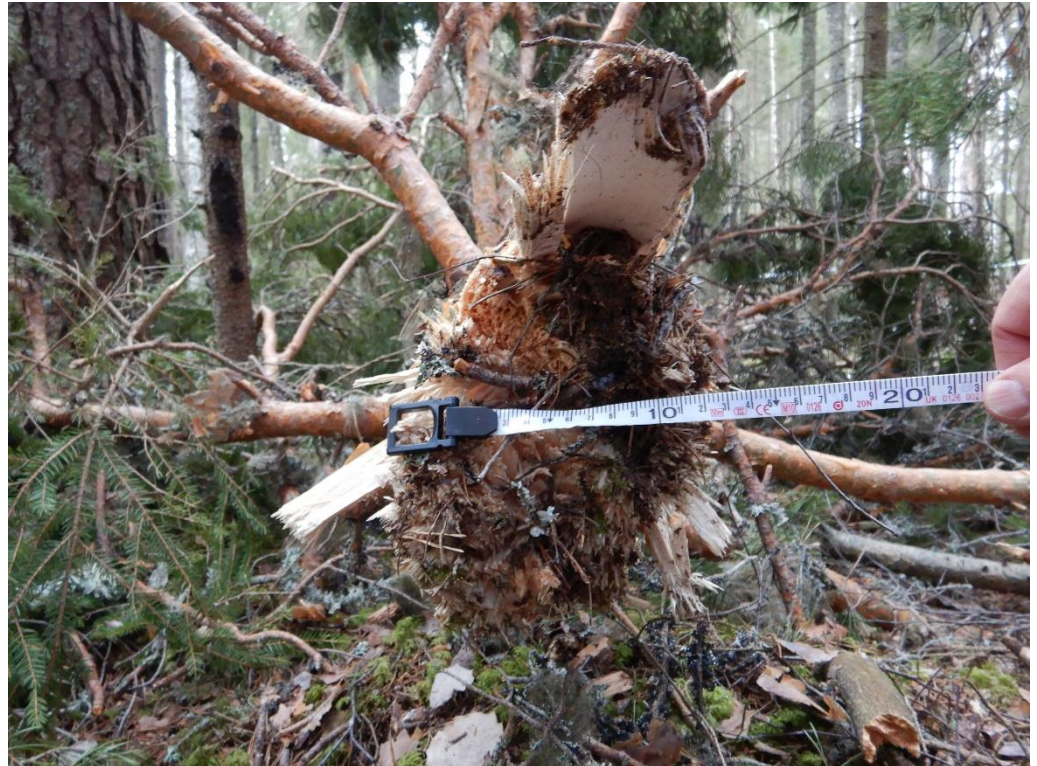
Figure 13. One of the tree trunks that was cut off by the main rotor blades. The diameter of the tree is 13 cm.

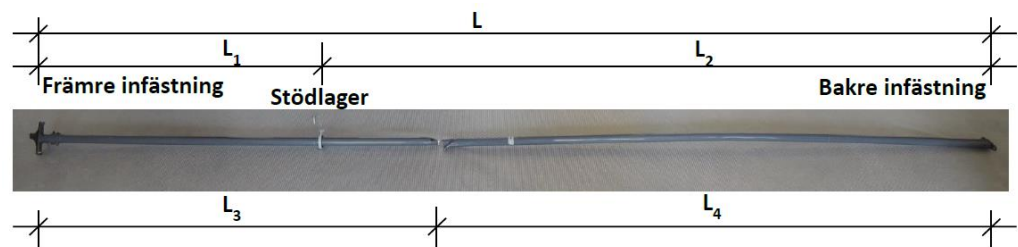
Figure 14. Measured lengths of the drive shaft.

Measurements showed that the drive shaft has a torsional deformation of about 40 degrees and a deflection of 125 mm. The torsional residual deformation of the drive shaft has resulted in wavelike pattern (buckling phenomenon) along the shaft. The damage indicates that the load that caused the fracture has been distributed along the drive shaft. This is also an indication that there has not been any weak materials areas, or extensive load concentration at the fracture location at the time of the fracture.

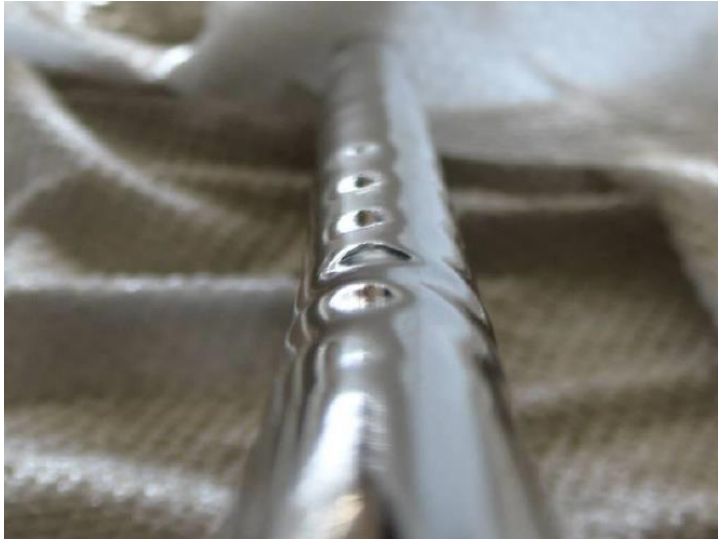
Figure 16. Waveform buckling as a result of torsion.

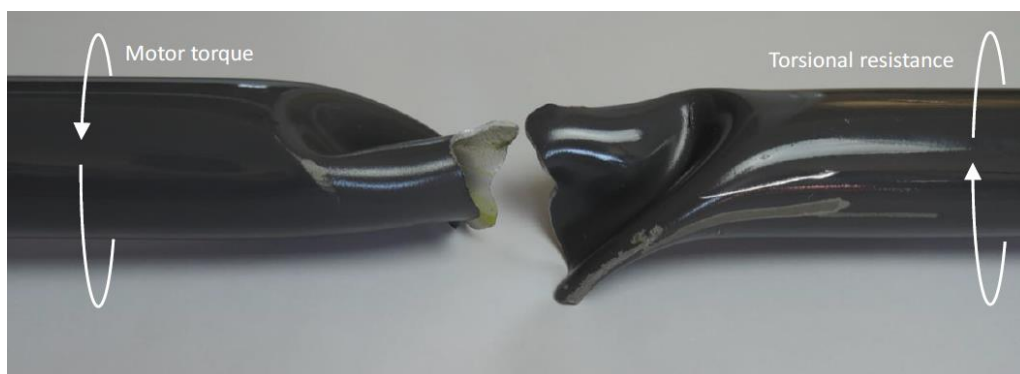
The load direction is in the direction of the engine torque. The damage corresponds with an overload fracture resulting from a torsional overload that has occurred on one single occasion (see Figure 17).

Figure 17. The fracture with load direction.

The examination of the broken tail rotor drive shaft showed that the fracture on the shaft was an overload fracture caused by torsional overload. The examination of the tail rotor gearbox did not show any abnormalities that may have caused the gearbox to have had high resistance or to have prevented free movement. The drive shaft has probably fractured in conjunction with the empennage breaking off the tail boom when the helicopter hit the trees.

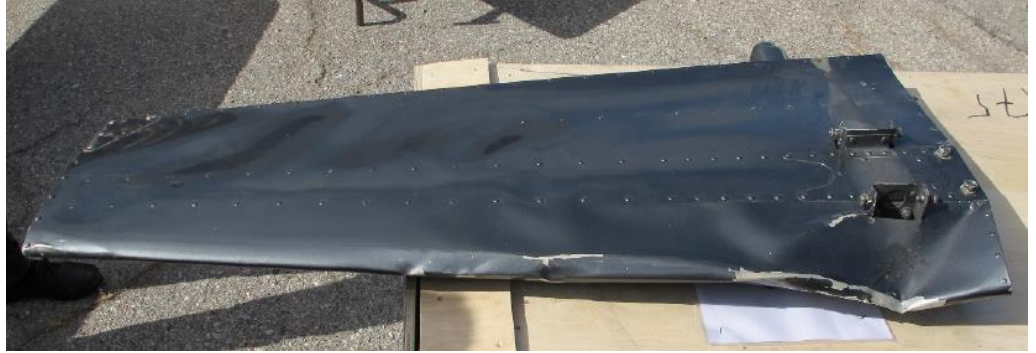
The stabilizers had sustained extensive damage. The upper vertical stabilizer had impact damage to its leading edge and at the tip of its trailing edge. The lower vertical stabilizer had severe impact damage to its leading edge. The horizontal stabilizer had impact damage to its leading edge and at the tip of the trailing edge.

Figure 18. Damage to the horizontal stabilizer.

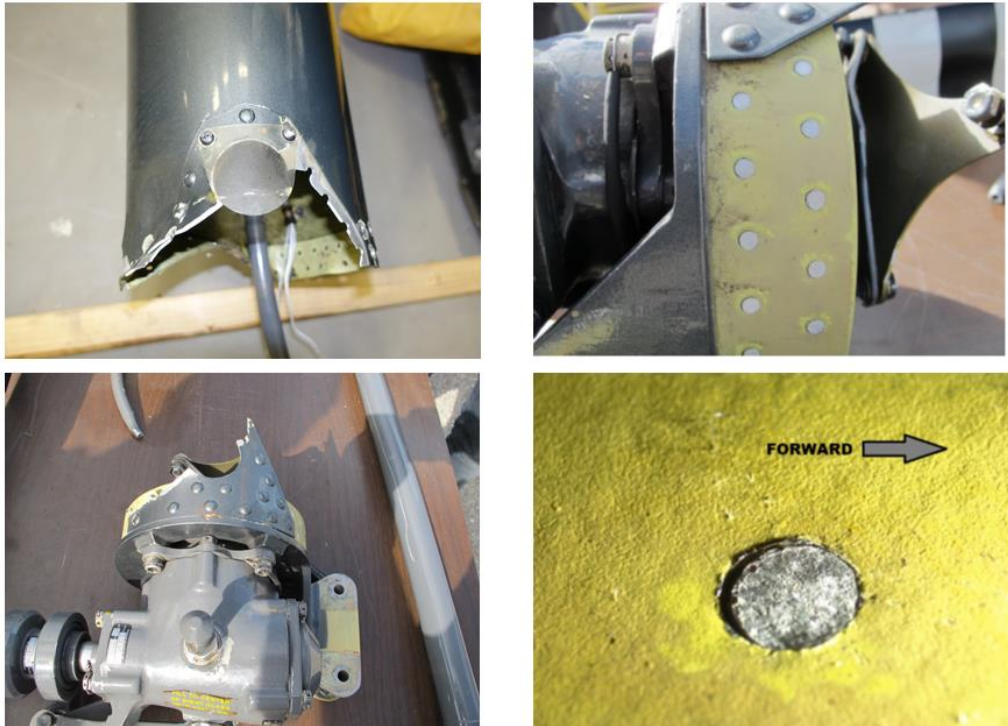
The attachment for the tail rotor gearbox in the tail boom was broken, with sheared rivets (see Figure 21). A small broken part of the boom's skin panel was remaining to the attachment. The rivets of the attachment were sheared in a direction that indicates the attachment has been broken off in a backwards direction in relation to the skin panel on the boom.

Figure 21. The tail rotor gearbox was broken off the tail boom.

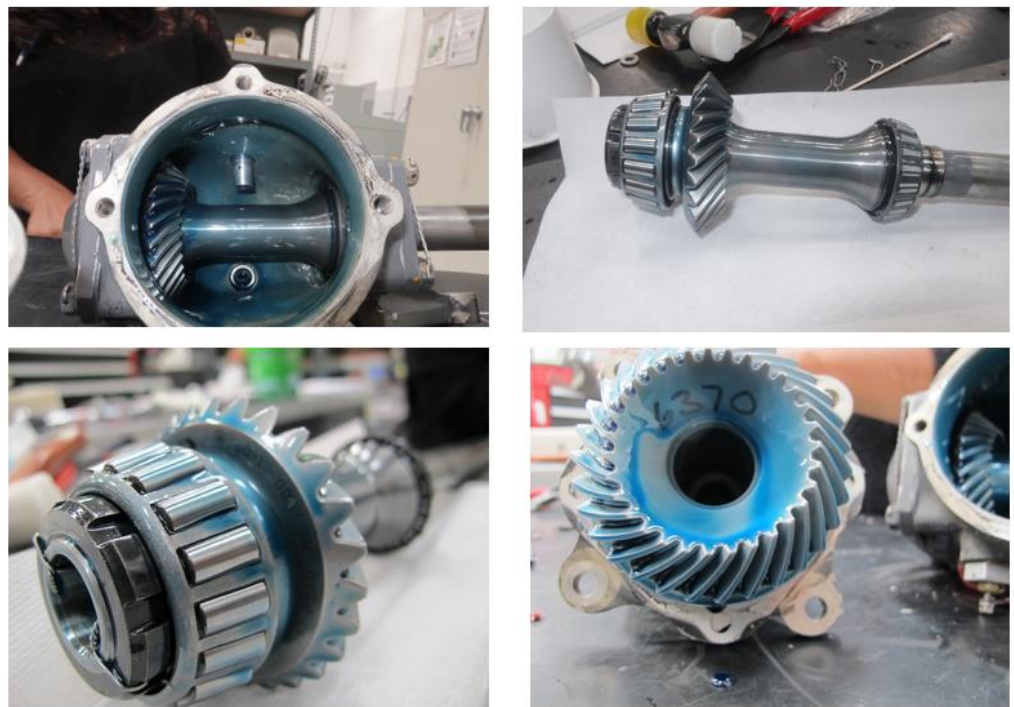
A disassembly of the tail rotor gear box did not show any anomalies. There was no damage to the gears. The roller bearings for the input and output shaft rotated smoothly and freely. The magnetic chip detector was free of any debris. Analysis of the oil did not show a high level of wear metals or external contaminants. The viscosity of the oil was consistent with the manufacturer's specifications.

Figure 22. Tail rotor gearbox with components.

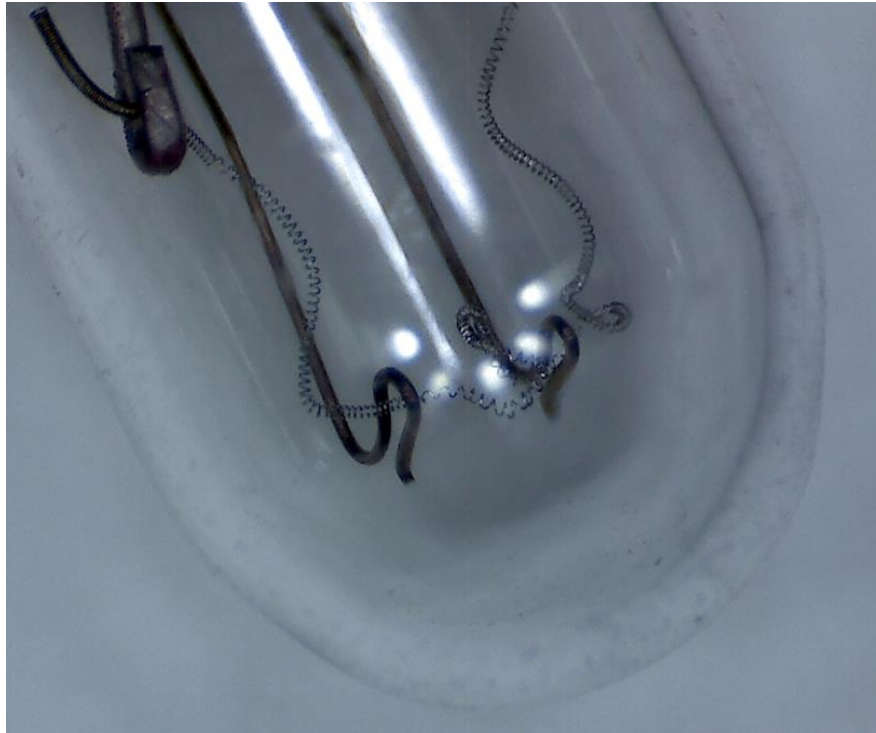
When a lit light bulb is subjected to g-forces, as is the case during a crash, the glowing filament is stretched. Inspection of the filaments from the warning lights under a microscope shows that it is highly probable that the warning light for low voltage from the alternator was illuminated (see Figure 24). This indicates that the engine had either stalled or had low RPM before the impact with the ground.

Figure 24. The warning light for low voltage with a stretched filament.

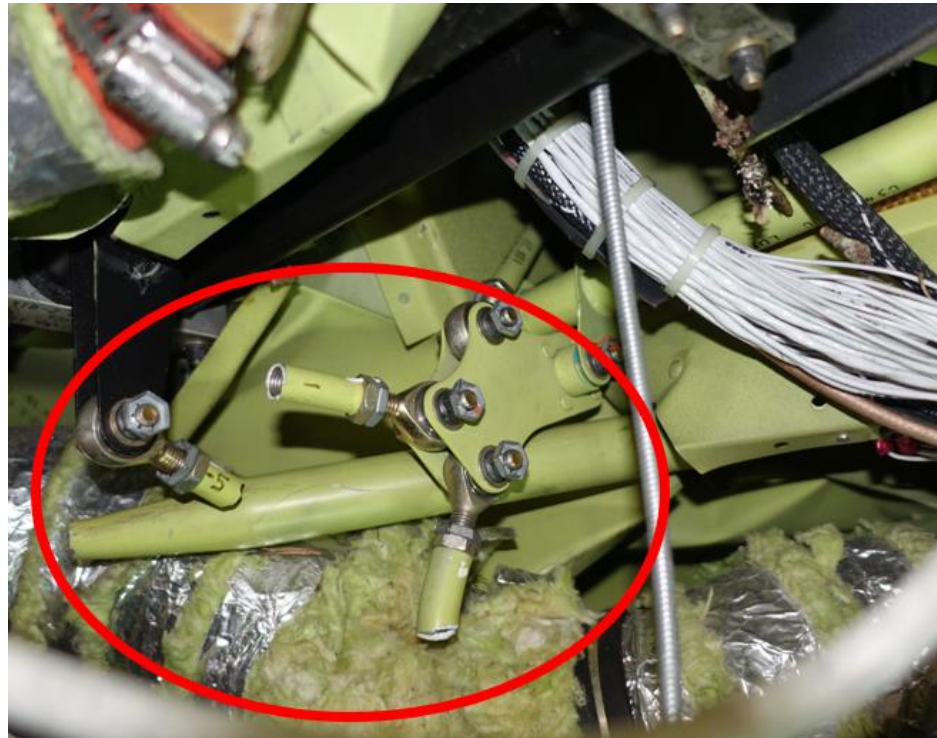
The system for tail rotor control was damaged in the area under the pedals, with broken push-pull tubes (see Figure 27). This area sustained major structural damage in the accident. The push-pull tube at the tail rotor was also broken (see Figure 28). All fracture surfaces have been examined and these showed that the fractures have occurred due to overload. There was connection in the remaining part of the yaw control system.

Figure 27. Broken push-pull tubes for the flight control system for yaw control in the area under the pedals.

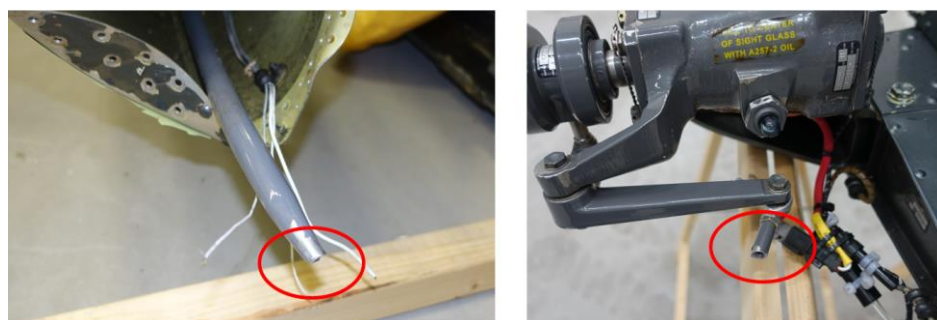
Figure 28. The broken push-pull tube at the tail rotor.
