**Islamic Republic of Iran  
Aircraft Accident Investigation Board**

**Ref No; S000123A7ANO  
Incident Investigation Report**

**A350, A7-ANO  
Near Midair Collision and Speed Warning  
around Position of PEKAM on April 12th, 2021**

*Issue date: 22 Aug, 2021*

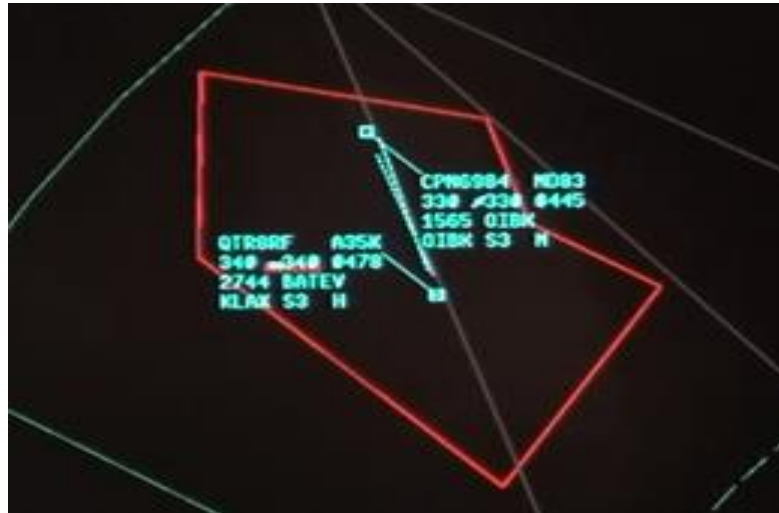
The FDR of MD83 aircraft showed that on the flight route at waypoint PEKAM magnetic track changed from 191° to 157° with engaged Autopilot. During turn, the aircraft started to loss altitude and reached to FL325. For overcoming prevailed situation, the captain disengaged auto-pilot and initiated climb maneuver to return FL330, so the aircraft ascended with rate of climb of 1800 ft/min. the FDR information showed that before reaching FL330, ROC increased to 2400 ft/min and MD83 pilot could not hold FL330 and passed desired

level. At this time, TCAS RA and descent command was issued but the aircraft continued climbing against the issued command and climbed to FL334.

Figure 1- MD83 received TCAS/RA descent clearance

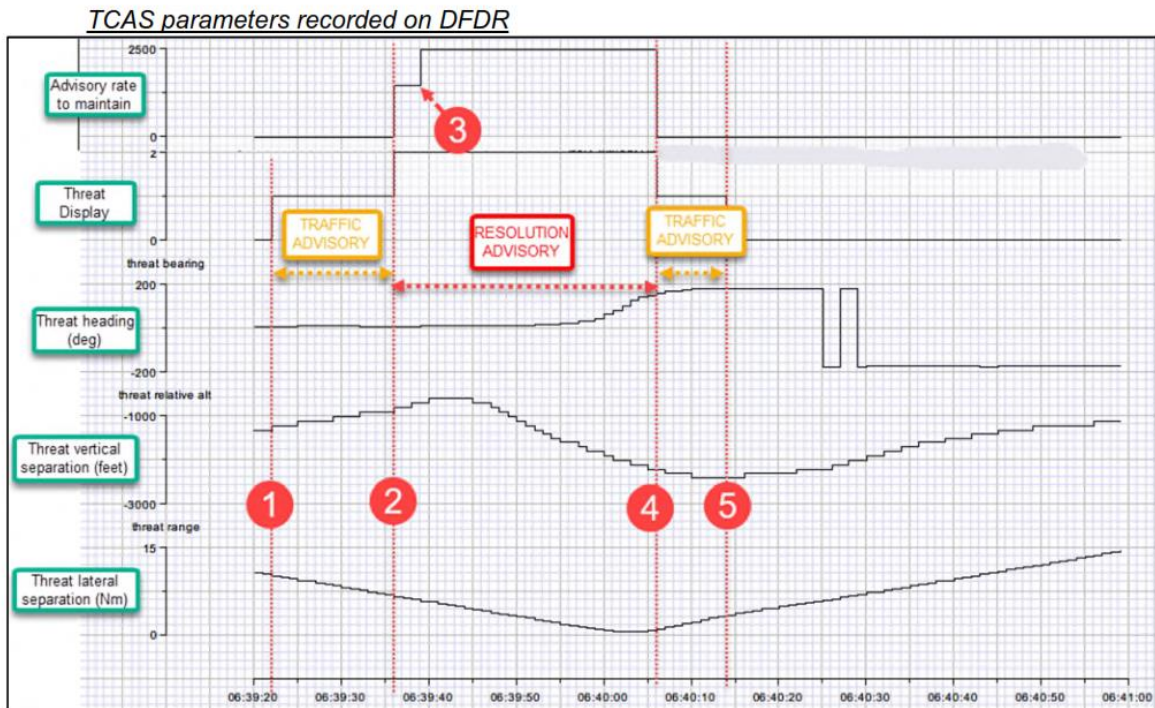
VLS was 268kts and CAS had fallen to 267kts, 1kt below the VLS threshold, triggering the low energy alert.

During this event the TCAS achieved the climb rate target for the required duration of 23s and at high altitude, while the speed transiently reduced to just below VLS, triggering the low energy alert. At this time the aircraft had started to descend back towards the selected altitude of 34000ft. aircraft behavior was normal.

Figure 2, A350 FDR Graph made by Airbus Co.

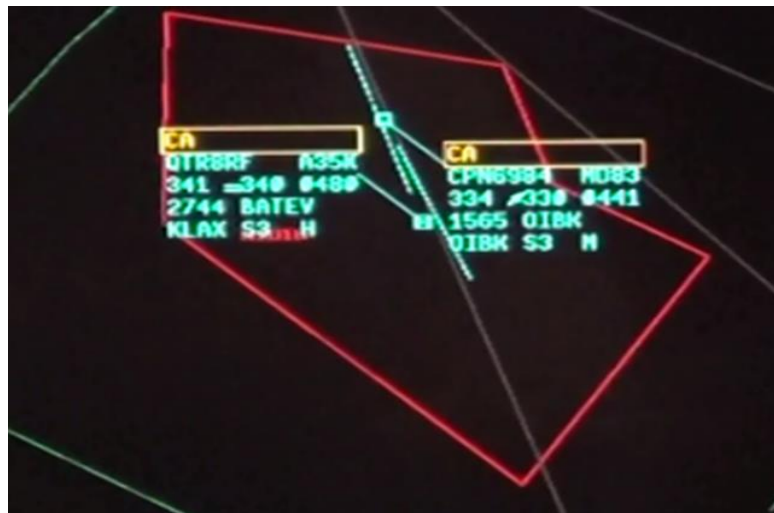
At 06:39:36UTC when longitudinal and vertical separation reduced to about 6.5 nm. and 800 ft., traffic resolution advisory (RA) was triggered and Vertical speed target changed to +1500ft/min, Pitch started to increase from 2.6° to 7° nose up, N1 thrust command increased to 94% so aircraft climbed up first with 1500 ft/min ROC then +2500 ft/min by the auto pilot. (the flight crew-maintained AP and A/THR engaged as per the FCOM procedure.) At this time, calibrated airspeed (CAS) started to decrease from 0.84 Mach.

Figure 3, 5 NM separation at 06:39:46, A350 started to climb
