LIMITED ACCIDENT INVESTIGATION

Reference Number	CA18/2/3/9986						
Classification	Accident	Date	15 April 2021	Time	0718Z		
Type of Operation	Agricultural (Part 137)						
Location							
Place of Departure	AJ Landing private airstrip	Place of Intended Landing			AJ Landing private airstrip		
Place of Accident	Kirkwood private farm in the Eastern Cape province						
GPS Co-ordinates	Latitude	33° 26' 31.79" S	Longitude	25° 23' 10.22 " E	Elevation	663 ft	
Aircraft Information							
Registration	ZS-LCI						
Model/Make	PA-36-375(93/074E)						
Damage to Aircraft	Substantial			Total Aircraft Hours	7830.11		
Pilot-in-command							
Licence Type	Commercial Pilot Licence		Gender	Male	Age	59	
Licence Valid	Yes						
Total Hours on Type	244.39			Total Flying Hours	4274.98		
People On-board	1+0	Injuries	0	Fatalities	0	Other (On Ground)	0
What Happened	<p>On the morning of 15 April 2021 at approximately 0650Z, a pilot on-board a Piper PA-36-375, registered ZS-LCI, took off from AJ Landing private airstrip on a commercial crop-spraying operation on a private farm. The flight was conducted under Visual Flight Rules (VFR) by day. The aircraft was loaded with 433 litres of pest solution and had

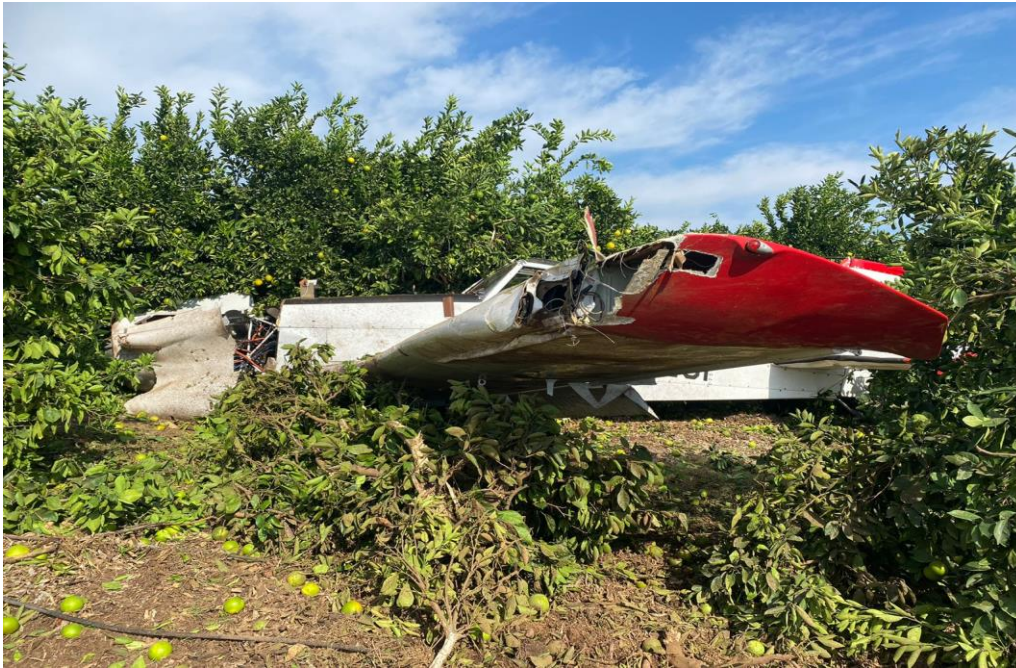
The pilot was not injured during the accident sequence and the aircraft sustained substantial damage. The left-side wing tip had hit one of the trees during the accident sequence and was damaged by impact force.

Figure 1: Damage on left-side wing tip.

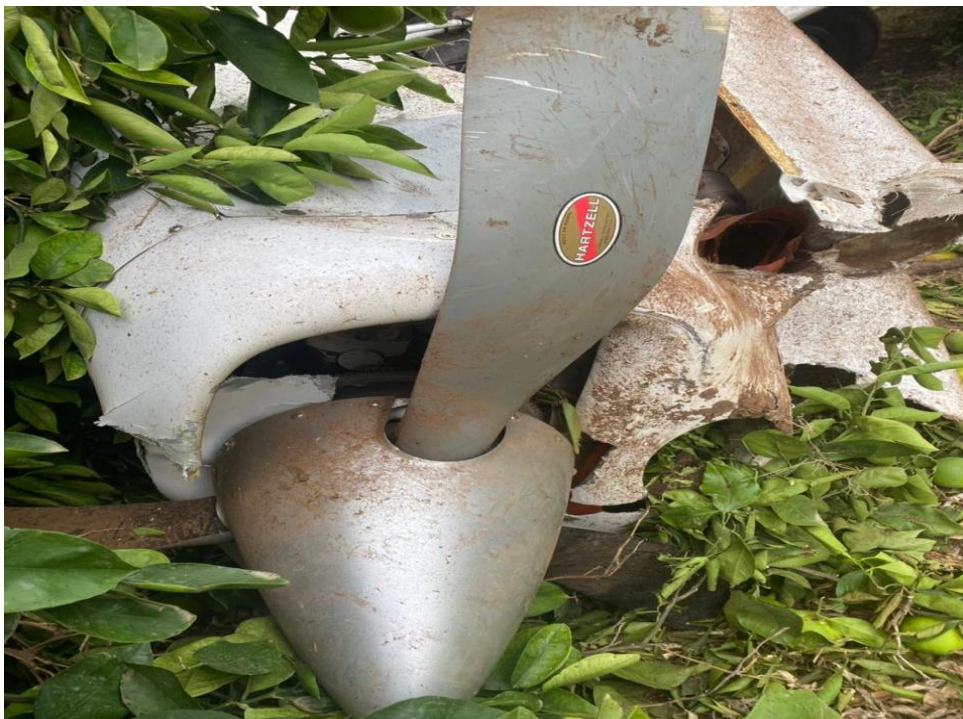
The engine cowling was damaged on impact. The propeller indicated that the engine was producing less power during impact.

Figure 2: A damaged cowling and bent propeller blades.

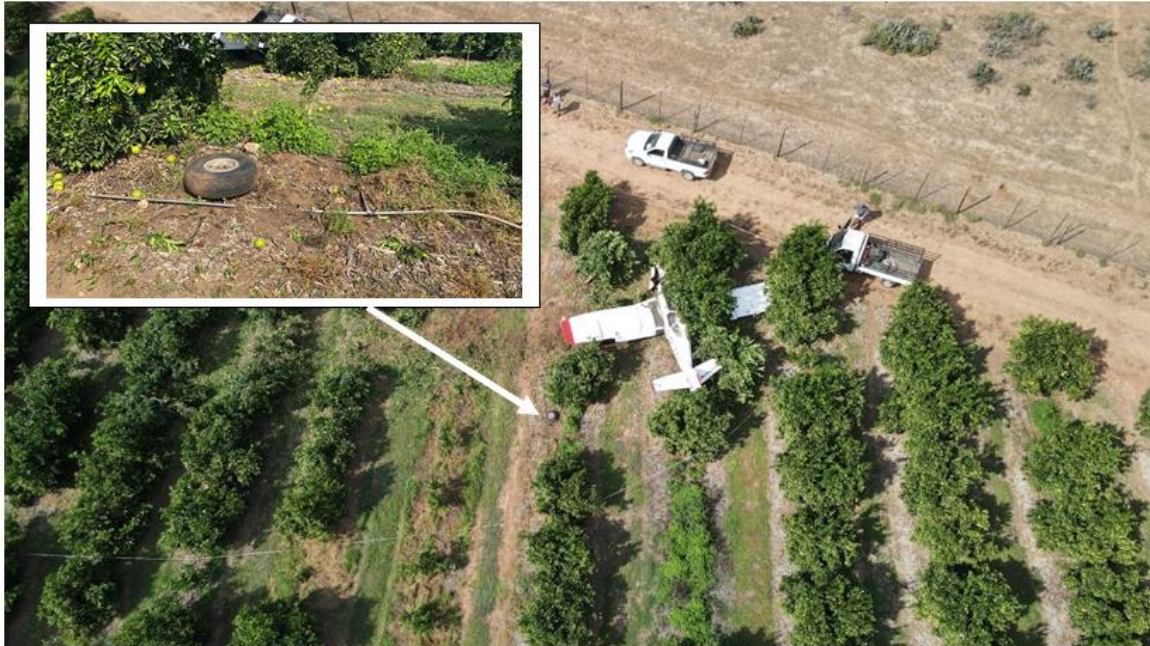
The left-side wheel assembly had separated from the axle during the accident sequence.

Figure 3: The wheel which had separated from the axle.

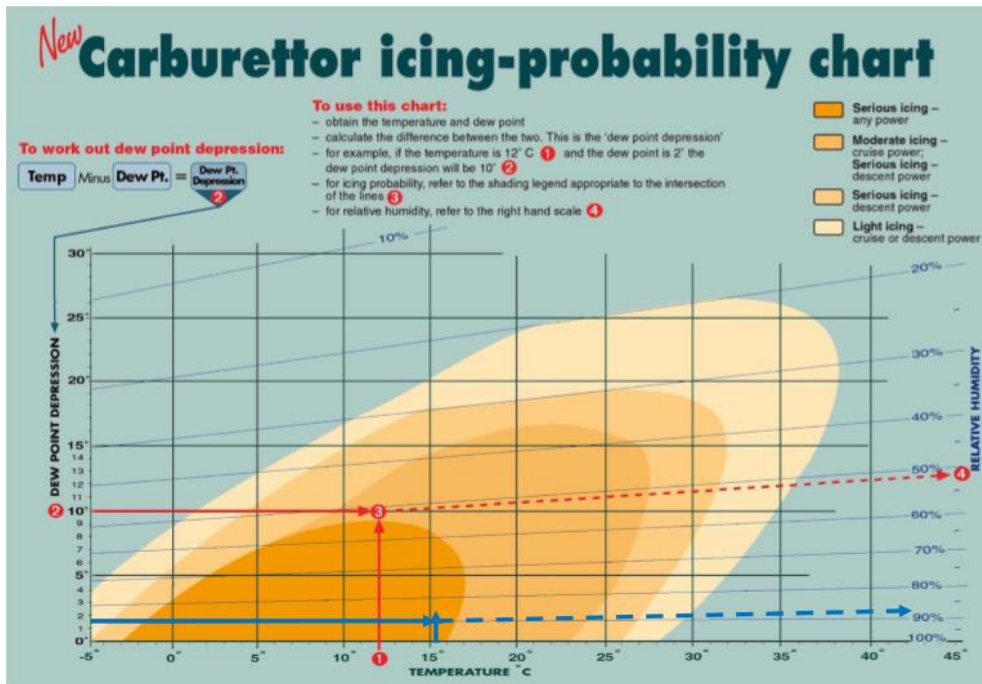
According to the weather information obtained from the South African Weather Service (SAWS), wind was 45°/03 knots; temperature: 15.5°C; dew point: 14.3°C; cloud: CAVOK; visibility: >10 km. With both temperature and dew point information available, dew point depression was determined to be 1.2°C. According to the carburettor icing-probability chart below, the probability of icing was serious in any power setting and the relative humidity in the area around Port Elizabeth International Airport (FAPE) was approximately 90%.

Figure 4: The blue lines indicate the severity of icing.

<p>Probable Cause:</p> <p>Partial loss of engine power during a turn for the third spray because of carburettor icing.</p>	
<p>Safety Action/s</p>	
<p>None.</p>	
<p>Safety Message and/or Safety Recommendation/s</p>	
<p>Safety message: Pilots are advised to carry out a proper flight planning prior to initiating any flight, with emphasis to the weather, especially the proximity of the temperature and dew point, which would indicate the icing probability. This would also prevent engine power loss or failure, thus, preventing loss of life and damage to property.</p>	
<p>Purpose of the Investigation</p>	
<p><i>In terms of Regulation 12.03.1 of the Civil Aviation Regulations (CAR) 2011, this report was compiled in the interest of the promotion of aviation safety and the reduction of the risk of aviation accidents or incidents and not to apportion blame or liability.</i></p>	
<p>About this Report</p>	
<p><i>Decisions regarding whether to investigate, and the scope of an investigation are based on many factors, including the level of safety benefit likely to be obtained from an investigation. For this occurrence, no investigation has been conducted, and the Accident and Incident Investigations Division (AIID) has relied on the information submitted by the affected person/s and organisation/s to compile this brief report. The report has been compiled using information supplied in the initial notification, as well as follow-up information to bring awareness of potential safety issues to the industry in respect of this occurrence, as well as possible safety action/s that the industry might want to consider in preventing a recurrence of a similar accident.</i></p> <p><i>This report provides an opportunity to share safety message/s in the absence of an investigation.</i></p> <p><i>All times given in this report are Co-ordinated Universal Time (UTC) and will be denoted by (Z). South African Standard Time is UTC plus 2 hours.</i></p>
