**LIMITED OCCURRENCE INVESTIGATION REPORT**

<b>Reference Number</b>	CA18/2/3/9992						
<b>Classification</b>	Accident	<b>Date</b>	3 May 2021	<b>Time</b>	1148Z		
<b>Type of Operation</b>	Training (Part 141)						
<b>Location</b>							
<b>Place of Departure</b>	Virginia Airport (FAVG)			<b>Place of Intended Landing</b>	FAVG		
Place	Umngeni River, Durban, KwaZulu-Natal						
<b>GPS Co-ordinates</b>	Latitude	S29° 46' 15"	Longitude	E031°03'37"	Elevation	1732ft	
<b>Aircraft Information</b>							
Registration	ZS-HBR						
Model/Make	Robinson R22, Beta II						
Damage to Aircraft	Destroyed		Total Aircraft Hours	3230.4			
<b>Pilot-in-command</b>							
Licence Type	Commercial Pilot Licence		Gender	Male	Age	24	
Licence Valid	Yes						
Total Hours on Type	170.7		Total Flying Hours	533.1			
People On-board	1 + 1	Injuries	0	Fatalities	2	Other (on Ground)	0
<b>What Happened</b>							
<p>On Monday morning 3 May 2021 at about 1148Z, a Robinson R22 Beta II helicopter with registration ZS-HBR was conducting a local training flight at Virginia Aerodrome (FAVG), north-east of Durban in KwaZulu-Natal province, when the accident occurred. On-board the helicopter were the student pilot and a Grade I

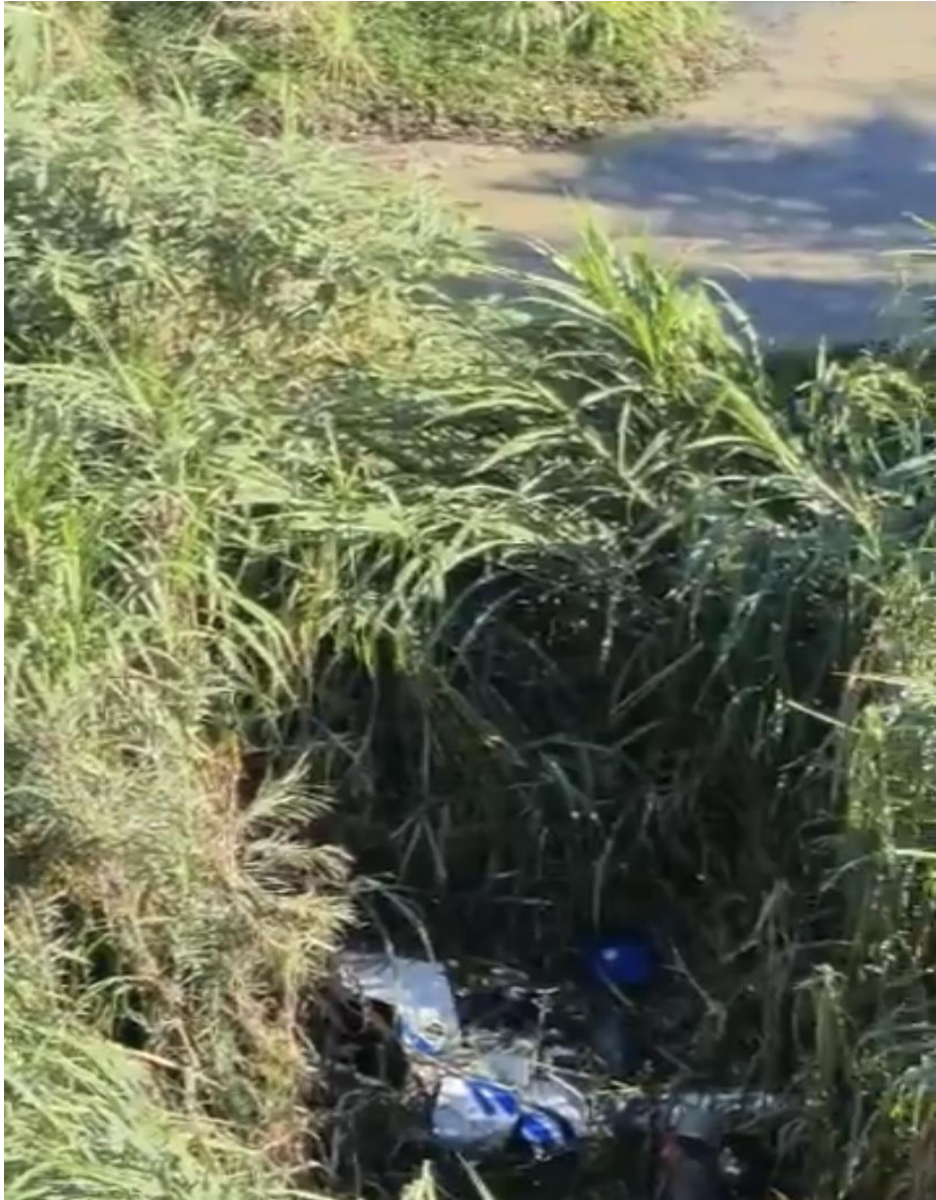
**Figure 1:** Aerial view of the helicopter in the reeds. (Source: Operator)

The helicopter was found lying on its right-side with the nose facing east. The cabin area was found compressed from impact. The helicopter had adequate Avgas LL100 fuel remaining in the tanks. The severed tail rotor drive shaft was found twisted, consistent with overstress fracture in torsion which emanated from vibration. A detailed examination of the flight controls revealed numerous overload failures of push-pull control tubes, but all were consistent with impact forces.

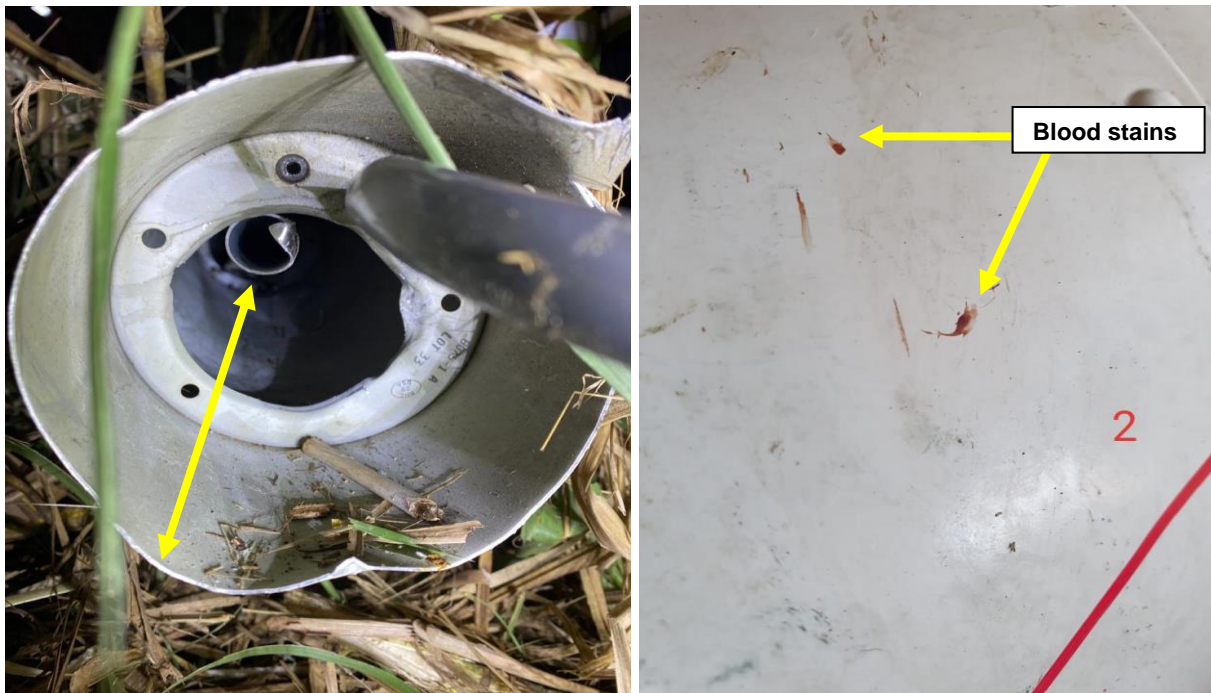
Upon examining the wreckage while focusing on the tail rotor, bird feathers were noted on one of the blades, as well as blood stains on the tail cone area. The investigators also noted several signs that indicated that the engine was running at the time of accident. The twist-grip throttle control rod attached to the engine carburettor was found at maximum power and the engine cooling fan displaying scoring around the perimeter and on the inlet cone surface indicated that it was turning at the time of accident. Witness marks on the tail rotor teetering hinge were an indication of a bird strike during normal rotation. Records indicated that the helicopter was certified, equipped and maintained in accordance with (IAW) the existing regulations and approved procedures. The helicopter had no known deficiencies before the flight and was being operated within its weight and centre of gravity limits.

**Figures 2 & 3:** Left picture shows the tail cone and a fractured tail rotor drive shaft; the right picture shows bird blood stains on the tail cone.

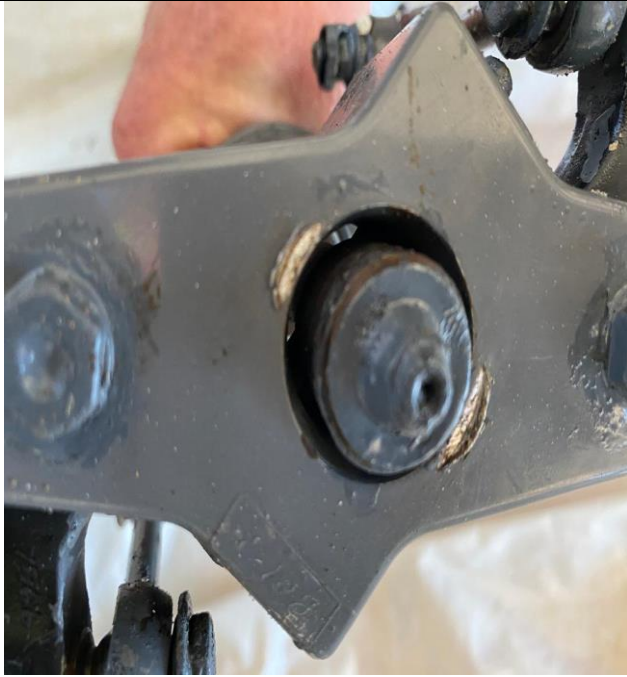
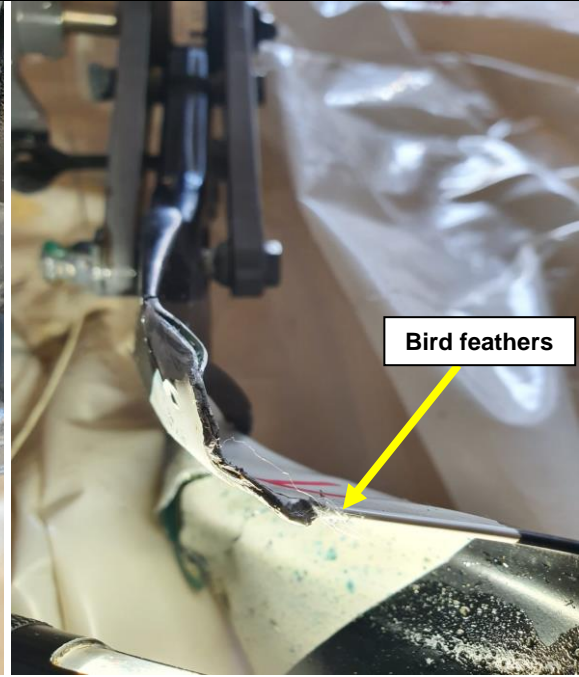
**Figures 4 & 5:** Left picture shows witness marks left on the tail rotor teetering hinge after a bird strike. Right picture shows bird feathers on the tail rotor blade.
