LIMITED ACCIDENT/INCIDENT INVESTIGATION
--

Reference Number		CA18/2/3/9999					
Classification	Accident	Date	10 May 2021	Time	1115Z		
Type of Operation		Private (Part 91)					
Location							
Place of Departure		Krugersdorp Airfield (FAKR)		Place of Intended Landing		FAKR	
Place of Accident		Krugersdorp Airfield (FAKR), Runway 35					
GPS Co-ordinates		Latitude	S 26° 05' 06"	Longitude	E 27° 43' 45"	Elevation	5500 ft
Aircraft Information							
Registration		ZS-HDC					
Model/Make		Bell 47					
Damage to Aircraft		Substantial		Total Aircraft Hours		3876.9	
Pilot-in-command							
Licence Valid		Yes		Gender		Male	
						Age	
						60	
Licence Type		Private Pilot Licence (Helicopter)					
Total Hours on Type		197.7		Total Flying Hours		669.0	
People On-board		1 + 0	Injuries	0	Fatalities	0	Other (On Ground)
							0
What Happened							
<p>On 10 May 2021, a pilot on-board a Bell 47 helicopter with registration ZS-HDC took off from Krugersdorp Airfield (FAKR) to practise simulated engine failure (autorotation) exercises. The flight was conducted under the provisions of Part 91 of the Civil Aviation Regulations (CAR) 2011 as amended.</p> <p>The pilot stated that he entered the practise

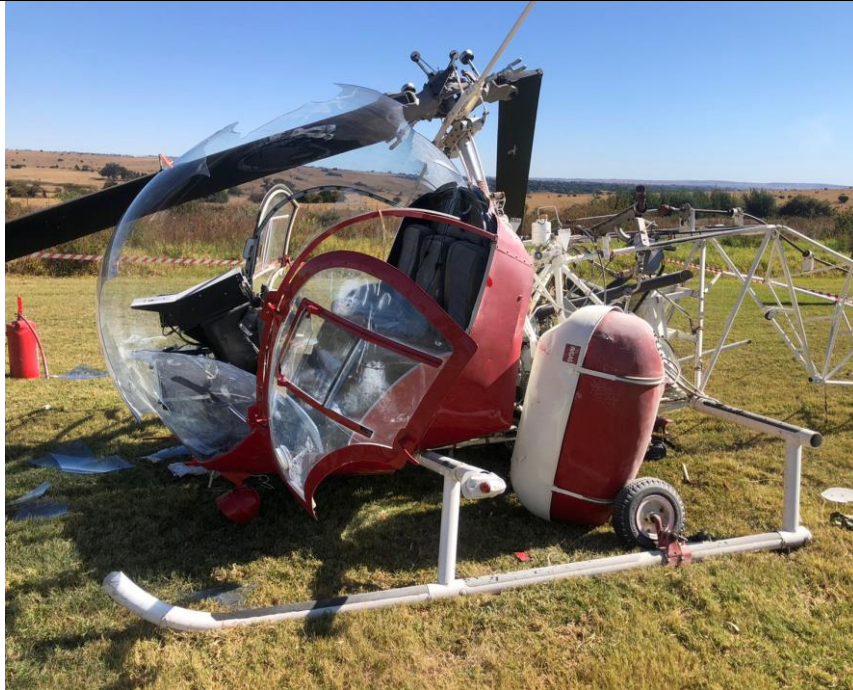
Figure 1: The helicopter at the accident site. (Source: Pilot)

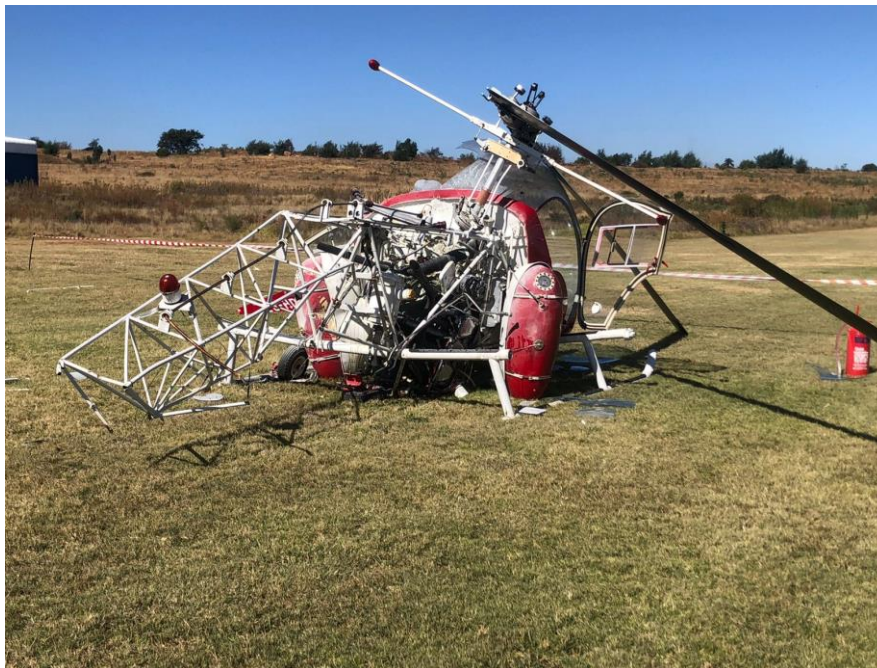
Figure 2: The helicopter's tail boom with the severed tail rotor. (Source: Pilot)

Probable Cause: The pilot initiated the flare too late as he had misjudged the aircraft's height above ground, causing the tail rotor to strike the ground.	
Safety Action/s	
None.	
Safety Message and/or Safety Recommendation/s	
None.	
Purpose of the Investigation	
<i>In terms of Regulation 12.03.1 of the Civil Aviation Regulations (CAR) 2011, this report was compiled in the interest of the promotion of aviation safety and the reduction of the risk of aviation accidents or incidents and not to apportion blame or liability.</i>	
About this Report	
<i>Decisions regarding whether to investigate, and the scope of an investigation are based on many factors, including the level of safety benefit likely to be obtained from an investigation. For this occurrence, no investigation has been conducted, and the Accident and Incident Investigations Division (AIID) has relied on the information submitted by the affected person/s and organisation/s to compile this brief report. The report has been compiled using information supplied in the initial notification, as well as follow-up information to bring awareness of potential safety issues to the industry in respect of this occurrence, as well as possible safety action/s that the industry might want to consider in preventing a recurrence of a similar accident.</i> <i>This report provides an opportunity to share safety message/s in the absence of an investigation.</i> <i>All times given in this report are Co-ordinated Universal Time (UTC) and will be denoted by (Z). South African Standard Time is UTC plus 2 hours.</i>
