DUTCH
SAFETY BOARD

Loss of engine power after takeoff

The Hague, April 2023

Identification number:	2021062
Classification:	Accident
Date, time of occurrence:	25 June 2021, 09.33 hours ¹
Location of occurrence:	West of International Airport Teuge (EHTE)
Operator:	Skydive Teuge
Registration:	PH-FST
Aircraft type:	Cessna 208B Supervan
Aircraft category:	Fixed wing, single engine turboprop
Engine type	Honeywell TPE331-12JR
Type of flight:	Parachute drop
Phase of operation:	Initial climb
Damage to aircraft:	Substantial
Flight crew:	One
Passengers:	Seventeen
Injuries:	One passenger minor
Light conditions:	Daylight

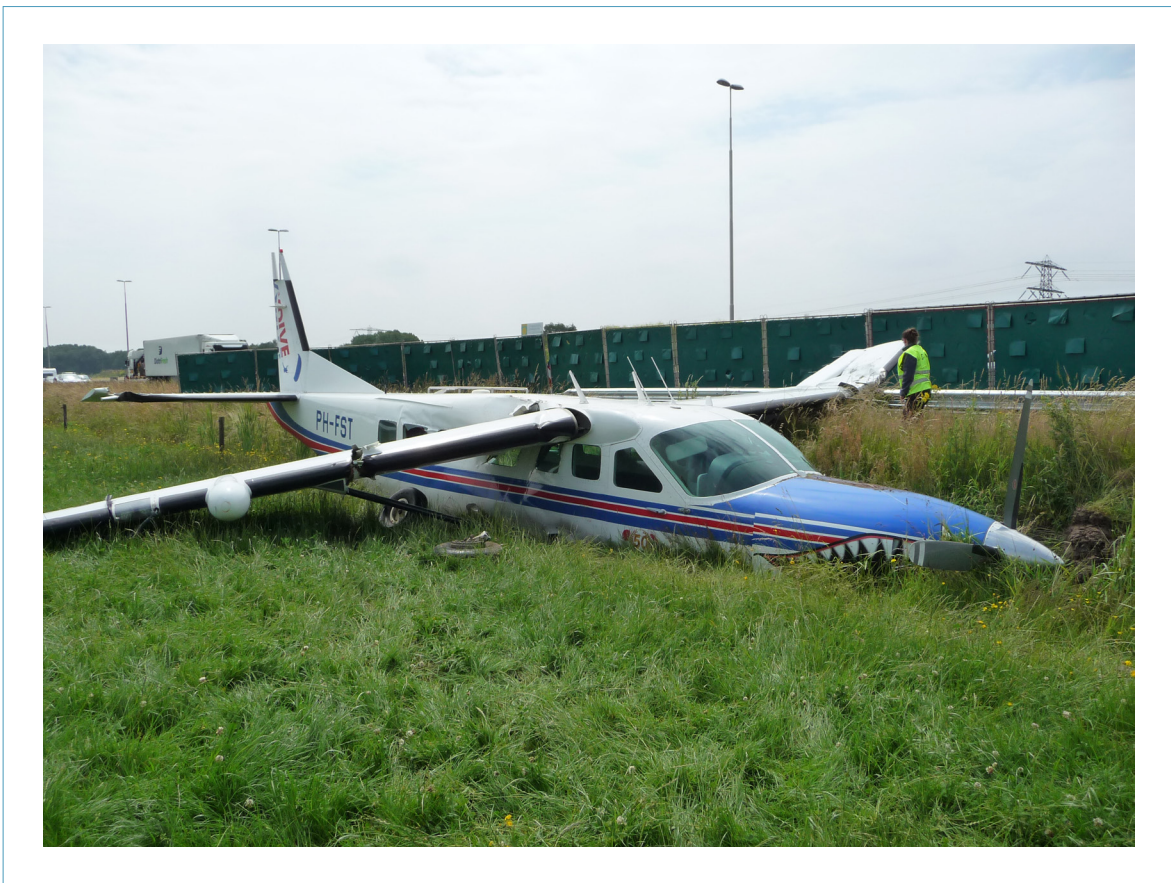
Figure 1: The final position of the aircraft. (Source: Dutch Safety Board)

After touchdown, the pilot steered to the left to avoid the motorway. He noted a ditch in the direction the aircraft was traveling. He attempted to pull up the nose of the aircraft and fly over the ditch, however the aircraft had slowed down to a speed whereby not enough lift could be produced. The nose gear collapsed after hitting the ditch and could not provide directional control anymore. After the right wing hit a billboard, the aircraft turned 180 degrees and came to rest in a small ditch against the crash barrier next to the motorway, see Figure 1.

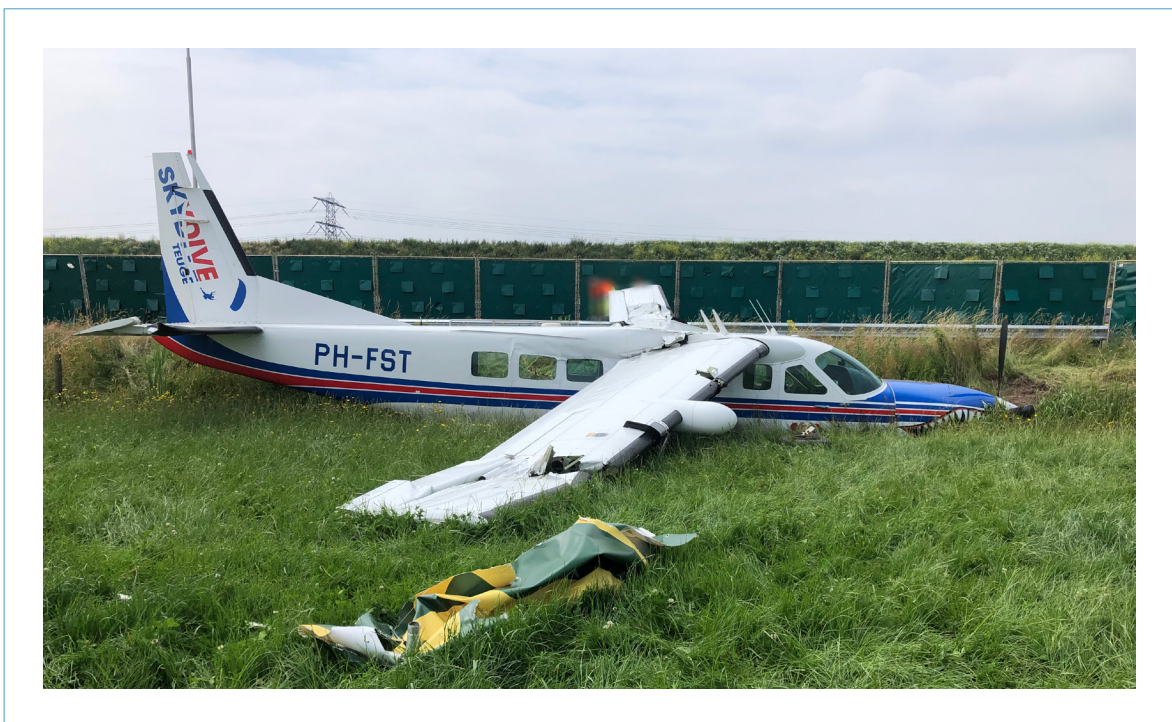
Figure 5: The aircraft's final position. (Source: Dutch Safety Board)

The aircraft sustained impact damage resulting from the landing in the field, the collision with the billboard and contact with the ditch, see Figure 5. The flaps were found in an extended position between 0 and 10 degrees.

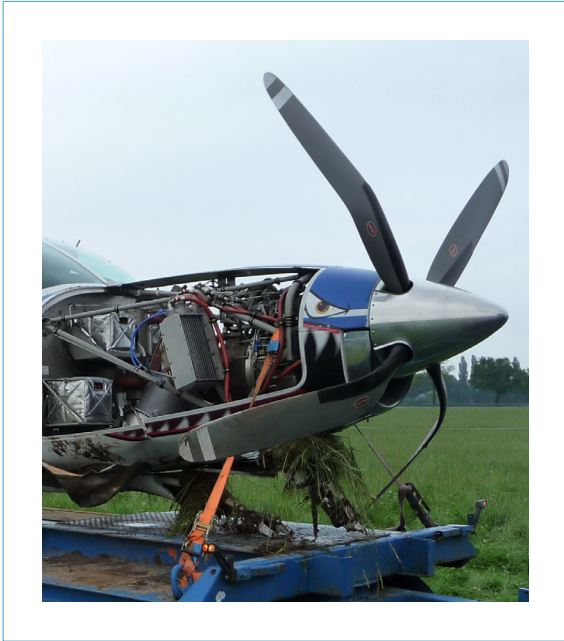
Figure 7: Propeller blade damage. (Source: Dutch Safety Board)

- The wiring of the magnetic pick-up of the propeller governor was found to be intact and connected correctly.
- The propeller blades did not show evidence of high-speed rotation at impact, see Figure 7. One blade appeared undamaged. The orientation of the damage on the blades was mostly spanwise, see Figure 8. No significant damage was found on the leading edges of the blades. All four blades were found in the start lock position.¹⁰ Some deformation was noted in the different blade attachments assemblies and for one blade, the start lock pin and start lock plate did not touch.

After the accident, the propeller blades were found in the start lock position. The damage to the propeller blades, with different amounts of bending and the absence of damage to one blade, indicate that there was little or no rotation at the time the propeller impacted the ground. It is considered feasible that, as there was little rotation, ground contact by one or more blades forcefully rotated the blades against the start locks. The deformation of one of the blade attachments where the start lock pin and start lock plate did not touch, is an indication of impact force on the propeller.

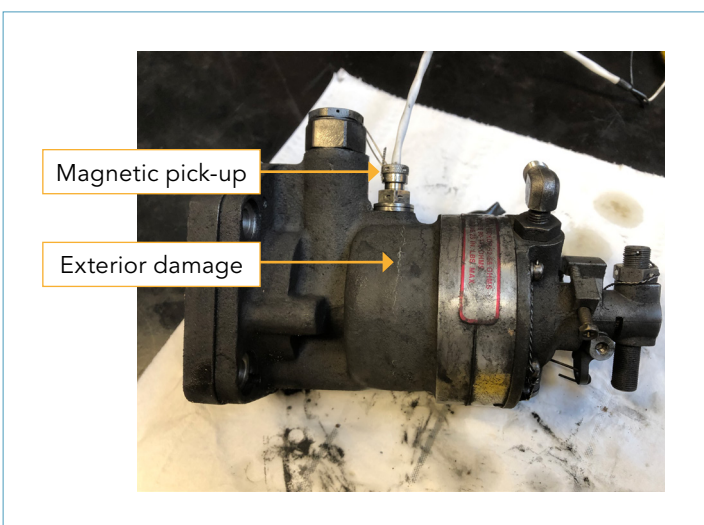
Figure 9: Damaged propeller governor. (Source: Dutch Safety Board)

The engine was partly disassembled to identify the source of the metal debris. The propeller governor was removed from the engine and examined in more detail. The exterior of the propeller governor housing showed damage, see Figure 9. Also, damage to the pick-up end of the magnetic pick-up was noted, see Figure 10.

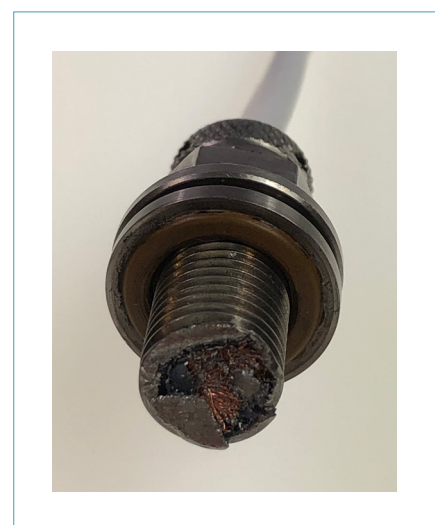
Figure 10: Damaged magnetic pick-up. (Source: Dutch Safety Board)

The damage observed on the toothed gear and the magnetic pick-up, indicated rotational contact of the teeth with the magnetic pick-up. It has been determined that most probably the magnetic pick-up had turned in the governor assembly slightly in between two gear teeth. This was not noticeable during the normal engine autostart and SRL check (systems which also use magnetic pick-up input). This resulted in damage to the magnetic pick-up, the ball head assembly and the propeller governor housing.

On 11 March 2022, the engine manufacturer issued a Service Information Letter¹⁵ regarding the installation of the magnetic pick-up. The purpose of a Service Information Letter is to inform all affected operators and organisations of the issue mentioned in the letter and of the engine manufacturer's actions or proposed solutions. The letter indicated that improper installation of the magnetic pick-up can result in contact damage between the pick-up and teeth of the governor assembly and that this can result in loss of engine speed control signal and propeller governor functional control. The letter included images to show incorrect and correct positioning of the gear teeth when replacing the magnetic pick-up. A Service information Letter is not an integral part of the maintenance manual.

On 29 July 2022, the engine manufacturer issued a revision¹⁶ of the engine maintenance manual regarding the procedure for replacement of the magnetic pick-up. The revision included:

- a warning statement regarding the possibility of incorrect placement of the magnetic pick-up resulting in severe damage to the propeller governor assembly;
- figures demonstrating how to ensure a tooth is centered within the magnetic pick-up port;
- more detailed instructions for ensuring the voltage is between 4-5 volts after magnetic pick-up installation/adjustments.

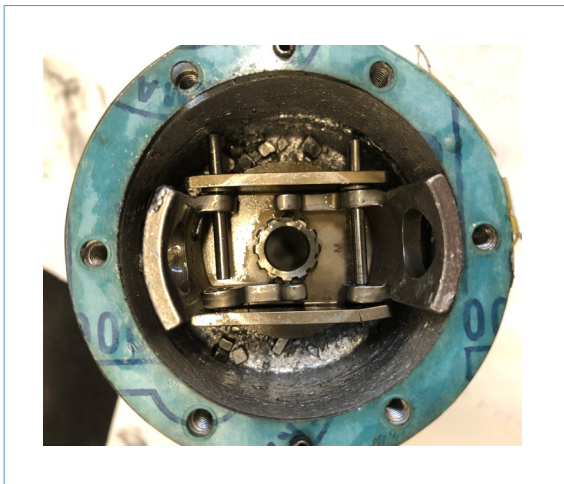
Figure 11: Debris found inside the governor housing. (Source: Dutch Safety Board)

The ball head assembly was found damaged and debris was found within the governor housing, see Figure 11. The ball head assembly showed several signs of damage. All teeth were missing from the ball head, except one tooth which was originally brazed to the ball head, see Figure 13 and Figure 14. The flyweight pins had slid out of the ball head and contacted the housing, causing scoring on the inside of the housing wall, see Figure 15. The damage on the outside of the propeller governor housing consisted of a circumferential crack coinciding with the location of the flyweight pins inside the housing.

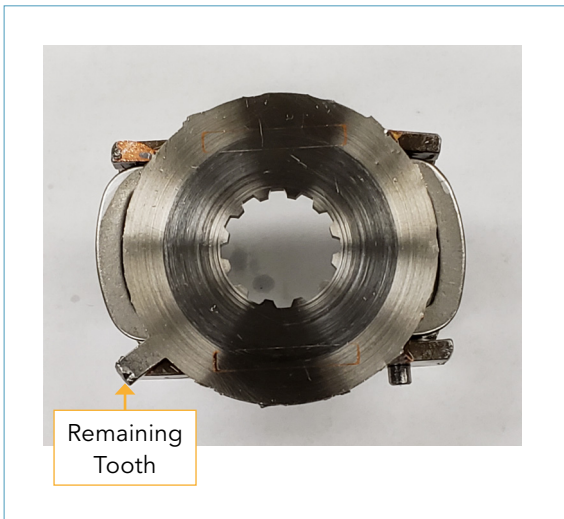
Figure 13: Bottom view of damaged ballhead assembly. (Source: Woodward)

Further metallurgic examination performed by the propeller governor manufacturer concluded that the ball head gear teeth had fractured at the root. The initial failure mode was determined to be overload resulting from impact events consistent with rotation contact with the magnetic pick-up. The debris found inside the governor was consistent with governor component material, except for a small copper fragment that contained zinc and silver.

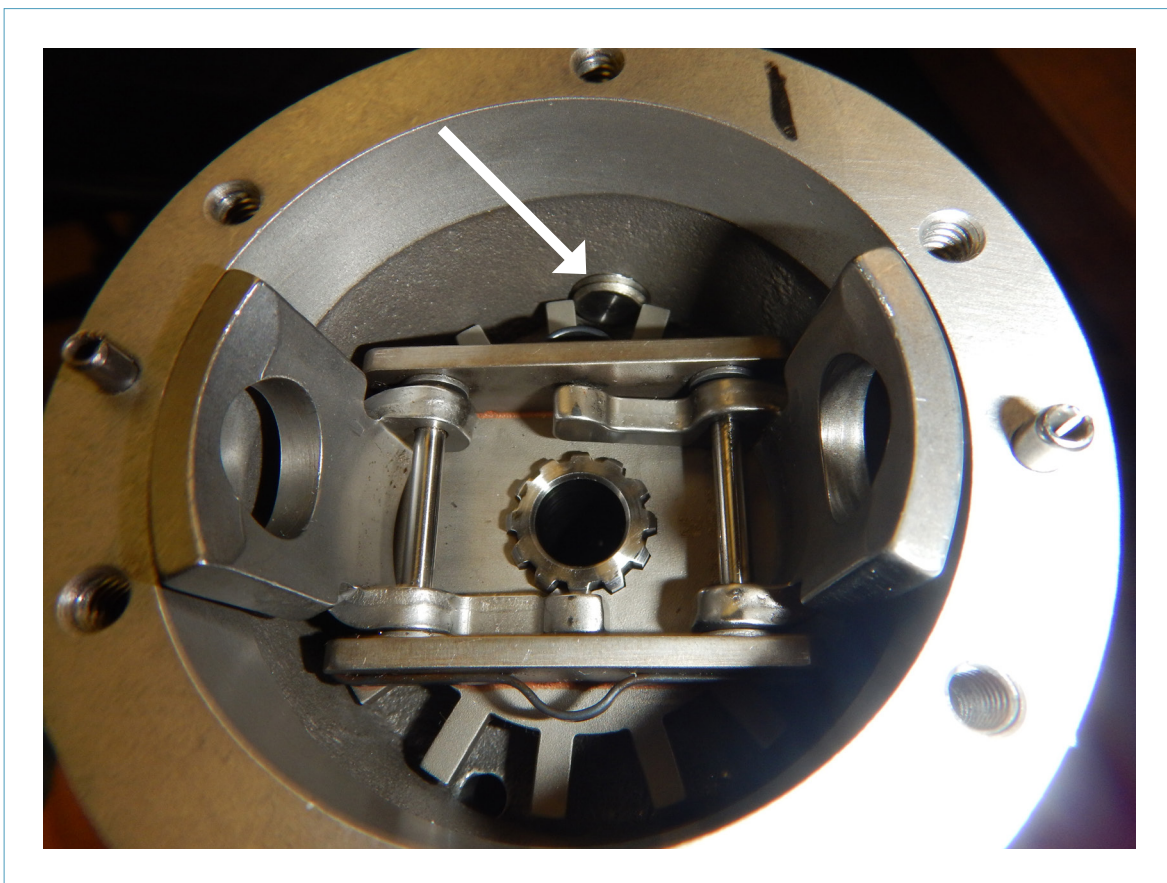
Figure 18: An undamaged toothed gear with magnetic pick-up positioned in between teeth, see arrow. (Source photo: Honeywell Aerospace)

On 30 December 2021, the Dutch Safety Board published a safety alert on its website in the form of a preliminary report to present initial findings and highlight the possibility to position the pick-up end of the magnetic pick-up in between the teeth of the ball head gear, see Figure 18. During the investigation the possibility to position the pick-up end of the monopole in between the teeth of the toothed gear was demonstrated. In such case, it was determined that loosening it by a half turn, as required by the maintenance instructions, is insufficient to ensure free rotation of the toothed gear.

With the 15 toothed gear, there is a possibility to position the pick-up end in between two teeth. In such a case, the pick-up is installed deeper than when placed correctly. Loosening the magnetic pick-up half a turn is insufficient to ensure necessary clearance between the pick-up end and the gear and the pick-up contacts the toothed gear when the gear starts to rotate.
