Final report RL 2022:06e

**Accident at Åsäng, Västernorrland
County on 16 November 2021 involving
the helicopter LN-OYH of the model AS
350 B3, operated by Heliscan**

File no. L-84/21

7 November 2022

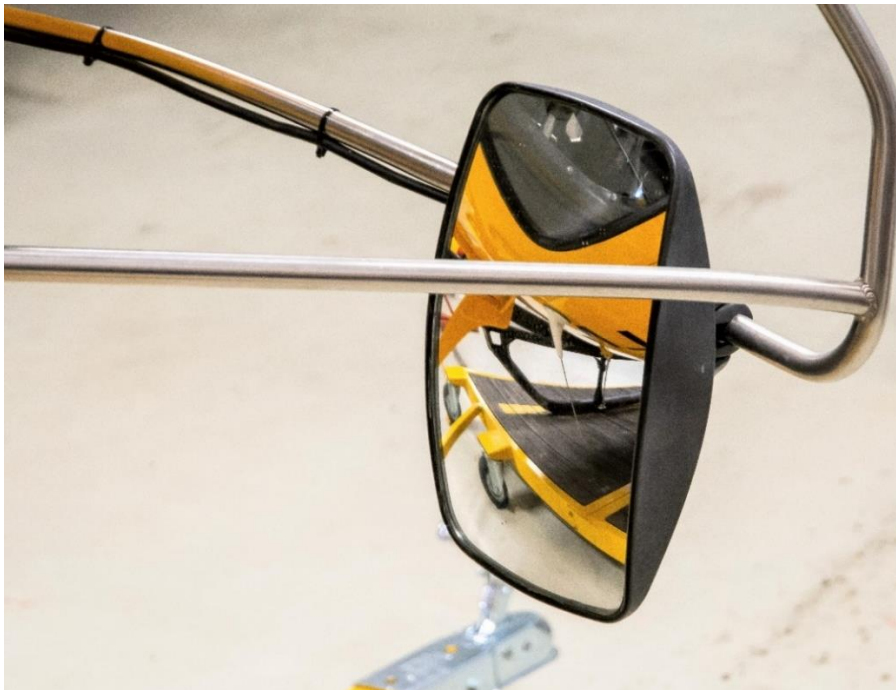
The pilot has stated that he had the electric heating on the rear-view mirror turned on while flying the whole day but that the electric heating did not have the capacity to provide a clear view when the pilot was moving forward due to the prevailing weather conditions.

Figure 7. Electrically heated rear-view mirror.

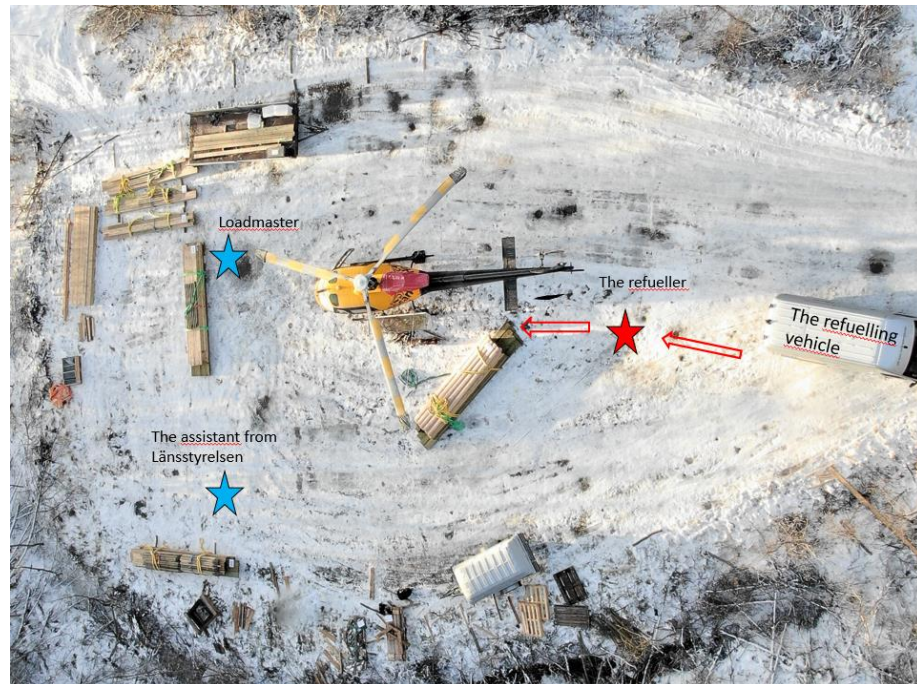
At the time of the accident, the people on site were located as shown in Figure 10.

Figure 10. The accident site with the positions of the people involved drawn in by SHK.

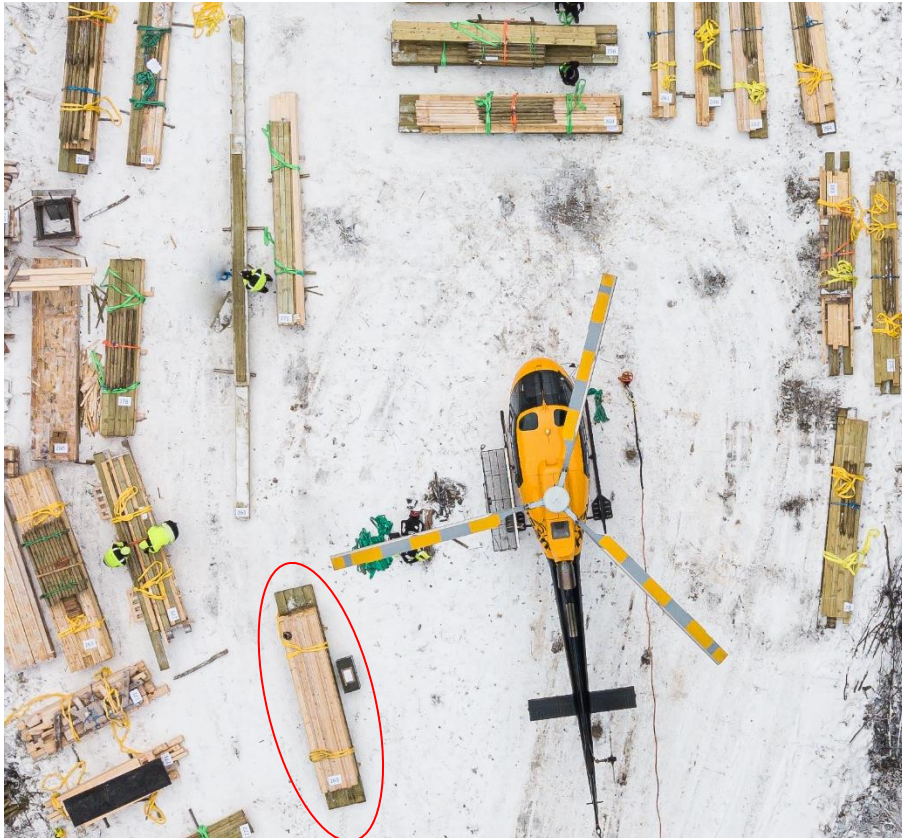
SHK has obtained photographs and videos from Länsstyrelsen. One photo has been taken from above the loading site with a drone before the work started and shows where the loads were located at the loading site. SHK has taken a photo from a similar vantage point that show the site after the occurrence; the photo shows where the load that was attached to the helicopter at the time of the occurrence was located afterwards. This photo indicates that the load was moved a few metres in conjunction with the accident (see Figures 11 and 12). The load in question is estimated to have a weight of around 1,000 kg.

Figure 11. Photo of the loading site before work started. The location of the load that was attached to the helicopter at the time of the occurrence has been circled in red by SHK. Photo: Erik Engelro Västernorrland County Administrative Board.

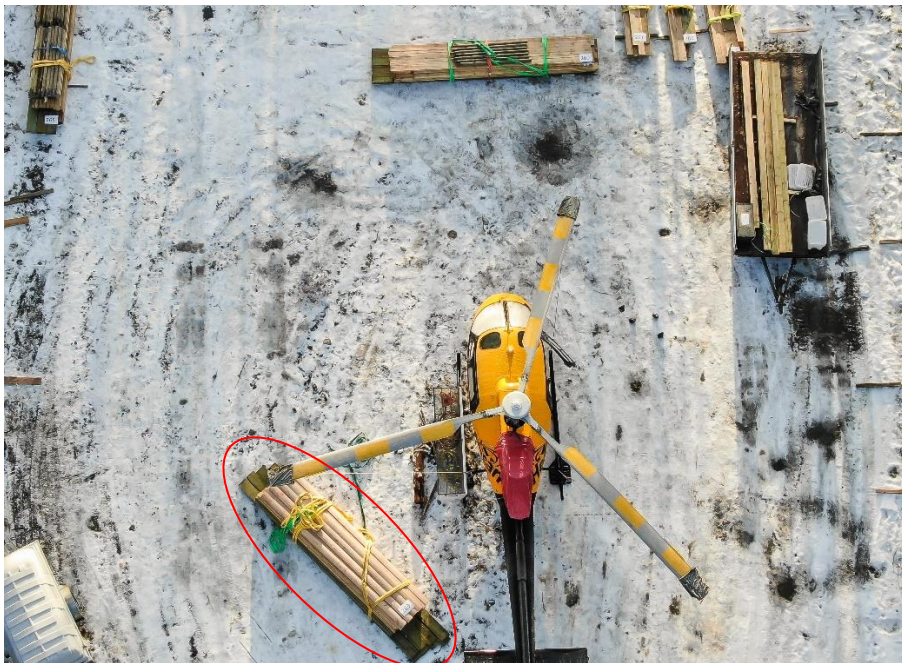
Figure 12. Photo of the loading site after the occurrence. The location of the load that was attached to the helicopter at the time of the occurrence has been circled in red by SHK.
