LIMITED ACCIDENT INVESTIGATION REPORT

Reference Number	CA18/3/2/10108						
Classification	Accident	Date	31 January 2022	Time	1144Z		
Type of Operation	Remotely Piloted Aircraft (Part 101)						
Location							
Place of Departure	Sun City Helipad, North West Province		Place of Intended Landing	Sun City Helipad, North West Province			
Place of Occurrence	Sun City, North West Province						
GPS Co-ordinates	Latitude	25°20'43.65" S	Longitude	27°05'16.40" E	Elevation	3 510 feet	
Aircraft Information							
Registration	ZT-UWB						
Model/Make	DJI Mavic 2 (Serial Number: MAV007)						
Damage to Aircraft	Unknown		Total Aircraft Hours	1 950			
Pilot-in-command							
Licence Type	Remote Pilot Licence (RPL)		Gender	Female	Age	36	
Licence Valid	Yes						
Total Hours on Type	35.10		Total Flying Hours	35.10			
People On-board	0	Injuries	0	Fatalities	0	Other (on ground)	0
What Happened							
<p>On 31 January 2022 at about 1140Z, a remotely piloted DJI Mavic Enterprise drone with registration ZT-UWB took off from Sun City Helipad with the intention to land back at the same helipad. The purpose of the flight was to survey the mountainous area of Sun City. The flight was conducted under the pro

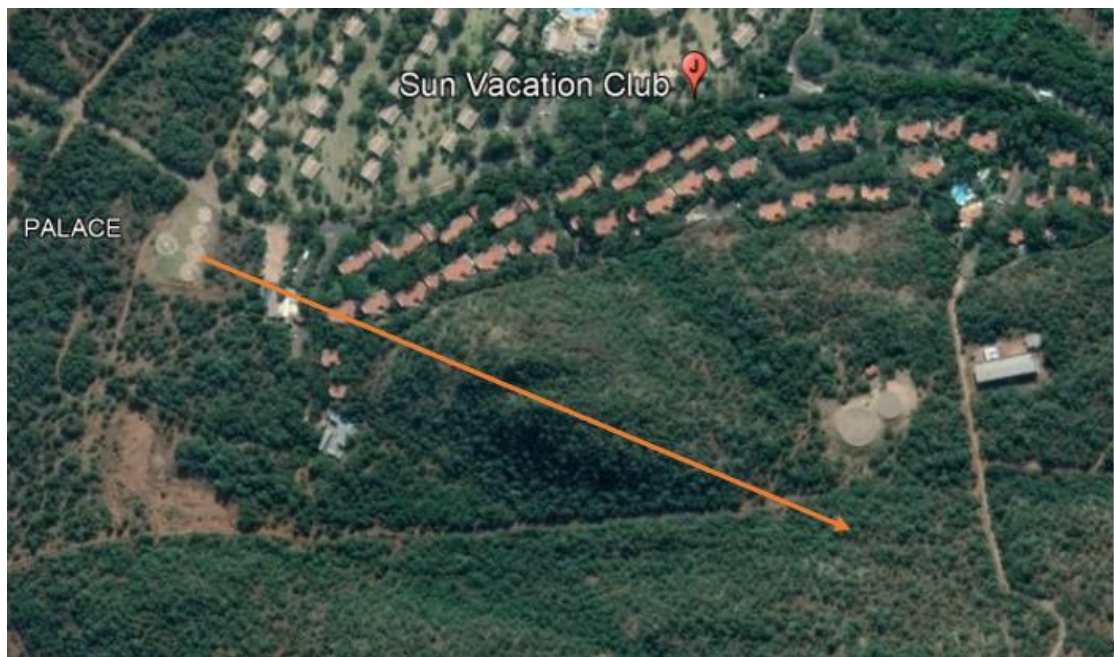
Figure 2: Flight path of the drone and the last known position: (Source: Google Earth)

- Post-accident, the operator’s safety manager (Accident Investigation office) conducted an internal investigation into the occurrence. A flight log (Pixhawk T-Log) for the accident flight was retrieved from the unit controller. A Fly012.DAT was used to determine the cause of the accident.
- According to the flight log, at 00:04s, the drone was launched to the waypoint mission (assignment). At 02:19s, the drone flew past the first peak. At 03:04s, the drone lost connection for 2.6s before coming back online; thereafter, it lost connection again and is assumed to have crashed.

- *The collision avoidance system was deactivated.*
- *The drone was being operated at 130 metres (426 feet) and the mountain/peak is 150m (500ft) high.*
- *The pilot-in-command (PIC) was using the wrong waypoint file for the assigned mission.*
- *The operator was issued a Remotely Piloted Aircraft (RPA) Operating Certificate on 25 October 2021 with an expiry date of 31 October 2022.*

- Fly with collision avoidance system active.
- Confirm the waypoint files before launch.
- Maintain visual confirmation during flight by examining what is showing on screen to observe (identify) obstacles.

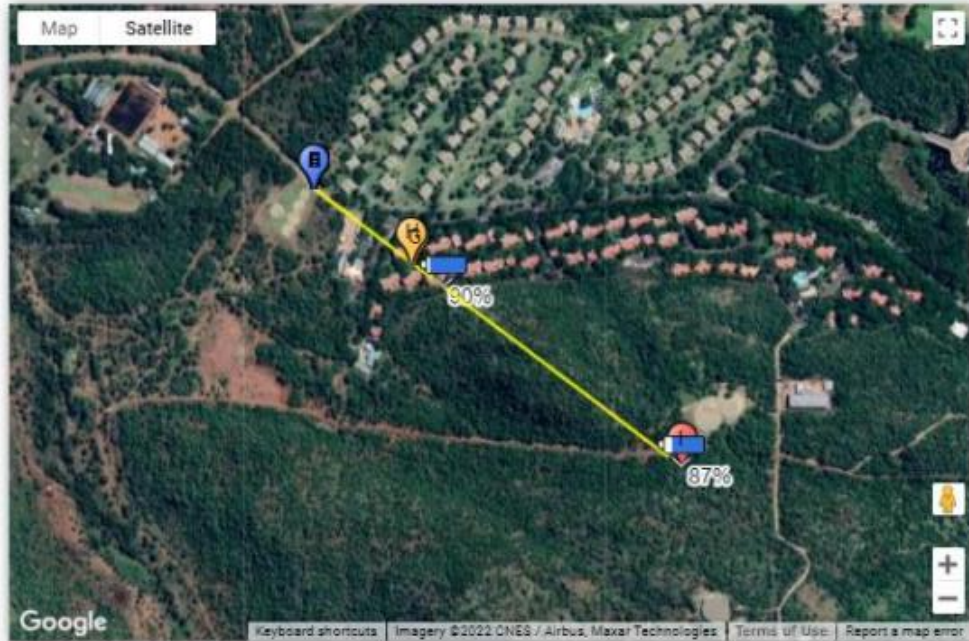
Flight time	Altitude	Home Dist	Type	Notification
A 00m 00s	0.0 m	0 m	Mode	Mode changed to Motors Started
B 00m 00s	0.0 m	0 m	Tip	<ul style="list-style-type: none"> ✓ Setting new Return-To-Home altitude to 130m (427 ft). ✓ Data Recorder File Index is 12. ✓ Setting new Maximum Flight Altitude to 500m (1640 ft)
C 00m 00s	0.0 m	0 m	Warning	Mavic 2 Enterprise Advanced Camera SD card is full Solution: Change SD card or delete some files
D 00m 01s	0.0 m	0 m	Mode	Mode changed to AutoTakeoff
E 00m 04s	1.0 m	0 m	Mode	Mode changed to P-GPS
F 00m 04s	1.1 m	0 m	Mode	Mode changed to Waypoint
G 01m 14s	129.7 m	192 m	Warning	Mavic 2 Enterprise Advanced Camera SD card is full Solution: Change SD card or delete some files
H 02m 11s	129.7 m	187 m	Warning	Mavic 2 Enterprise Advanced Camera SD card is full Solution: Change SD card or delete some files
02m 19s	129.7 m	249 m		90% Battery
I 03m 04s	129.7 m	703 m	Data Loss	⚠ Downlink data connection lost for 2.6 seconds

03m 04s	129.7 m	704 m		87% Battery at maximum distance

Figure 3: The waypoints and Pixhawk T-log. (Source: Log Analysis Report)
