**LIMITED ACCIDENT INVESTIGATION REPORT**

<b>Reference Number</b>	CA18/2/3/10112						
<b>Classification</b>	Accident	<b>Date</b>	8 February 2022	<b>Time</b>	0800Z		
<b>Type of Operation</b>	Aerial Work Operations (Part 137)						
<b>Location</b>							
Place of Departure	Barland Airfield, KwaZulu-Natal Province		Place of Intended Landing	Barland Airfield, KwaZulu-Natal Province			
Place of Accident	1.1 nautical miles (nm) south-east of Howick Airfield (FAHC), KwaZulu-Natal Province						
GPS Co-ordinates	Latitude	S 29° 33' 43"	Longitude	E 30° 13' 55"	Elevation	3703 ft	
<b>Aircraft Information</b>							
Registration	ZS-JDH						
Make/Model	Cessna A188B (Serial Number: 188-02275)						
Damage to Aircraft	Destroyed		Total Aircraft Hours	7 440.0			
<b>Pilot-in-command</b>							
Licence Valid	Yes	Gender	Male	Age	55		
Licence Type	Airline Transport Pilot Licence (ATPL) Aeroplane						
Total Hours on Type	117.2		Total Flying Hours	17 676.5			
People On-board	1 + 0	Injuries	1	Fatalities	0	Other (On Ground)	0

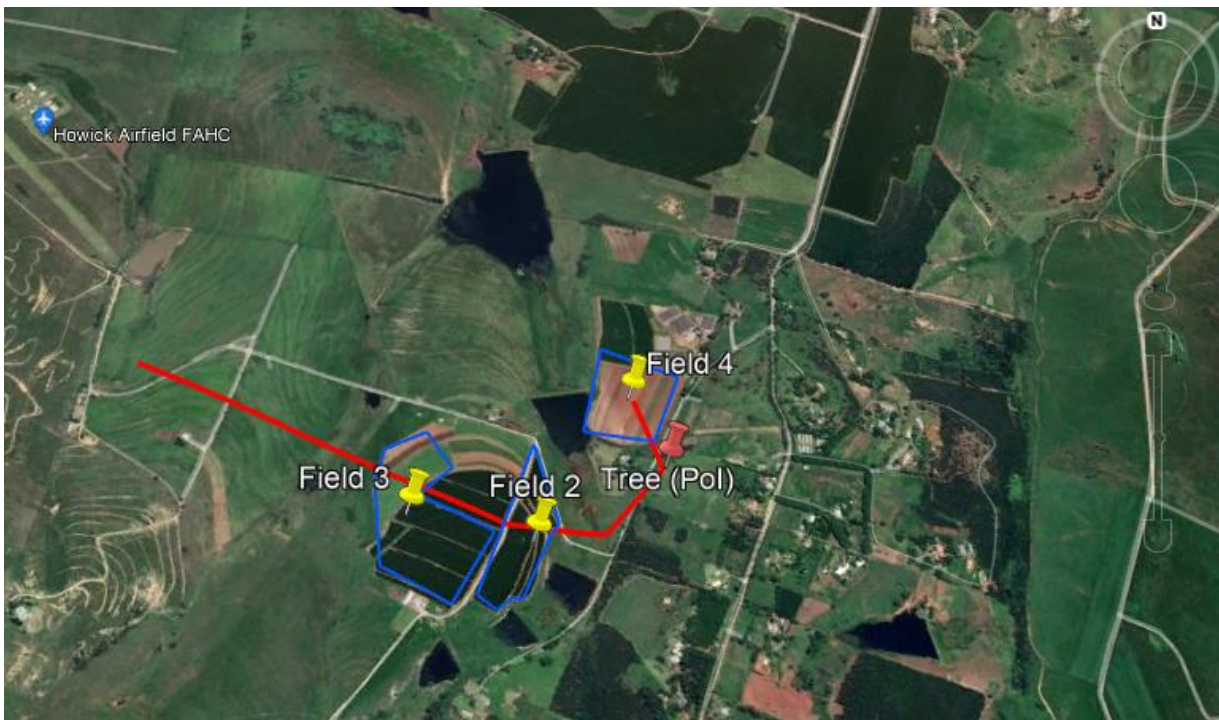
**Figure 1:** Aerial view of accident site. (Source: Pilot)

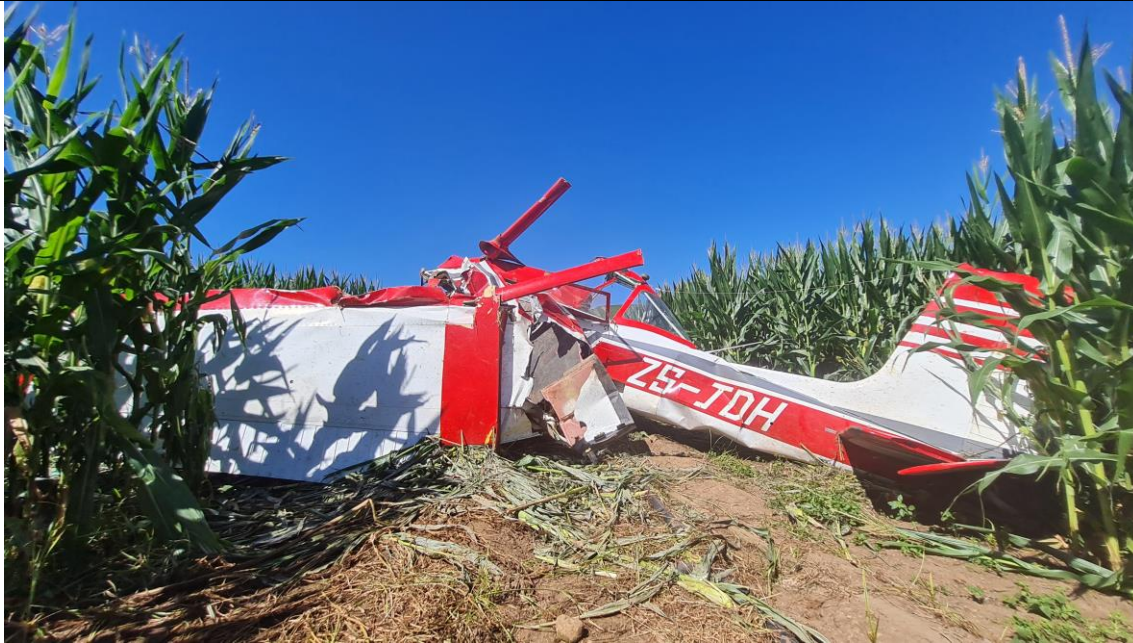
**Figure 2:** The aircraft as found on site.

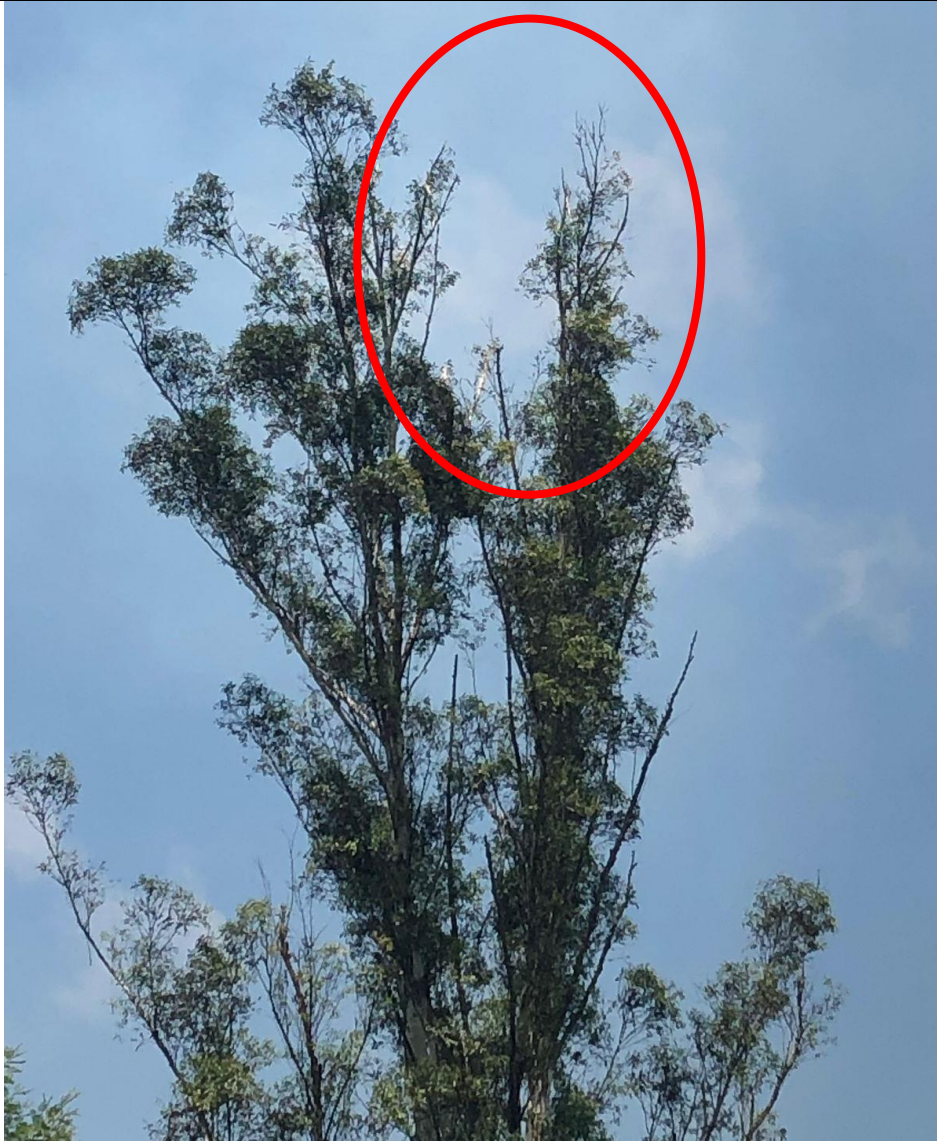
- The aircraft was initially issued a Certificate of Airworthiness (C of A) on 19 December 2002 with an expiry date of 31 December 2022.
- On-site investigation revealed that the left wing of the aircraft impacted a tree that was 230m south-east of the maize field that the pilot intended to spray. The first point of impact with the ground was 40m south-east of the main wreckage. The left-wing flap and the left wheel assembly detached from their respective attachment points and were found approximately 20m south-east of the main wreckage. All three propeller blades showed that the engine was producing a substantial amount of power prior to impact. The engine was intact and still secured to the cradle with signs of minor damages. The flight control continuity could not be established as some of the control cables in the aft fuselage had snapped due to impact. Both fuel tanks had approximately one-third of fuel remaining, respectively. Examination of fuel indicated no signs of contamination, and that fuel was of the correct grade.

**Figure 3:** The blue gum tree which the left wing impacted.

The pilot did not observe a tree in the aircraft's flight path which caused the aircraft's left wing to impact the tree. The pilot lost control and the aircraft descended and impacted the ground.

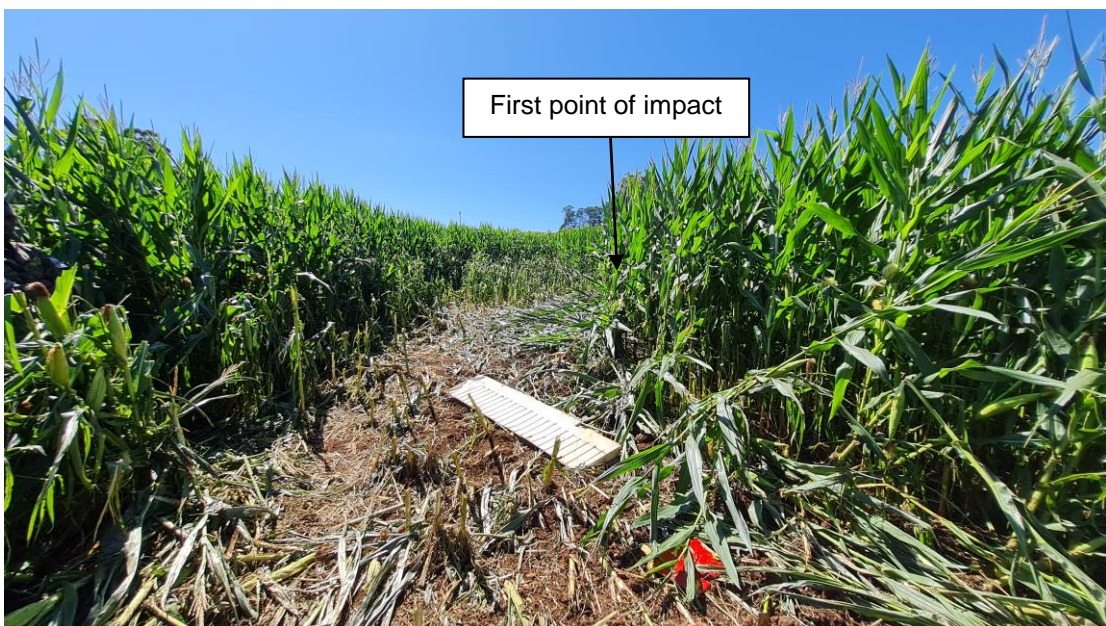
**Figure 4:** The left-wing flap and the aircraft's first point of impact with the ground.

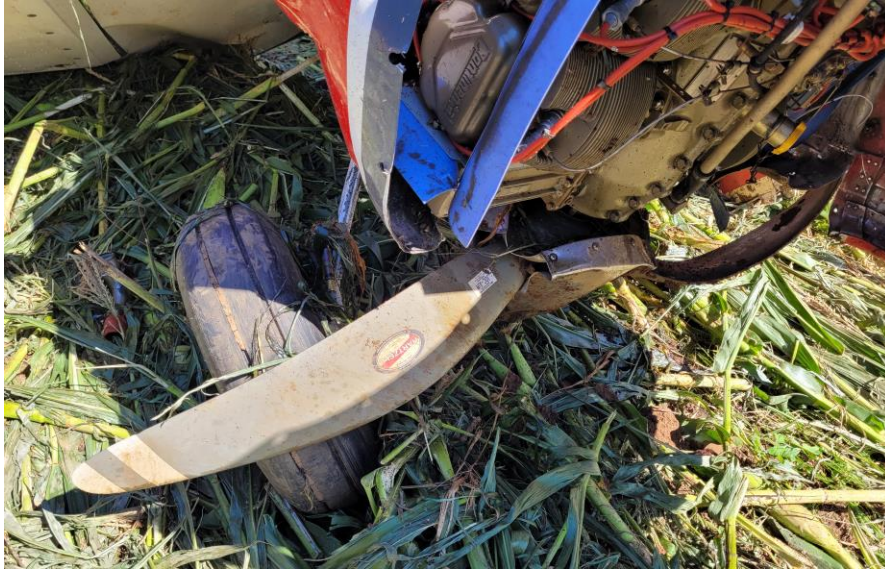
**Figure 5:** The propeller blades and the spinner showing signs of rotation before impact.
