**LIMITED ACCIDENT INVESTIGATION REPORT**

<b>Reference Number</b>	CA18/2/3/10119						
<b>Classification</b>	Accident	<b>Date</b>	12 February 2022	<b>Time</b>	0710Z		
<b>Type of Operation</b>	Private (Part 94)						
<b>Location</b>							
<b>Place of Departure</b>	Morningstar Aerodrome, Western Cape Province		<b>Place of Intended Landing</b>	Gannabos and Doringrivier Private Farm near Nieuwoudtville Aerodrome (FANV), Northern Cape Province			
<b>Place of Accident</b>	On a road at Gannabos and Doringrivier private farm near Nieuwoudtville Aerodrome						
<b>GPS Co-ordinates</b>	<b>Latitude</b>	S31°13'38.0"	<b>Longitude</b>	E19°13'27.8"	<b>Elevation</b>	1 293 feet	
<b>Aircraft Information</b>							
<b>Registration</b>	ZU-WAB (Serial Number: 71334)						
<b>Model/Make</b>	Vans RV-7						
<b>Damage to Aircraft</b>	Substantial		<b>Total Aircraft Hours</b>	211.4			
<b>Pilot-in-command</b>							
<b>Licence Type</b>	Private Pilot Licence (PPL) Aeroplane	<b>Gender</b>	Male		<b>Age:</b> 47

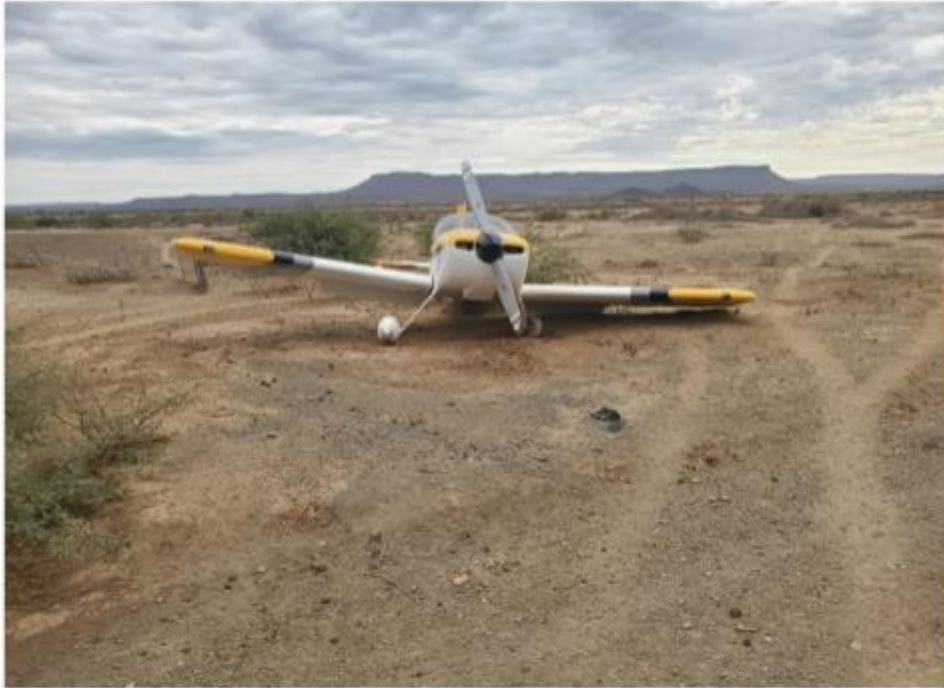
**Figure 1:** The final resting position of the aircraft post-accident. (Source: Pilot)

- The pilot lost directional control of the aircraft and veered off to the right of the gravel road after the right wing collided with a thorn bush during landing.

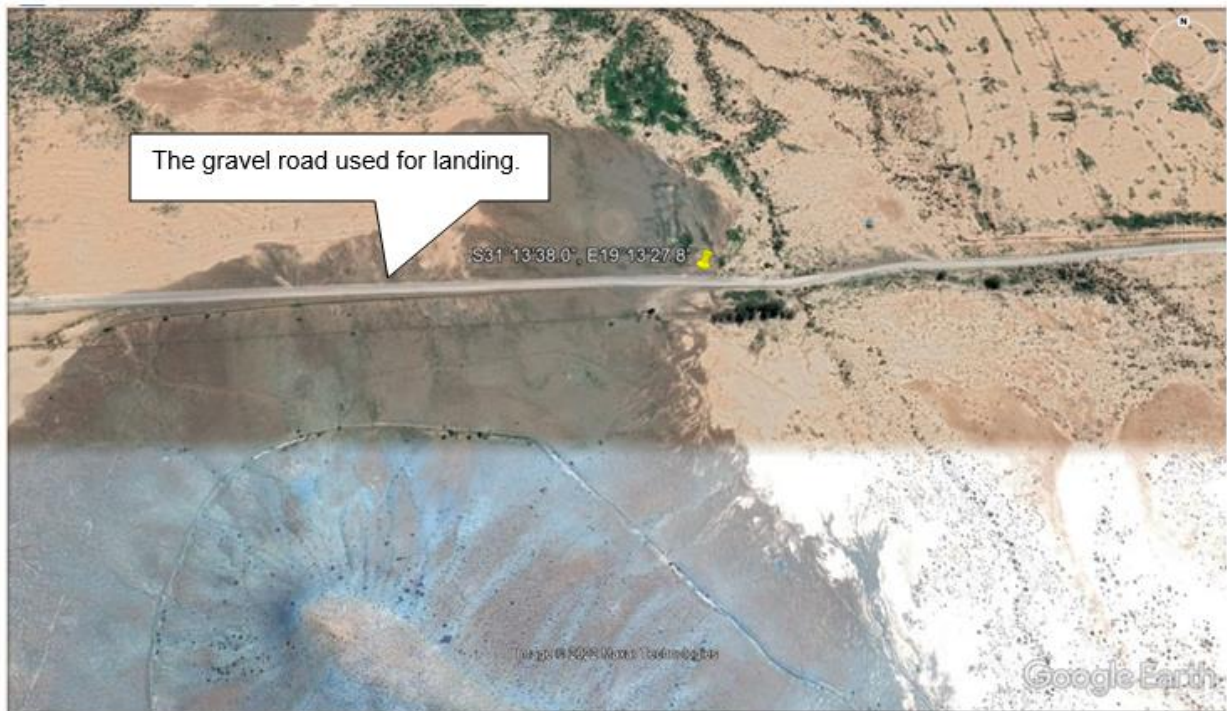
**Figure 3:** The gravel road (used as a private landing strip) where the aircraft landed.

- No inspection of the gravel road prior to landing.
- Landing on a road is in contravention of CAR 2011, Part 91.06.1 as amended.
