LIMITED ACCIDENT INVESTIGATION REPORT
--

Reference Number		CA18/3/2/10123					
Classification	Accident	Date	24 February 2022	Time	0940Z		
Type of Operation	Training (Part 141)						
Location							
Place of Departure	Grand Central Aerodrome (FAGC)		Place of Intended Landing	Grand Central Aerodrome (FAGC)			
Place of Accident	Runway 35, FAGC						
GPS Co-ordinates	Latitude	S25°59'33.98"	Longitude	E028°08'37.68"	Elevation	5326 feet	
Aircraft Information							
Registration	ZS-OBA (Serial Number 30-1601)						
Model/Make	PA30, Piper Aircraft Corporation						
Damage to Aircraft	Substantial		Total Aircraft Hours	7459.5			
Pilot-in-command							
Licence Type	Commercial Pilot Licence (CPL) Aeroplane		Gender	Male	Age	42	
Licence Valid							
Total Hours on Type	70.1		Total Flying Hours	1429.0			
People On-board	1+1	Injuries	0	Fatalities	0	Other (on ground)	0
What Happened

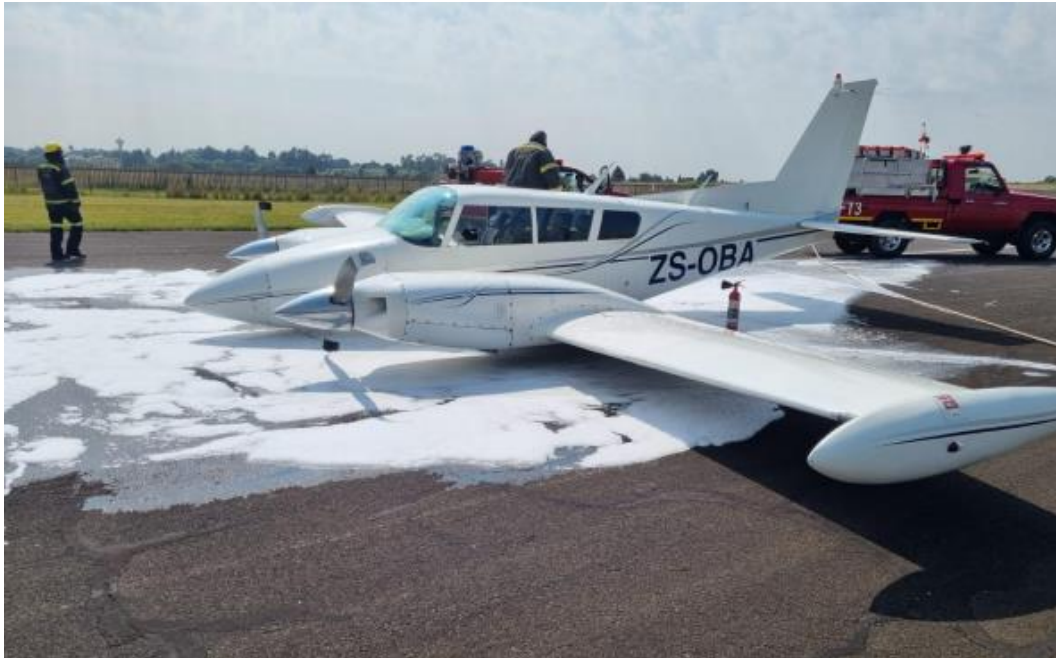
downwind leg and were now commencing with their descent; the aircraft reached the short final approach a little higher than normal and approximately 15 miles per hour (mph) faster than the normal approach speed of 90mph (78 kts). Whilst on short finals, the instructor reminded the student pilot to complete CPUFF checks which, at the time, were not completed yet (see CPUFF explanation below). As the instructor and the student pilot were busy chasing the glide slope, they did not remember to lower the undercarriage. (Note: *The warning horn for 'undercarriage not down' activates when the aircraft has full flaps, and the manifold pressure is below 12 inches before landing.*) Both the instructor and the student pilot confirmed that the only time they realised that the undercarriage was still retracted was during flare when the aircraft kept sinking until it landed on its belly. The aircraft sustained damages to both propellers as well as the lower airframe. Neither the instructor nor the student pilot was injured during the accident.

Figure 1: The aircraft as it came to rest on RWY 35. (Source: Pilot)

The aircraft landed on its belly due to the crew not lowering the landing gears.

1. The instructor was distracted by the instability of the aircraft on approach.
2. The CPUFF checks were not completed on time before landing.

Pilots are urged to always conform to the tasks at hand especially during the critical take-off and landing phases of flight which could cause injury or damage to property if not executed correctly.
