LIMITED ACCIDENT INVESTIGATION

Reference Number	CA18/2/3/10135					
Classification	Accident	Date	12 March 2022	Time	1130Z	
Type of Operation	Private (Part 94)					
Location						
Place of Departure	Warmbaths Aerodrome (FAWA), Limpopo Province		Place of Intended Landing	Warmbaths Aerodrome (FAWA), Limpopo Province		
Place of Accident	Zingela Nature Reserve in Tolwe, Limpopo Province					
GPS Co-ordinates	Latitude	S 23°00'03.44"	Longitude	E 028°39'50.51"	Elevation	2 575 feet
Aircraft Information						
Registration	ZU-ING					
Model/Make	Kitplanes Safari LSA (Serial Number: 034-09-17SAF3)					
Damage to Aircraft	Destroyed		Total Aircraft Hours	±32		
Pilot-in-command						
Licence Type	Private Pilot Licence (PPL)	Gender	Male		Age: 58	
Licence Valid	Yes					
Total Hours on Type	±20		Total Flying Hours	3 943		
People On-board	1 + 1	Injuries	2	Fatalities	0	Other (on ground) 0
What Happened

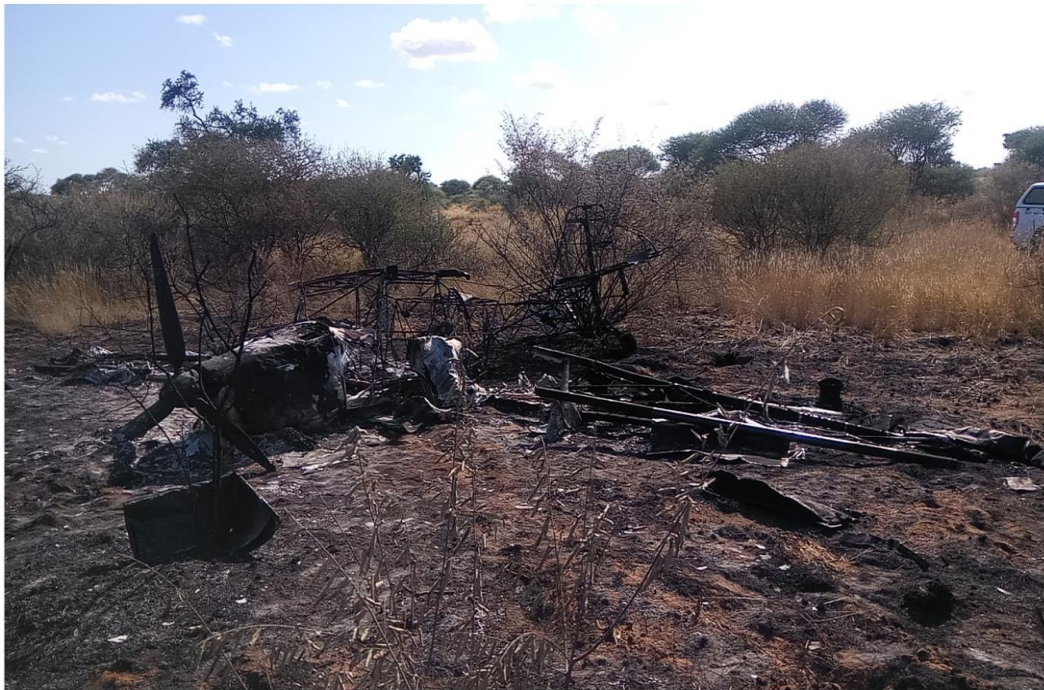
The pilot exited the aircraft and assisted the passenger out of the aircraft, which was already ablaze. The aircraft was destroyed by impact forces and a post-impact fuel-fed fire. Both occupants sustained serious burn injuries; they were airlifted to the hospital for medical treatment.

Figure 1: The wreckage at the accident site.

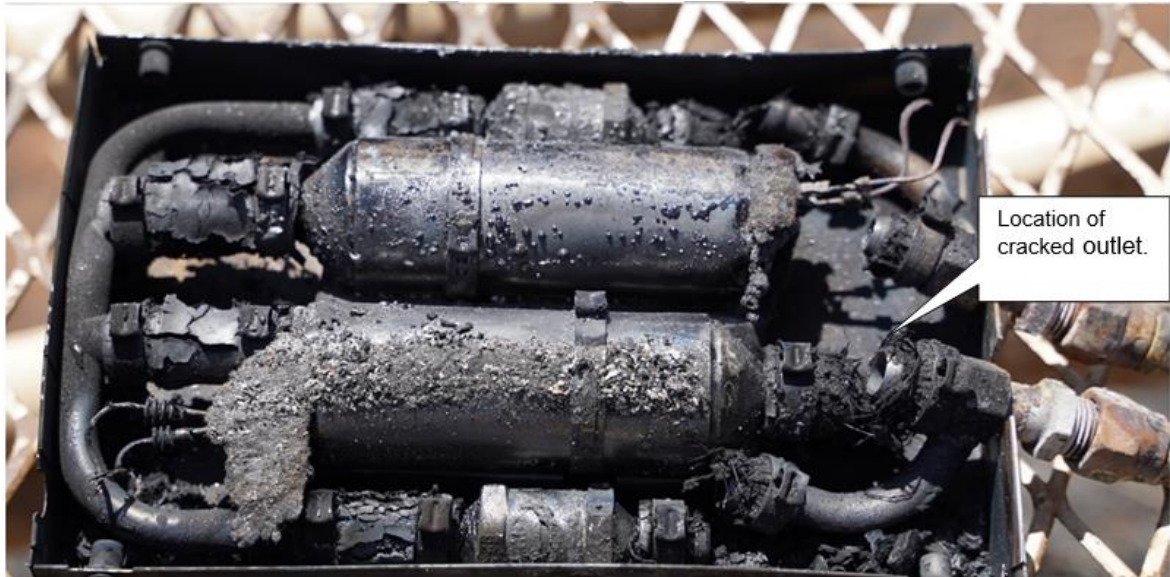
- The fuel pump assembly was removed from the firewall and disassembled. The fuel pump housing is installed on the right-side of the engine firewall. All components seemed to be in place except for the outlet fuel supply line of the high-pressure side of the auxiliary fuel pump. The outlet nipple, with a clamp and a short hose, was found loose inside the pump housing. A closer examination of the outlet nipple showed that the nipple detached during the accident sequence, however, the bottom half showed evidence of nicks/cracks. It was evident that it was not completely attached at the time the fire erupted.

Figure 5: Opened fuel pump assembly at the accident site - SN 19.5057 (Source: AMO)

- The fuel hose in the same area showed signs of fuel blown outwards under pressure as the fuel hose missed parts, and there was what looked like a channel which was burnt outwards from the nipple. It seemed, from the evidence, that the fuel outlet nipple and the hose might have sustained damage due to an overtight crimp or a manufacturing flaw of the plastic outlet, which subsequently failed during the long flight due to consistent pressure and high heat in the engine compartment.

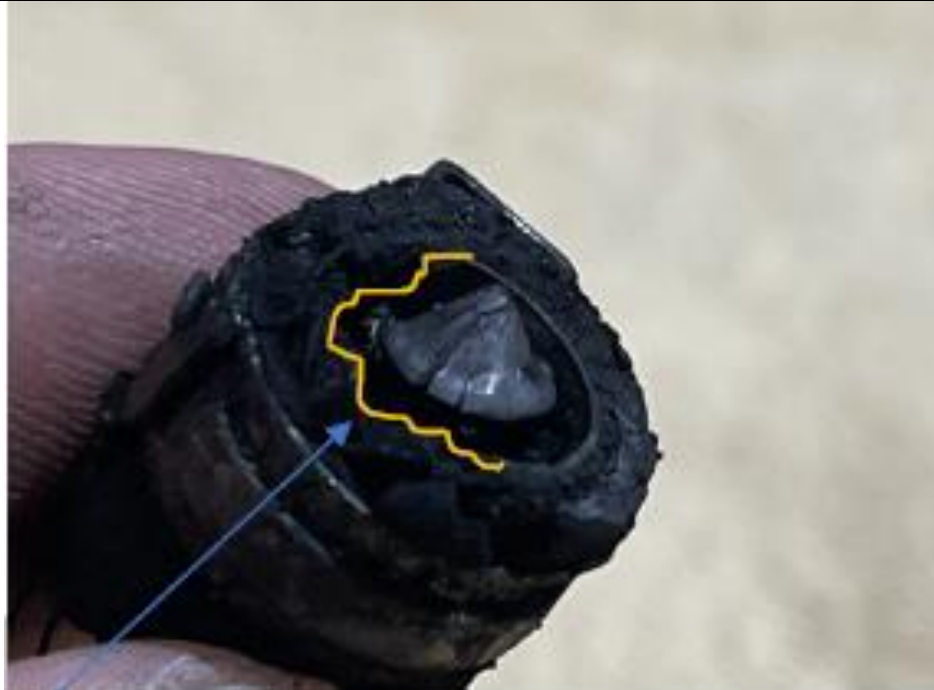
Figure 6: Fuel outlet nipple in the auxiliary pump showing a cracked area, and the yellow line indicates the deformation of the nipple housing. (Source: AMO)

- In conclusion, it is highly likely that the fuel pump high pressure outlet had a crack or was damaged and, thus, failed. This caused the fuel to leak in the engine bay, hence, the subsequent fuel starvation and engine failure. The fuel leak was exacerbated by the fact that the pilot attempted to re-start the engine by switching the engine control unit (ECU) and the auxiliary fuel pump (2) on.

The fuel pump high pressure outlet had a crack, causing fuel to leak in the engine bay and, hence, the subsequent fuel starvation which caused the engine stoppage and the resultant forced landing. During the forced landing, it is likely that the hot engine surface came into contact with the leaked fuel, which led to post-impact fire that consumed the aircraft.

It is possible that during assembly of the fuel pump, the pressure outlet pipe was not supported when it was tightened, and this caused it to crack, resulting in fuel leakage.

It is recommended that the manufacturer, during assembly, exercise extra care when tightening pipes with rubber hoses to prevent any damage that might occur when nuts are fastened.
