Hard landing following autorotation Hélicoptères Guimbal Cabri G2, PH-HCC

low flying area Flevopolder, 29 April 2022

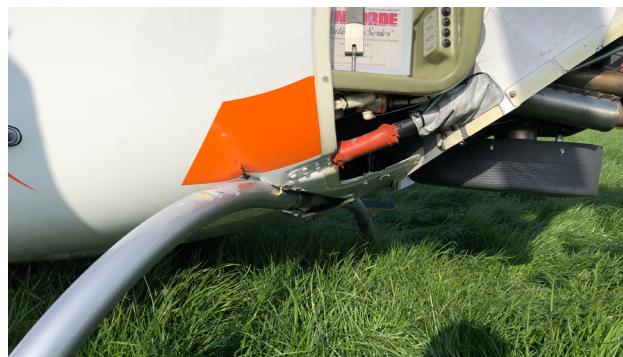
The instructor reported attempting to apply power twice, but the engine did not respond. Given the low altitude, he decided to treat the exercise as an emergency situation. During the finalization of the maneuver, the instructor attempted to select power one or two more times, during which the engine appeared to respond limitedly. During the landing, the engine provided power, and the helicopter's nose turned left, resulting in a sideward hard landing that damaged the left skid.

▲ The left skid. (Source: Helicentre)

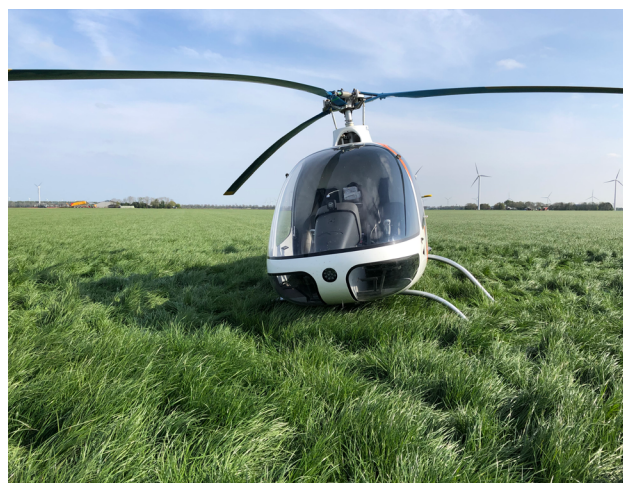
▲ The helicopter after the hard landing. (Source: Helicentre)
