LIMITED ACCIDENT INVESTIGATION REPORT
--

Reference Number		CA18/2/3/10153					
Classification	Accident	Date	4 May 2022	Time	1000Z		
Type of Operation		Private (Part 91)					
Location							
Place of Departure		Botselo Private Airstrip, North West Province		Place of Intended Landing		Botselo Private Airstrip, North West Province	
Place of Accident		Botselo Private Airstrip, North West Province					
GPS Co-ordinates	Latitude	S26°02'10.0"	Longitude	E025°18'17.2"	Elevation	4110 feet	
Aircraft Information							
Registration		ZS-OBR					
Model/Make		Air Tractor / AT-502B (Serial Number: 502B-0431)					
Damage to Aircraft		Substantial		Total Aircraft Hours		6445.3	
Pilot-in-command							
Licence Valid		Yes	Gender	Male	Age	72	
Licence Type		Commercial Pilot Licence (A) (CPL)					
Total Hours on Type		5134.6		Total Flying Hours		14583.5	
People On-board	1 + 0	Injuries	0	Fatalities	0	Other (On Ground)	0
What Happened							
<p>On Wednesday, 4 May 2022, a pilot on-board an Air Tractor AT502B aircraft with registration ZS-OBR was engaged in a crop-spraying operation at Botselo Private Farm when the accident occurred. The aircraft took off from Botselo Private Farm Airstrip with the intentio

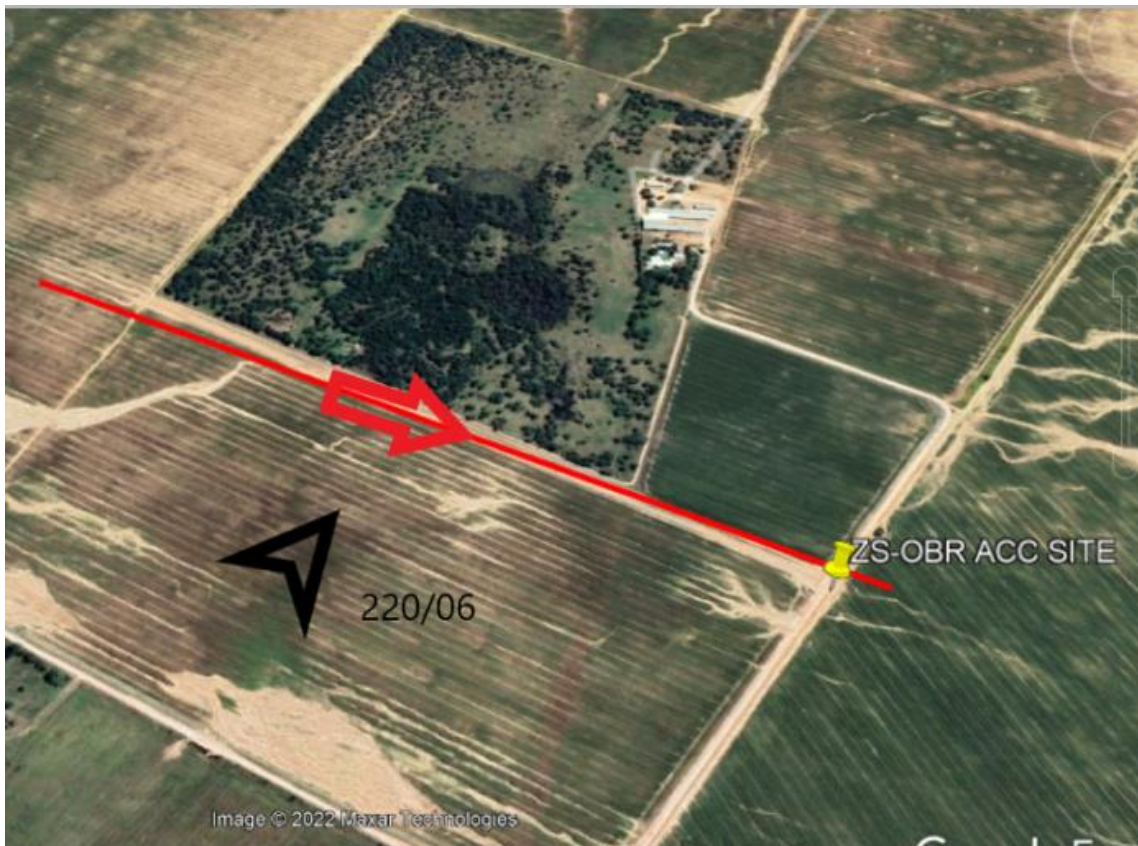
The pilot indicated that the wind direction changed from 180° to 220° shortly after take-off and the aircraft lost lift during climb out. The aircraft descended rapidly and crashed on the soft ground before it nosed over. It came to rest in an inverted position.

Figure 1: Direction of flight.

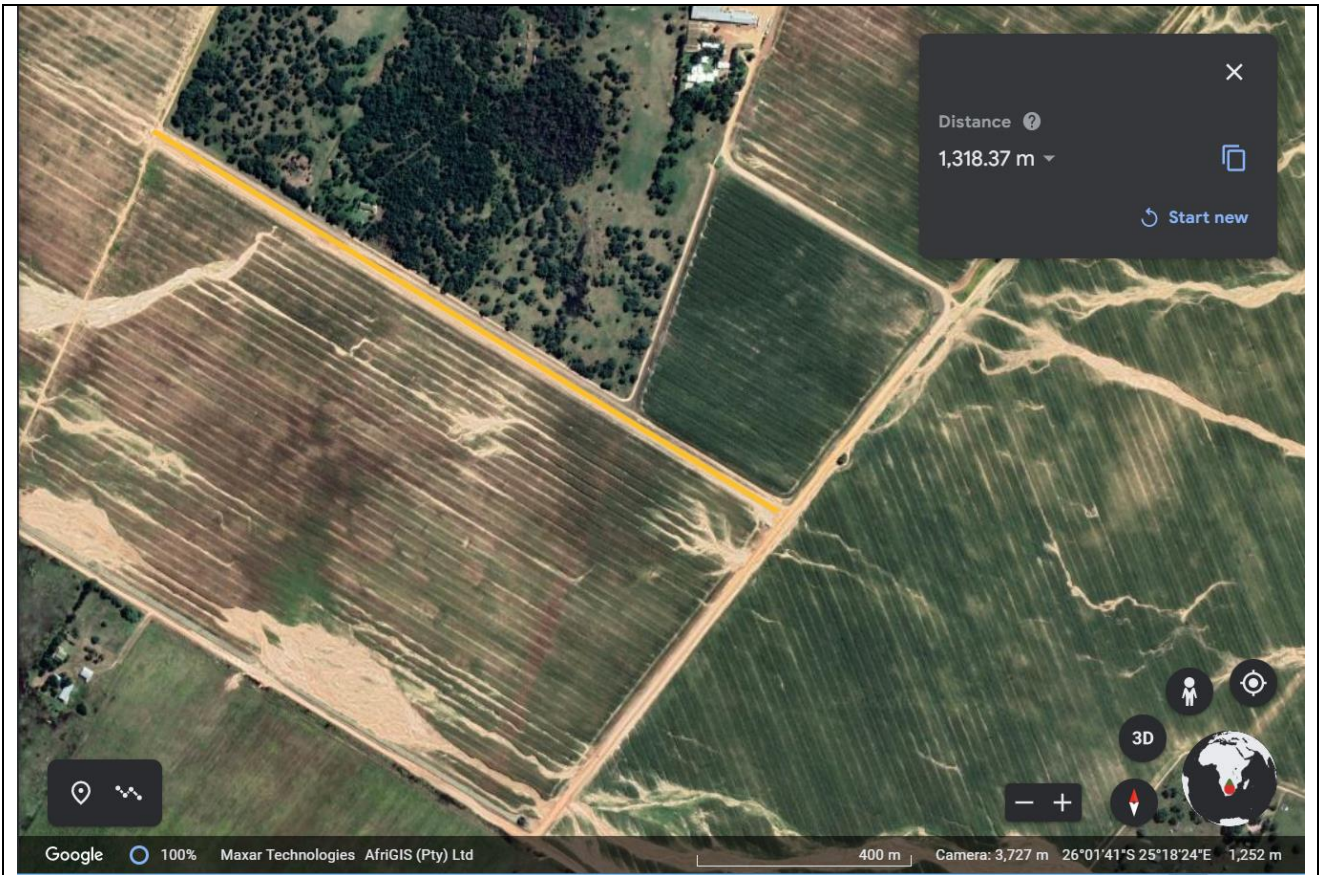
Figure 2: The length of the take-off runway/road is approximately 1318.37 metres.

It is probable that the aircraft did not use the entire length of the runway or road, which resulted in the pilot rotating prior to attaining the required speed (to rotate) and causing the aircraft's failure to climb; hence, the subsequent crash.

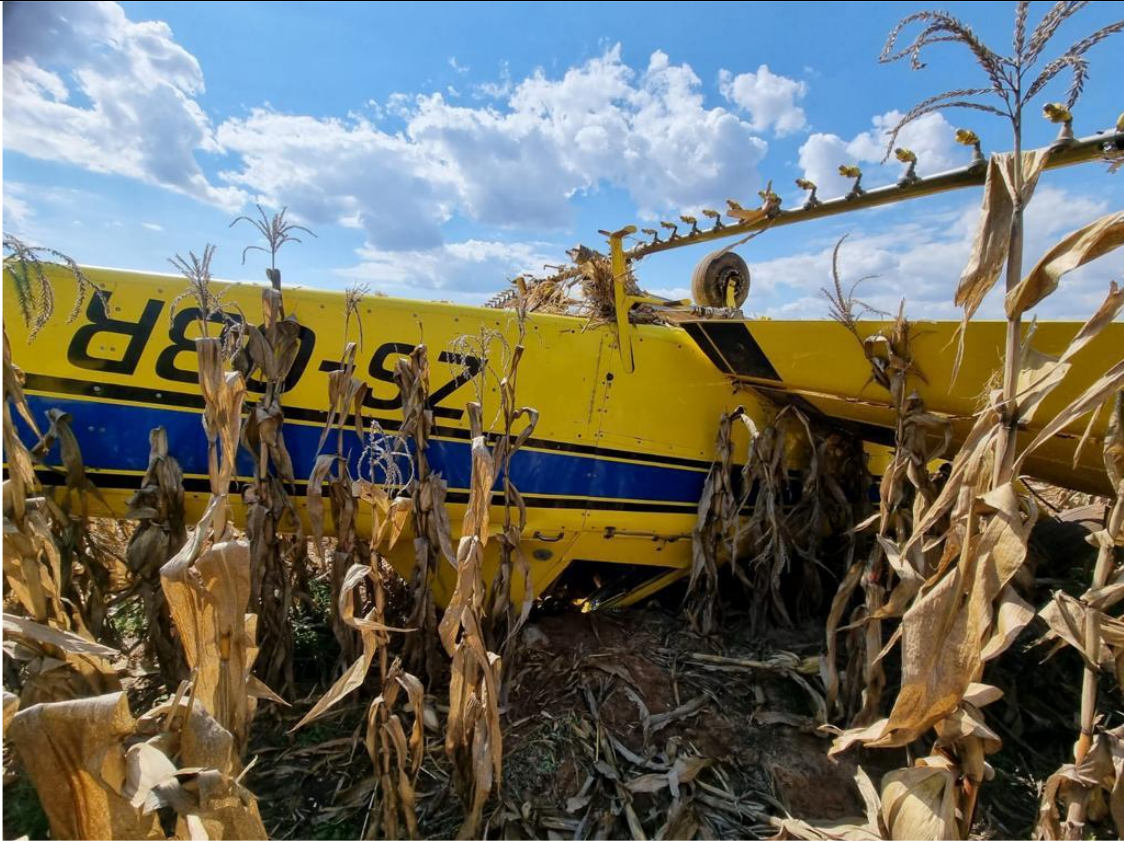
Figure 3: The aircraft as it came to rest in an inverted position. (Source: Pilot)

Pilots engaged in aerial work are advised to always evaluate risk and mitigate it prior to engaging in their operations.
