FINAL REPORT

OCCURRENCE NO – 2022/2231

AIRCRAFT – Gyroplane AutoGyro Cavalon, OK-AWC98

DATE AND PLACE OF OCCURRENCE – 13 May 2022, Brzeziny

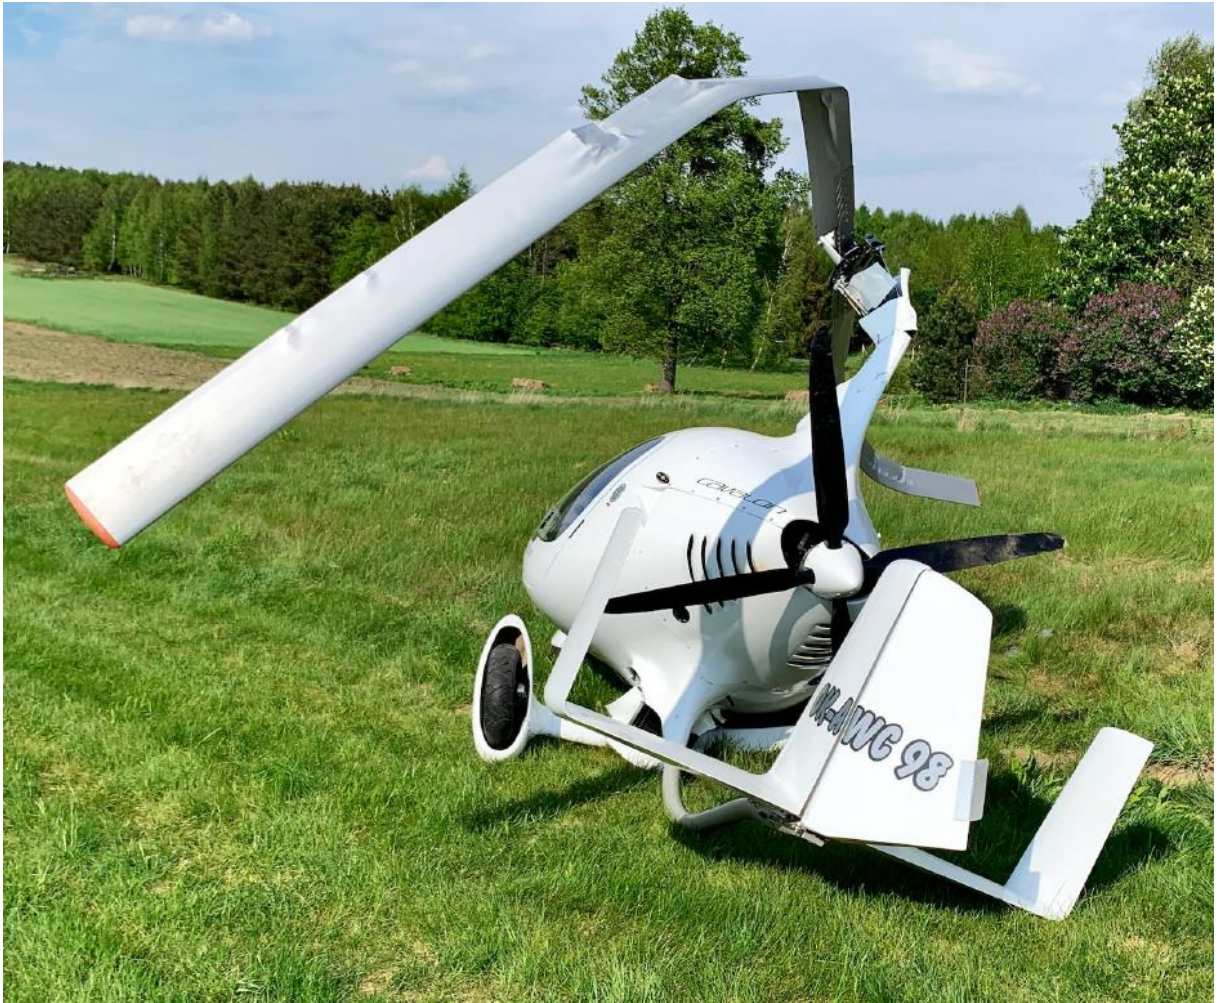
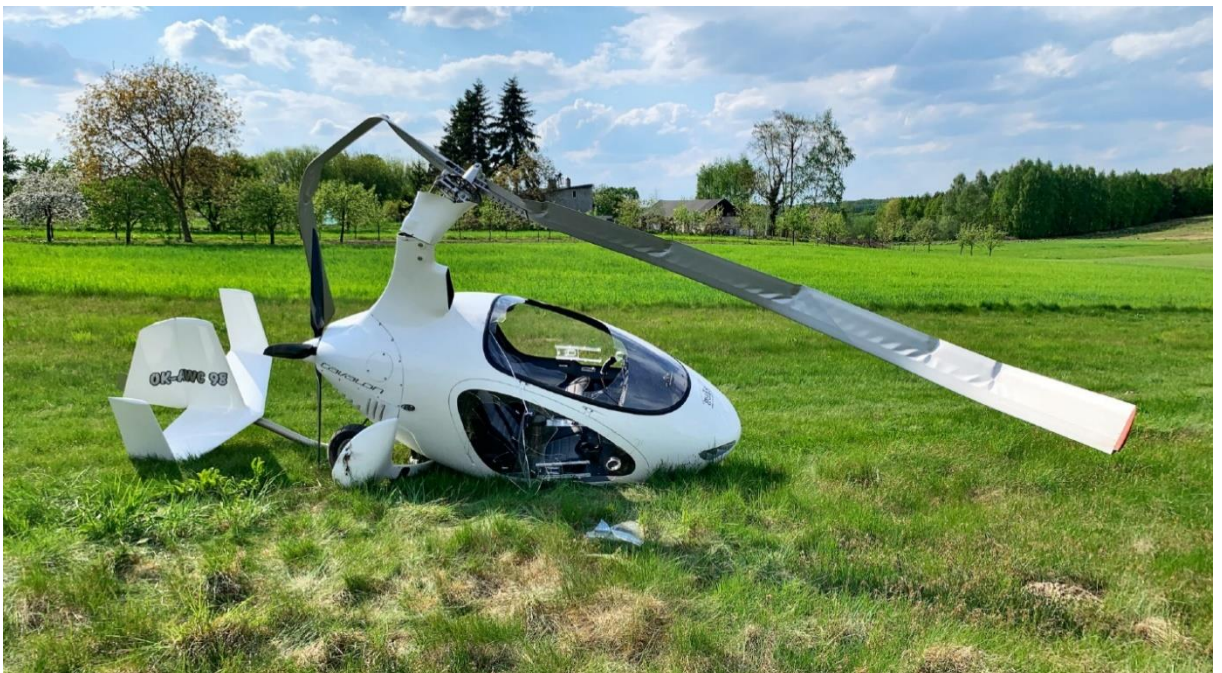
The accident aircraft was substantially damaged. The main landing gear detached from the fuselage, causing that the gyroplane turned over on its side and the operating main rotor collided with the ground, which resulted in its destruction. The rotor mast and the polycarbonate glazing of the fuselage were also damaged.

Fig. 2. OK-AWC98 gyroplane at the accident site [Source: PKBWL]

Fig. 3. OK-AWC98 gyroplane at the accident site [Source: PKBWL]

Pilot's error consisting in starting the take-off run with braked wheels of the main landing gear, which resulted in the creation of destructive forces at the landing gear attachment points resulting in the landing gear damage during take-off run.
