DUTCH
SAFETY BOARD

Fatal accident Dyn'Aéro MCR01

5 June 2022

The Hague, 8 November 2023

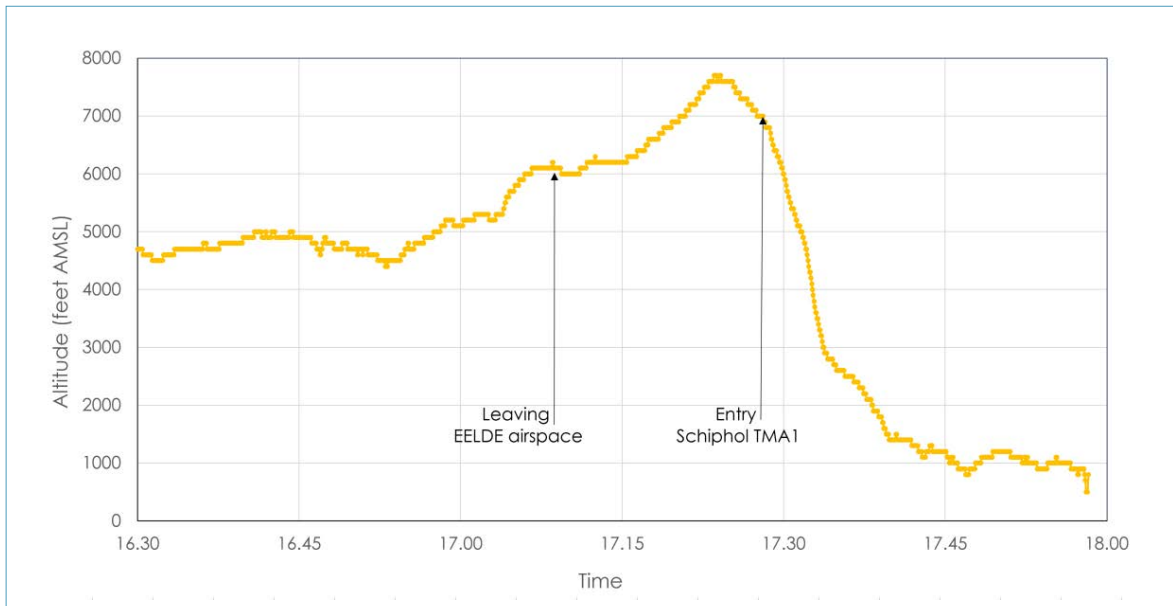
Figure 2: Altitude of the aircraft, expressed in feet AMSL, QNH 1012 mbar. (Source radar data: LVNL)

The cause of the accident could not be determined. Based on available radar data, the accident occurred at approximately 17.58:30 hours. Radar data confirm that altitude variations occurred during the last part of the flight before the aircraft descended from 800 feet above mean sea level (AMSL) and impacted the water.

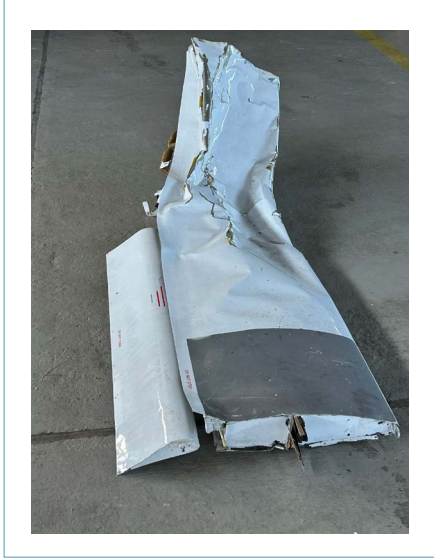
Figure 3: Left wing. (Source: Dutch Safety Board)

The recovered wreckage parts were examined by the Dutch Safety Board. The severely damaged left wing was recovered (see Figure 3). The flap was still attached to the wooden rear spar, the aileron was found separately. The flap and aileron sustained relatively minor damage. Of the right wing, only the front and rear spar of the wing were recovered; the wing skin was missing (see Figure 4). The aileron was attached to a piece of the rear spar and had minor damage. The flap had severe damage and both hinges were still attached to parts of the rear spar.

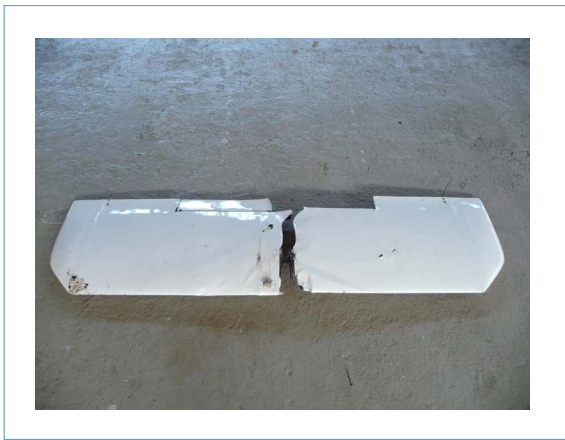
Figure 5: Tailplane. (Source: Dutch Safety Board)

The tailplane (horizontal stabilizer) was recovered in a fractured condition, separated in a left and a right part (see Figure 5). The trim-tab was partly in place on the left side. The trim rod was connected to the trim-tab by a rod-end. During the examination, the rod-end was stuck and unable to move freely. The two rivets to hold the rod-end in place were intact. The other side of the trim rod was loose, one rivet was missing and one rivet was damaged. Both tailplane attachment fittings, attaching the tailplane to the vertical fin, were sheared. Only a part of the inner construction of the vertical fin was recovered. It was noticed on the wreckage that the attachment fittings on the tailplane were the originally installed type 1 fittings.¹⁵

The tailplane of the accident aircraft EC-ZAF was recovered and found separated from the vertical fin (see Section 2.3). The fracture surfaces of tailplane attachment fittings were examined by a laboratory on request of the Dutch Safety Board. The examination concluded that the attachment fittings have failed in overload; no signs of stress corrosion or other failure modes were observed. It was determined that the damage to the tailplane was most probably caused on impact.

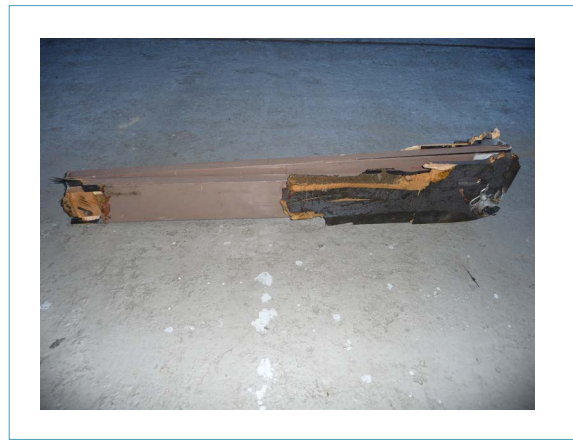
Figure 6: Parts of hull structure frames. (Source: Dutch Safety Board)

Both seats, parts of the hull structure (i.e. parts of the wooden front and aft frames, see one part in Figure 6) and a number of smaller, fractured parts, including parts of the propeller were recovered. Apart from the flaps, no parts of the flaperon system were recovered.

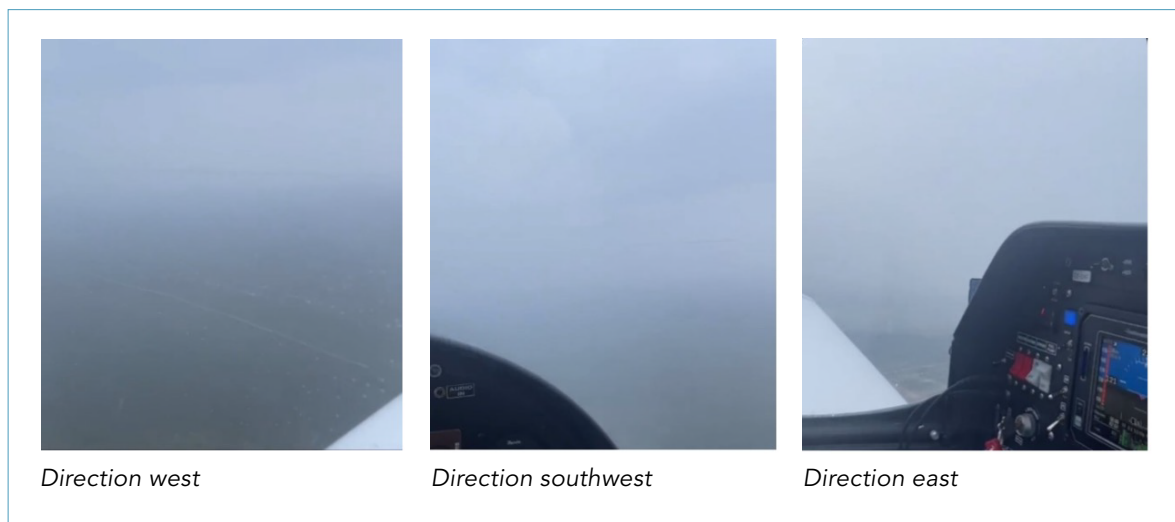
Figure 10: Images from video recording taken approximately two to four minutes prior to the accident.

From the passenger's video recording, taken approximately two to four minutes before the accident, an impression of the weather conditions could be obtained. The recording shows Visual Meteorological Conditions (VMC) with light rain. In all directions, either ground or water are in sight, see also the images taken from the recording in Figure 10. In south-westerly and westerly direction the horizon is visible, while in easterly direction the horizon is moderately visible.

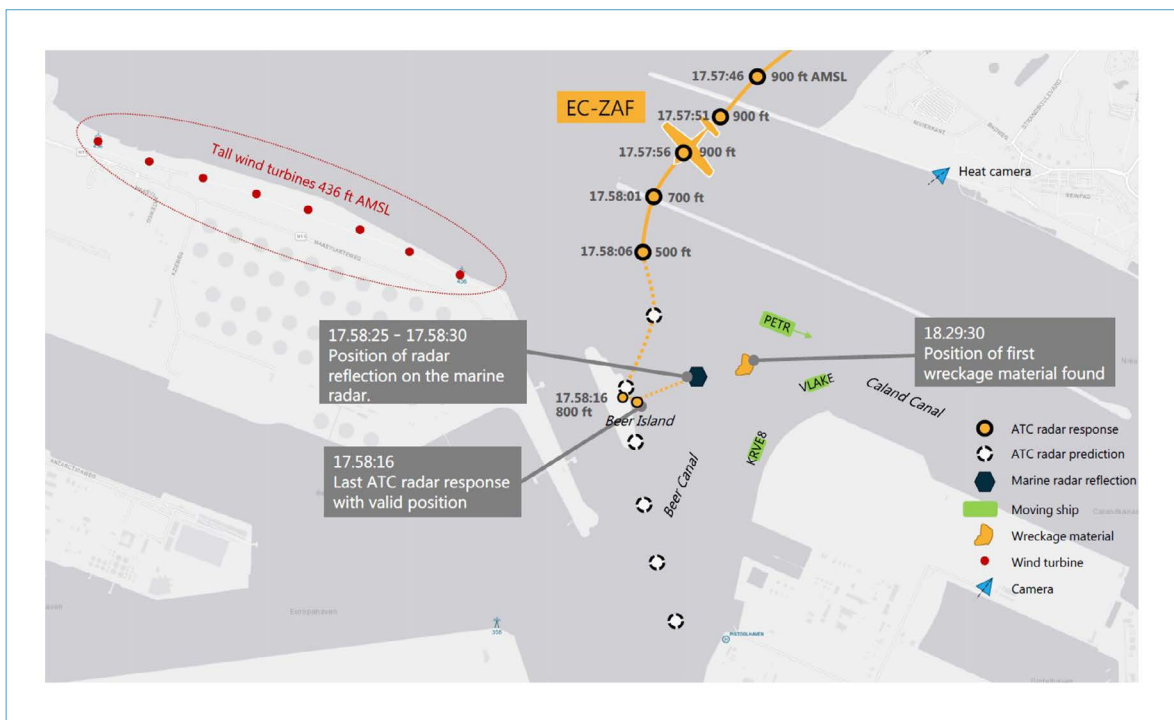
Figure 12: Final stage horizontal flight path. (Source data: LVNL and RPA)

By combining the information obtained from the ATC radar and maritime radar, an approximation of the flight path of the final stage of the flight was made and is depicted in Figures 12 and 13. Given the validity of the radar responses and taking into consideration the maritime radar reflection, after the last valid ATC measurement at 17:58:16 hours, the aircraft (or parts thereof) changed heading and was traversing in easterly direction.

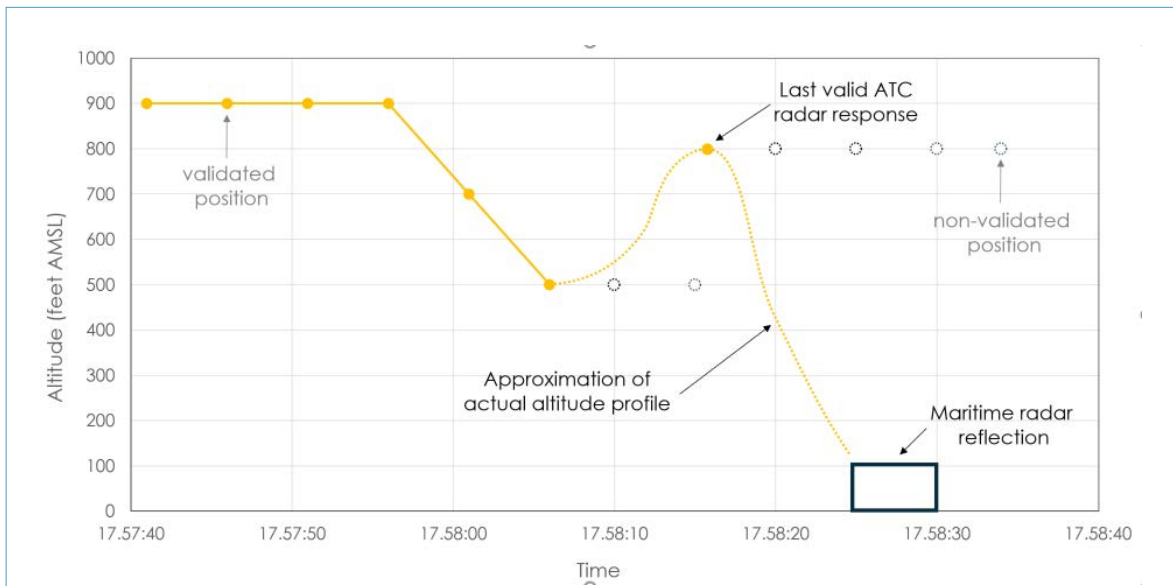
Figure 13: Final stage vertical flight path. (Source data: LVNL and RPA)

Radar data from ATC shows that just before the accident, the aircraft was flying at an altitude of about 900 feet AMSL. In a period of 10 seconds, the aircraft descended over the Nieuwe Waterweg and Caland Canal to an altitude of 500 feet AMSL. What happened the seconds after, remains unclear. The last valid radar measurement, with an altitude determined at 800 feet AMSL, indicates that altitude variations occurred during the latter part of the flight.
