## *Final report* *SHK 2023:12e*

**Seaplane accident at Lake Siljan, Dalarna County on 18 July 2022 involving the aeroplane N747HJ of the model UC-1 Twin Bee**

File no. L-70/22

23 October 2023

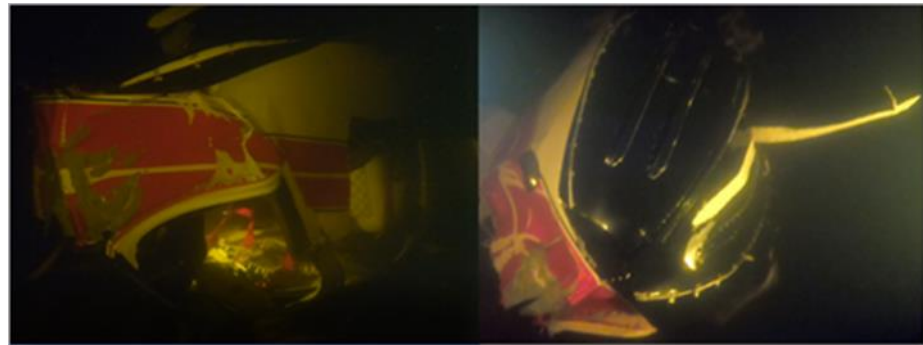
The aircraft's cabin structure and nose were heavily damaged, (see Figure 18). The entire hull and the keel were damaged and had compression creases, (see Figure 19). Parts of the hull and the keel were missing.

Figure 18. The nose and forward part of the keel of the aircraft. Image: The Swedish Police.

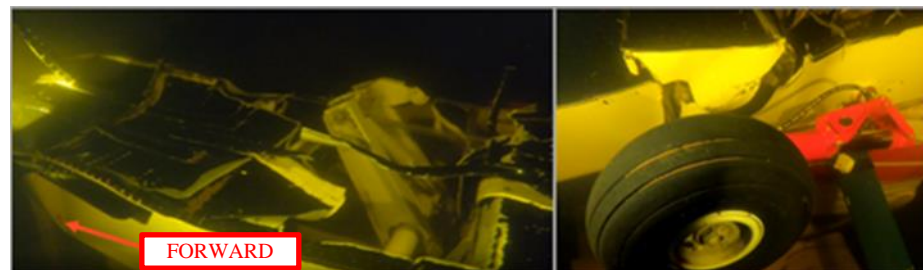
Large compression creases were found along the sides of the bottom hull. There were also large fractures on the sides of the bottom hull at and around the step. The damage was so severe that the tail boom was almost separated from the hull. The top of the rudder was damaged.

Figure 19. The left part of the picture shows the damage to the keel and where parts of the keel plates are missing. The right picture shows damage to the side of the bottom hull at the step. The position of the main landing gear after the accident is also visible. Photo: The Swedish Police.

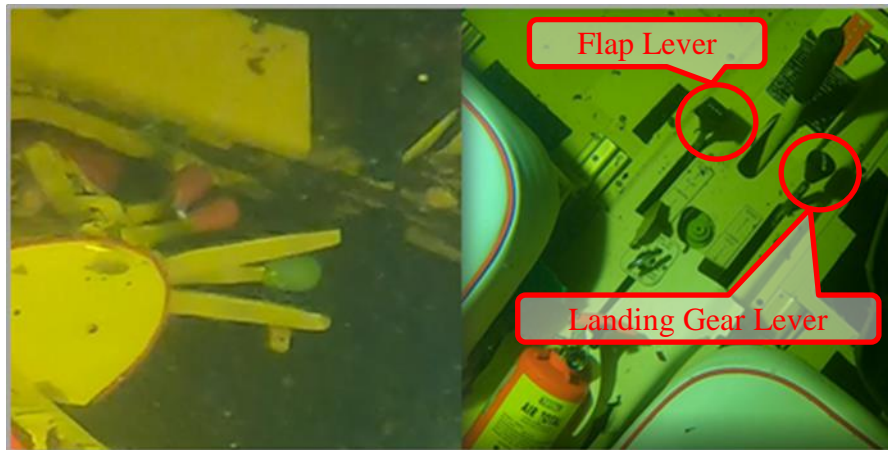
All engine and propeller controls located in the ceiling were in the full forward or near full forward position, (see Figure 20).

Figure 20. The picture on the left shows the engine and propeller controls. The image to the right shows the landing gear lever, flap lever and fuel selector positions. Photo: The Swedish Police. Markings inserted by SHK.

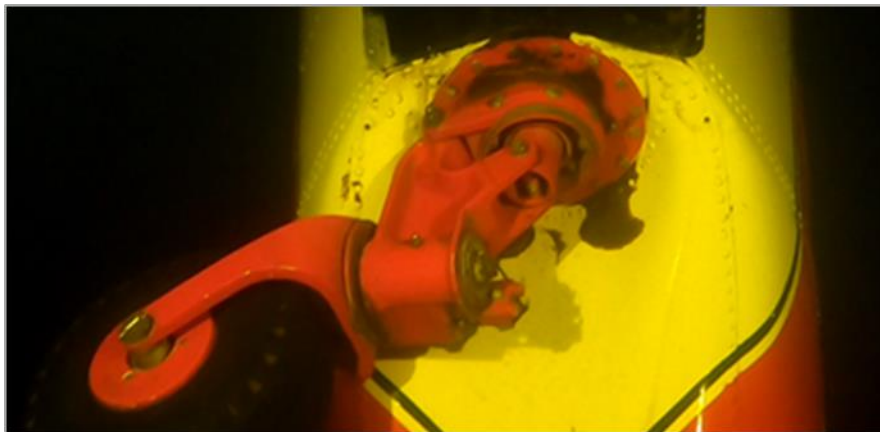
The tail wheel appeared to be in the UP position, (see Figure 21).

Figure 21. The position of the Tail Wheel during the diving. Photo: The Swedish Police.

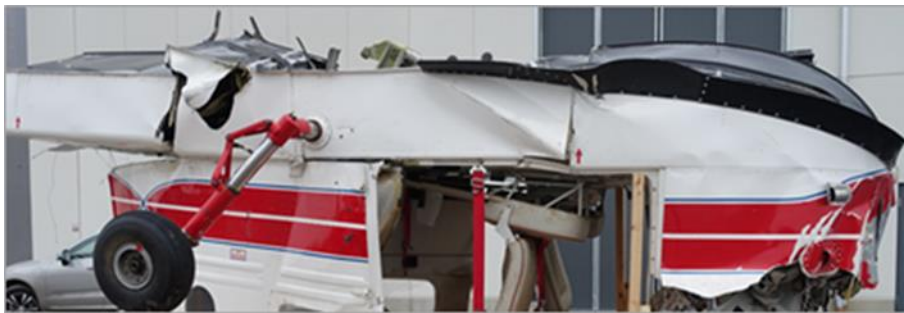
The nose had big dents. The forward part of the airframe had been compressed backwards and bent down to the left. The keel showed signs of both compression folds and tensile failure. Large compression creases were found along the sides of the bottom hull, (see Figure 24).

Figure 24. Left side of bottom hull, keel, nose and cabin. The fuselage is upside down in the picture.

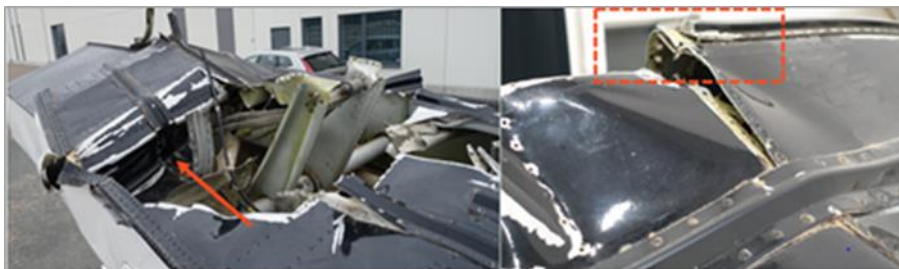
At the aircraft's landing gear and forward to the first bulkhead, large parts of the keel plate were missing or pushed back in the direction of travel, (see Figure 25). A damage to the keel bar at the first bulkhead showed that it had bent downwards and broken off. At the same bulkhead, the keel plate had also been pulled out of its rivet attachments. The bulkhead behind the main landing gear had been pushed back in the direction of travel and punctured the main fuel tank. Also, the bulkheads behind had been pushed back.

Figure 25. The left picture shows the damage to the keel. The arrow points to the pushed back keel plates. The right picture shows the bent and broken keel bar. The fuselage is upside down in the picture.

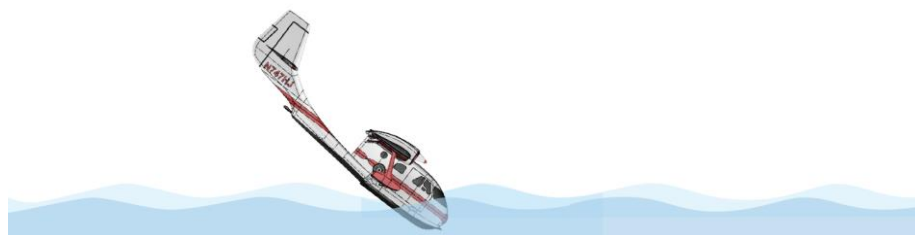
There were also large fractures on the sides of the bottom hull at and around of the step. The location and nature of the damage indicate that the aircraft has been affected by heavy deceleration and rapid movements in pitch, (see Figure 33).

Figure 33. Principle sketch, the aircraft decelerates sharply and tips forward.

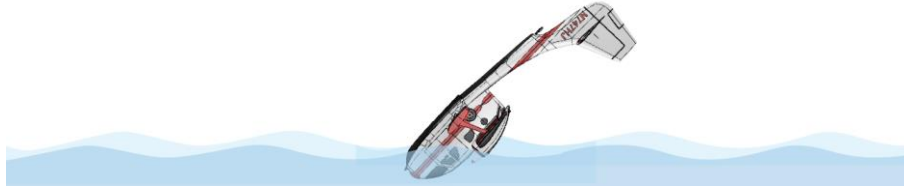
The aircraft's wings were damaged when the aircraft flipped and hit the water, (see Figure 34). The compression damage on the left wing indicates that the aircraft had a slight yaw and that the left wing hit the water first and therefore absorbed most of the energy. After that, the cabin roof was also pushed in and the aircraft ended up upside down and then sank.

Figure 34. Principle sketch, the aircraft turns around.
