LIMITED OCCURRENCE INVESTIGATION REPORT – FINAL

Reference Number	CA18/2/3/10199						
Classification	Accident	Date	2 August 2022		Time	0852Z	
Type of Operation	Remotely Piloted Aircraft (Part 101)						
Location							
Place of Departure	Gamsberg Mine, Northern Cape		Place of Intended Landing		Gamsberg Mine, Northern Cape		
Place of Occurrence	Overhead Tailings Dam in Gamsberg Mine						
GPS Co-ordinates	Latitude	29° 11' 51.9" S	Longitude	18° 56' 46.5" E	Elevation	3080 ft	
Aircraft Information							
Registration	ZT-XDC						
Make; Model; S/N	DJI; Matrice 200 (Serial Number: 0FZDFAP0P30036)						
Damage to Aircraft	Destroyed			Total Aircraft Hours	28.3		
Pilot-in-command							
Licence Type	Remote Pilot Licence (RPL)		Gender	Male		Age	20
Licence Valid	Yes	Total Hours	15.9	Total Hours on Type	5.5		
Total Hours Past 90 days	5.5		Total Hours on Type Past 90 days	5.5			
People Controlling	1 + 0	Injuries	0	Fatalities	0	Other (on ground)	0
What Happened

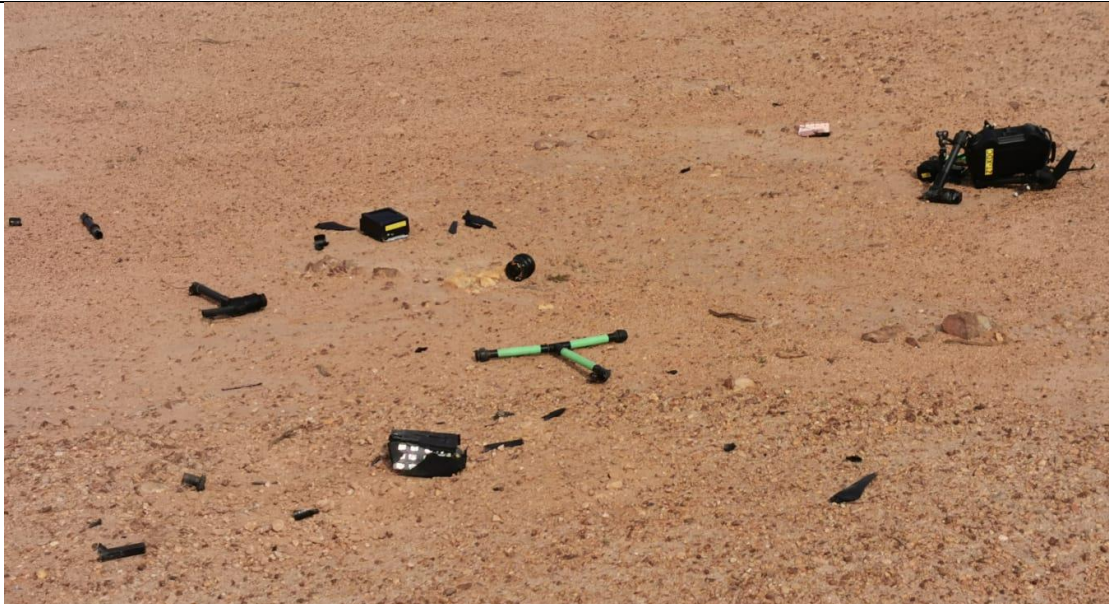
Figure 1: The wreckage of the RPA as found on site. (Source: Operator)

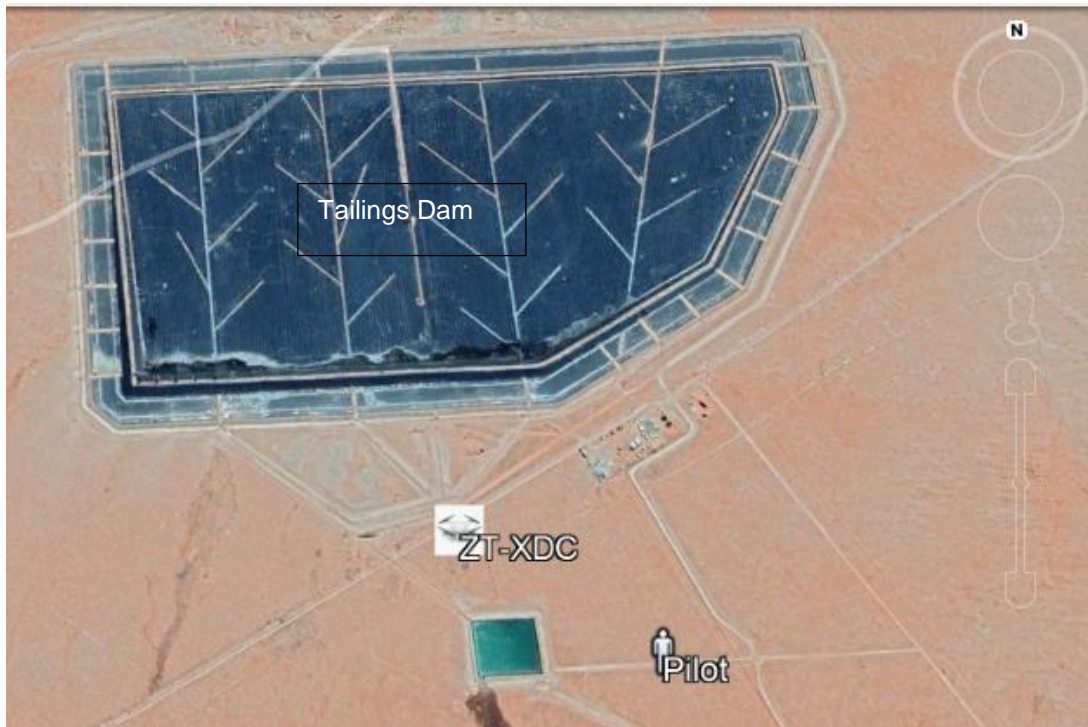
Figure 2: An aerial view of the accident site. (Source: Google Earth)
