CA18/2/3/8792

ACCIDENT REPORT – EXECUTIVE SUMMARY

Aircraft Registration	ZS-OTA	Date of Accident	03 June 2010	Time of Accident	07:00Z
Type of Aircraft	AYRES S2R-T15		Type of Operation		Agricultural
Pilot-in-command Licence Type	Commercial Pilot	Age	60	Licence Valid	Yes
Pilot-in-command Flying Experience	Total Flying Hours	8384,1		Hours on Type	4771,55
Last point of departure	Greefdale Private Aerodrome near Hartswater in the North-West Province				
Next point of intended landing	Taung in the North-West Province.				
Location of the accident site with reference to easily defined geographical points (GPS readings if possible)					
On a private runway at Greefdale Aerodrome, Hartswater. GPS position determined as S27° 48.43.99 E024° 44.00.13					
Meteorological Information	Wind: Calm; Temperature: 7 °C; Visibility: Good				
Number of people on board	1 + 0	No. of people injured	1	No. of people killed	None
Synopsis	<p>It was reported by the pilot that he was to perform a crop spraying detail. During the takeoff roll he lost directional control and the aircraft's left wing clipped a tree next to the runway, which caused the aircraft to ground loop through 180 degrees, leaving the aircra

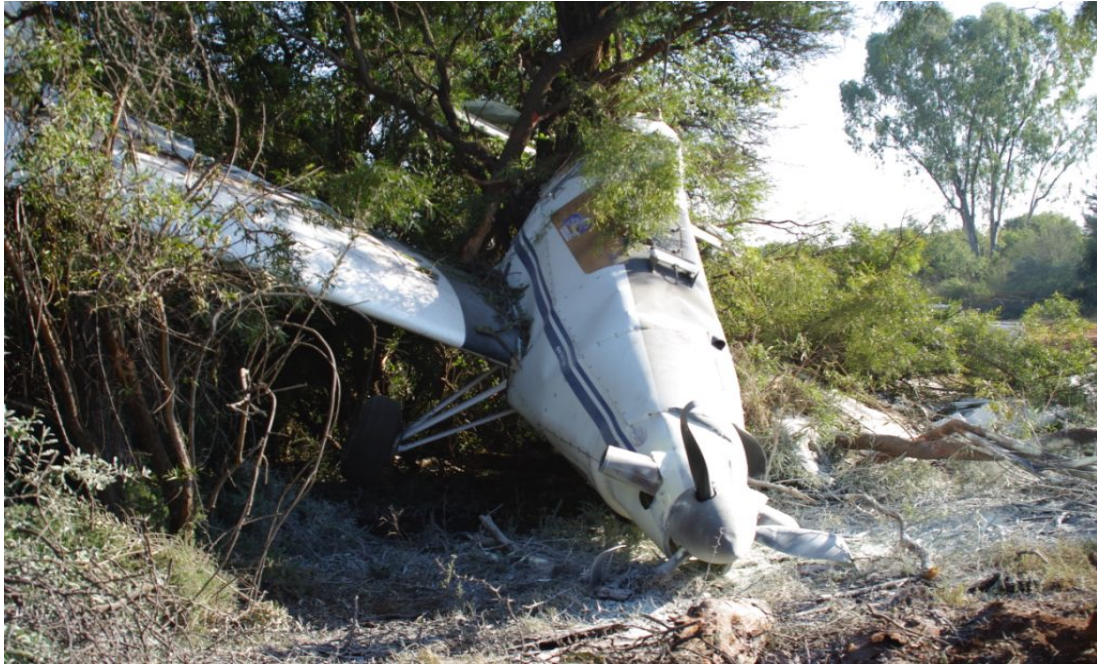
- 1.3.1 The aircraft sustained substantial damage to the wings, airframe, engine and propeller.

Picture 1 Accident site.

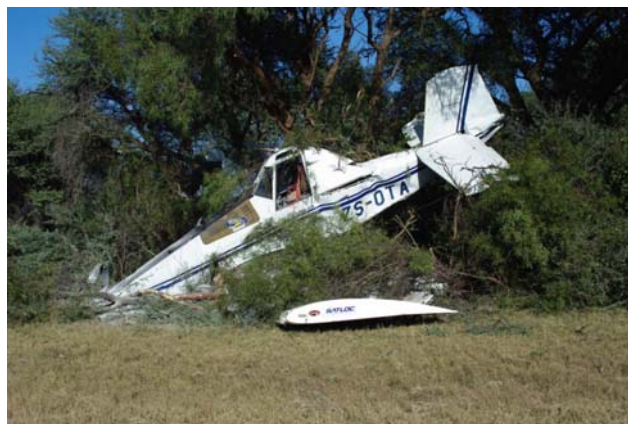
1.12.1 The pilot was about to commence with a crop spraying detail. During the takeoff roll in a northerly direction, the pilot lost directional control of the aircraft and hit trees 700 metres down the runway, next to the runway.

Picture 2 Damage to the aircraft

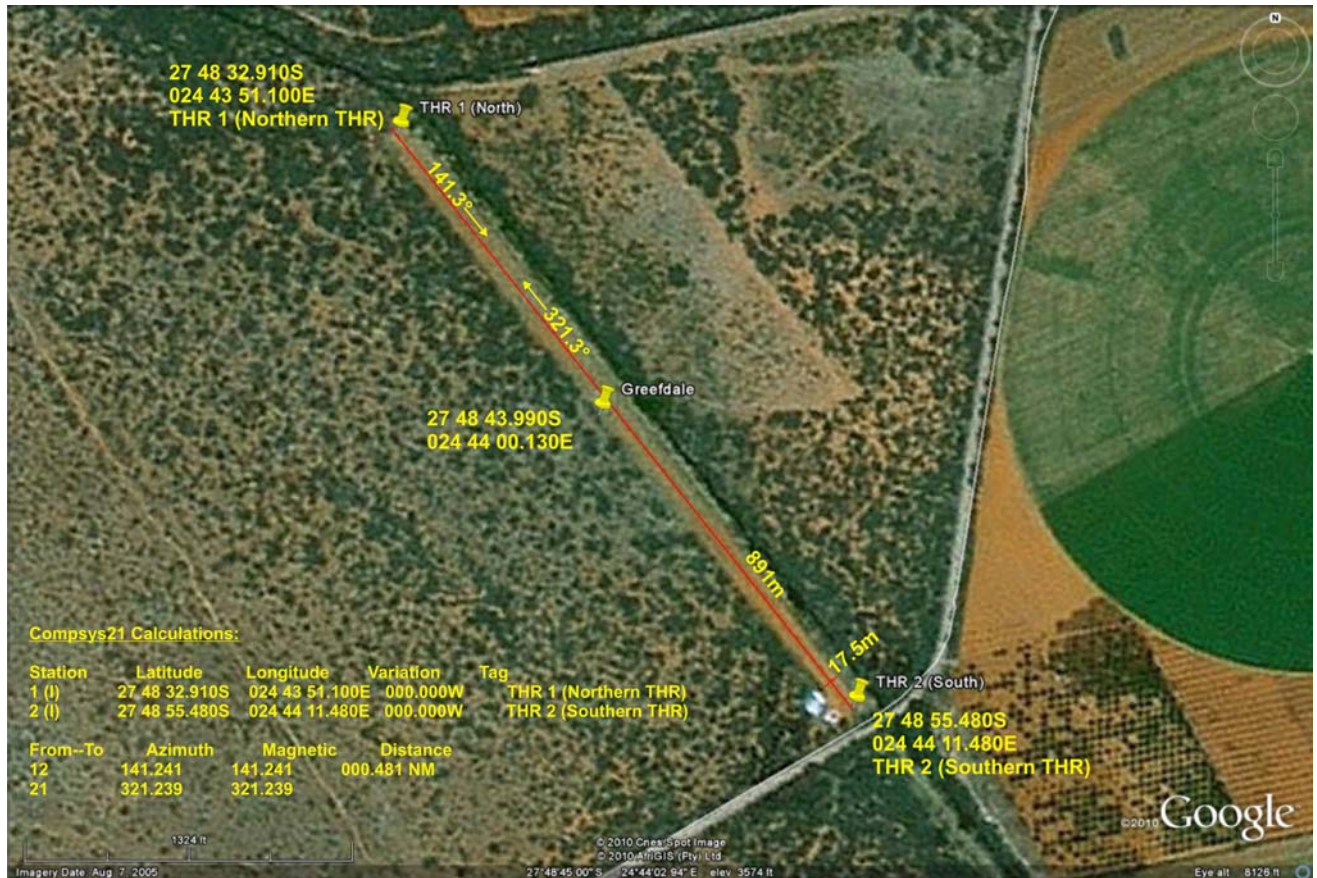
1.18.4 The private aerodrome is located at S27°48.43.99 E024°44.00.13 from the Google Earth image below. The width of the runway was determined to be approximately 17,5m.

1.18.5 The Google Earth calculations to determine the runway dimensions were done with the Digital Aeronautical Database System (DADS) (Version 2.8/06) software. The results of the calculations can be seen on photo 2 attached below.

1.18.6 The width of the runway was determined by the trees bordering the runway. The distance between the rows of trees bordering the runway and parallel to the runway was determined to be 17.5m.

Picture 3 Google Earth image

The investigation determined that the clearance between the aircraft and the trees on the edge of the runway, as seen from the Google Earth image, posed a potential hazard to the pilot.

The space left between the aircraft wingtip and the trees left the pilot with a very small margin for error in case of a loss of directional control.
